COLORADO
Division of Reclamation,
Mining and Safety
Department of Natural Resources

Permit Number: C-1996-083 Mine Name: Bowie No. 2 Mine Operator: Bowie Resources, LLC Operator Address: Mr. Basil Bear P.O. Box 1488 Paonia, CO 81428	County: Delta Operation Type: Underground Permit Status: Active Ownership: Private
	Operator Representative Present: None
Operator Representative Signature: (Field Issuance Only)

Inspection Start Date: March 31, 2021 Inspection Start Time: 11:25 Inspection End Date: March 31, 2021 Inspection End Time: 11:30		Inspection Type: Aerial Inspection Inspection Reason: Normal I&E Program Weather: Clear	
Joint Inspection Agency: None		Joint Inspection Contacts: 	
Post Inspection Agency: None		Post Inspection Contacts: 	
Inspector(s): Robert Zuber, P.E. Brock Bowles	Inspector's Signature: <i>Robert D. Zuber</i>		Signature Date: 4/5/2021

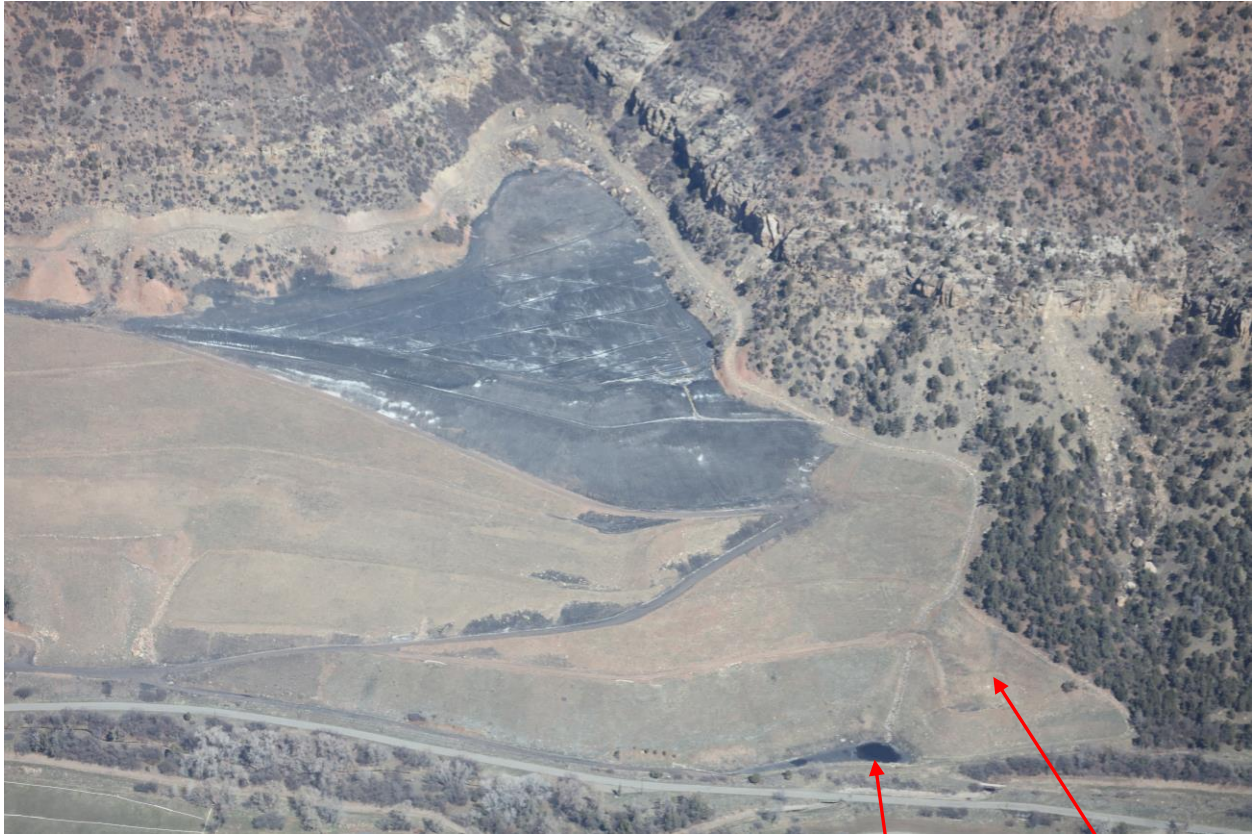
Minor erosion on Gob Pile #2 and Gob Pile #3 does not appear to be a problem, and there is no sign of significant coal waste in the ditch below the pile (Ditch J3).

Gob Pile #1, Gob Pile #4, and the reclaimed portion of Gob Pile #2 all appear to be in adequate shape with minimal areas that are bare. The hillsides along the access road to the mine appear to be in excellent condition. No signs of significant erosion can be seen in the photographs.

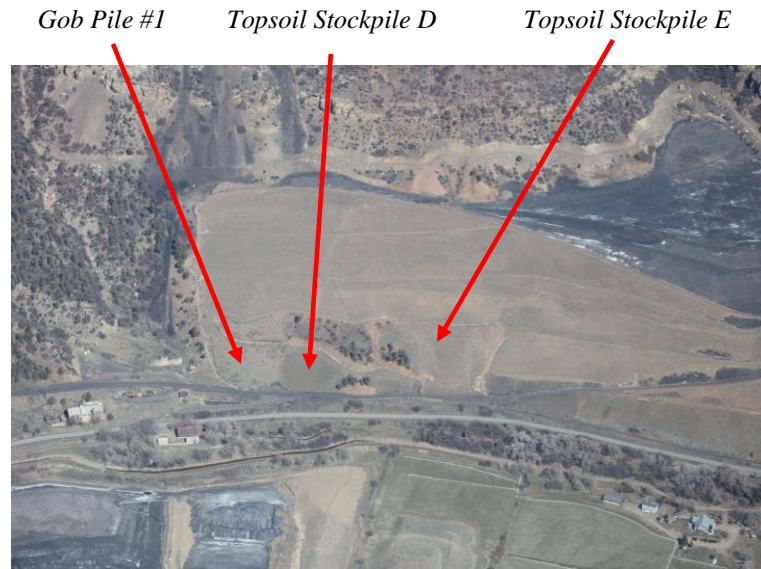
Gob Pile #1, Gob Pile #4, and soil piles

Topsoil stockpiles and coverfill piles appear stable. These include:

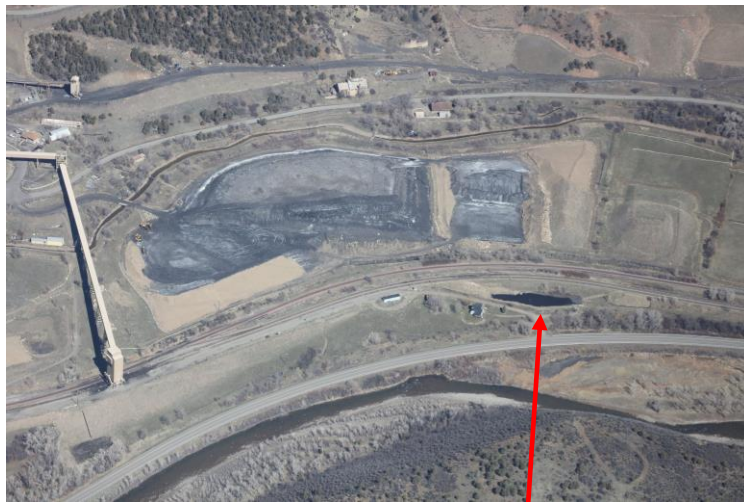
Gob Pile #3

The following ponds were inspected: B, C, D, F, J, and K. Most of the ponds appeared to be dry or nearly dry. The exception was Pond J below Gob Pile #3. No problems were identified with embankments or other features of the ponds.

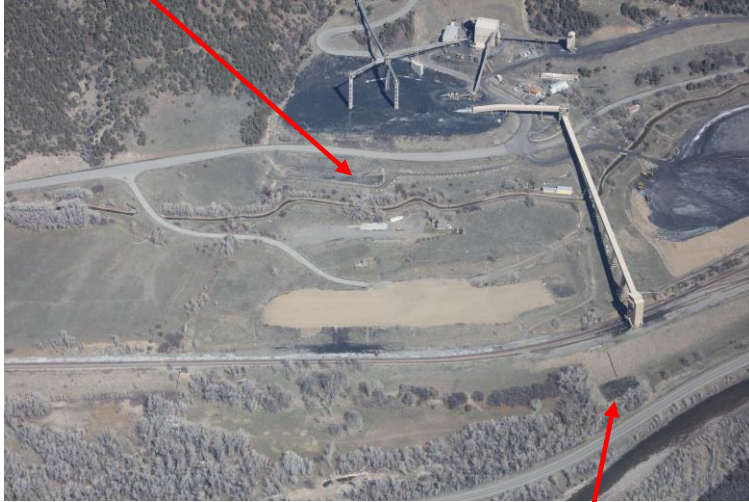
Coal Storage Pad and area below

No problems were identified with any facility areas, including the following: the Utility Bench, the D Portal Bench, the B Portal Bench, the Material Storage Area by Curve #4, the Conveyor Corridor, the Coal Stockpile Pad, the office, the Preparation Plant area, the storage area and buildings near Pond D, the train loadout area.

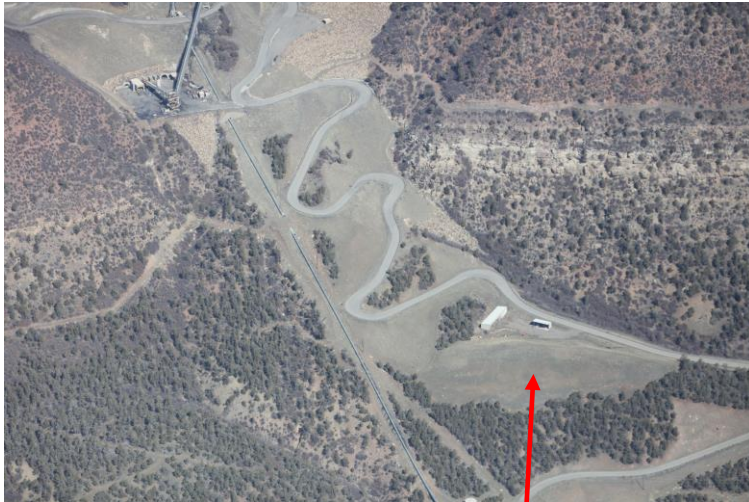
Access Road and B Portal Bench

No problems were seen with the access roads (to the portals and Utility Bench and to the refuse area). Roads near the Terror Creek Vent Shaft were inspected; no problems were seen.

It appears that slumps have not moved significantly in the recent past. These include slumps by the B Portal and by Curve Number 11 along the Haul Road.

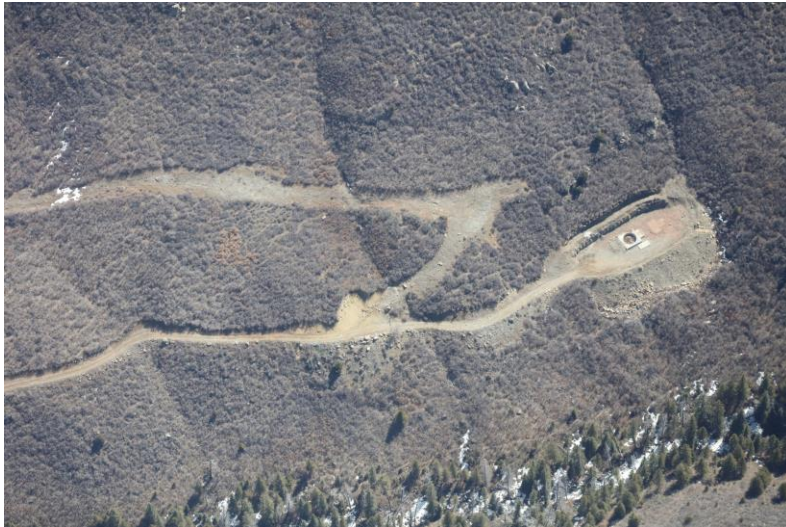
Pad and roads for Terror Creek Vent Shaft

The pad for the Terror Creek Vent Shaft was inspected. No problems were identified.
