COLORADO
Division of Reclamation,
Mining and Safety
Department of Natural Resources

Permit Number: C-1980-004 Mine Name: McClane Canyon Mine Operator: ARC McClane Canyon, LLC Operator Address: Jim E Stover 2352 N 7th Street, Unit C Grand Junction , CO 81501	County: Garfield Operation Type: Underground Permit Status: Temporary Cessation Ownership: Private
	Operator Representative Present: Chuck Selingo
Operator Representative Signature: (Field Issuance Only)

Inspection Start Date: March 31, 2021 Inspection Start Time: 08:35 Inspection End Date: March 31, 2021 Inspection End Time: 09:20		Inspection Type: Coal Complete Inspection Inspection Reason: Normal I&E Program Weather: Clear	
Joint Inspection Agency: None		Joint Inspection Contacts: None	
Post Inspection Agency: None		Post Inspection Contacts: None	
Inspector(s): Clayton Wein	Inspector's Signature: <i>Clayton Wein</i>		Signature Date: 4/5/2021

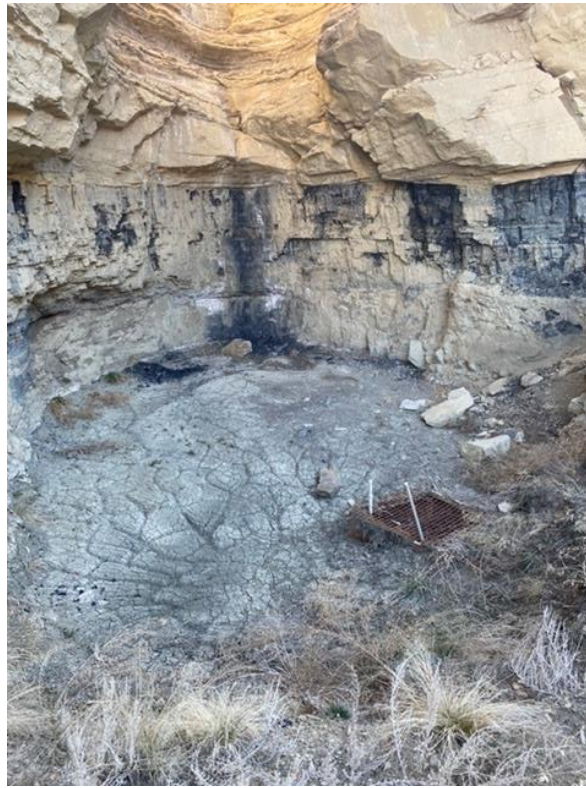
There are two sumps located at the portals area. The eastern sump was dry during the inspection (Photo 1). The outlet was clear of debris. There were no erosional features observed. The northern sump was also dry. The outlet for the sump was unobstructed. There were no indications of erosion.

Photo 1: The eastern sump in the portals area.

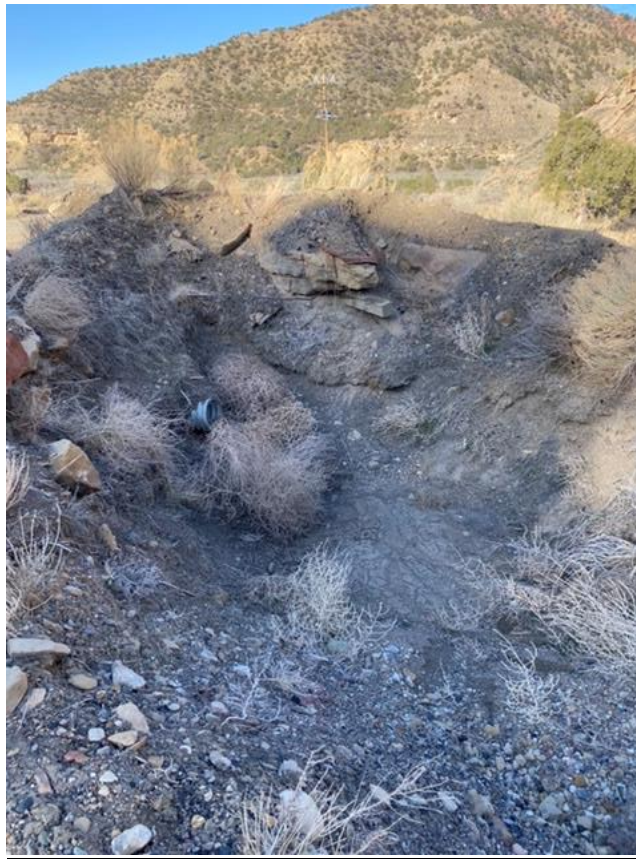
The ditches along the haul road were dry and clear of debris (Photo 2). The ditches were stable and no indications of side cutting were observed. The multiple sumps along the haul road were observed to be dry. The outlets of the sumps were clear. There were no indications of instability or erosion observed.

Photo 2: One of the sumps along the haul road.

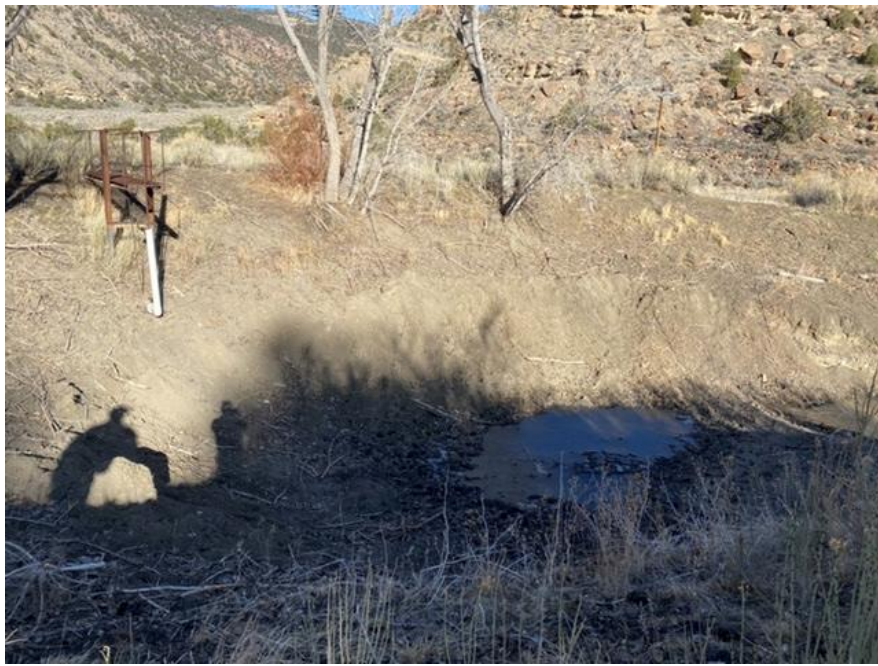
The sediment pond was holding a small puddle of water in it (Photo 3). There was no discharge from the pond. The outlet riser was clear of obstructions. The embankment was stable with vegetation. There were no indications of erosional features.

Photo 3: The sediment pond.

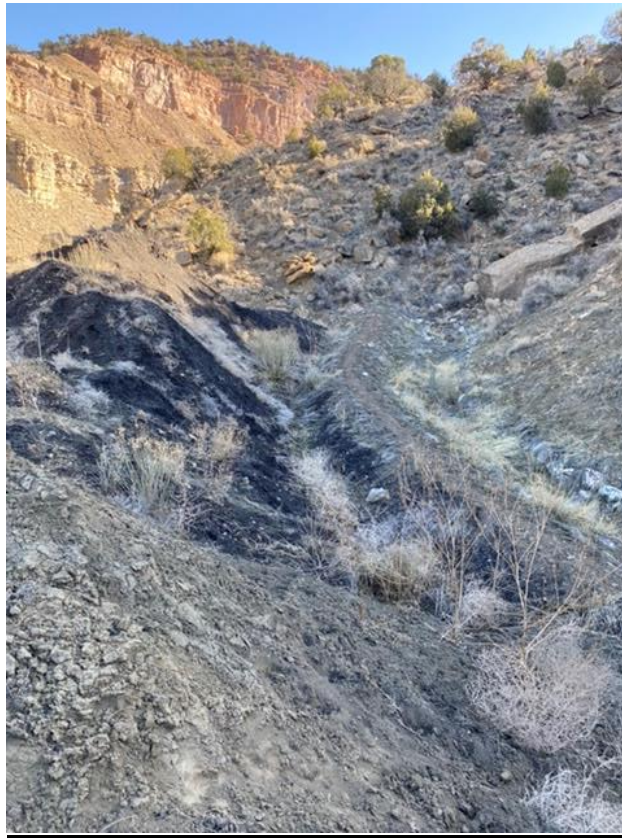
The Coal Waste Pile is located to the east of the sediment pond. The pile was stable and there were no erosional features identified (Photo 4). The berm and perimeter ditch were intact and vegetated. There were no off site impacts observed.

Photo 4: The eastern side of the coal waste pile.

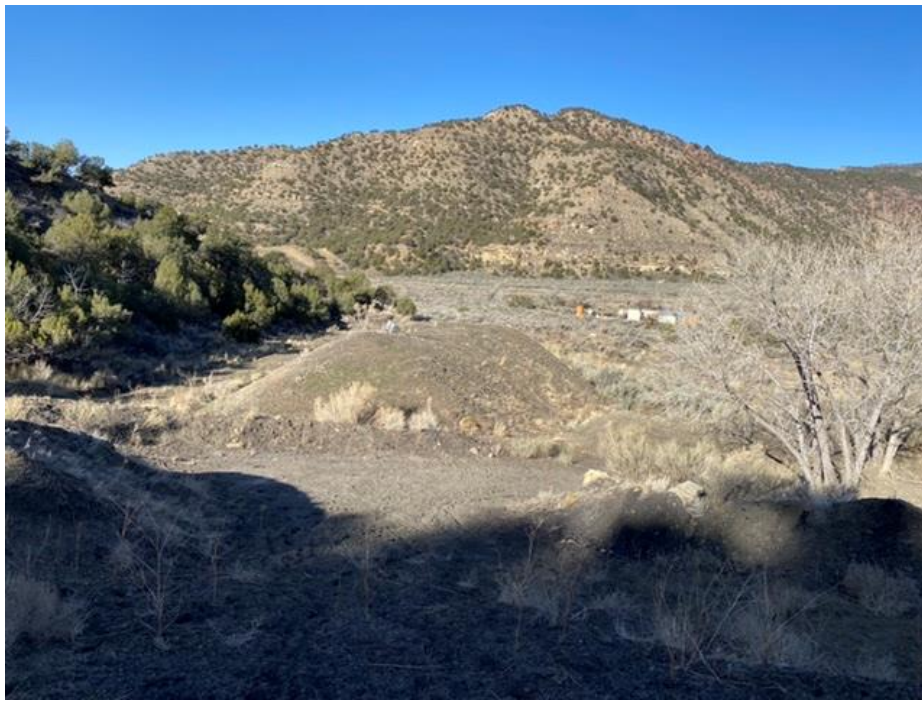
The topsoil pile was stable with mature vegetation (Photo 5). There were no erosional features observed on the pile. The perimeter ditch was stable and clear from obstructions. The topsoil pile marker was seen on top of the pile in a clearly marked location.

Photo 5: The topsoil pile.
