COLORADO
Division of Reclamation,
Mining and Safety
Department of Natural Resources

Permit Number: C-1981-018 Mine Name: Deserado Mine Operator: Blue Mountain Energy, Inc. Operator Address: Mr. Kurtis Blunt 3607 County Road 65 Rangely, CO, 81648	County: Moffat, Rio Blanco Operation Type: Underground Permit Status: Active Ownership: Private
	Operator Representative Present: Mike Meinzer
Operator Representative Signature: (Field Issuance Only)

Inspection Start Date: March 30, 2021 Inspection Start Time: 11:45 Inspection End Date: March 30, 2021 Inspection End Time: 14:45		Inspection Type: Coal Complete Inspection Inspection Reason: Normal I&E Program Weather: Clear	
Joint Inspection Agency: None		Joint Inspection Contacts: None	
Post Inspection Agency: None		Post Inspection Contacts: None	
Inspector(s): Clayton Wein	Inspector's Signature: <i>Clayton Wein</i>		Signature Date: 4/7/2021

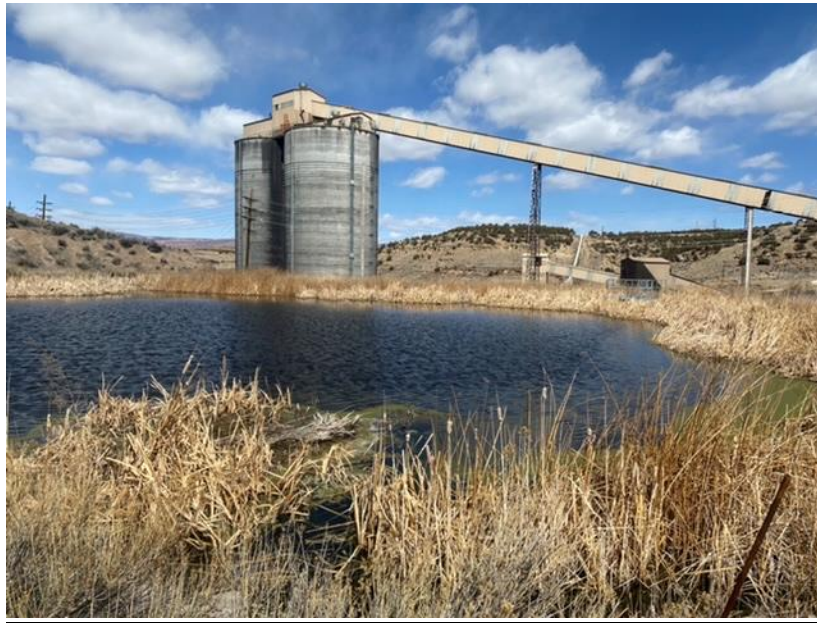
(Photo 1). During the inspection, the DP-1 Pond was impounding water. The level of water impounded in the pond had reached the primary spillway. The pond was discharging. The spillway was clear of debris and functioning. The embankment for the pond was stable with vegetative cover. There were no indications of erosion. Due to the high level of traffic within the prep plant area, the PP-1 Pond was not visited during this inspection. The PP-2 Pond was holding water during the inspection. There was no discharge occurring. The embankment was observed to be vegetated and stable. No erosional features were identified.

Photo 1: The PP-2 Pond.

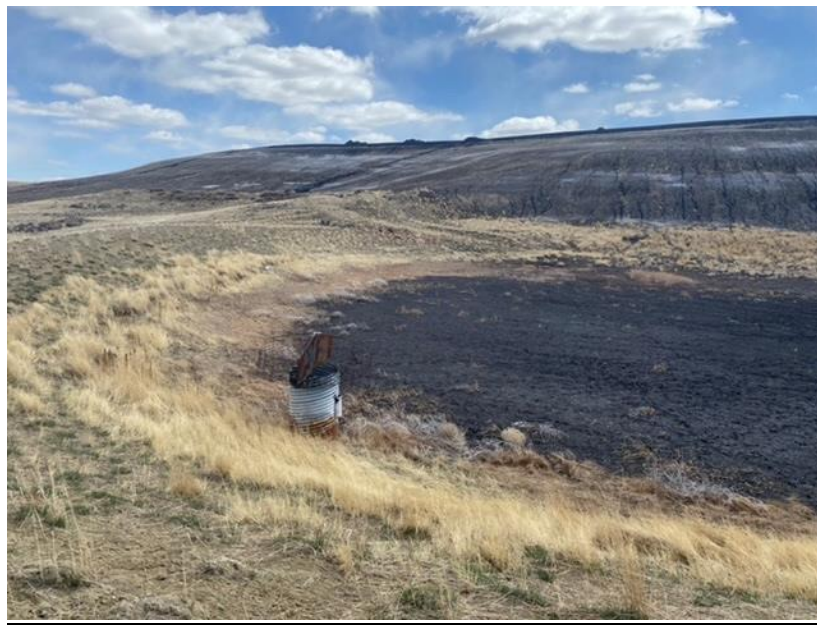
The RP-4 Pond is located at the northwestern base of the RP-2/3/4 refuse pile. The pond was dry at the time of the inspection. The embankment for the pond was vegetated and stable. There were no indications of erosion. The spillway for the pond was unobstructed (Photo 2).

Photo 2: The outlet of the RP-4 Pond.

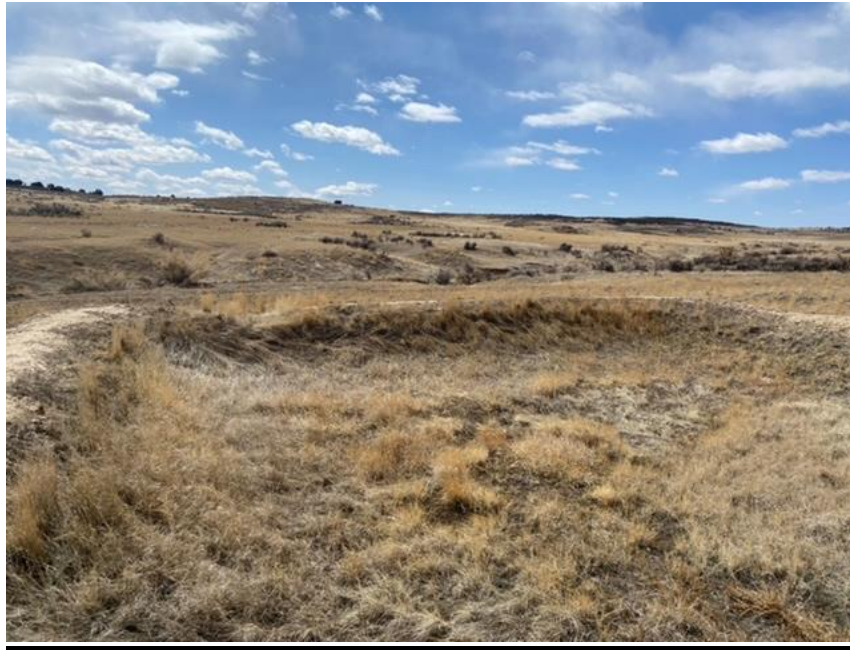
There is one sump, RS-1, and one pond, RR-1 associated with the Rail Loadout. The sump is located at the southwest corner of the loadout. The sump was dry (Photo 3). The outlet to the sump was clear of debris. The embankments were vegetated and stable. There were no erosional features. The RR-1 Pond was dry during the inspection. The outlet for the pond was unobstructed. The embankment was covered with vegetation. There were no indications of instability or erosion.

Photo 3: The RS-1 Sump.

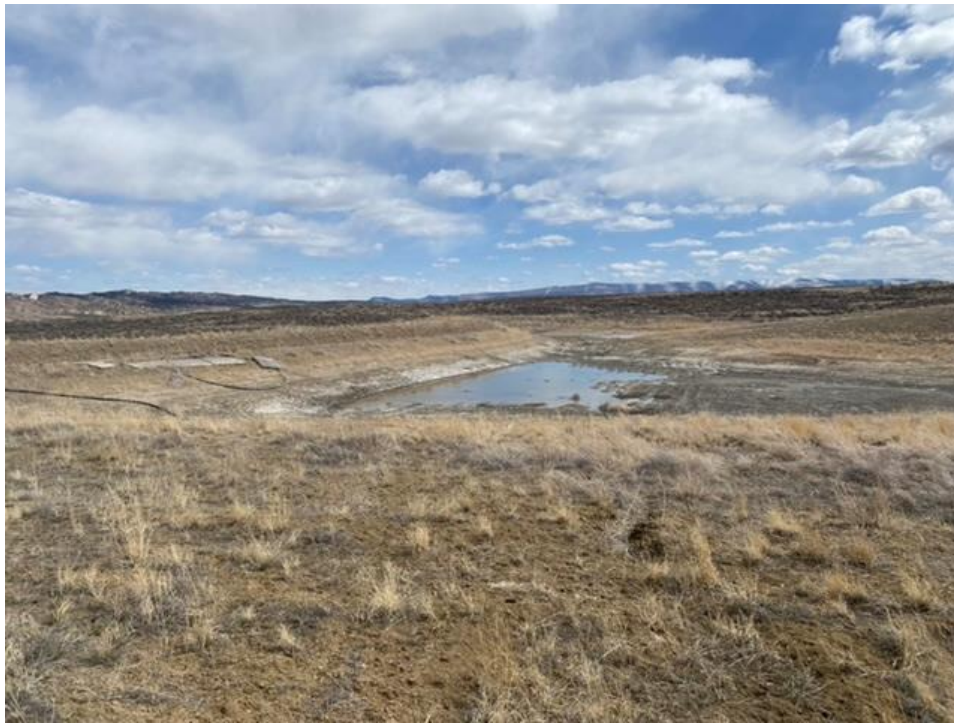
The B Seam Dewatering System No. 2 was inactive at the time of the inspection. A small amount of water was impounded in the first and second cells (Photo 4). There was no discharge occurring. The embankments for the cells were covered with vegetation and stable. No indications of erosion were noted.

Photo 4: The second cell of the B Seam Dewatering System No. 2.

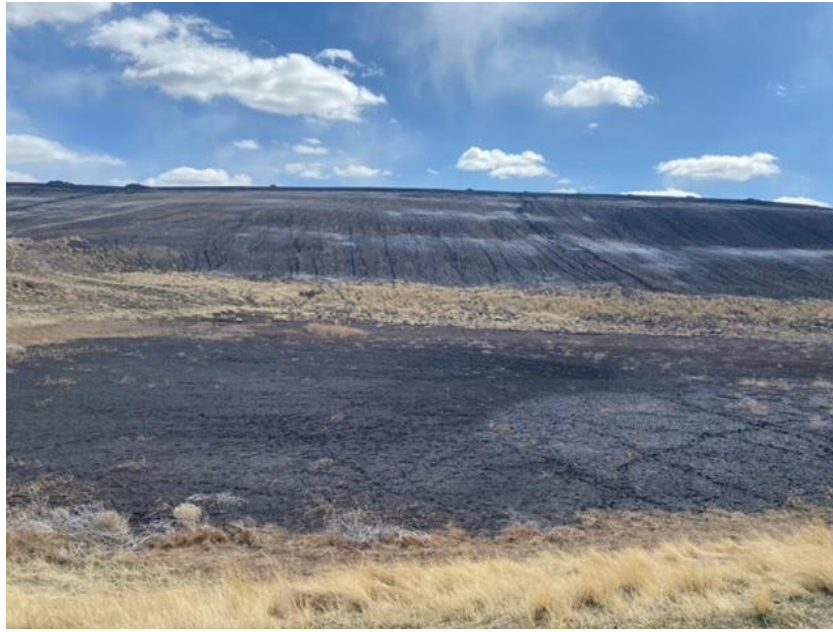
Refuse material on top of RP-2/3/4 was stockpiled in wind rows. The pile was stable with localized erosion on the slopes. The slopes were stable and the localized erosion was not thought to be affecting the stability of the pile. The erosion on the slopes is in the form of rills and a few that have progressed to the size of gullies (Photo 5).

Photo 5: The RP-2/3/4 refuse pile above the RP-4 Pond.

Please ensure that the slopes of the RP-2/3/4 refuse pile are included on the spring maintenance list for 2021.

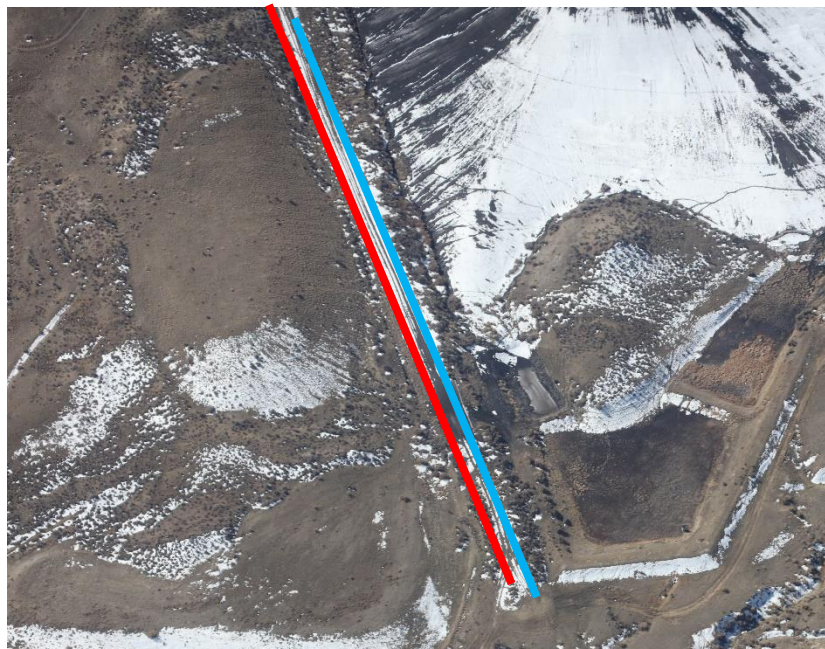
Access road throughout the mine site were observed to be stable with no erosional features. **The access road located on the east side of RP-2/3/4 needs its eastern ditch maintained. The middle and lower portions of the ditch have begun filling with sediment.** Please see the attached aerial photo (Photo 6) for the location mentioned.

Photo 6: The RP-2/3/4 refuse pile and RP-2/3 pond Access road is identified by a blue line in the above March 2021 aerial Photo. The red line above is the ditch requiring maintenance.

5. **Refuse Disposal Area/Refuse Area Ponds Access Road:** The access road located on the east side of RP-2/3/4 needs its eastern ditch maintained. The middle and lower portions of the ditch have begun filling with sediment.

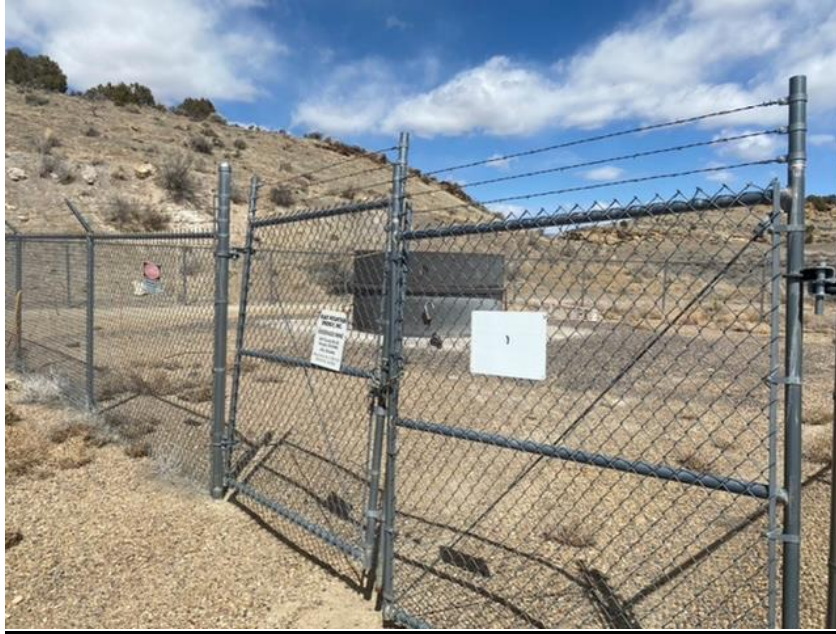
Photo 7: The B Vent Shaft No. 1.
