**MINERALS PROGRAM INSPECTION REPORT**  
**PHONE: (303) 866-3567**

| <b>MINE NAME:</b><br>Goose Haven Reservoir #2- Complex Expansion | <b>MINE/PROSPECTING ID#:</b><br>M-2010-071 | <b>MINERAL:</b><br>Borrow material for construction | <b>COUNTY:</b><br>Boulder |
| <b>INSPECTION TYPE:</b><br>Monitoring | <b>INSPECTOR(S):</b><br>Amy Eschberger | <b>INSP. DATE:</b><br>April 1, 2021 | <b>INSP. TIME:</b><br>10:00 |
| <b>OPERATOR:</b><br>The City of Lafayette | <b>OPERATOR REPRESENTATIVE(S):</b><br>Melanie Asquith, Jon File | <b>TYPE OF OPERATION:</b><br>112c - Construction Regular Operation | |

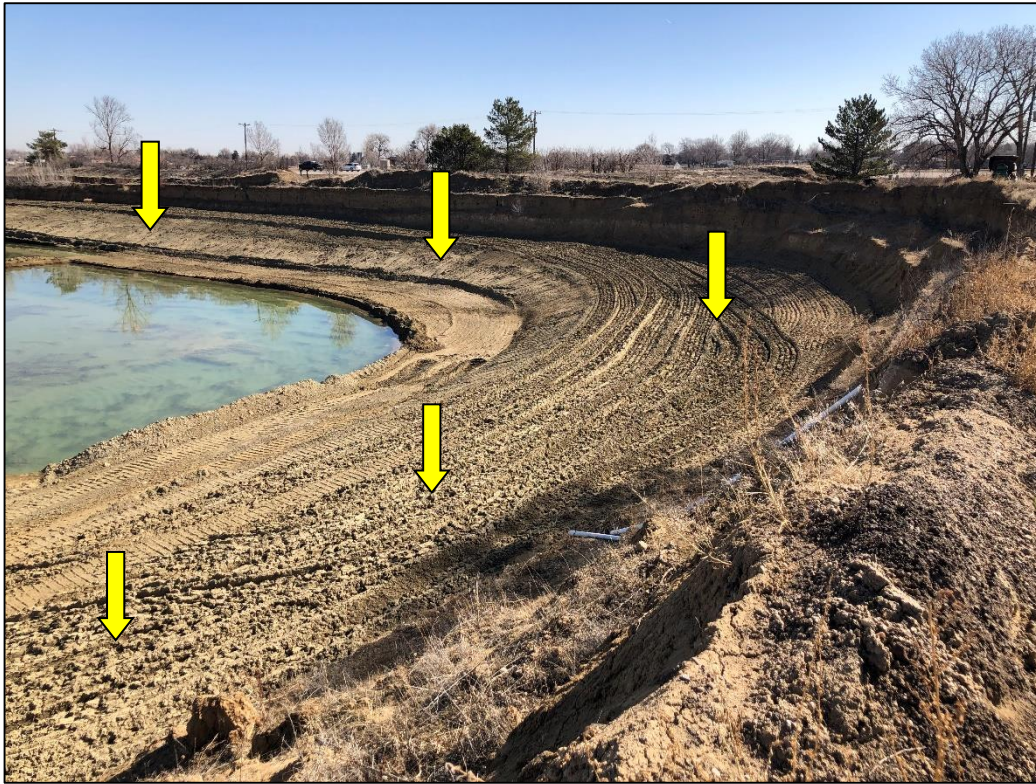
**Photo 1.** View looking east across southeastern edge of Reservoir # 4 pit, showing partially installed clay liner (indicated with arrows) with slopes of 3H:1V or flatter. Note standing water on pit floor.

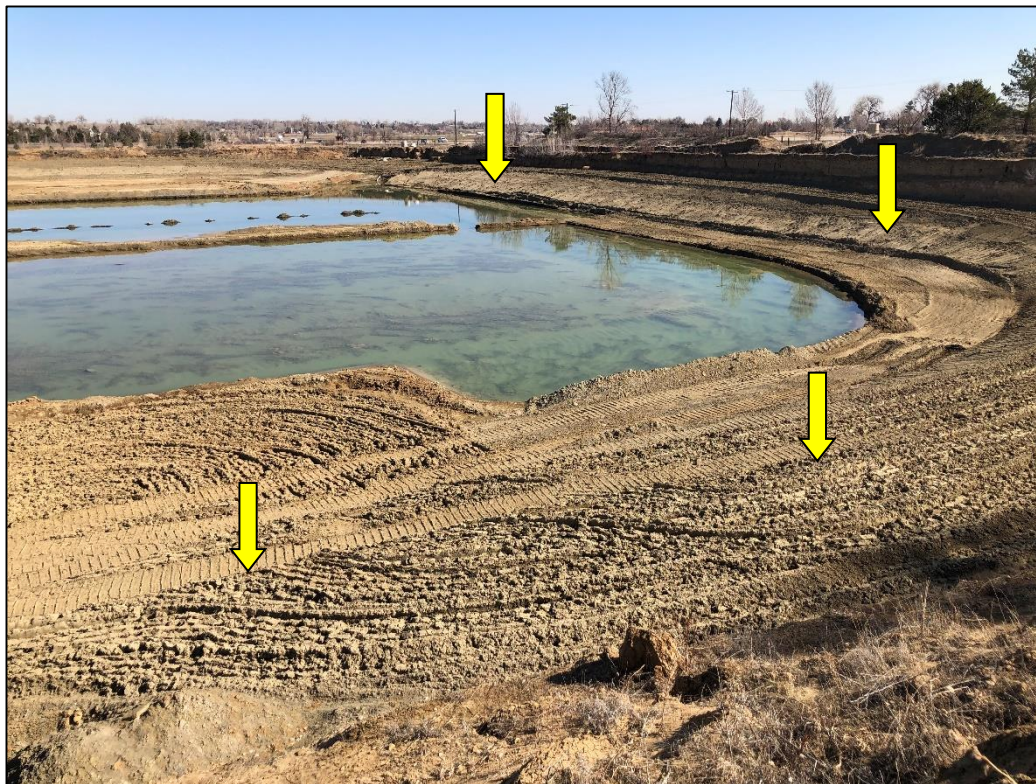
**Photo 2.** View looking northeast across eastern edge of Reservoir # 4 pit, showing partially installed clay liner (indicated with arrows) with slopes of 3H:1V or flatter. Note standing water on pit floor.

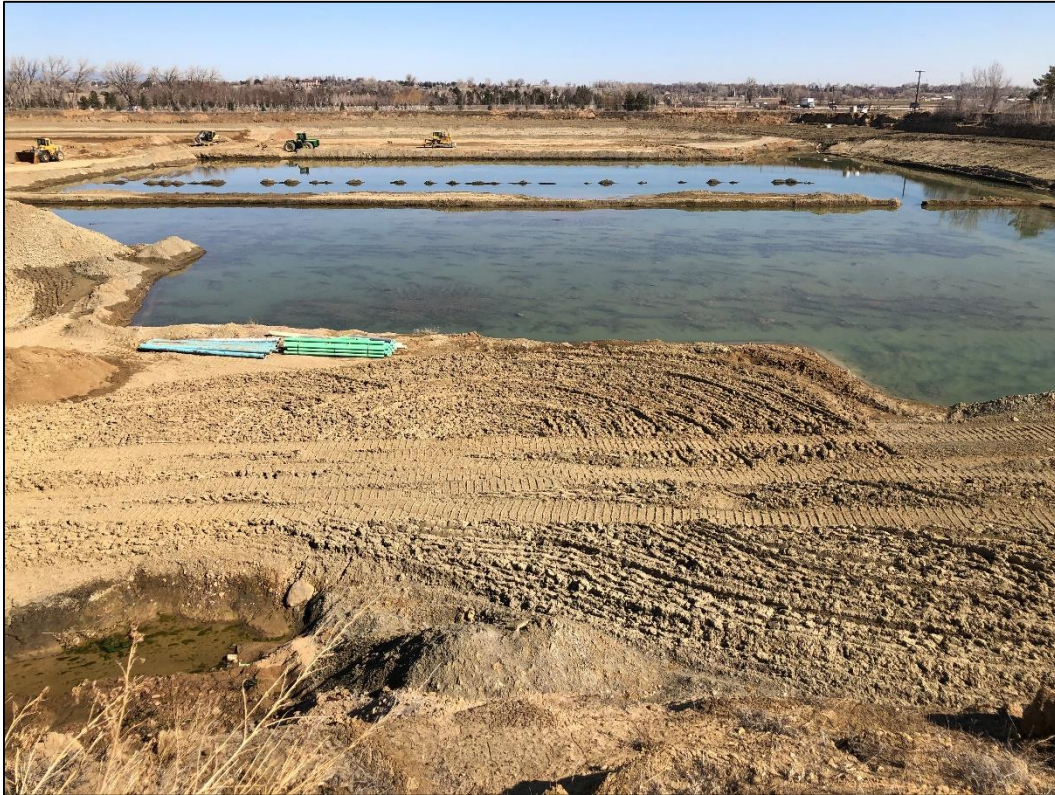
**Photo 3.** View looking north across eastern portion of Reservoir # 4 pit. Note standing water on pit floor.

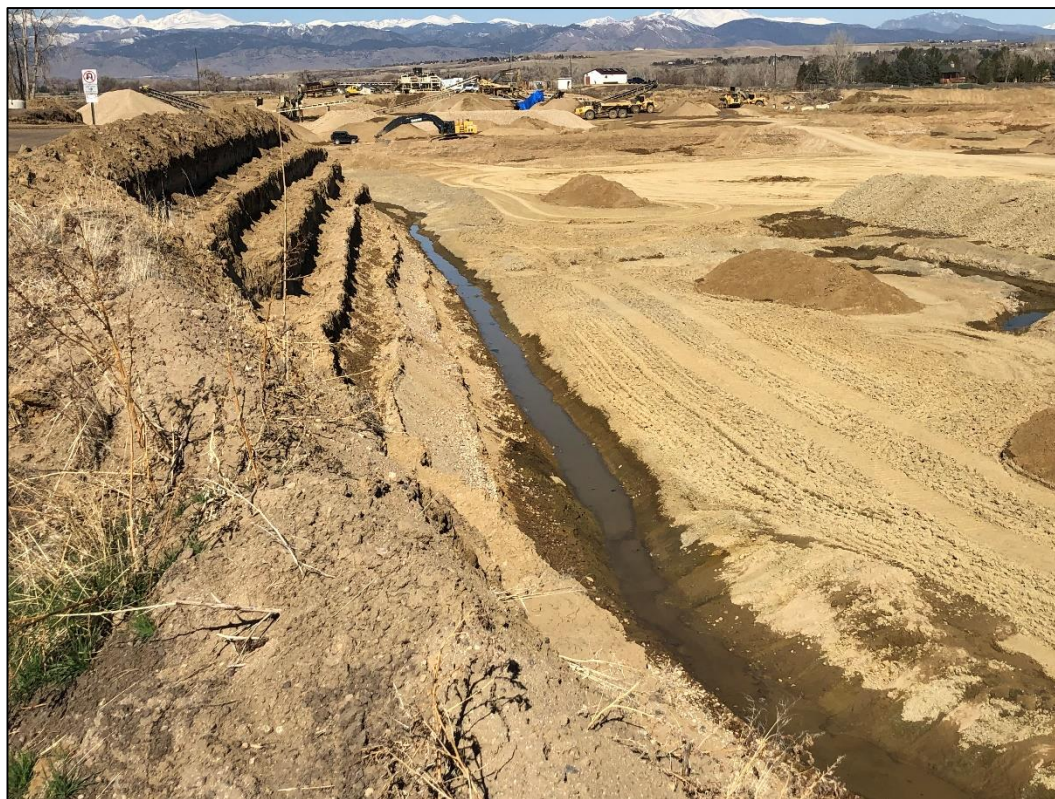
**Photo 4.** View looking west across southern edge of Reservoir # 4 pit. Note dewatering trench present along inside perimeter of pit and clay liner not yet installed in this area.

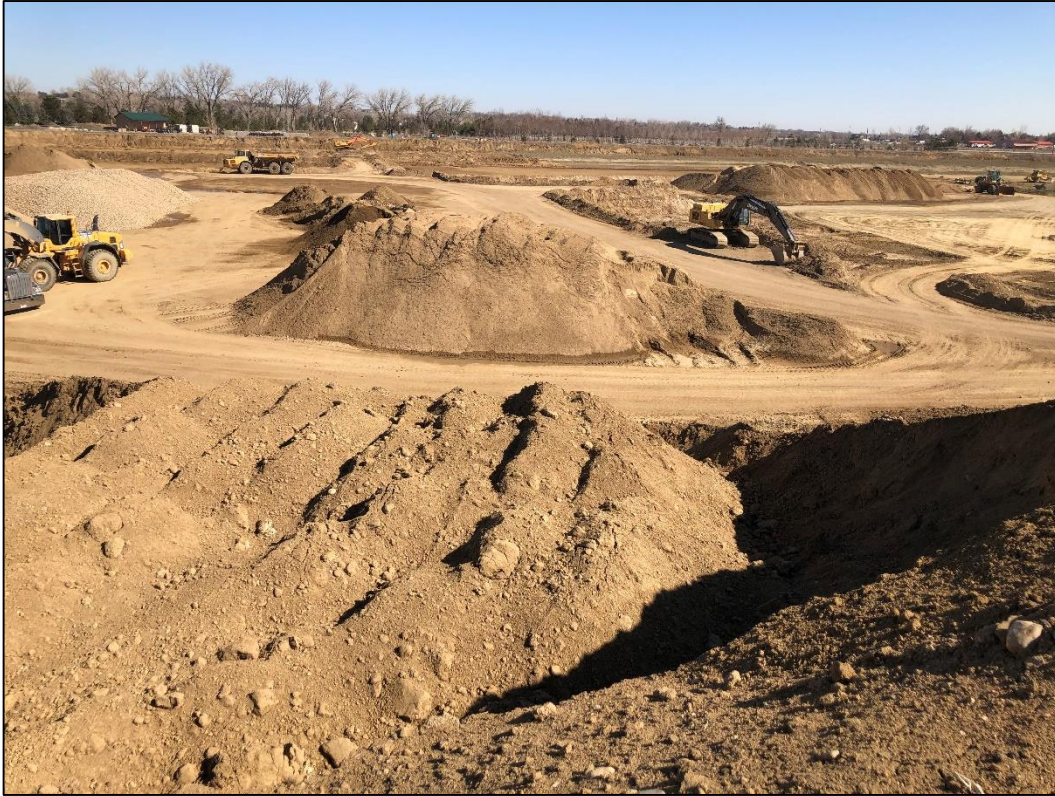
**Photo 5.** View looking north across central portion of Reservoir # 4 pit. Note various material stockpiles stored on pit floor.

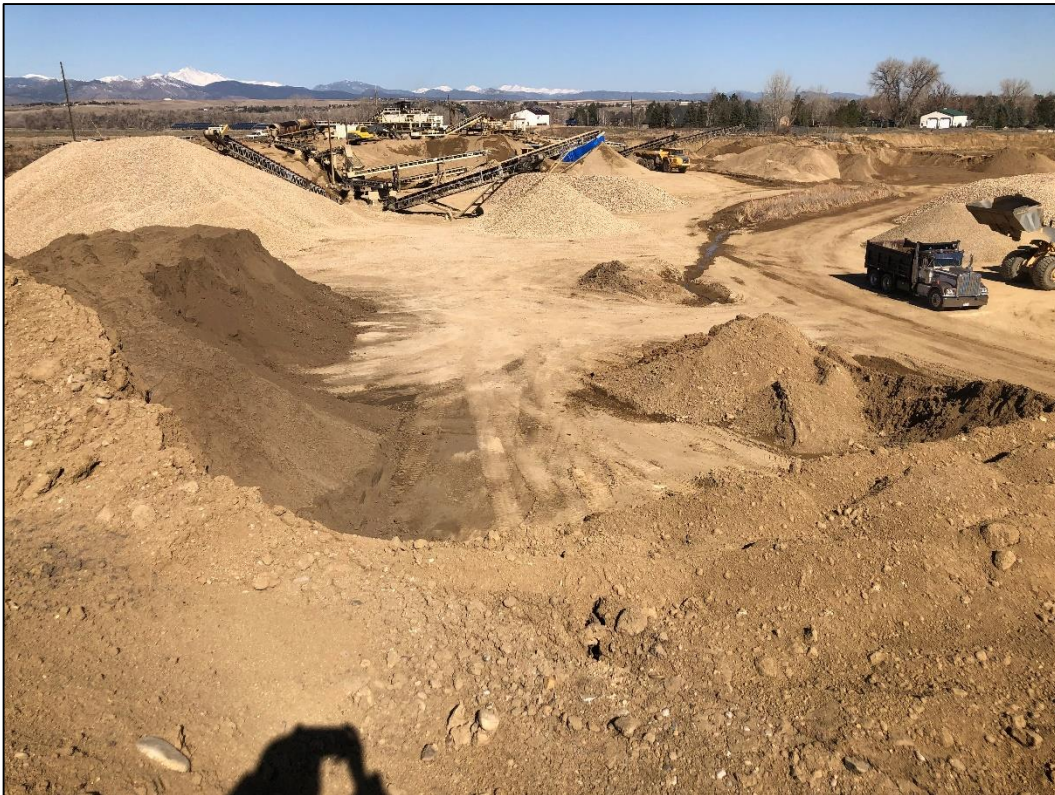
**Photo 6.** View looking northwest across western portion of Reservoir # 4 pit. Note various material stockpiles stored on pit floor and processing plant operating in background.

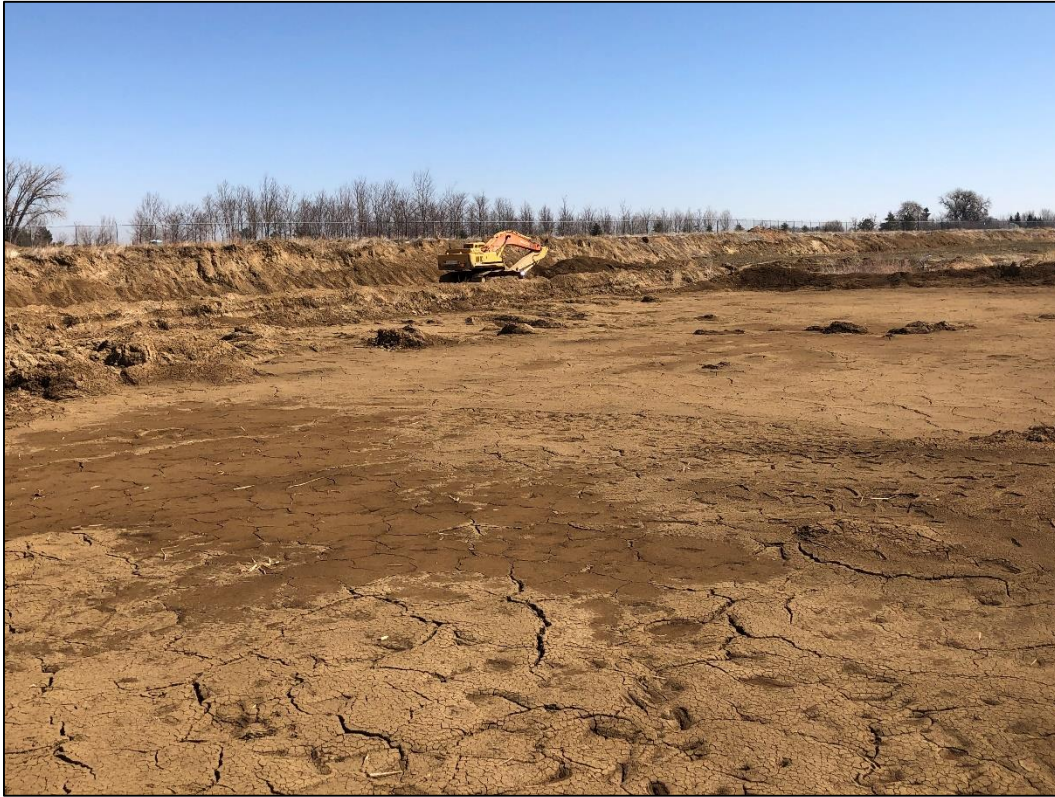
**Photo 7.** View looking northeast across northwestern portion of Reservoir #4 pit. This portion of the pit will be mined deeper. The clay liner has not yet been installed in this area.

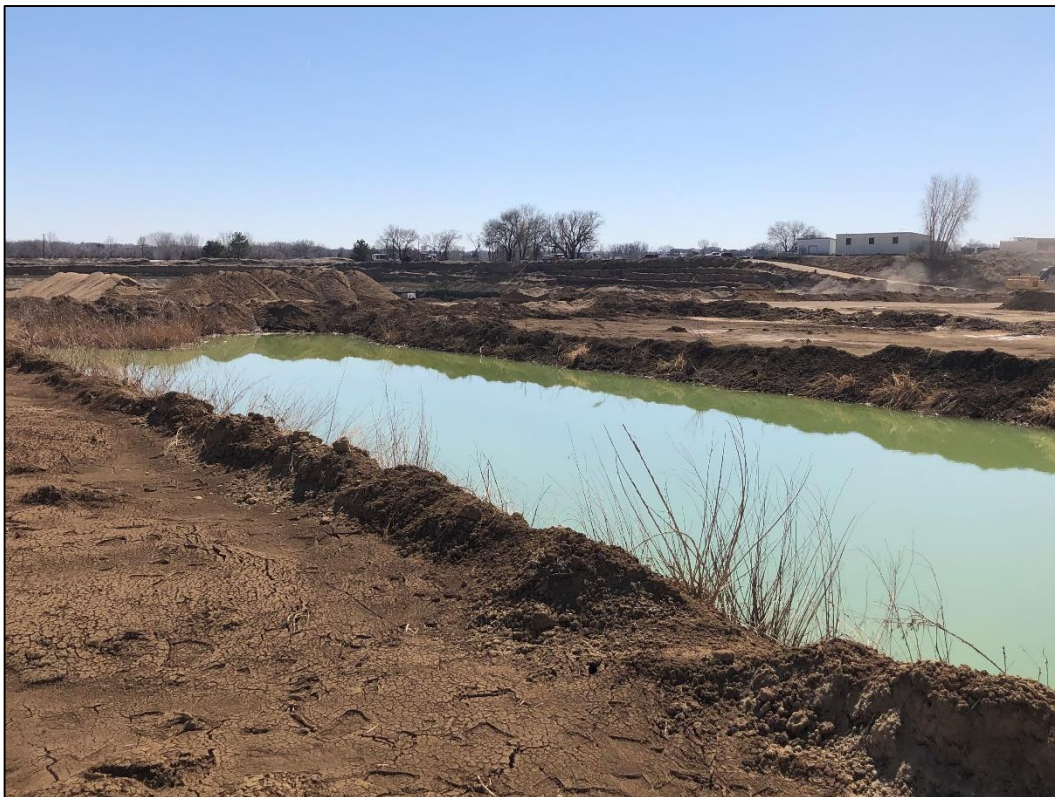
**Photo 8.** View looking southeast across one of two settling ponds present in northwestern portion of Reservoir #4 pit. Water from settling ponds is routed north of site to eventually discharge into Boulder Creek.

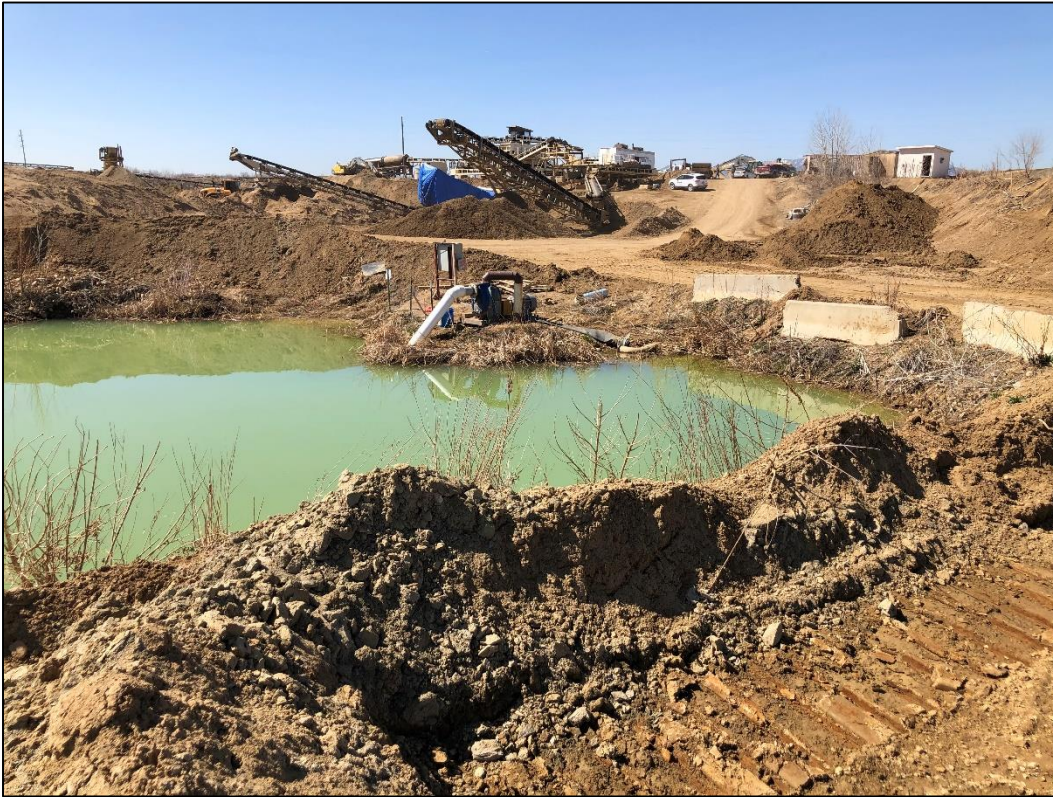
**Photo 9.** View looking west across western portion of Reservoir #4 pit, showing one of two settling ponds (in foreground), and processing plant (in background).

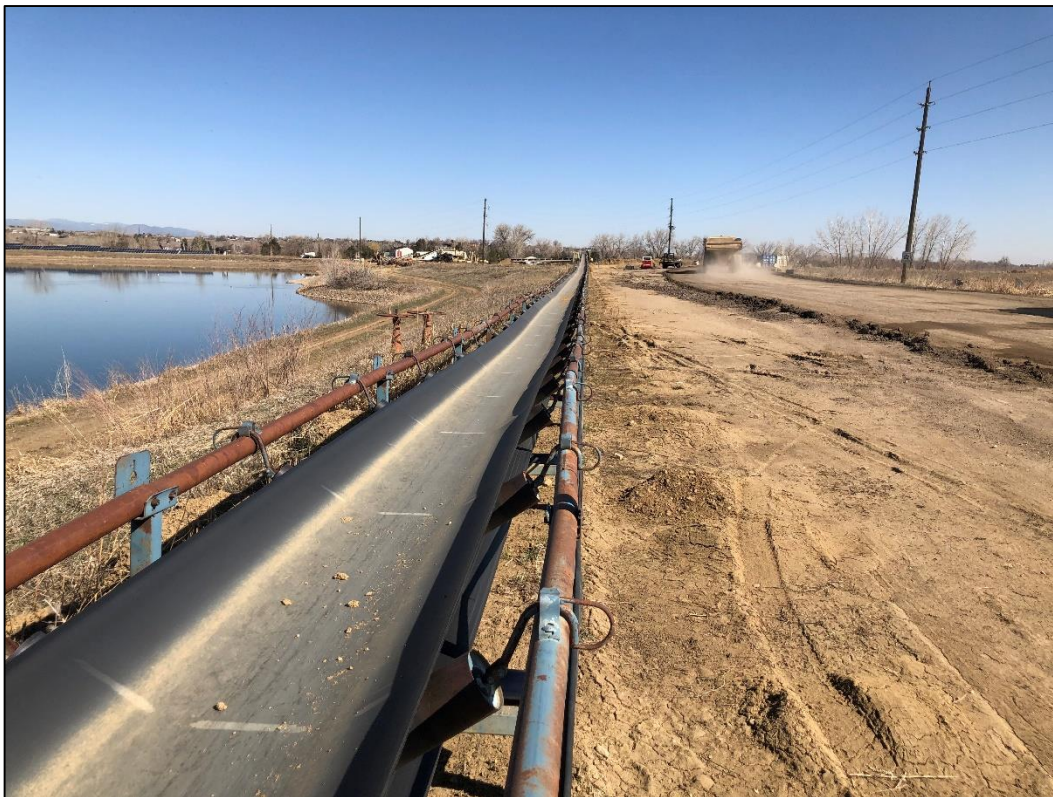
**Photo 10.** View looking north across conveyor system installed between Reservoir #2 pit (to the south) and processing plant in Reservoir #4 pit (to the north). This system was offline during the inspection, and according to operator, will no longer be used by the operation.

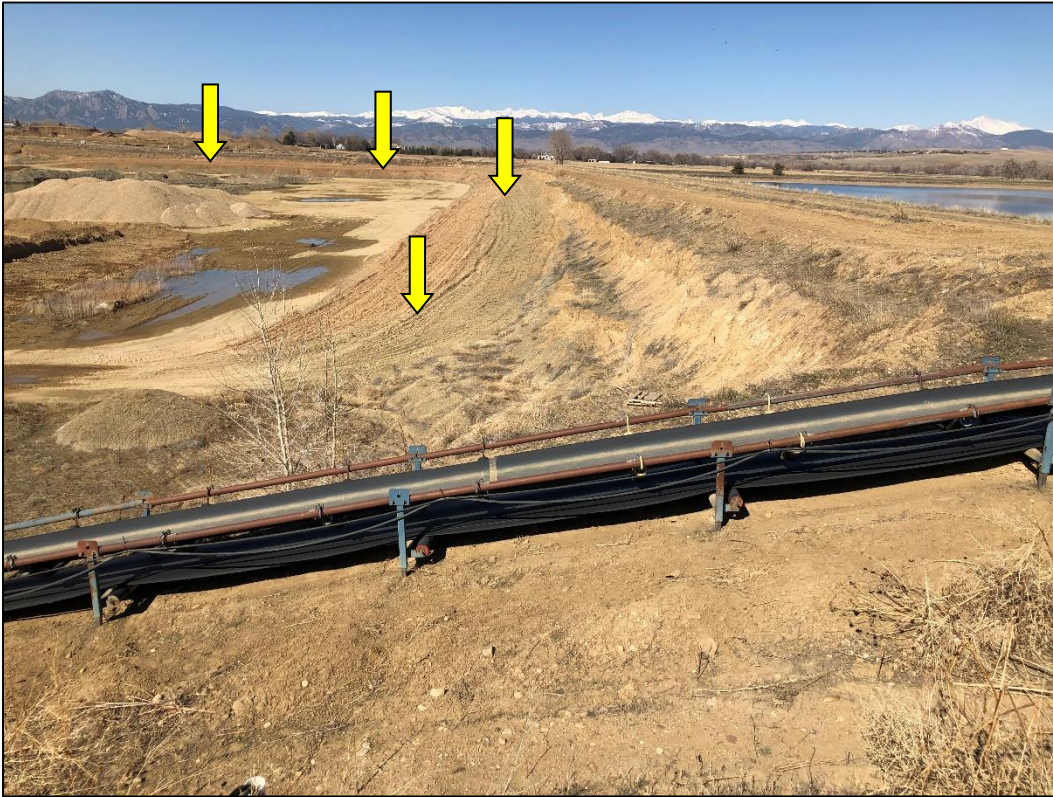
**Photo 11.** View looking west across northern edge of Reservoir #2 pit. Note partially installed clay liner (indicated with arrows).

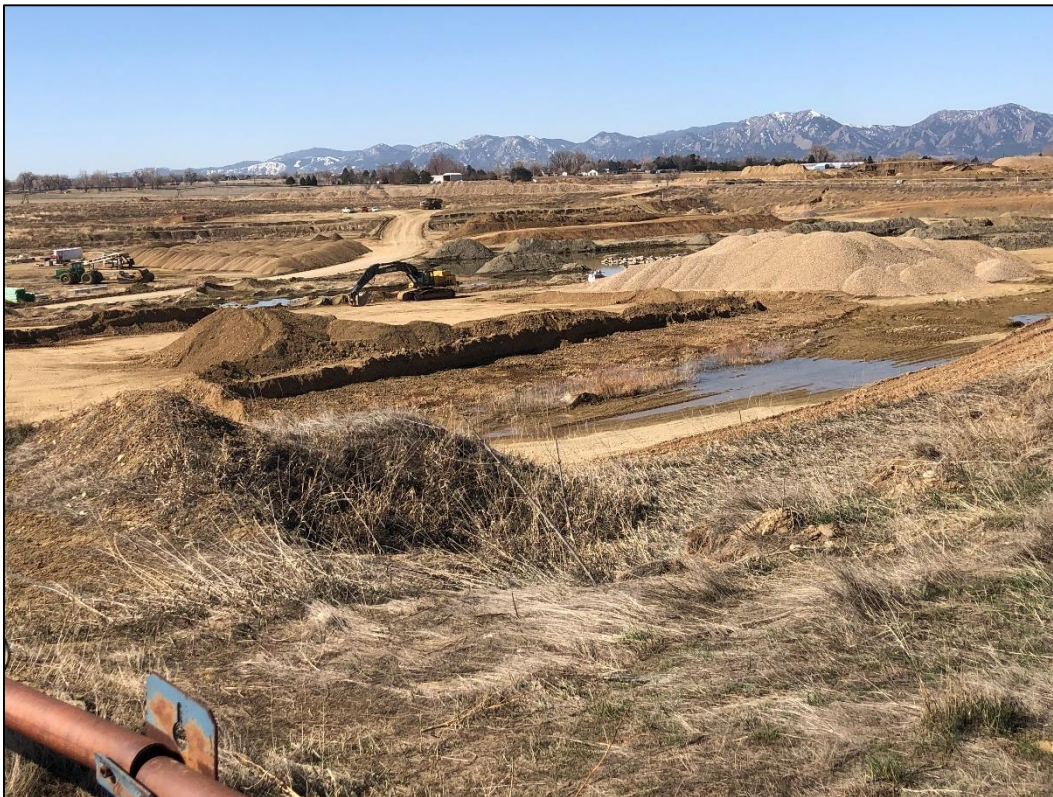
**Photo 12.** View looking southwest across Reservoir #2 pit. Note various material stockpiles stored on pit floor and some standing water present on pit floor.

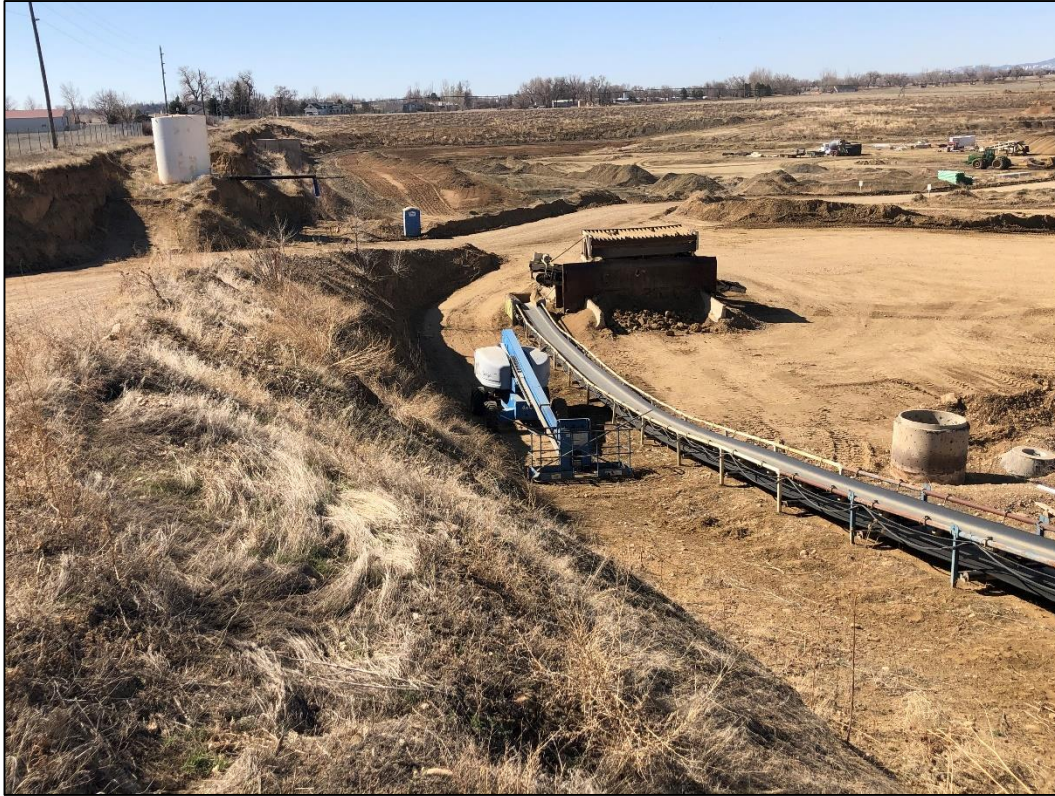
**Photo 13.** View looking south across northeastern portion of Reservoir #2 pit. Note conveyor system not in use by operation. Mined material from this pit is currently transported via haul trucks to processing plant in Reservoir #4 pit.

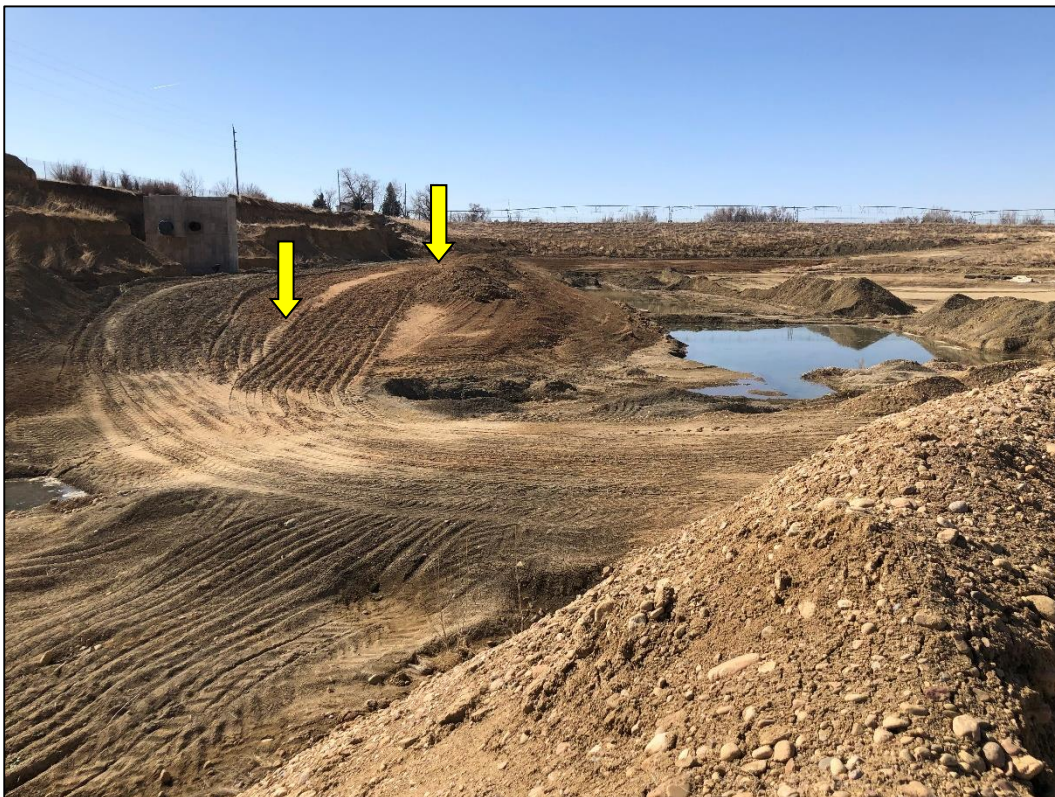
**Photo 14.** View looking south across eastern edge of Reservoir #2 pit, showing partially installed clay liner (indicated with arrows). Note standing water on pit floor.

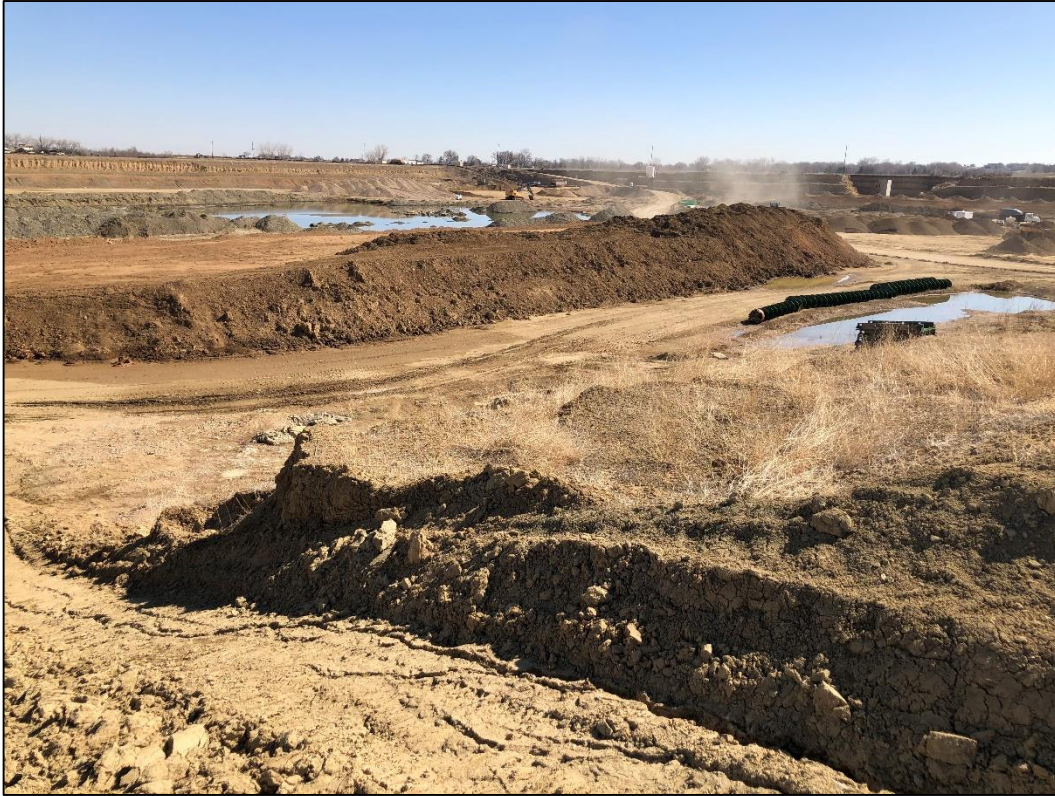
**Photo 15.** View looking northeast across Reservoir #2 pit. Note various material stockpiles stored on pit floor and some standing water present on pit floor.

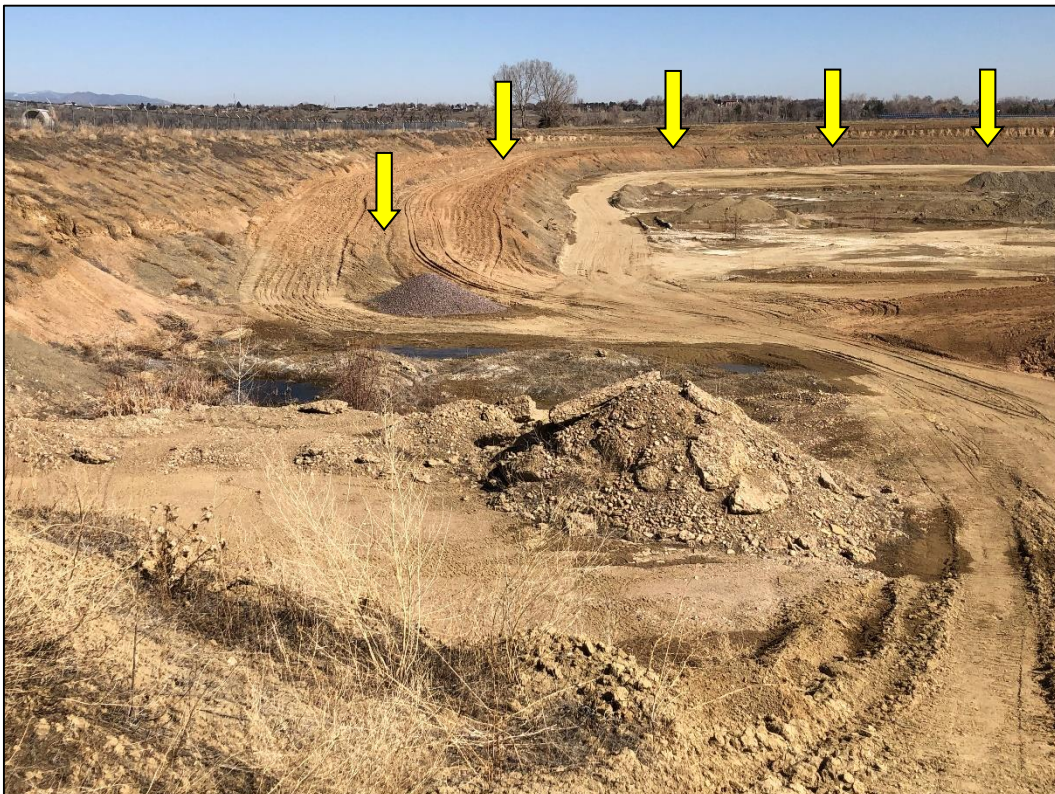
**Photo 16.** View looking north across western edge of Reservoir #2 pit, showing partially installed clay liner (indicated with arrows).

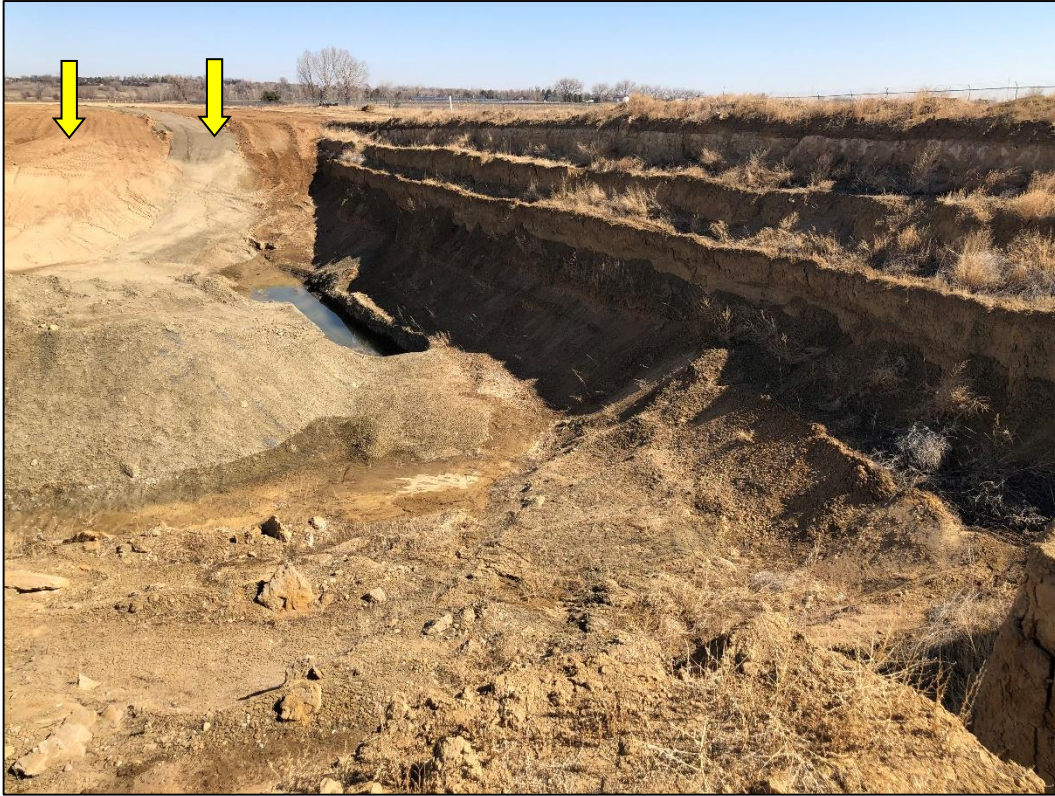
Salvaged topsoil and overburden are stockpiled in the area west of the Reservoir #2 pit for use in reclamation, per the approved mining plan. However, the northern portion of this area is being developed into another clay-lined reservoir, which is not part of the approved mining and reclamation plans. The operation has excavated a pit in this area approximately 35 acres in size and approximately 30 feet deep (at the eastern end). Standing water was also present on the floor of this pit, particularly at the deeper eastern end. According to aerial imagery available in Google Earth, it appears the operation began excavating the new pit in early 2018 (a year after AM-01 was approved). The operator estimates construction of the clay liner around this pit is approximately 80% complete. The operator indicated the eastern edge of the reservoir is being constructed as a dam in coordination with the DWR's Dam Safety Program. The Division has not reviewed or approved any design specifications for the construction of this dam. Additionally, the operator has not demonstrated what impacts construction of the additional clay-lined reservoir will have on the prevailing hydrologic balance of the affected land and surrounding area in accordance with Rule 3.1.6. The Ground Water Response Study prepared by CTL Thompson Inc., dated September 8, 2010, and the groundwater monitoring and mitigation plan submitted with AM-01 do not address the new reservoir.

**This is cited as a possible violation in this report (see page 1) for failing to comply with the conditions of a permit pursuant to C.R.S. 34-32.5-124. Specifically, the operator has failed to comply with the mining and reclamation plans approved in the permit by constructing a new clay-lined reservoir within the affected lands. The operator has also failed to comply with the approved permit by failing to submit the required quarterly groundwater monitoring data on an annual basis (the most recent groundwater level monitoring data on file was submitted to our office on September 8, 2015).** This matter will be scheduled for consideration before the Mined Land Reclamation Board (MLRB) at their May 19, 2021 meeting, during which, the MLRB may issue a violation, assess a civil penalty, and/or order corrective actions. The Division will recommend the required corrective actions include submitting an Amendment application to update the mining and reclamation plans and maps for the site to address the new reservoir construction. The Amendment application must also demonstrate that construction of the new reservoir will have a minimal disturbance on the prevailing hydrologic balance of the affected land and surrounding area in accordance with Rule 3.1.6. A Reason to Believe a Violation Exists and Notice of Board Hearing letter will be sent to the operator separately from this report, including more details on the MLRB hearing.

**Photo 17.** View looking north across eastern edge of new (unauthorized) reservoir pit, showing near vertical highwalls and partially installed clay liner (indicated with arrows) forming “dam”.

**CORRECTIVE ACTIONS:** This matter will be scheduled for consideration by the Mined Land Reclamation Board (MLRB) at their May 19, 2021 meeting, during which, the MLRB may issue a violation, assess a civil penalty, and/or order corrective actions. A Reason to Believe a Violation Exists and Notice of Board Hearing letter will be sent to the operator separately from this report.

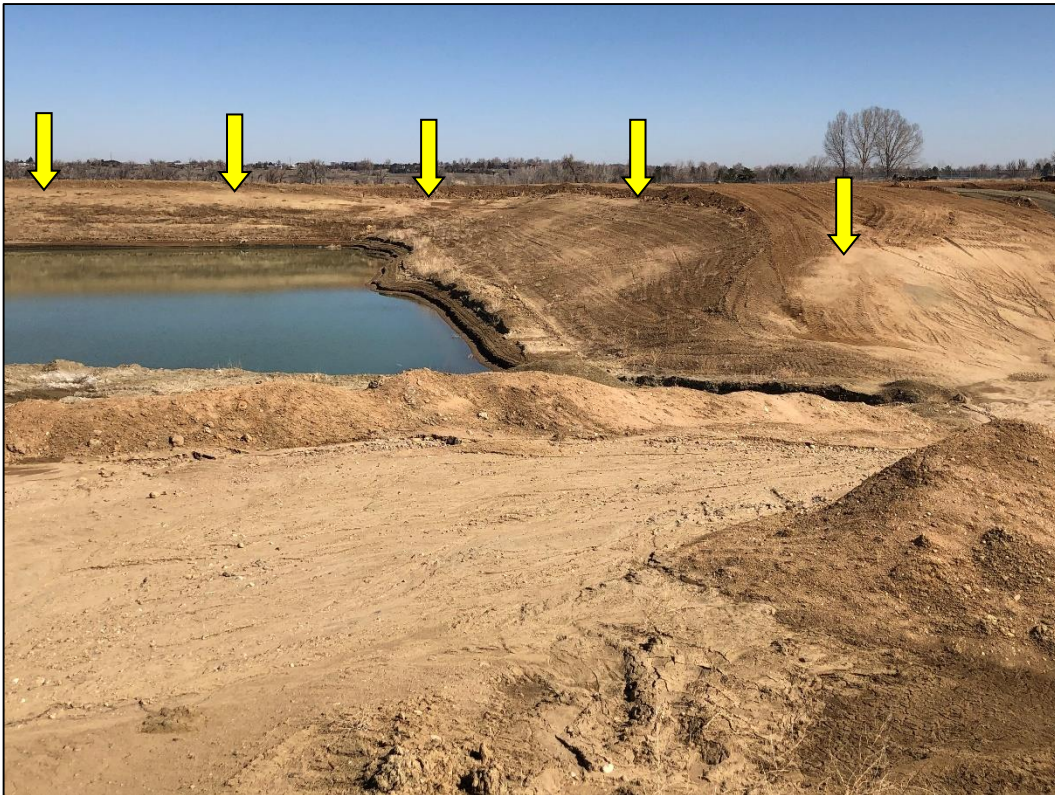
**Photo 18.** View looking north across eastern portion of new (unauthorized) reservoir pit, showing partially installed clay liner (indicated with arrows) forming “dam” and standing water on pit floor. Note inside slopes of clay liner at 3H:1V or flatter.

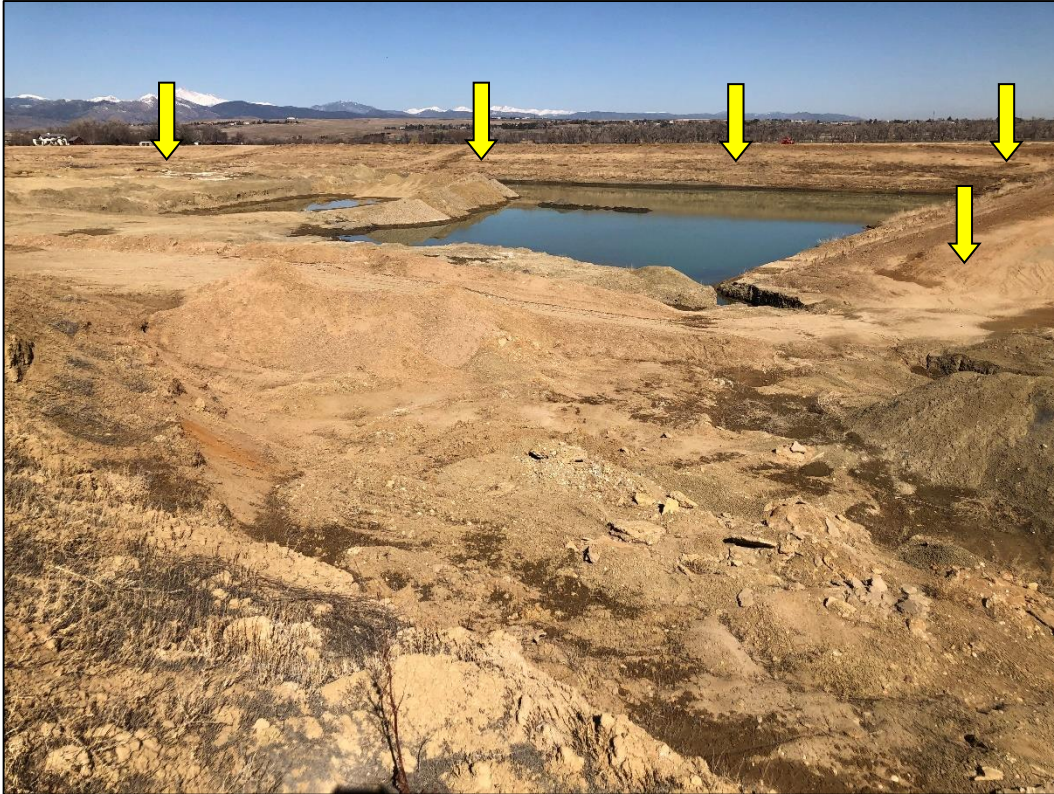
**Photo 19.** View looking northwest across eastern portion of new (unauthorized) reservoir pit, showing partially installed clay liner (indicated with arrows) and material stockpiles on pit floor. Note standing water on pit floor.

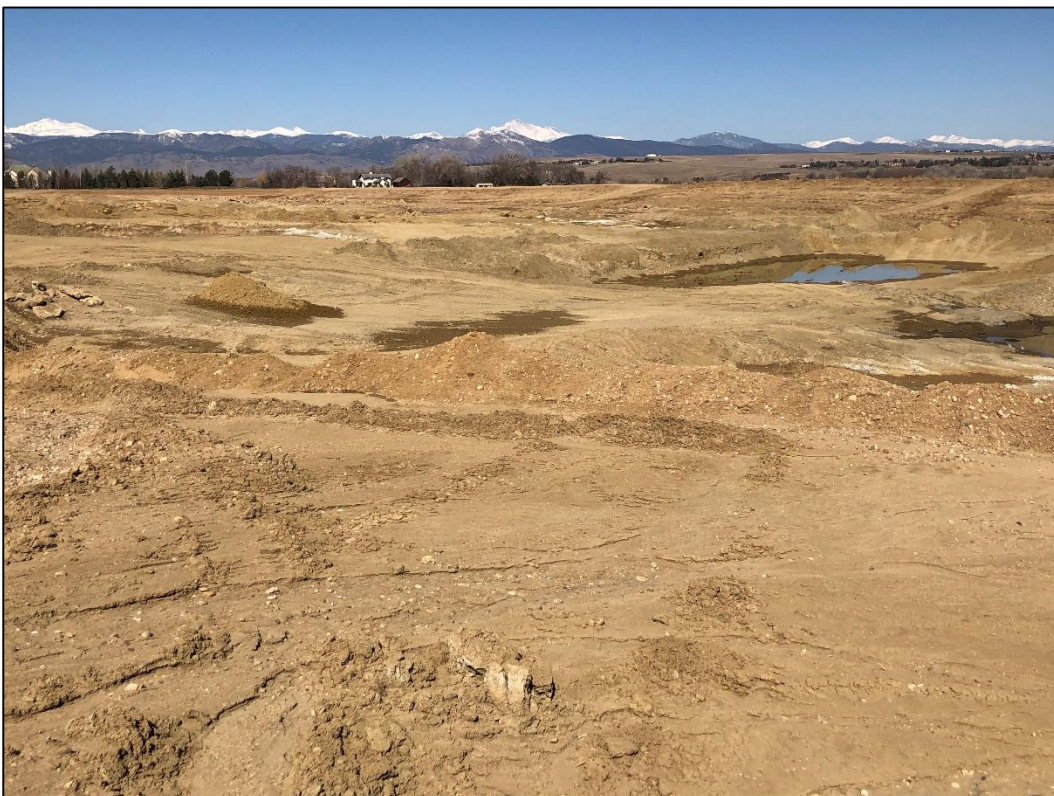
**Photo 20.** View looking west across new (unauthorized) reservoir pit. Note standing water on pit floor (at right).

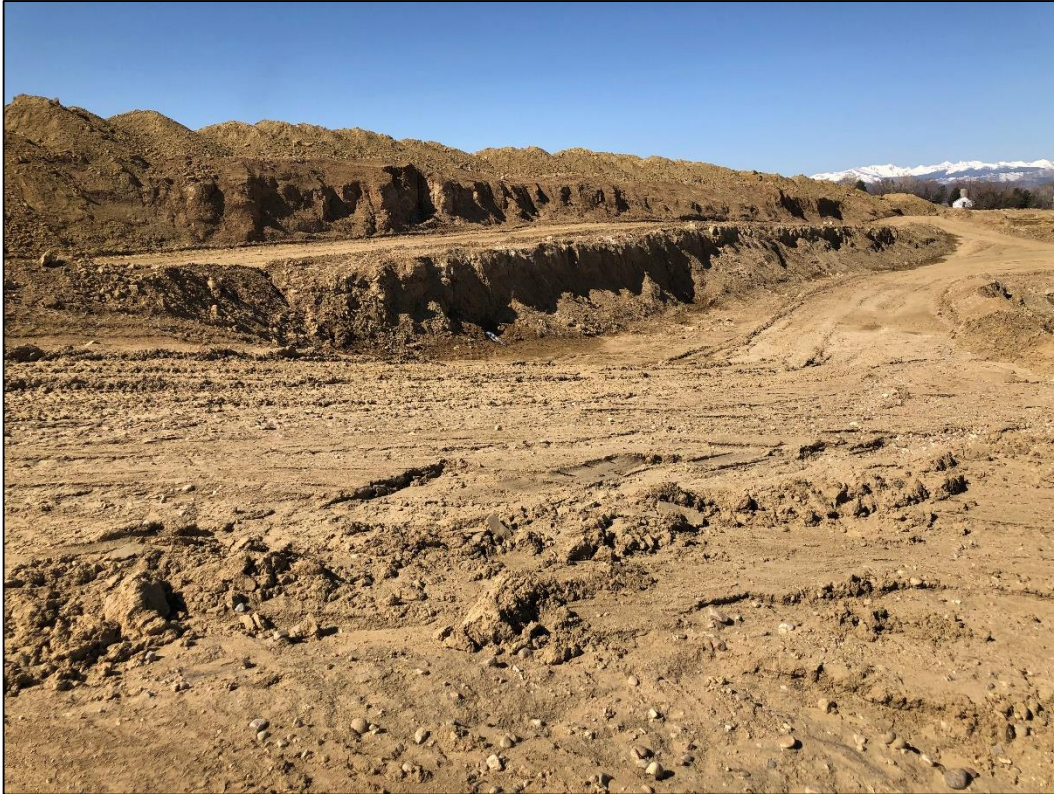
**Photo 21.** View looking west across southern edge of new (unauthorized) reservoir pit where clay liner has not been installed. Note overburden stockpiles (above pit wall) in storage area south of reservoir.

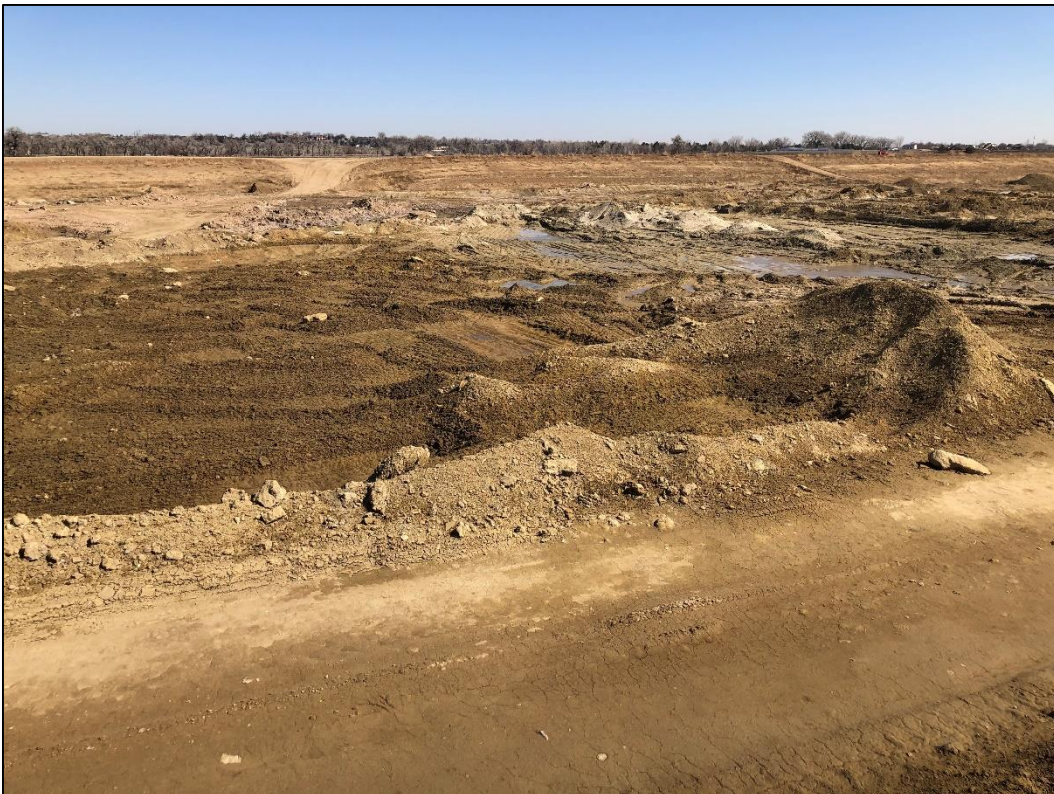
**Photo 22.** View looking north across central portion of new (unauthorized) reservoir pit. Note various material stockpiles on pit floor and some standing water.

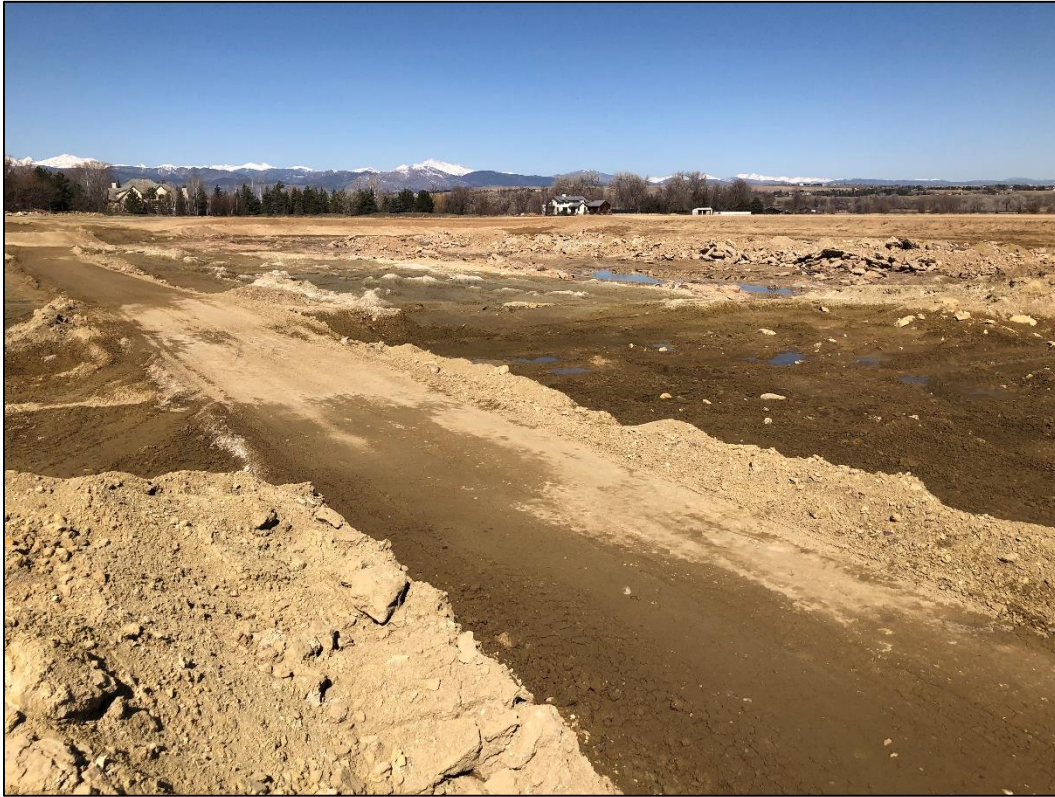
**Photo 23.** View looking northwest across central portion of new (unauthorized) reservoir pit.
