**MINERALS PROGRAM INSPECTION REPORT**  
**PHONE: (303) 866-3567**

| <b>MINE NAME:</b><br>Goose Haven Reservoir #2- Complex Expansion | <b>MINE/PROSPECTING ID#:</b><br>M-2010-071 | <b>MINERAL:</b><br>Borrow material for construction | <b>COUNTY:</b><br>Boulder |
| <b>INSPECTION TYPE:</b><br>Monitoring | <b>INSPECTOR(S):</b><br>Amy Eschberger | <b>INSP. DATE:</b><br>April 1, 2021 | <b>INSP. TIME:</b><br>10:00 |
| <b>OPERATOR:</b><br>The City of Lafayette | <b>OPERATOR REPRESENTATIVE(S):</b><br>Melanie Asquith, Jon File | <b>TYPE OF OPERATION:</b><br>112c - Construction Regular Operation | |

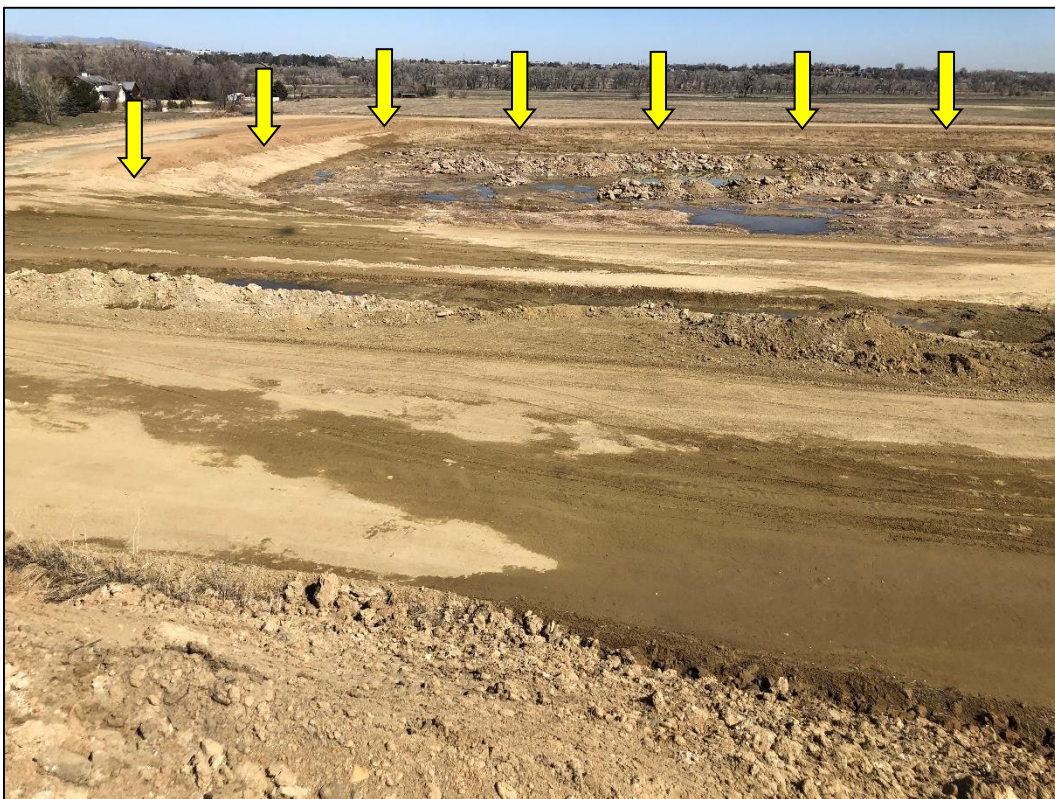
Salvaged topsoil and overburden are stockpiled in the area west of the Reservoir #2 pit for use in reclamation, per the approved mining plan. However, the northern portion of this area is being developed into another clay-lined reservoir, which is not part of the approved mining and reclamation plans. The operation has excavated a pit in this area approximately 35 acres in size and approximately 30 feet deep (at the eastern end). Standing water was also present on the floor of this pit, particularly at the deeper eastern end. According to aerial imagery available in Google Earth, it appears the operation began excavating the new pit in early 2018 (a year after AM-01 was approved). The operator estimates construction of the clay liner around this pit is approximately 80% complete. The operator indicated the eastern edge of the reservoir is being constructed as a dam in coordination with the DWR's Dam Safety Program. The Division has not reviewed or approved any design specifications for the construction of this dam. Additionally, the operator has not demonstrated what impacts construction of the additional clay-lined reservoir will have on the prevailing hydrologic balance of the affected land and surrounding area in accordance with Rule 3.1.6. The Ground Water Response Study prepared by CTL Thompson Inc., dated September 8, 2010, and the groundwater monitoring and mitigation plan submitted with AM-01 do not address the new reservoir.

**This is cited as a possible violation in this report (see page 1) for failing to comply with the conditions of a permit pursuant to C.R.S. 34-32.5-124. Specifically, the operator has failed to comply with the mining and reclamation plans approved in the permit by constructing a new clay-lined reservoir within the affected lands. The operator has also failed to comply with the approved permit by failing to submit the required quarterly groundwater monitoring data on an annual basis (the most recent groundwater level monitoring data on file was submitted to our office on September 8, 2015).** This matter will be scheduled for consideration before the Mined Land Reclamation Board (MLRB) at their May 19, 2021 meeting, during which, the MLRB may issue a violation, assess a civil penalty, and/or order corrective actions. The Division will recommend the required corrective actions include submitting an Amendment application to update the mining and reclamation plans and maps for the site to address the new reservoir construction. The Amendment application must also demonstrate that construction of the new reservoir will have a minimal disturbance on the prevailing hydrologic balance of the affected land and surrounding area in accordance with Rule 3.1.6. A Reason to Believe a Violation Exists and Notice of Board Hearing letter will be sent to the operator separately from this report, including more details on the MLRB hearing.

**Photo 24.** View looking north across western edge of new (unauthorized) reservoir pit, showing partially installed clay liner (indicated with arrows) and standing water on pit floor. Note inside slopes of clay liner at 3H:1V or flatter.

**CORRECTIVE ACTIONS:** This matter will be scheduled for consideration by the Mined Land Reclamation Board (MLRB) at their May 19, 2021 meeting, during which, the MLRB may issue a violation, assess a civil penalty, and/or order corrective actions. A Reason to Believe a Violation Exists and Notice of Board Hearing letter will be sent to the operator separately from this report.

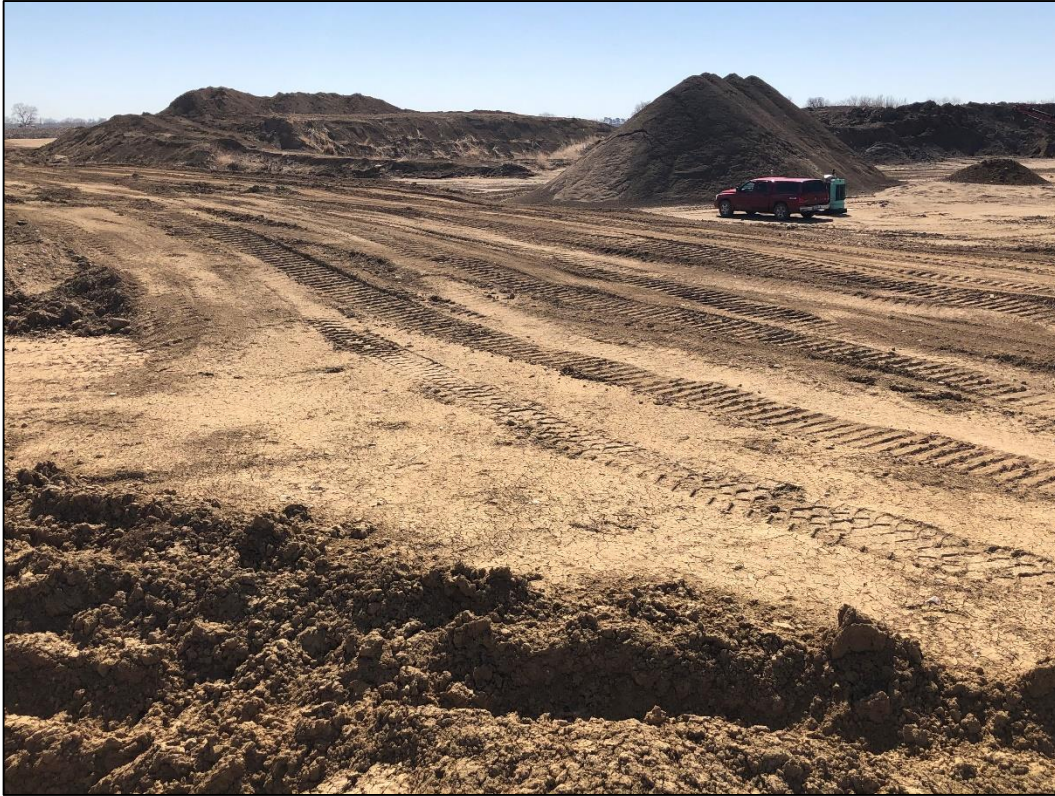
**Photo 25.** View looking southeast across topsoil/overburden storage area located west of Reservoir #2 pit and directly south of new (unauthorized) reservoir pit.

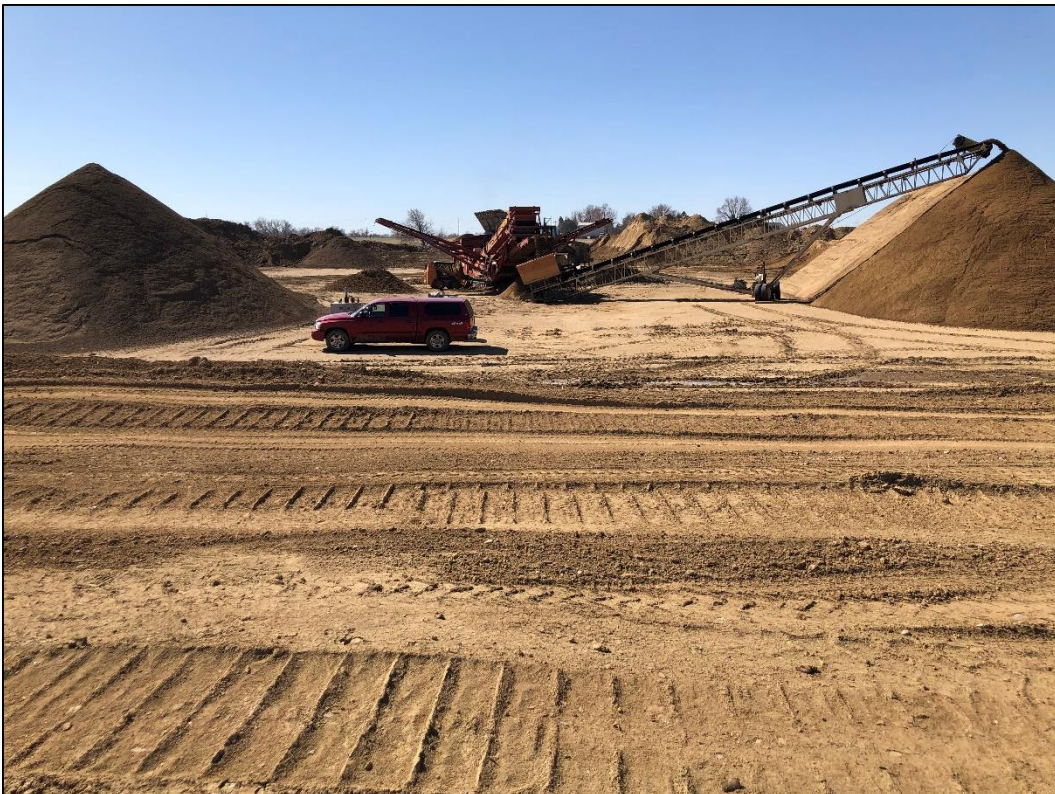
**Photo 26.** View looking south across topsoil/overburden storage area located west of Reservoir #2 pit and directly south of new (unauthorized) reservoir pit. It appears this area is also being used to process material for pit liner construction.

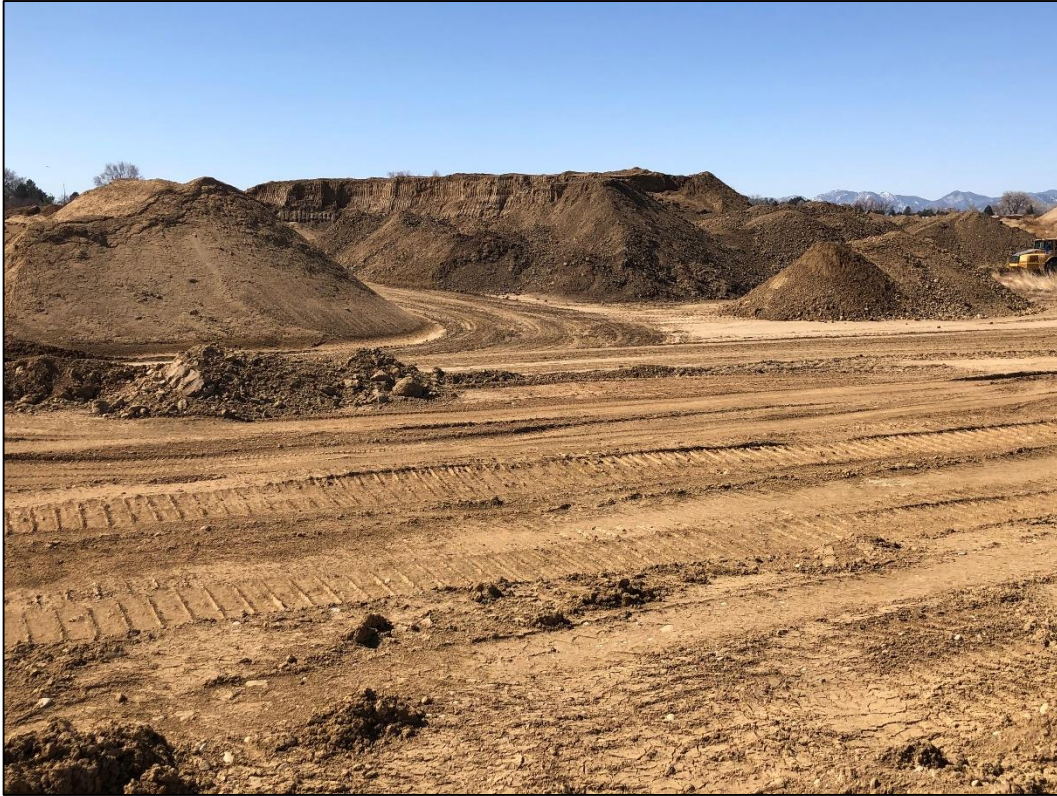
**Photo 27.** View looking southwest across topsoil/overburden storage area located west of Reservoir #2 pit and directly south of new (unauthorized) reservoir pit.

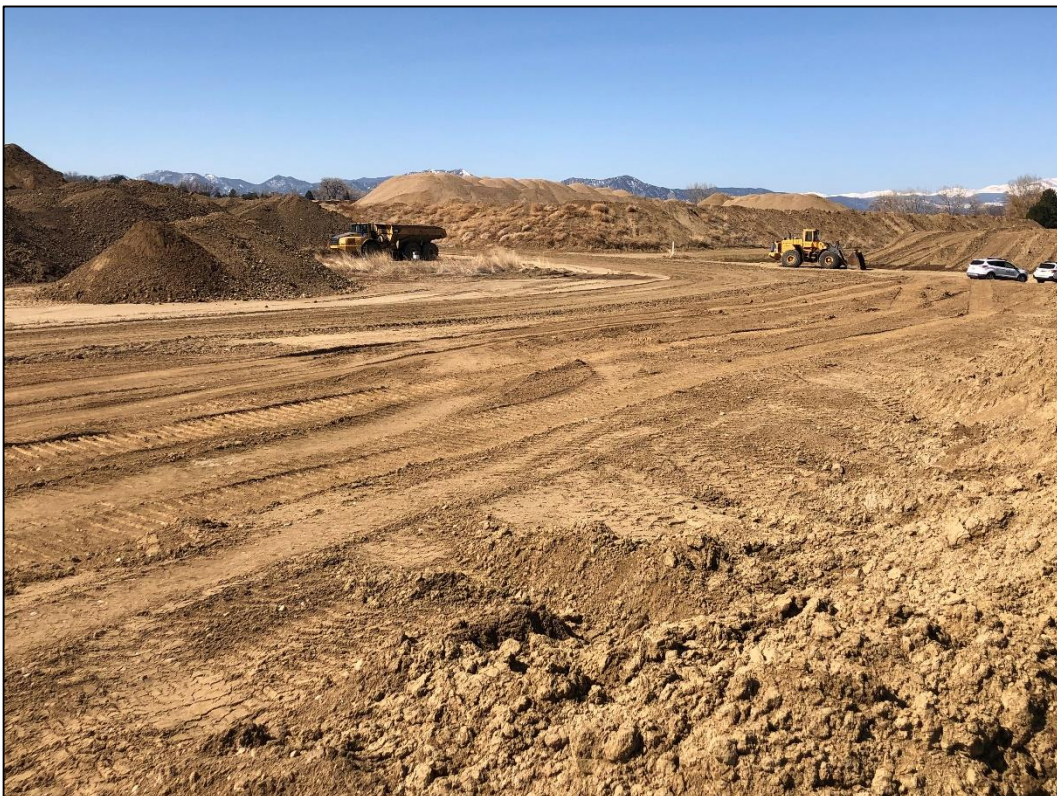
**Photo 28.** View looking west across topsoil/overburden storage area located west of Reservoir #2 pit and directly south of new (unauthorized) reservoir pit.

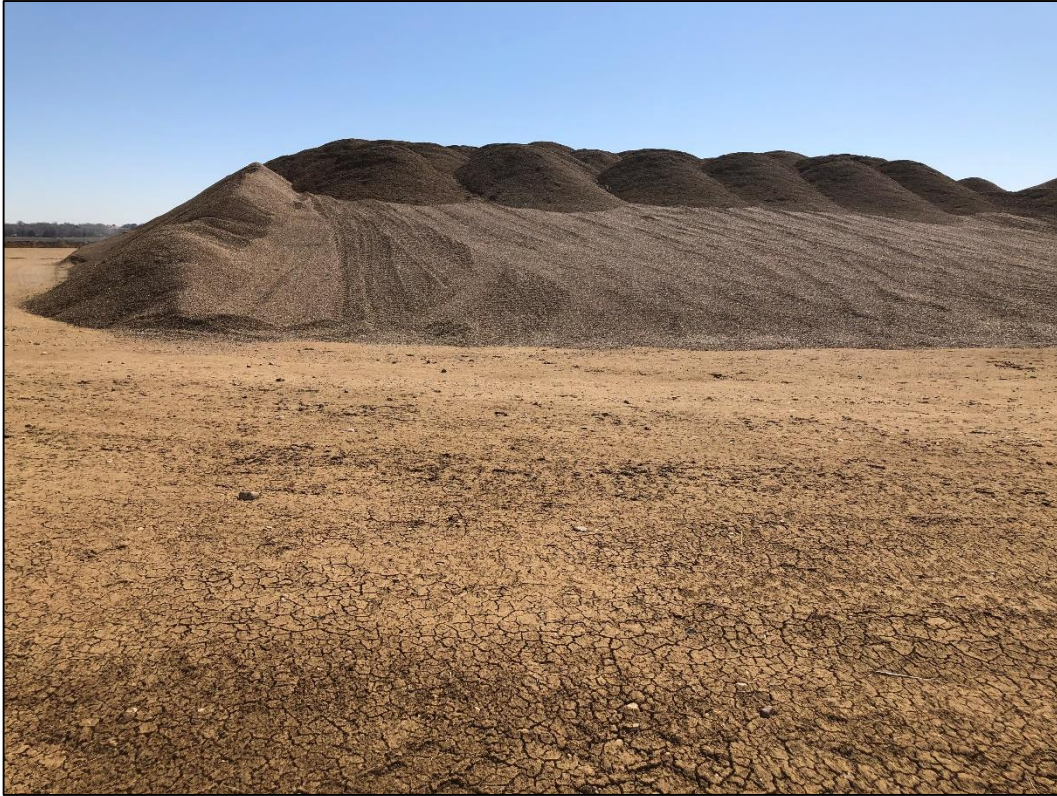
**Photo 29.** View looking east at large gravel stockpile stored at western edge of topsoil/overburden storage area. This material will be used to construct the protective upper shell along the upper portion of clay-lined reservoir slopes.

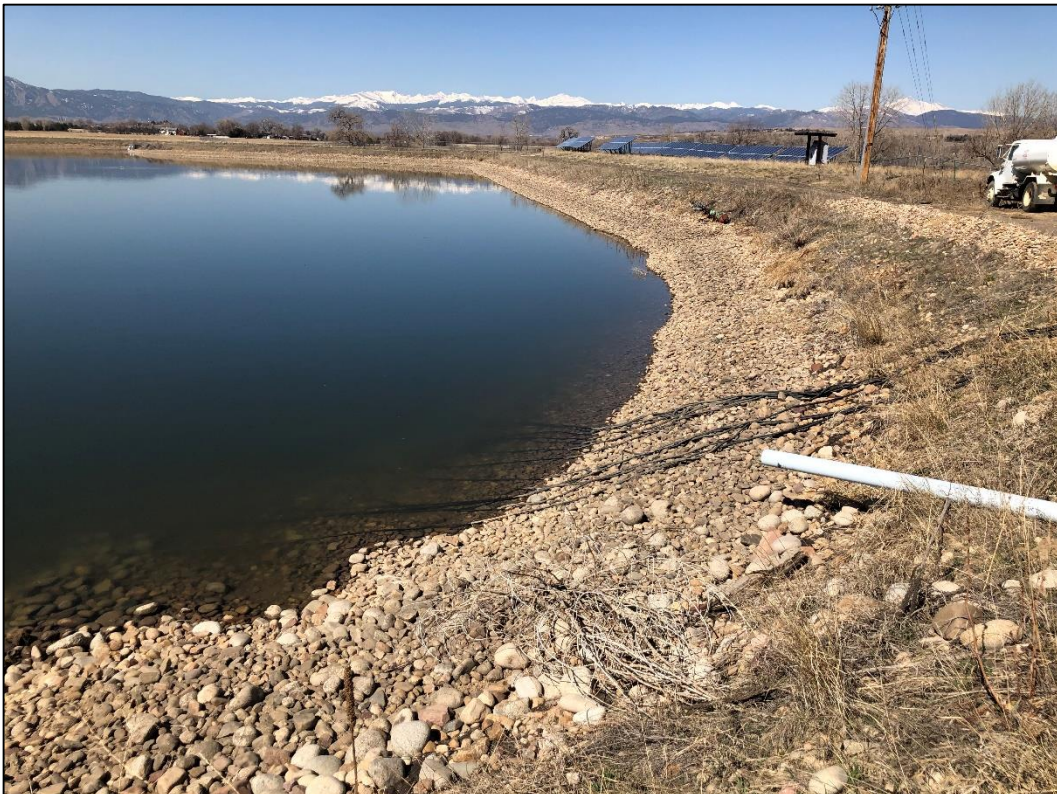
**Photo 30.** View looking west across northern edge of existing clay-lined Reservoir #1 located in northwestern portion of permit area.

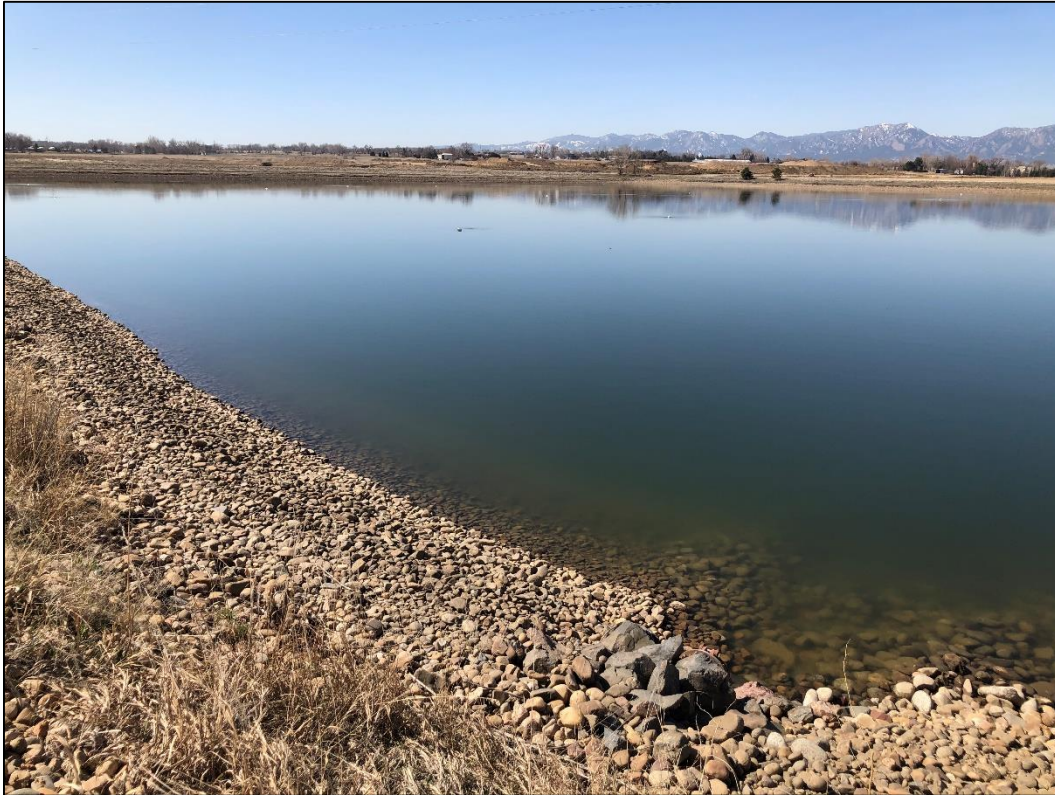
**Photo 31.** View looking southwest across existing clay-lined Reservoir #1 located in northwestern portion of permit area.

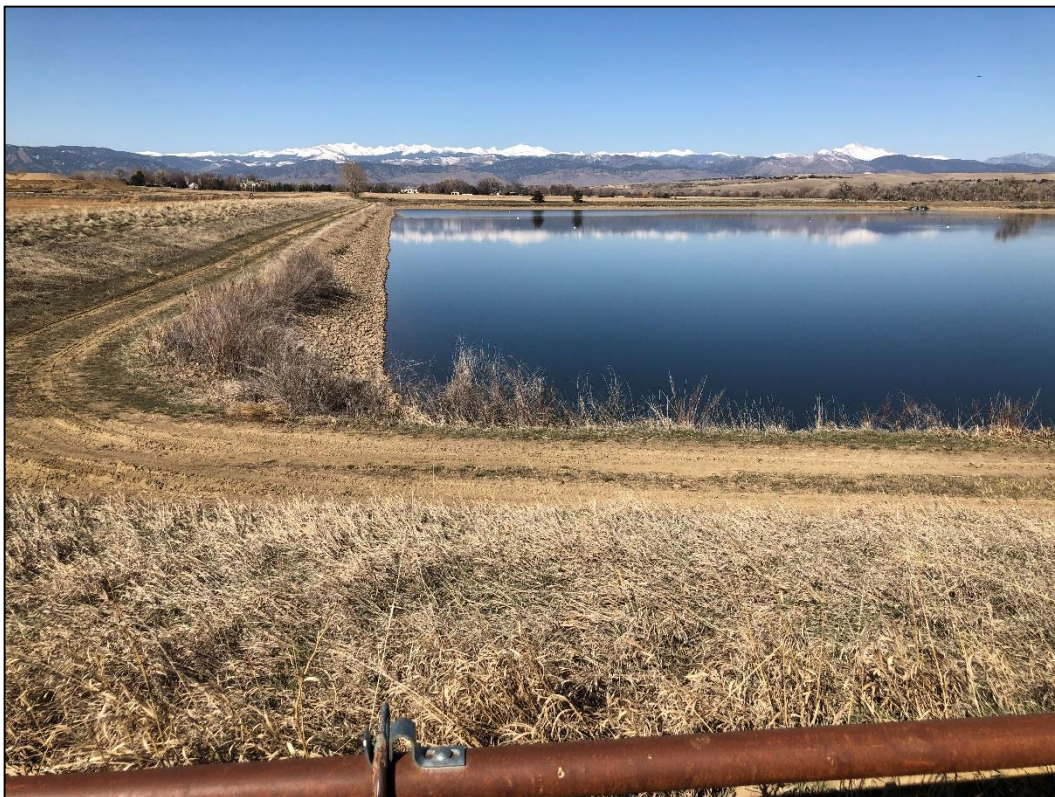
**Photo 32.** View looking west across southern edge of existing clay-lined Reservoir #1 located in northwestern portion of permit area.

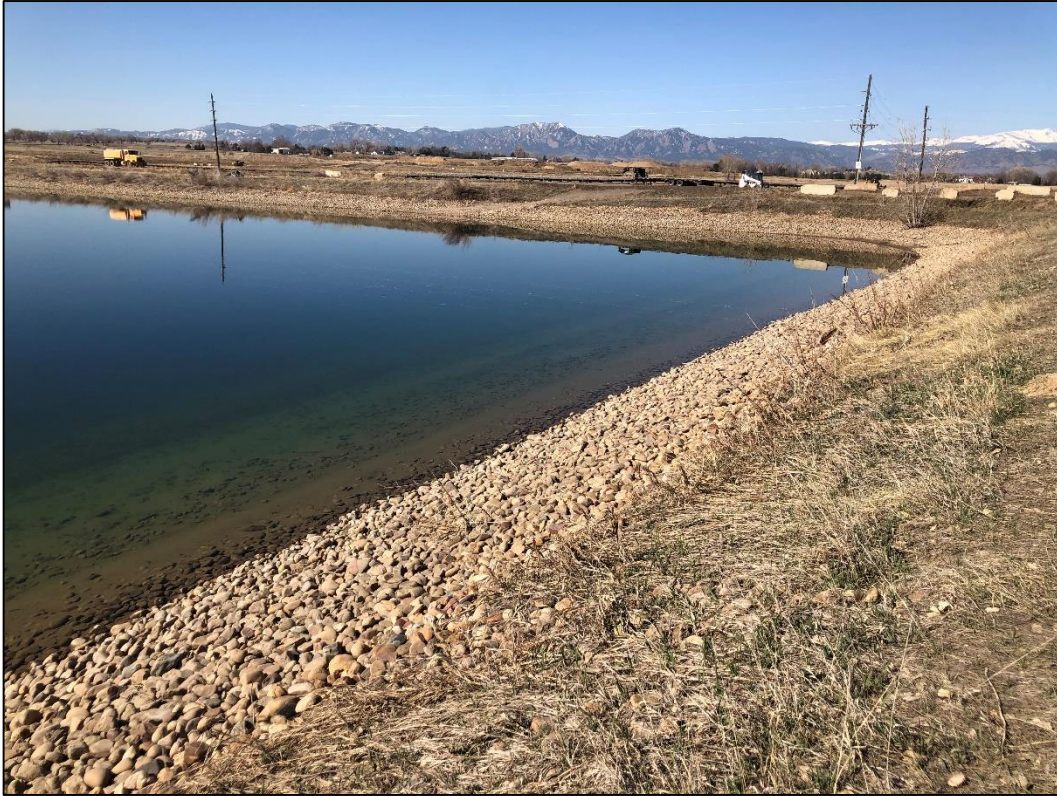
**Photo 33.** View looking southwest across northwestern edge of existing clay-lined Reservoir #3 located in southeastern portion of permit area.

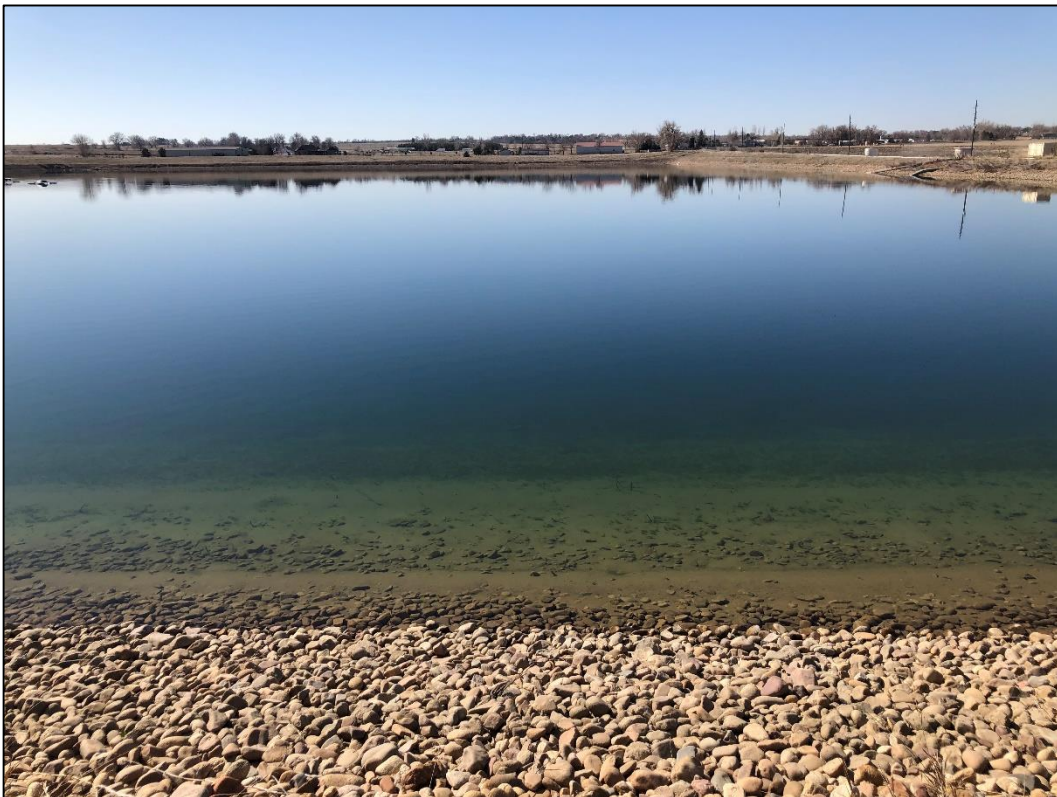
**Photo 34.** View looking south across existing clay-lined Reservoir #3 located in southeastern portion of permit area.

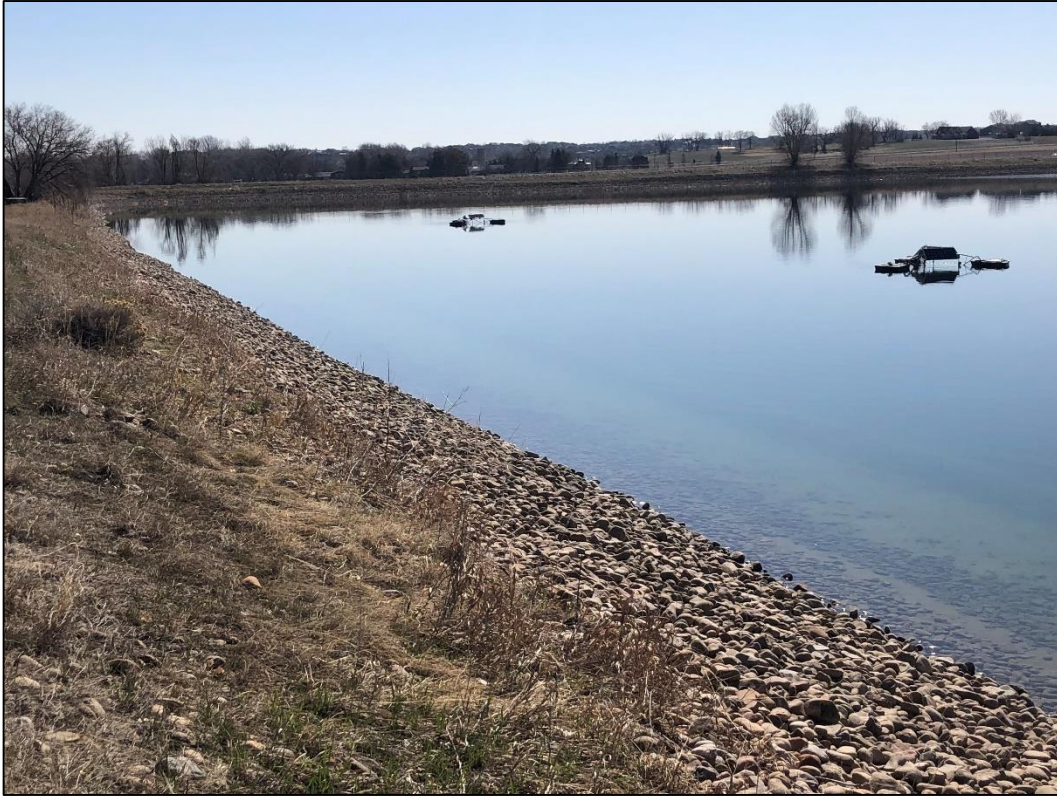
**Photo 35.** View looking east across northeastern edge of existing clay-lined Reservoir #3 located in southeastern portion of permit area.

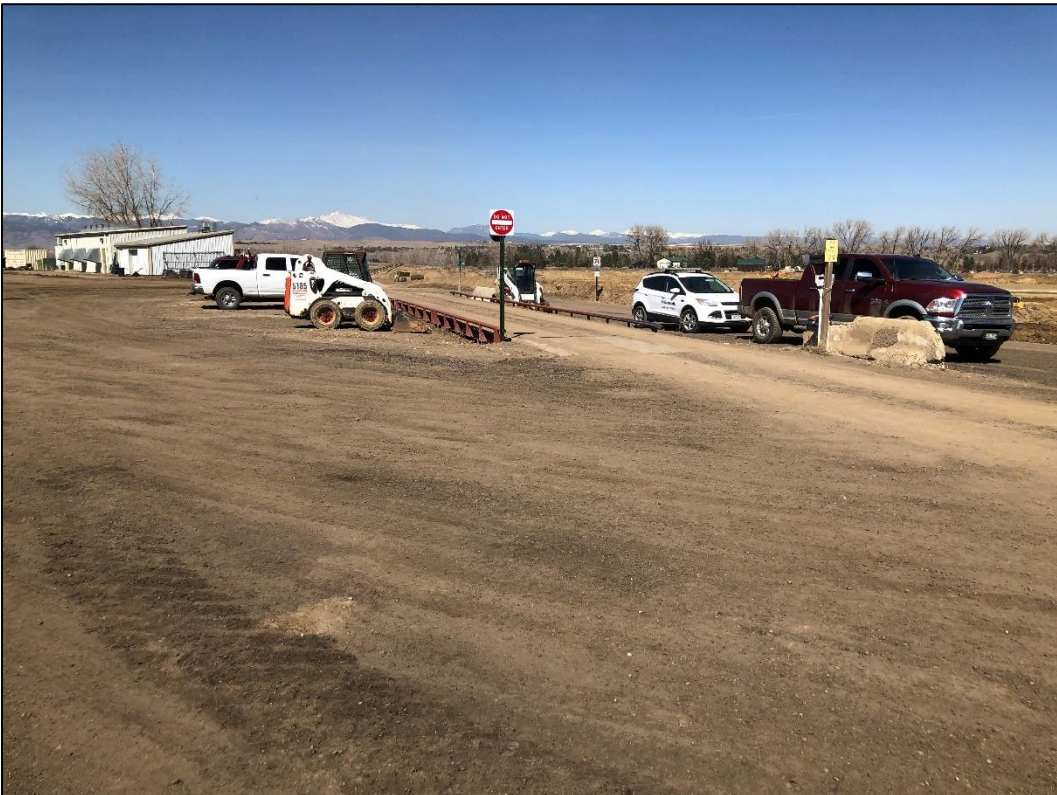
**Photo 36.** View looking east at main site entrance off US-287/N 107<sup>th</sup> Street where scale and scale house are located.

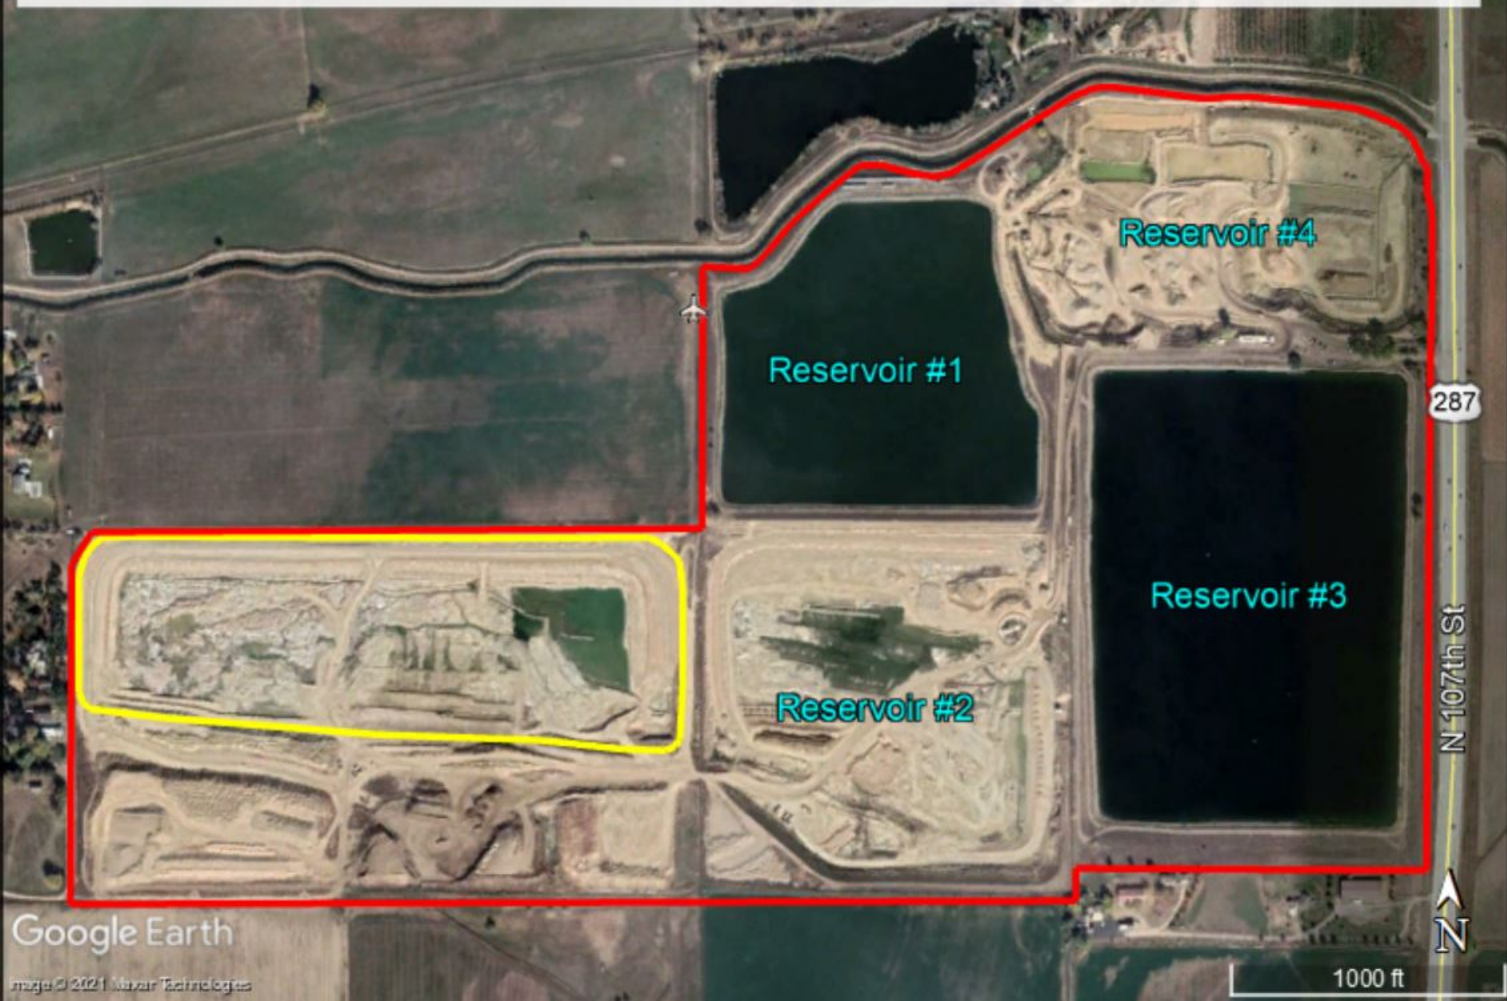
Red outline = 232 acres = Approved permit area (location approximated based on permit maps)

Yellow outline = 35 acres = New (unauthorized) clay-lined reservoir construction
