MINERALS PROGRAM INSPECTION REPORT

MINE NAME: Diehl Borrow Pit	MINE/PROSPECTING ID#: M-2018-054	MINERAL: Borrow material for construction	COUNTY: Larimer
INSPECTION TYPE: Monitoring	INSPECTOR(S): Amy Eschberger	INSP. DATE: April 1, 2021	INSP. TIME: 14:00
OPERATOR: SEMA Construction, Inc.	OPERATOR REPRESENTATIVE: Jason Kidston	TYPE OF OPERATION: 111 - Construction by Government Agency

M-2018-054 / Diehl Borrow Pit / SEMA Construction, Inc.

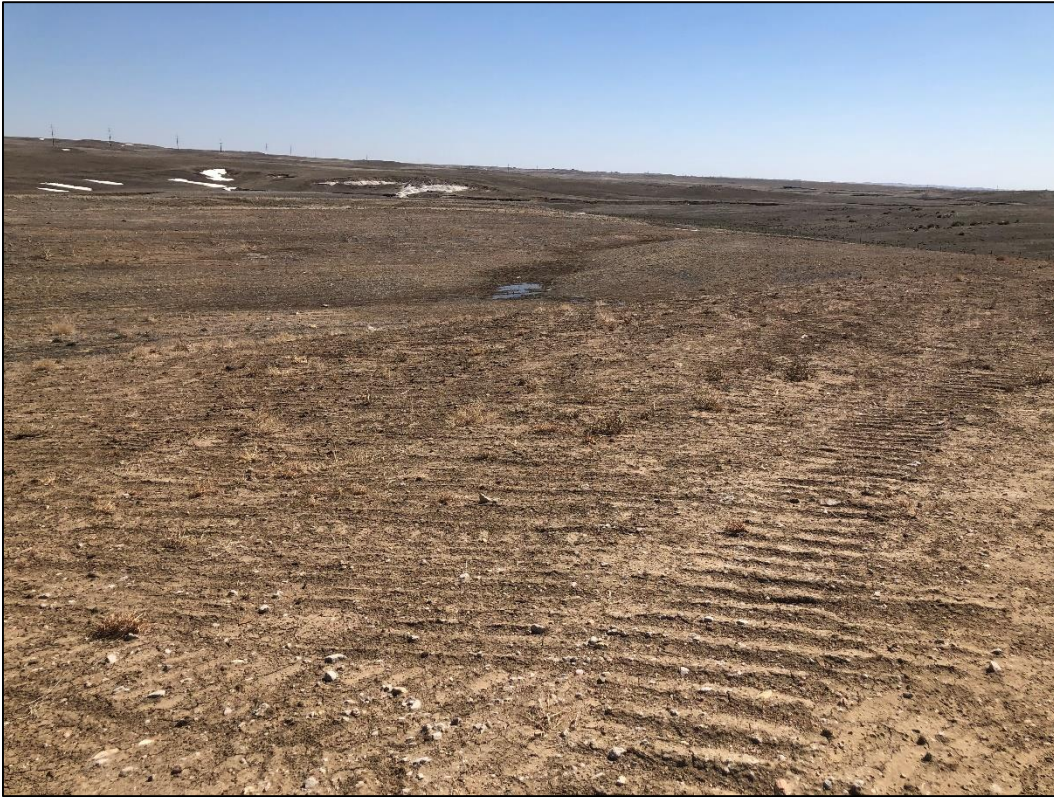
Photo 1. View looking southeast across southern edge of south mining area, showing slopes graded to 3H:1V or flatter. Very little grass growth is present in this area at this time.

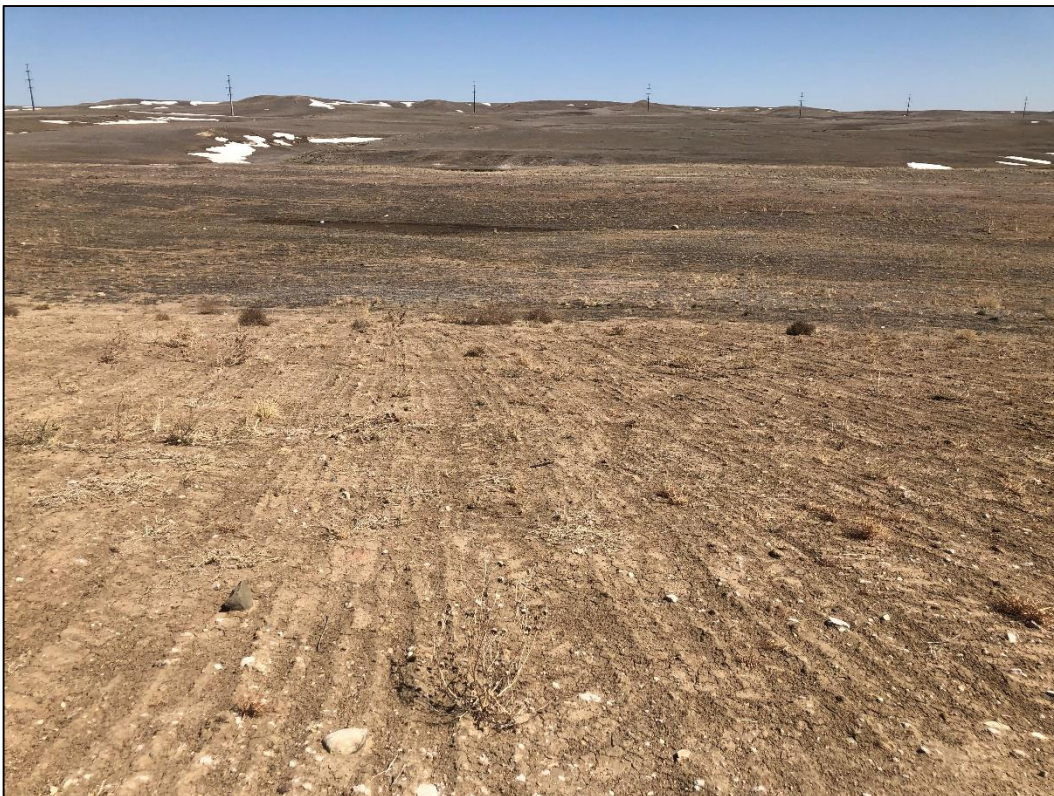
Photo 2. View looking east across central portion of south mining area, showing slopes graded to 3H:1V or flatter. Very little grass growth is present in this area at this time.

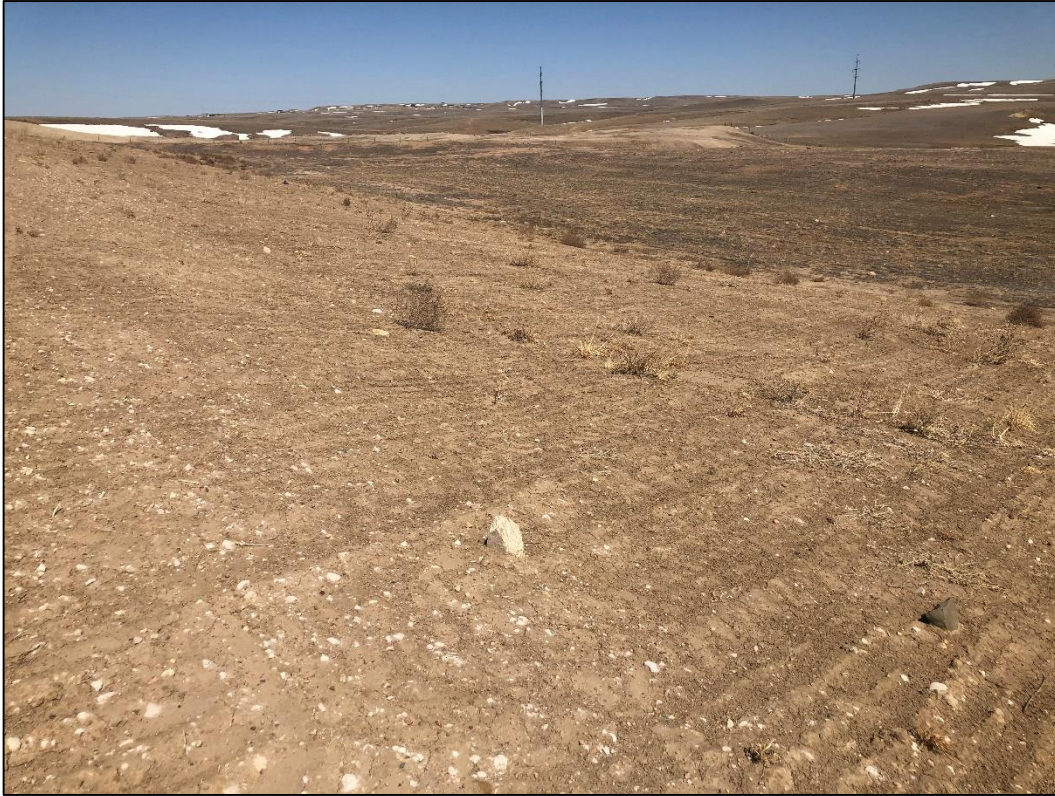
Photo 3. View looking northeast across south mining area, showing slopes graded to 3H:1V or flatter. Very little grass growth is present in this area at this time.

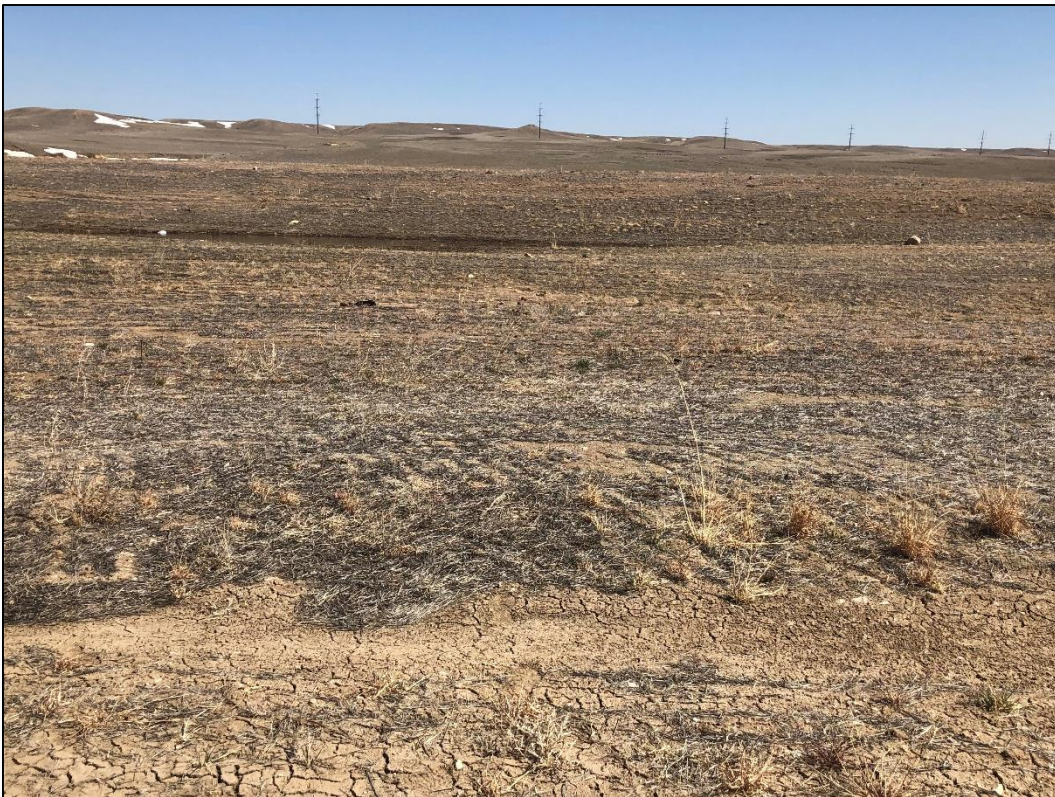
Photo 4. View looking east across pit floor in south mining area, showing more grass growth present here than on pit slopes, but still sparse overall.

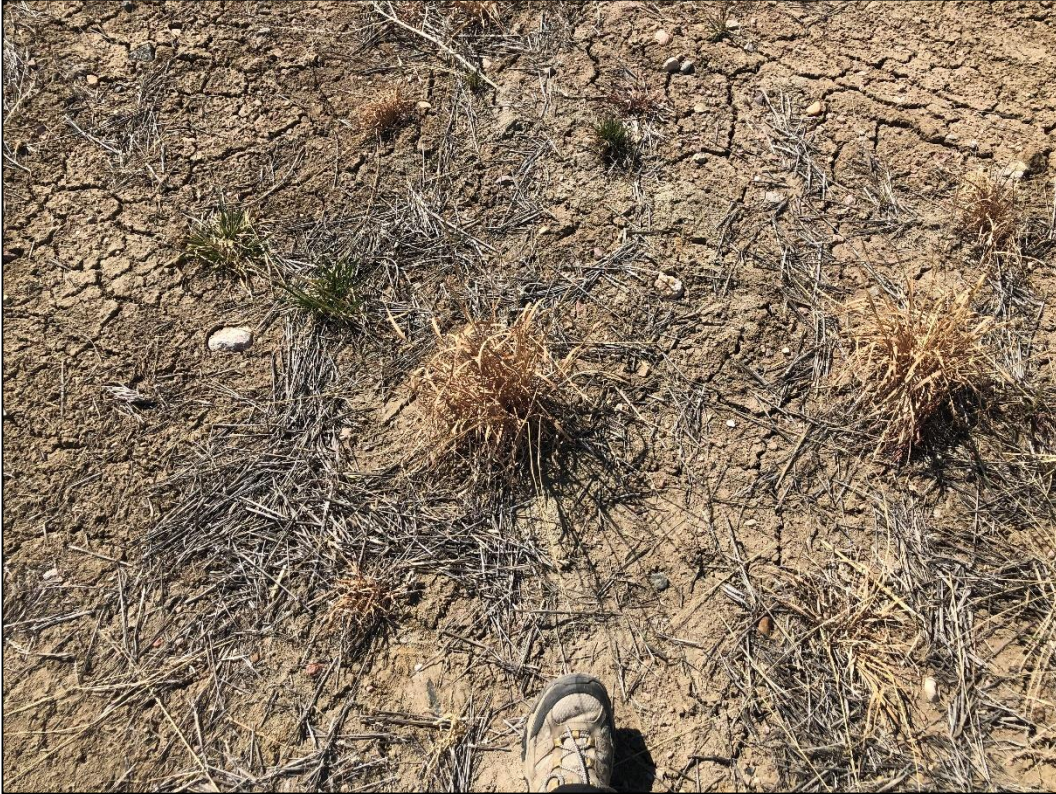
Photo 5. Ground view of pit floor in north mining area, showing some grass growth present in this area.

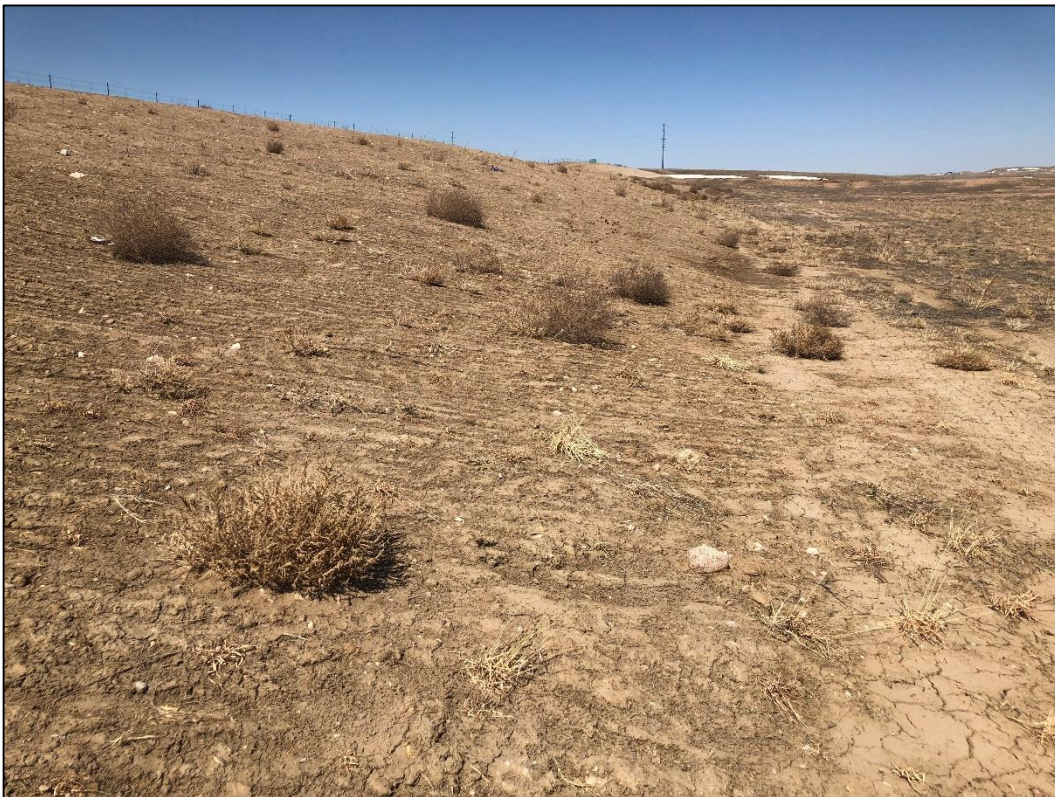
Photo 6. View looking north across pit slope in south mining area, showing slope graded to 3H:1V or flatter. Very little grass growth is present on this slope compared with the pit floor.

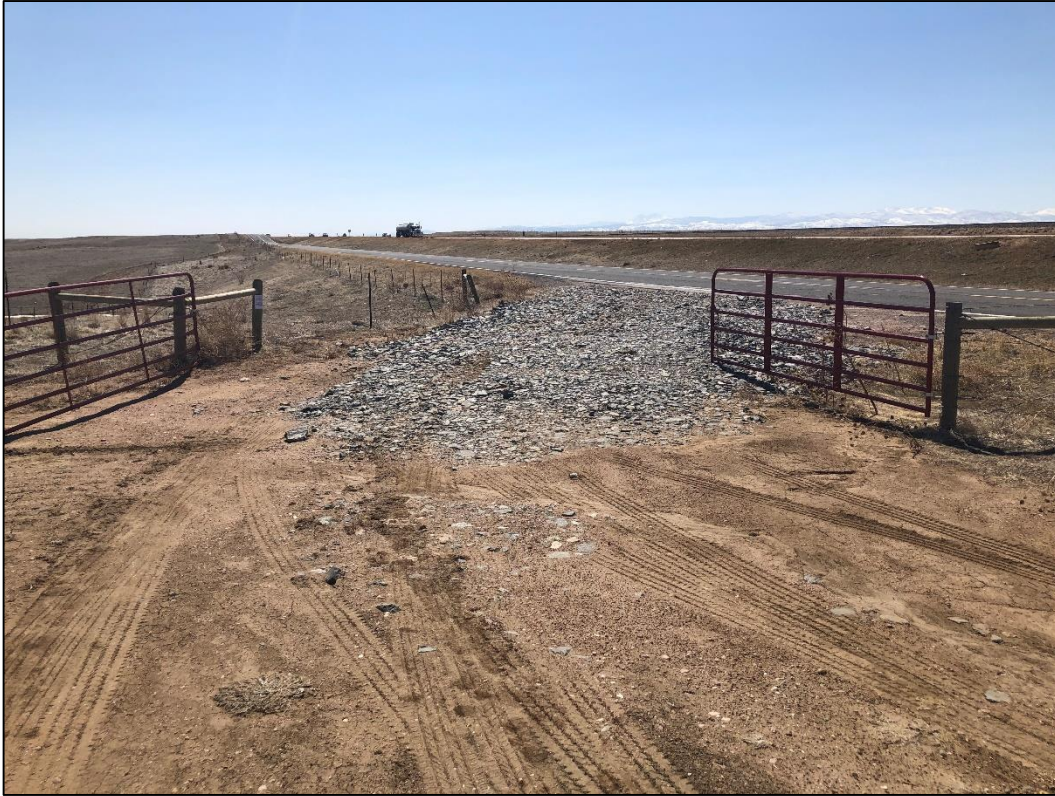
Photo 7. View looking southwest at gated entrance/access road constructed off I-25 frontage road to enter south mining area. This entrance/road will remain for reclamation per the landowner's request.

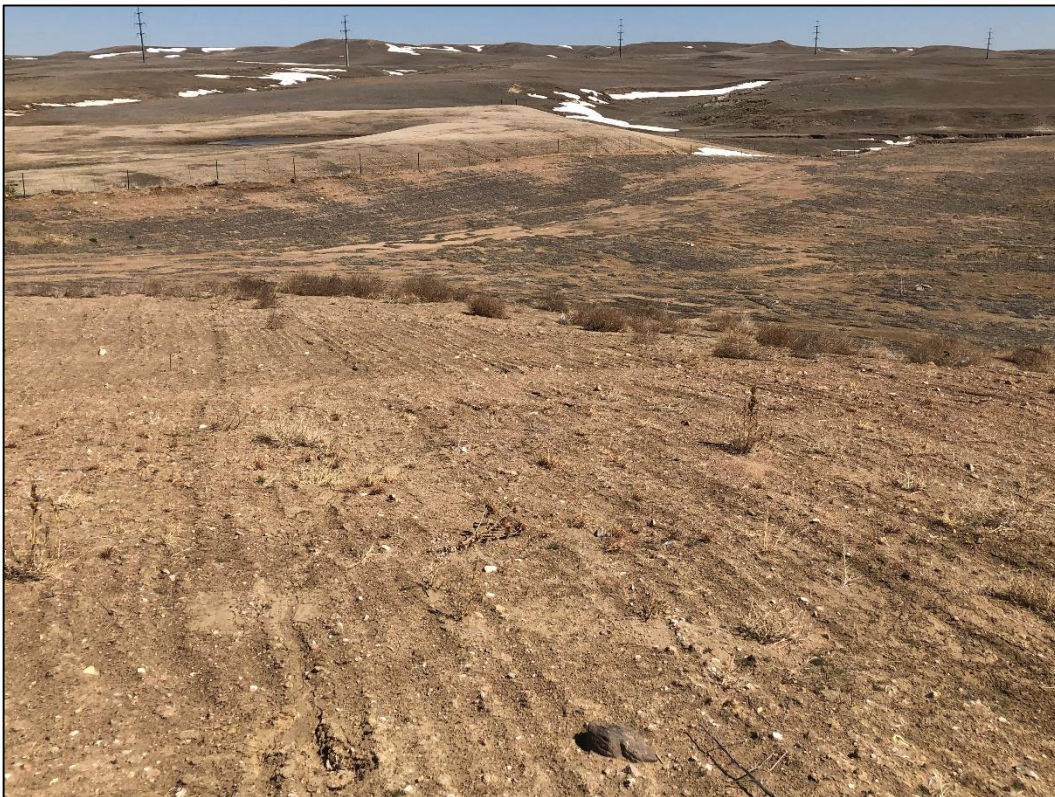
Photo 8. View looking northeast across northern edge of south mining area, showing slopes graded to 3H:1V or flatter. Very little grass growth is present in this area at this time.

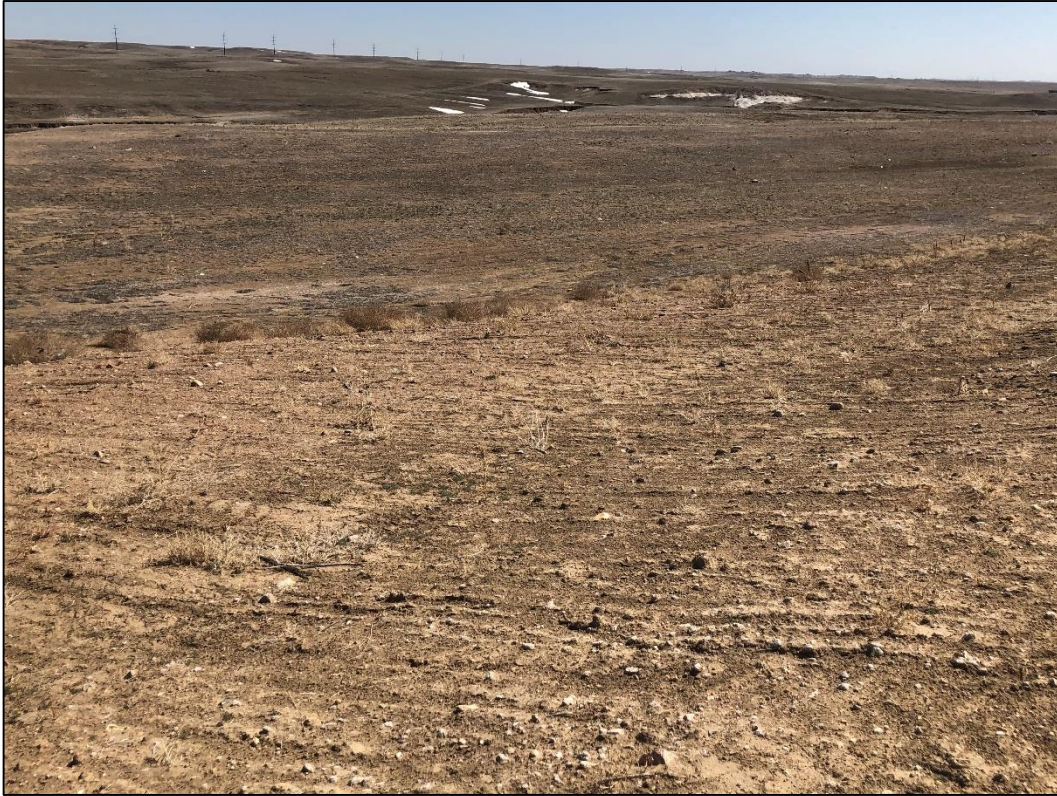
Photo 9. View looking northeast across northern edge of south mining area, showing slopes graded to 3H:1V or flatter. Very little grass growth is present in this area at this time.

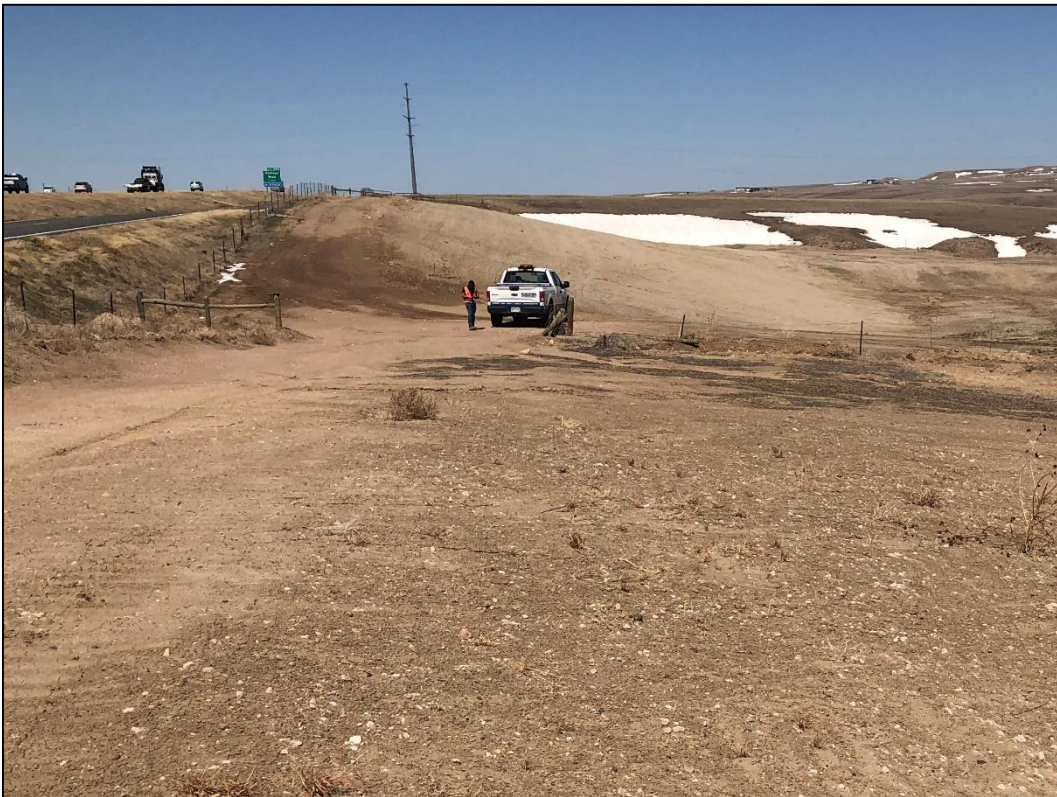
Photo 10. View looking north at internal access between north and south mining areas.

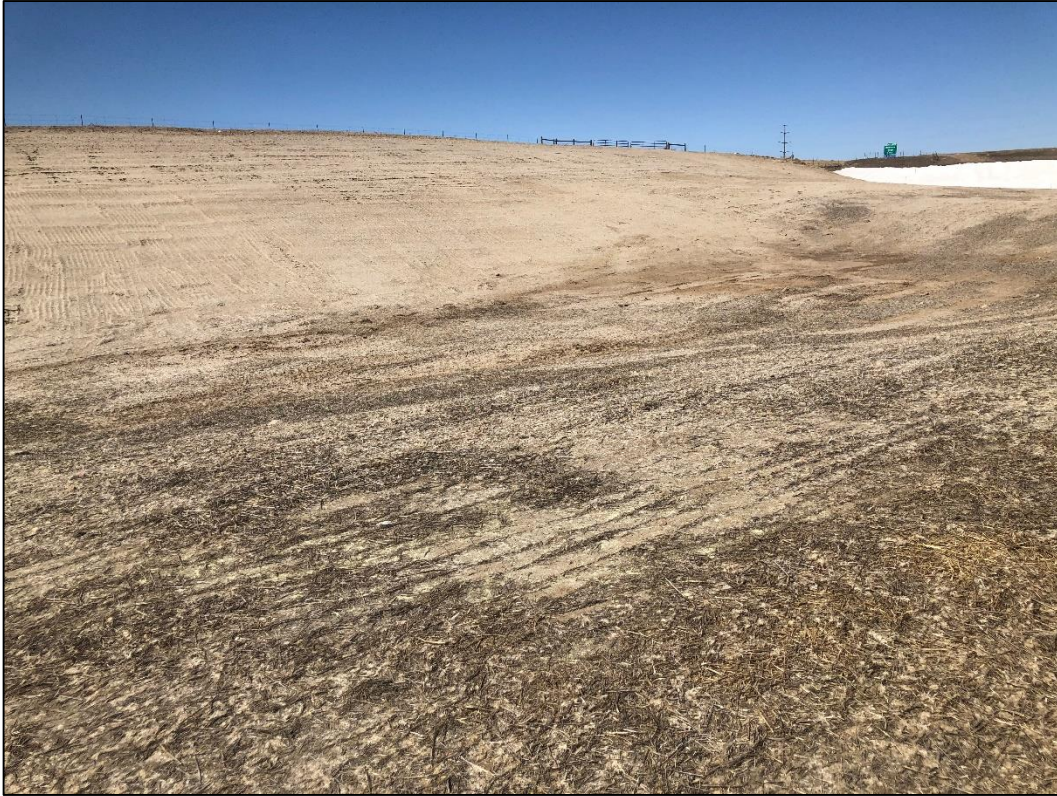
Photo 11. View looking northwest at pit wall in north mining area, showing slopes graded to 3H:1V or flatter. Very little grass growth is present in this area at this time, especially on the pit slope.

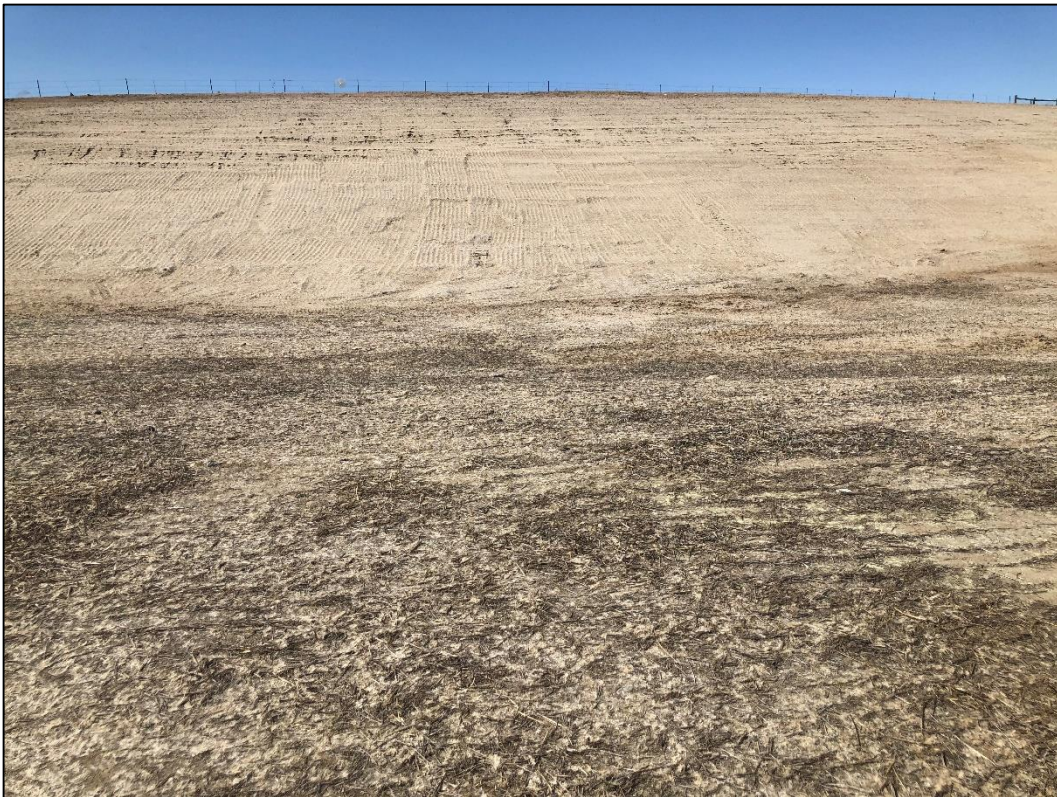
Photo 12. View looking west at pit wall in north mining area, showing slopes graded to 3H:1V or flatter. Very little grass growth is present in this area at this time, especially on the pit slope.

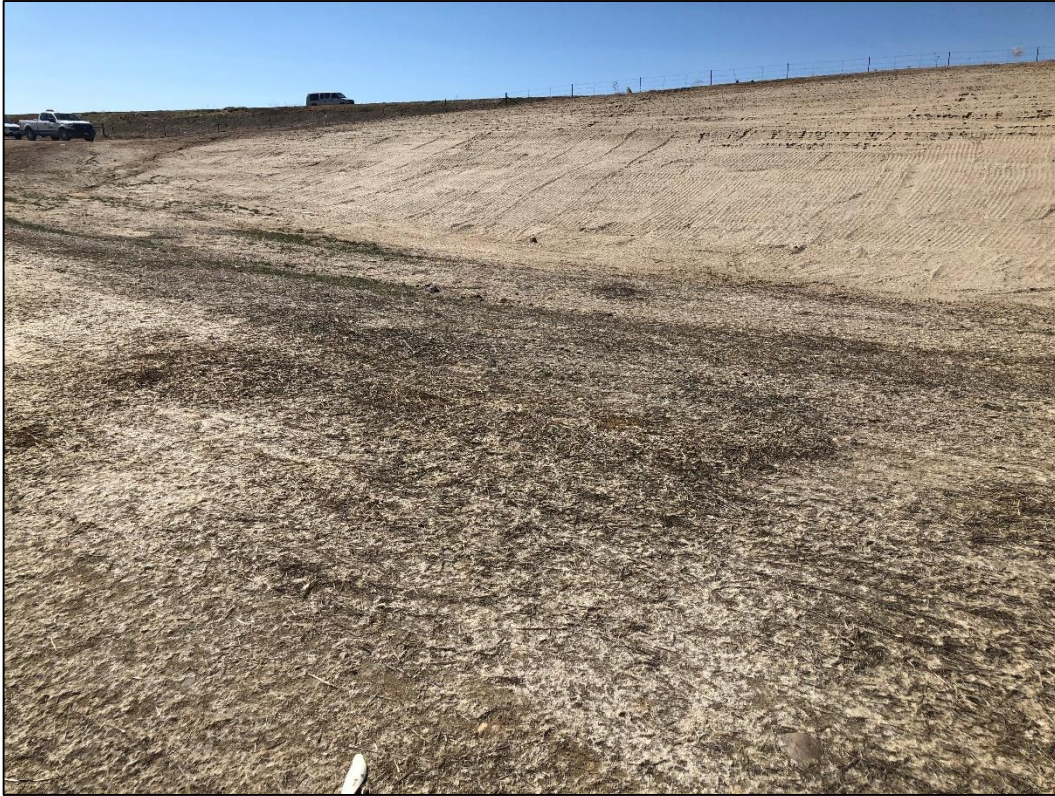
Photo 13. View looking southwest at pit wall in north mining area, showing slopes graded to 3H:1V or flatter. Very little grass growth is present in this area at this time, especially on the pit slope.

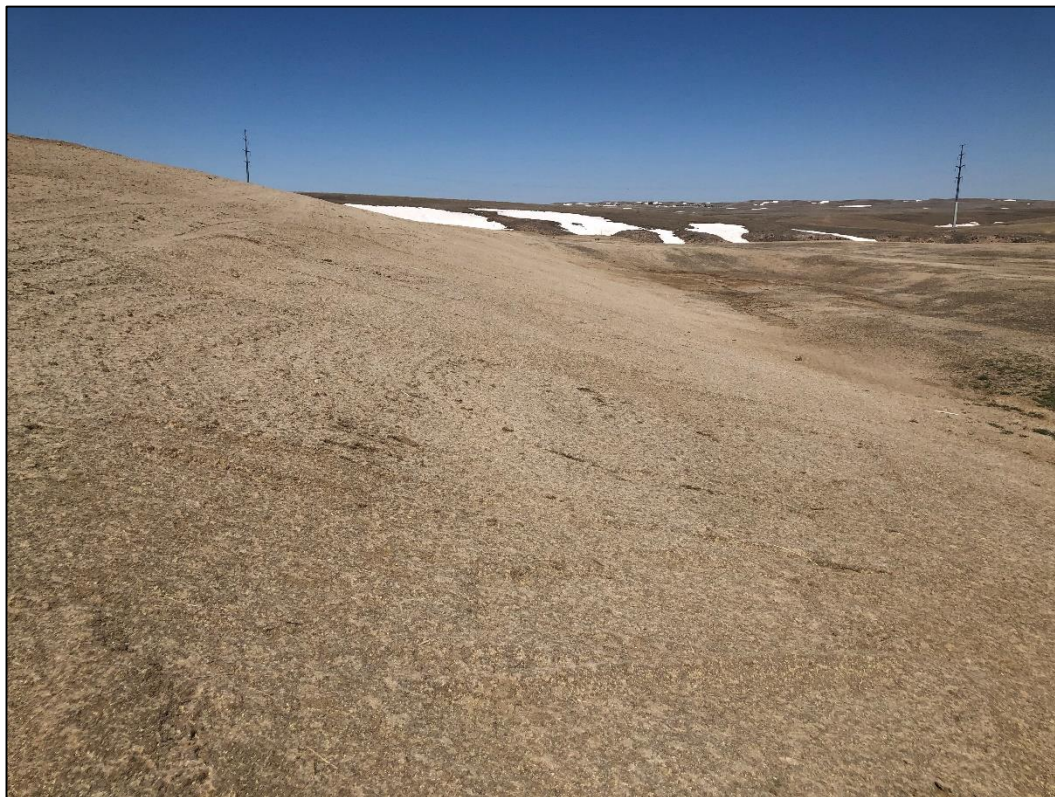
Photo 14. View looking north across pit wall in north mining area, showing slopes graded to 3H:1V or flatter. Very little grass growth is present on the pit slope at this time.

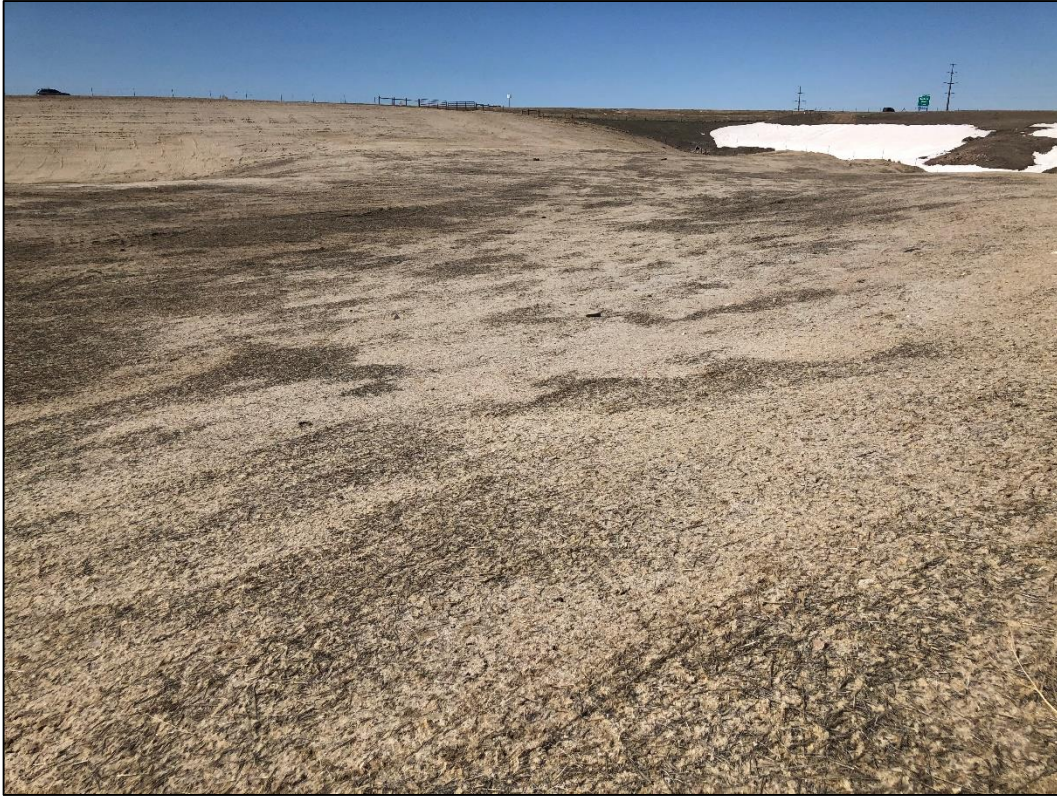
Photo 15. View looking northwest across pit floor of north mining area, showing slopes graded to 3H:1V or flatter. Very little grass growth is present in this area at this time.

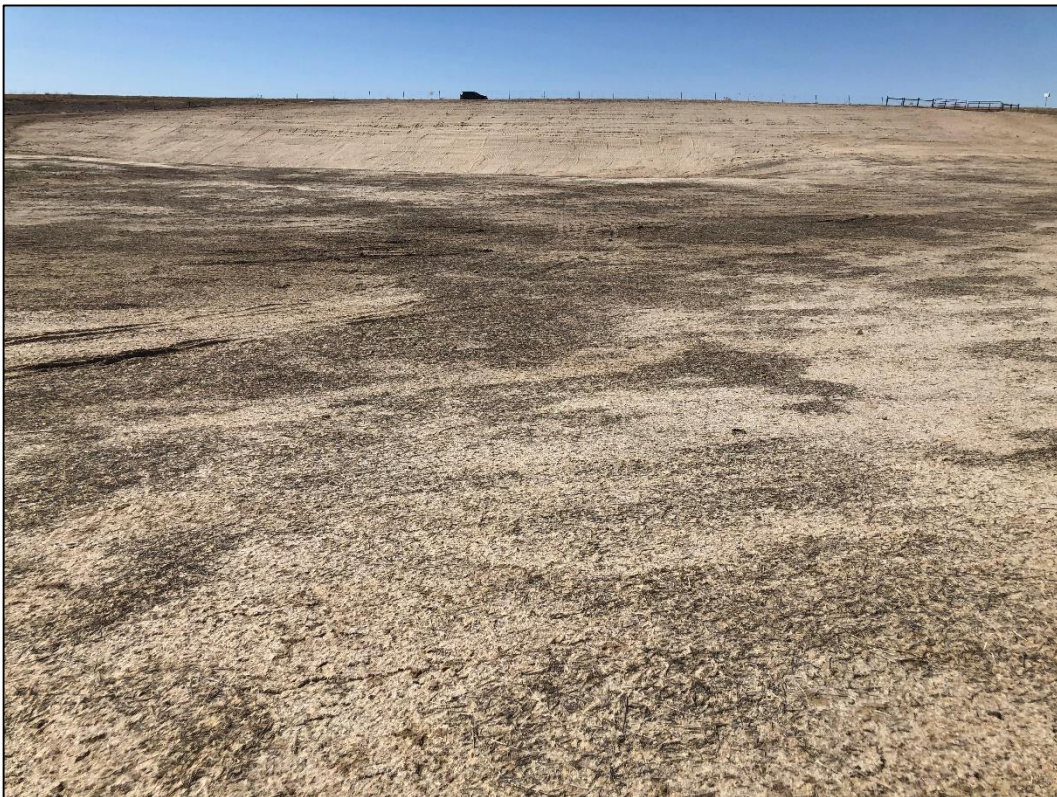
Photo 16. View looking west across pit floor of north mining area, showing slopes graded to 3H:1V or flatter. Very little grass growth is present in this area at this time.

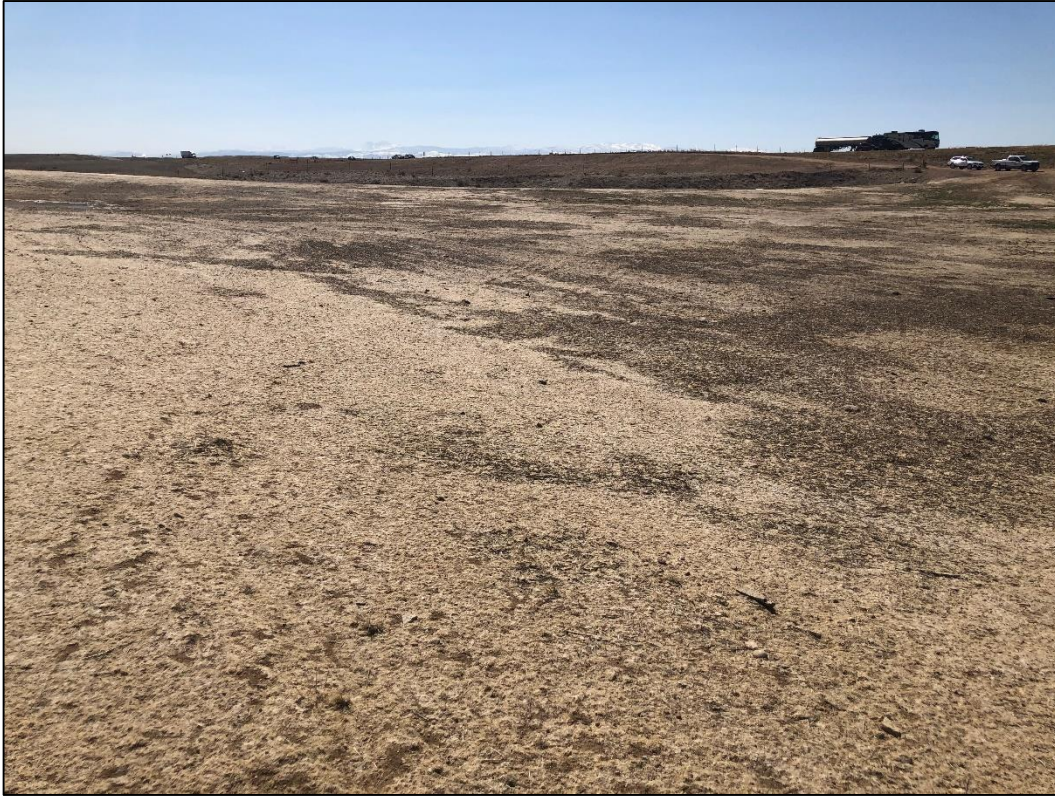
Photo 17. View looking southwest across pit floor of north mining area, showing slopes graded to 3H:1V or flatter. Very little grass growth is present in this area at this time.

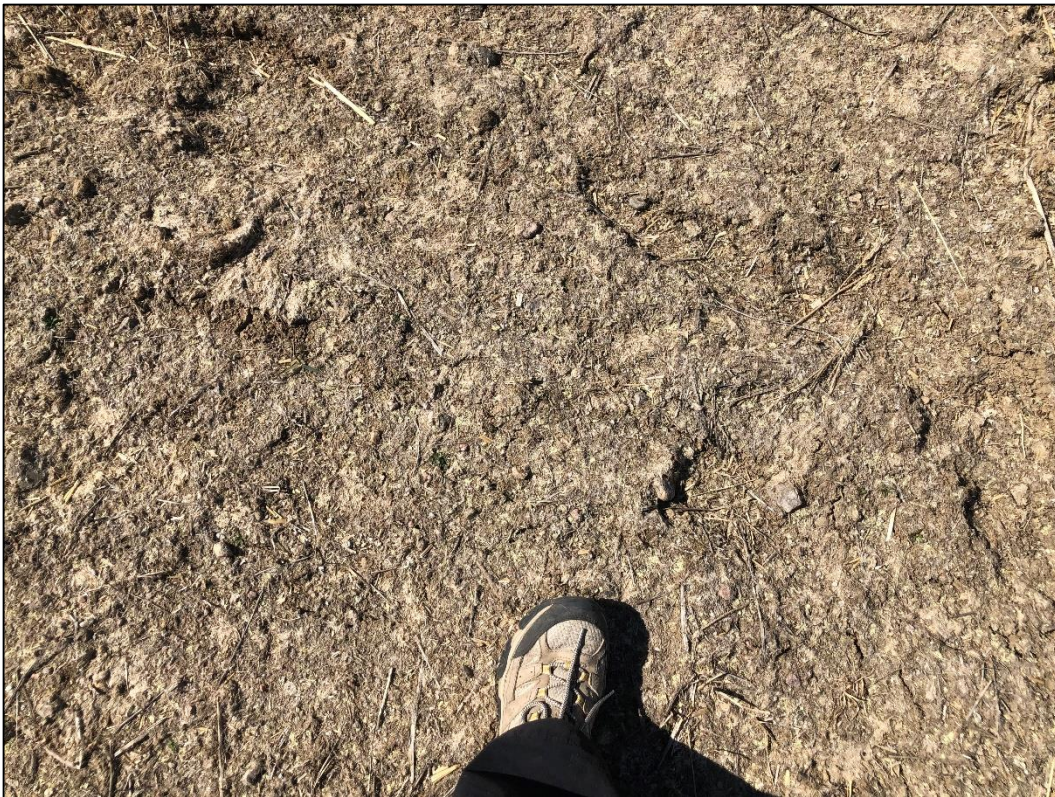
The north mining area was retopsoiled and seeded in the summer of 2020. A sulfur soil amendment was applied in this area in the fall of 2020 to lower the pH of the soils per the soil test results. The operator also applied a bonded fiber matrix mulch in this area which, given the high winds in this region, should be more effective than the standard straw or hay mulch application. Very sparse grass growth was observed in this area at this time. More grass growth was present along the southern edge of this area. Fewer annual weeds were observed in this area compared with the south mining area. No erosion issues were observed in this area.

Photo 18. Ground view of pit floor in north mining area, showing bonded fiber matrix mulch applied in this area and very little to no grass growth at this time.

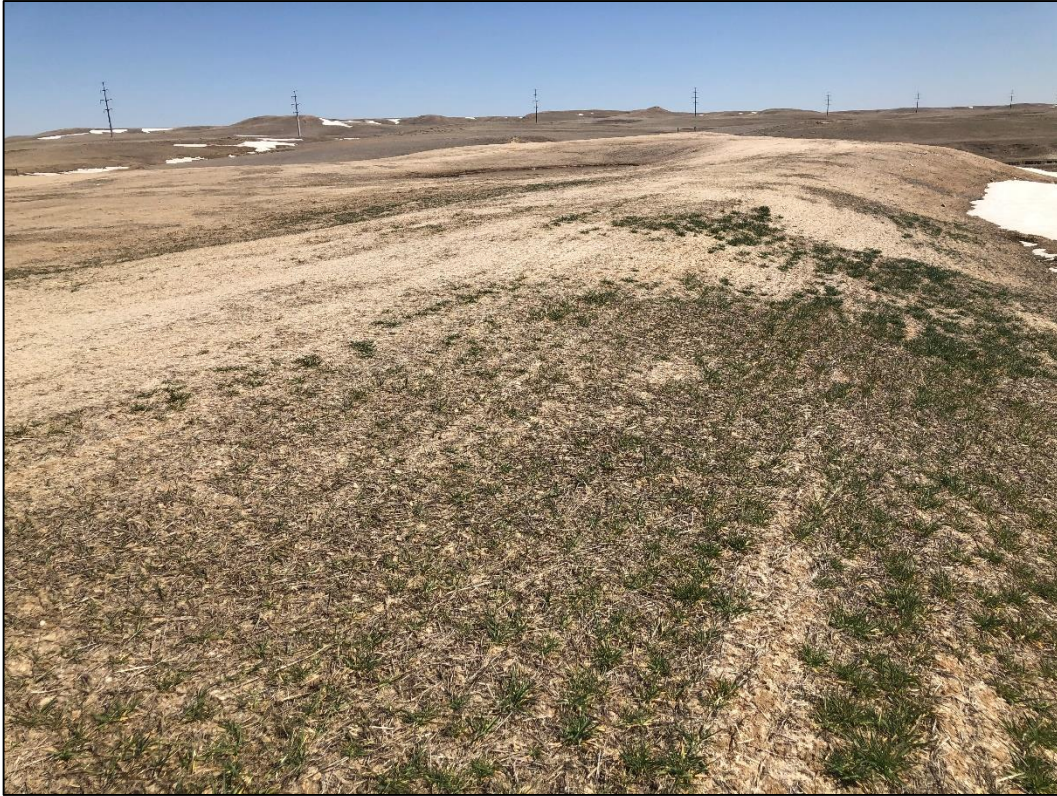
Photo 19. View looking east across southern edge of north mining area, showing slopes graded to 3H:1V or flatter and a bit more grass growth in this area.

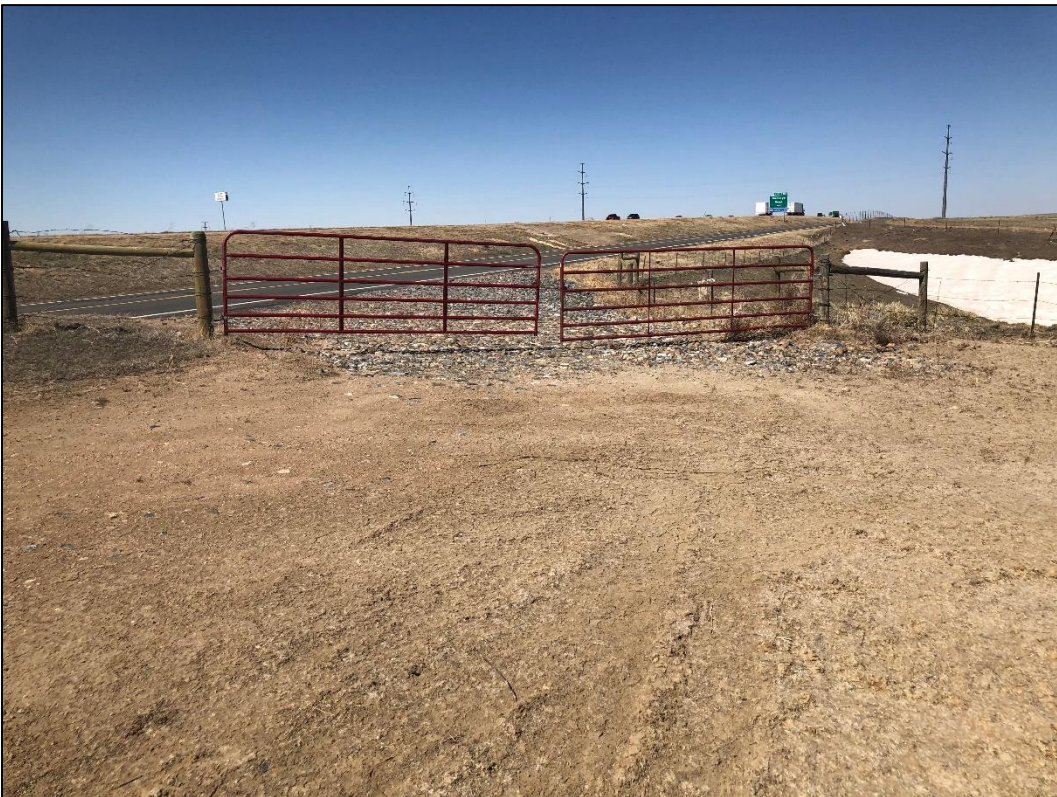
Photo 20. View looking northwest at gated entrance/access road constructed off I-25 frontage road to enter north mining area. This entrance/road will remain for reclamation per the landowner's request
