MINERALS PROGRAM INSPECTION REPORT
PHONE: (303) 866-3567

MINE NAME: Barlow Pit	MINE/PROSPECTING ID#: M-1974-092	MINERAL: Sand and gravel	COUNTY: Morgan
INSPECTION TYPE: Monitoring	INSPECTOR(S): Brock Bowles	INSP. DATE: March 19, 2021	INSP. TIME: 10:00
OPERATOR: Dorn Ready Mix Corp.	OPERATOR REPRESENTATIVE: Ross Dowling	TYPE OF OPERATION: 112c - Construction Regular Operation

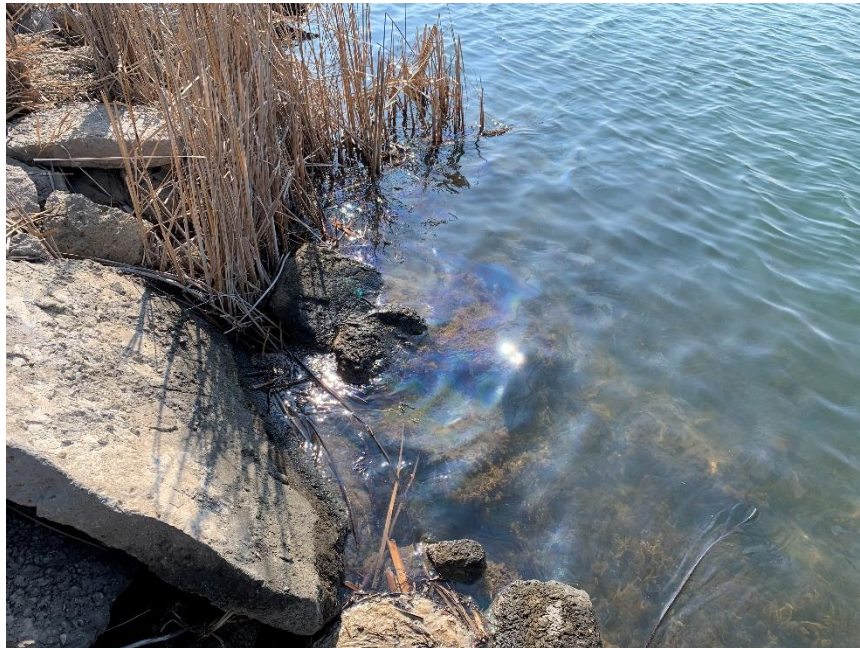
PROBLEM/POSSIBLE VIOLATION: Problem: A fuel spill has occurred at the site which has impacted soils, surface water or groundwater. This is a problem pursuant to Rule 3.6.1(1)(b) for failure to comply with federal and Colorado water quality laws and regulations, including statewide water quality laws and regulations, including statewide water quality standards.

This inspection was conducted as a follow-up to a Spill Report submitted to CDPHE by the operator on March 16, 2021. It was reported that 15 gallons of hydraulic fluid was spilled into the water pond located on the minesite. The pond is about 18 acres in size and does not connect to any other water way. The operator deployed oil absorbent devices to clean up the site on the day of the spill. The operator said it was actually diesel fuel that spilled. There was a miscommunication among the company staff. Upon inspection of the pond, an oil sheen was seen on the eastern shore of the pond (photo 1). The remaining spill needs to be cleaned up and a water sample needs to be taken and submitted for analysis to determine that the remaining spilled diesel was cleaned up (Rule 3.6.1(1)(b)). The water sample needs to be taken within two weeks of the date of this inspection (by April 2, 2021). The test results then need to be submitted to DRMS within 1 week of receipt.

Photo 1 – Petroleum sheen seen on eastern shoreline of pond.

CORRECTIVE ACTIONS: The operator shall immediately remediate the spill and submit a final report to the Division containing at least the following information:

- 1.) A description of how the spill was cleaned up containing at a minimum - volumes removed, sample locations, analytical data, and photo documentation.
- 2.) A water sample needs to be taken and submitted for analysis to determine that the remaining spilled diesel was cleaned up. The water sample needs to be taken within two weeks of the date of the inspection (by April 2, 2021). The test results will then be submitted to DRMS within 1 week of receipt.

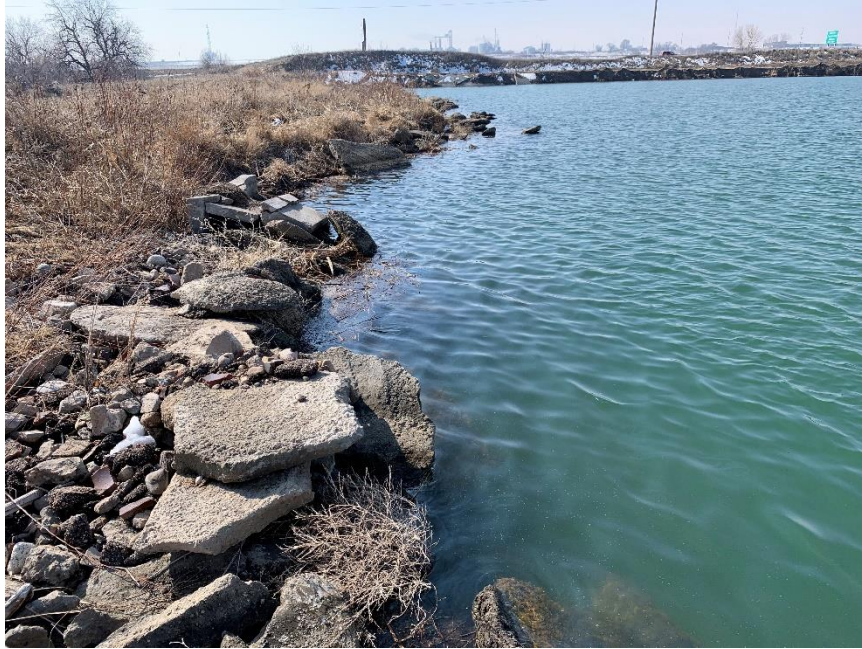
The eastern shore of the pond was lined with rocks and concrete pieces (photo 2). Vegetation was well established around the rocks/concrete and the shoreline appeared stable. The south shoreline parallels Interstate 76. This area contained some concrete pieces/blocks and sand. This shoreline is where the waste material from the wash plant is deposited increasing the distance between the pond and highway (photo 3). The north shoreline is the active mining area and where the wash plant is located (photo 4). These areas did not have vegetation but appeared to be stable. The western shoreline is also being mined on the north section (photo 5). The southern section of the western shoreline is not being mine and is not reclaimed but appears stable.

Photo 2 – Eastern shoreline facing south

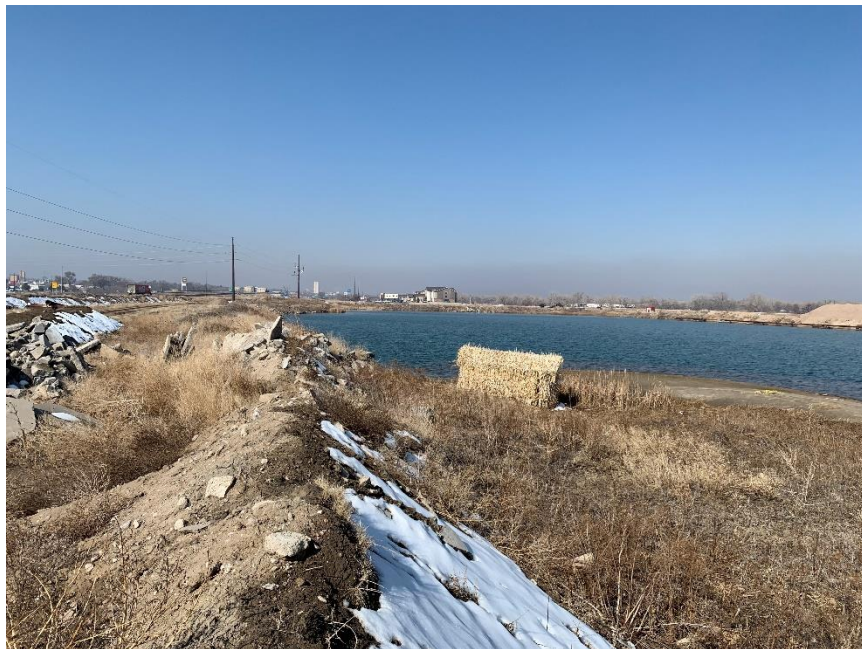
Photo 3- Southern shoreline facing west

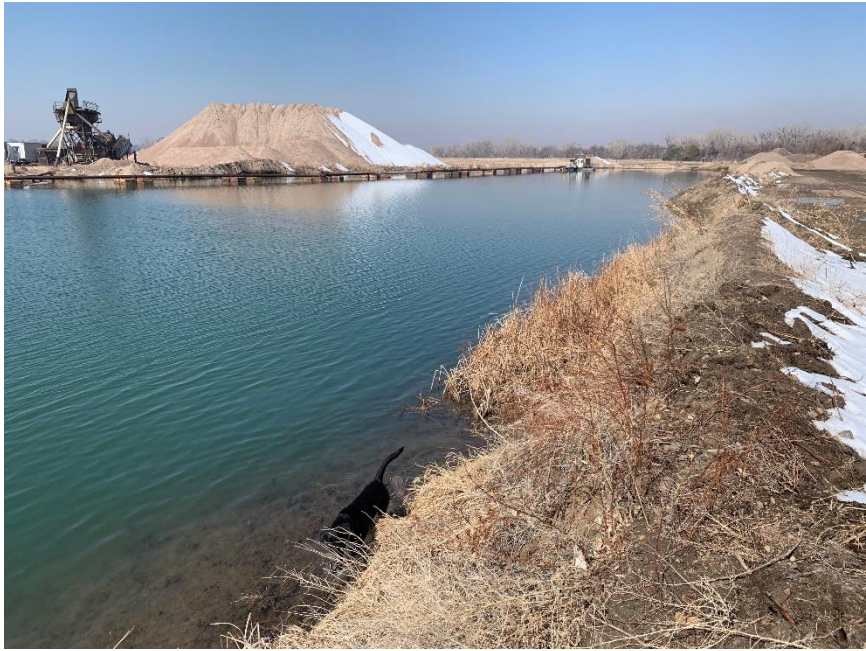
Mining was not taking place during the inspection. The annual report shows that the last activity was in Oct 2020. This date appears consistent with site conditions. A large sand stockpile was located next to the wash plant ready for shipment.

Photo 4 – Wash plant, stockpile and dredge. From eastern shore facing northwest

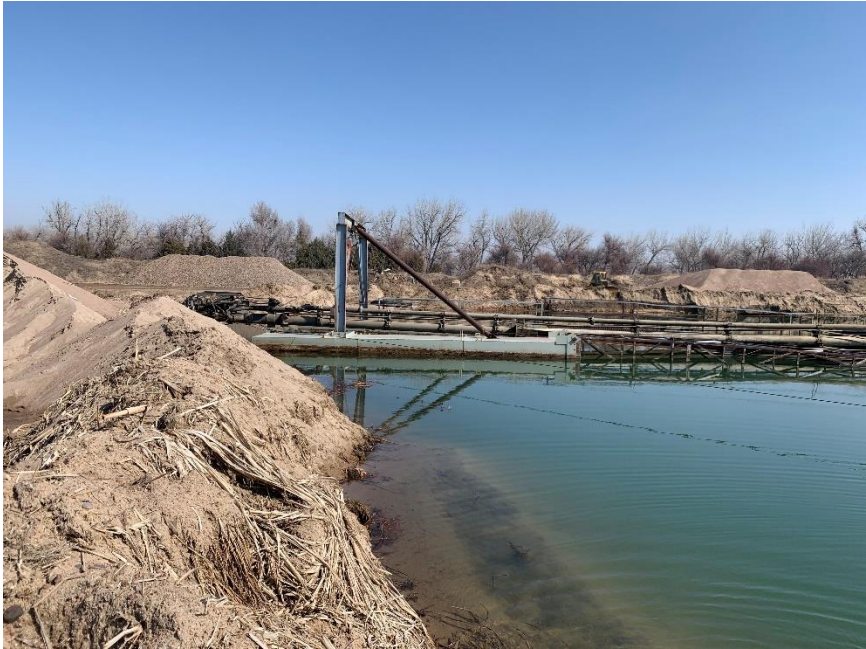
Photo 5 – Dredge in the northern part of the pond, mining to the west. The tree line in the background is the property line.
