**COLORADO**Division of Reclamation,
Mining and Safety

PERMIT INFORMATION

Permit Number: C-2010-088 Mine Name: Fruita Loadout Operator: CAM-Colorado, LLC Operator Address: Ronald Hull 424 Lewis Hargett Circle Suite 250 Lexington, KY 40503	County: Mesa Operation Type: Loadout Permit Status: Temporary Cessation Ownership: Private
	Operator Representative Present: Jim Stover
Operator Representative Signature: (Field Issuance Only)

Inspection Start Date: March 31, 2021 Inspection Start Time: 13:00 Inspection End Date: March 31, 2021 Inspection End Time: 13:35		Inspection Type: Coal Complete Inspection Inspection Reason: Surety Release Requested Weather: Clear	
Joint Inspection Agency: None		Joint Inspection Contacts: None	
Post Inspection Agency: None		Post Inspection Contacts: None	
Inspector(s): Clayton Wein	Inspector's Signature: <i>Clayton Wein</i>		Signature Date: 4/9/2021

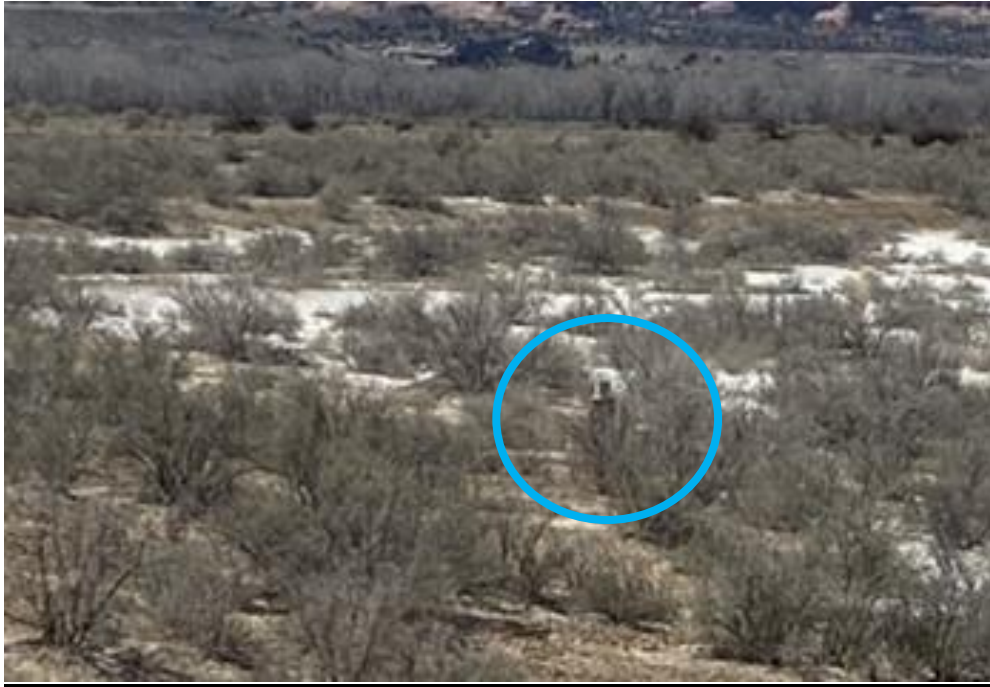
observed signs of runoff from the permit area and no off-site impacts were seen. Hydrologic monitoring wells RW-1 (Photo 1) and RW-2 (Photo 2) are located within the permit boundary. The sites for the wells were stable and the well casings were in good condition. The hydrologic monitoring wells have been transferred to the surface owner and will remain as a permanent feature.

Photo 1: Groundwater monitoring well RW-1 is outlined in a blue circle in the photo above.

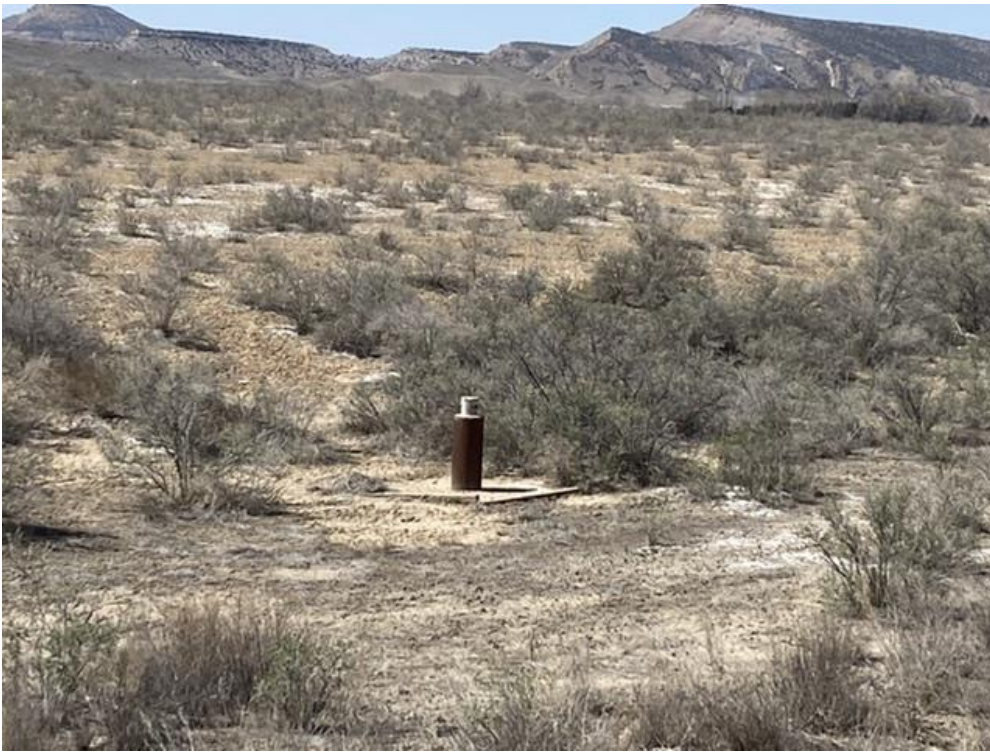
Photo 2: Groundwater well RW-2.

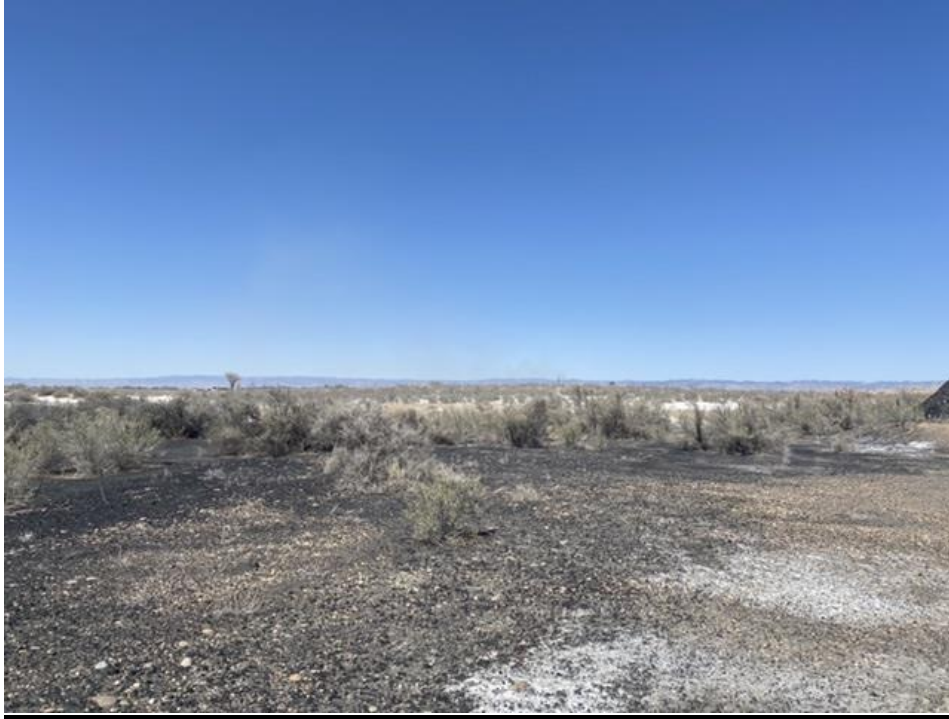
Photo 4: The eastern portion of the loadout looking to the northwest.

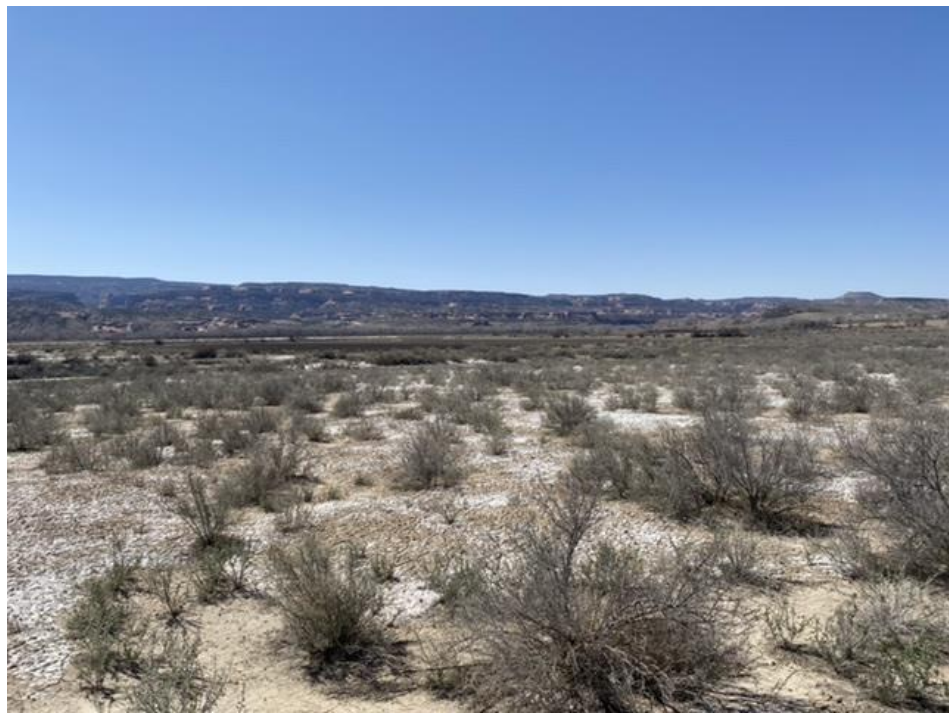
Photo 4: The middle portion of the loadout looking to the Southwest.

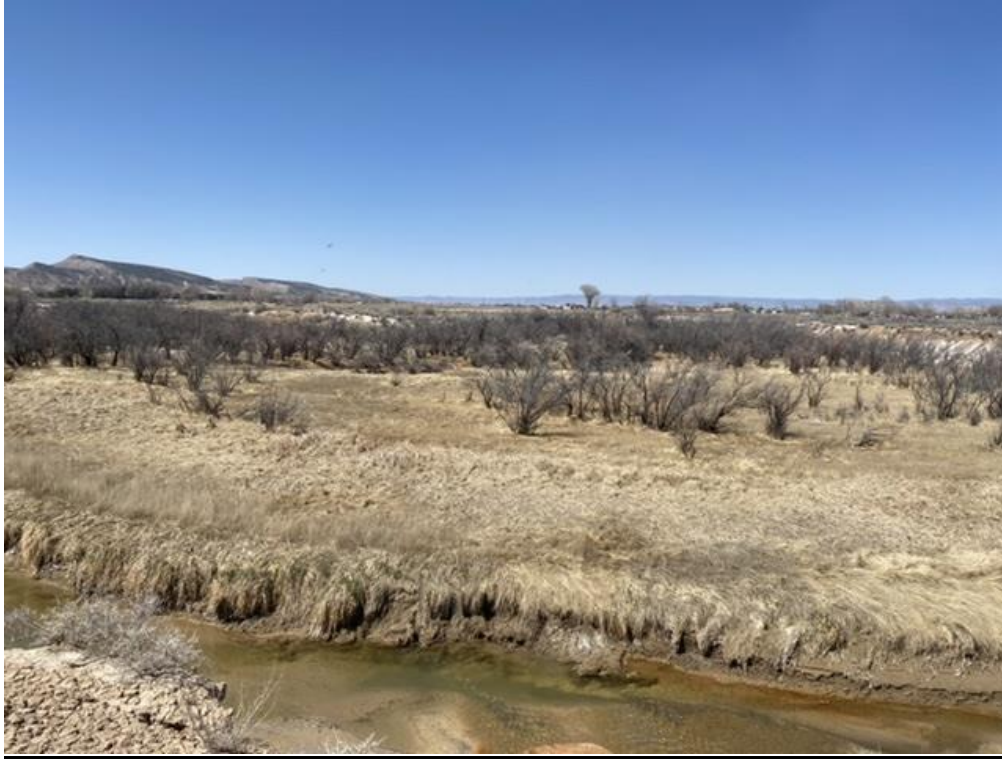
Reed Wash was flowing at the time of the inspection. There were no indications of impacts to the stream from the permitted area. No facilities were constructed within the permit area and no mining related activity occurred at the site. No indications of erosional features were identified during the inspection. There were no

Photo 5: The western portion of the loadout looking west. Reed Was is in the foreground of the photo above.

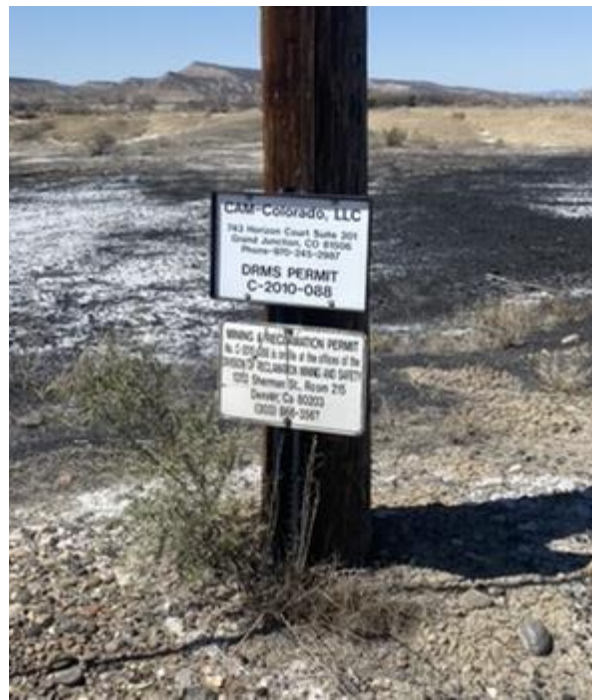
The mine identification signs were located at the entrance to the loadout. The signs were in good condition and the information posted was legible. Posted on the signs included information regarding the permit number, the permittee and the Division. Contact phone numbers for the permittee and the Division were also posted.

Photo 6: The mine identification signs displayed at the entrance to the loadout.
