**MINERALS PROGRAM INSPECTION REPORT**  
**PHONE: (303) 866-3567**

<b>MINE NAME:</b> Climax Mine	<b>MINE/PROSPECTING ID#:</b> M-1977-493	<b>MINERAL:</b> Molybdenum	<b>COUNTY:</b> Lake, Summit
<b>INSPECTION TYPE:</b> Aerial Inspection	<b>INSPECTOR(S):</b> Dustin Czaplá	<b>INSP. DATE:</b> March 31, 2021	<b>INSP. TIME:</b> 12:00
<b>OPERATOR:</b> Climax Molybdenum Company	<b>OPERATOR REPRESENTATIVE:</b>	<b>TYPE OF OPERATION:</b> 112d-3 - Designated Mining Operation	
<b>REASON FOR INSPECTION:</b> Normal I&E Program	<b>BOND CALCULATION TYPE:</b> None	<b>BOND AMOUNT:</b> \$91,011,850.00	
<b>DATE OF COMPLAINT:</b> NA	<b>POST INSP. CONTACTS:</b> None	<b>JOINT INSP. AGENCY:</b> None	
<b>WEATHER:</b> Clear	<b>INSPECTOR'S SIGNATURE:</b>

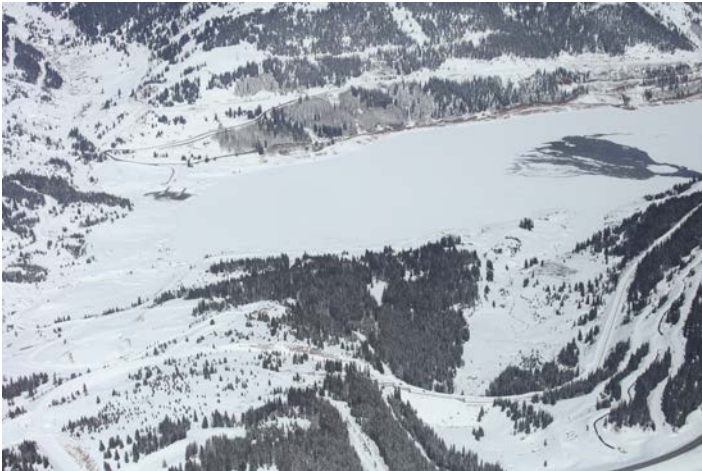
The Mayflower TSF and 5 Dam, Tenmile TSF and 3 Dam, Robinson TSF and 1 and 2 Dams, Robinson Lake, Eagle Park Reservoir and 4 Dam were observed. The area was under thick snow cover. No staining or discoloration were noted at any of the TSF dams. No abnormal conditions were noted. TSF's appear to be functioning within the established design criteria.

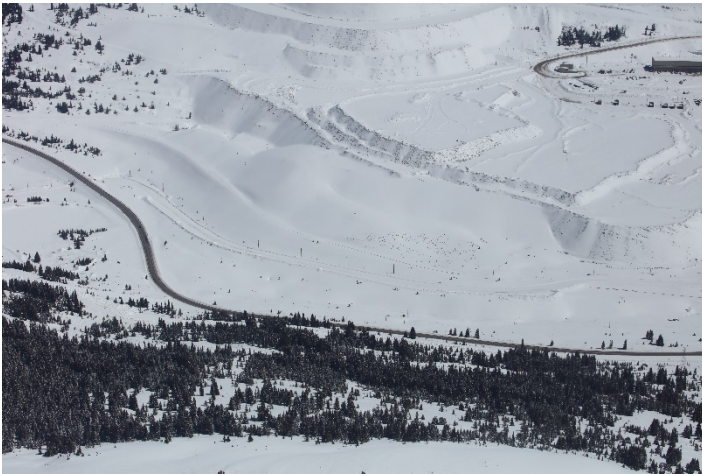
North 40 OSF

The North 40 and McNulty OSF's were observed. Deposition was occurring during this inspection, in the upper north part of the McNulty OSF. The current OSF operating plan was drafted by Golder Associates in December 2016. The plan was submitted to the Division as part of TR-25. In the Plan Golder states that snow accumulations of up to 2-3 feet on OSF faces do not significantly impact operation of large OSFs, however larger accumulations greater than 3 feet can become trapped as a continuous layer and form a weak layer or saturate finer grained layers as melting occurs. Therefore Golder recommended that waste rock only be deposited on slopes with less than 3 feet of snow accumulation. Accumulated snow was not observed in the area of deposition. Climax appears to be in compliance with Golder recommendations for OSF operations. No problems were noted with the OSF's.

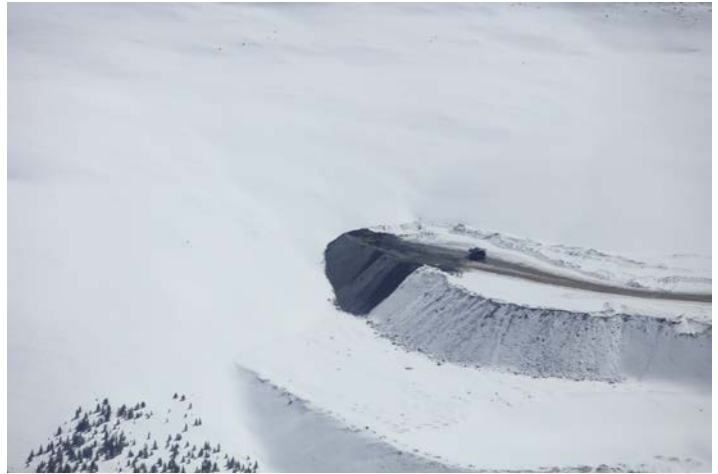
Dumping at McNulty OSF
