To: Jerald Schnabel From: Paul Kos  
Continental Materials Corp. Denver, CO 80222  
File: February 28, 2021 Monitoring Summary Date: March 31, 2021

**Reference: February 2021 Geotechnical Monitoring Summary Pikeview Quarry**

Client/Project  
CONTINENTAL MATERIALS  
CORP.  
PIKEVIEW QUARRY SLOPE  
MONITORING

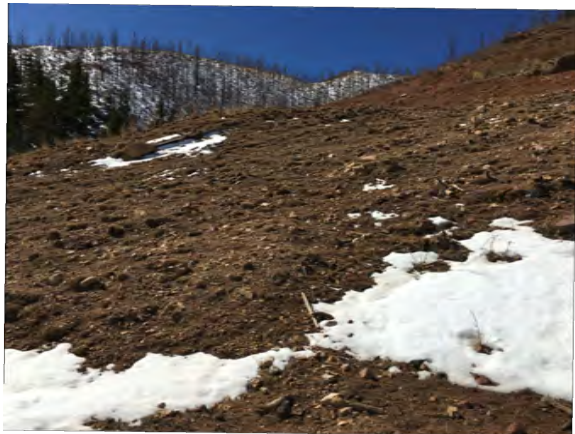
6. AREA ABOVE THE SLIDE

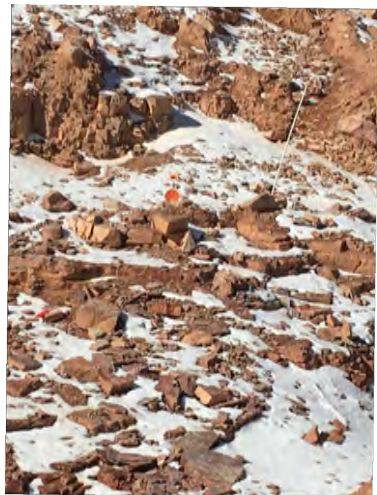
- Walked to the new 3 new prisms installed at the toe. (Note 5)
- The area upstream of the culvert has been excavated to clear the pipe for storm water. (Note 1)

5. A NEW PRISM AT THE TOE

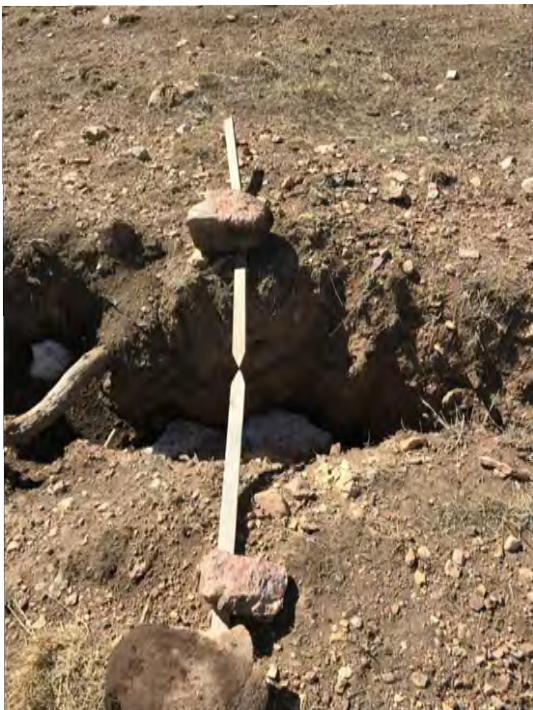
- Gullies and Rills: Gullies and rills have formed on the slopes above the slide area as well as in the burn areas above the quarry. (Note 8)
- Open Cracks: An open crack was observed during this visit. This feature is in an area where cracking is expected to occur as a result of ongoing slope settlement and relaxation. The edges of the crack have eroded suggesting it is not a new feature. (Note 7)

- Healed Cracks: A crack was observed on the slope adjacent to the slide where cracking had previously been observed. This crack runs parallel to the slide and appears to be “healed” and did not indicate any recent movement. (Note 7)

7. HISTORIC CRACK PARALLEL TO SLIDE

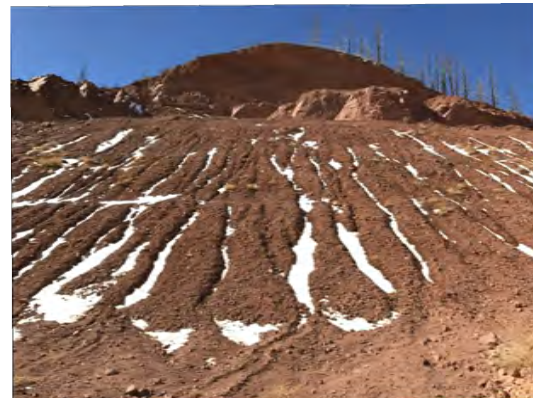
8. RILLS ON SLOPE UNDER PEAK

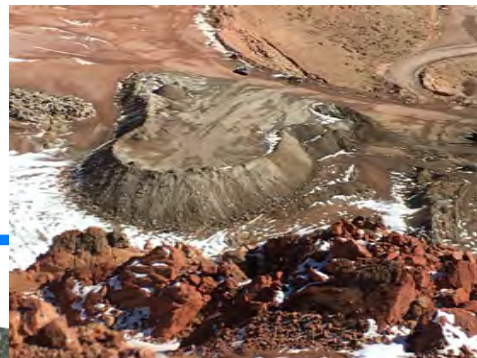
4. FILL DEPOSITED AT TOE OF SLIDE AREA

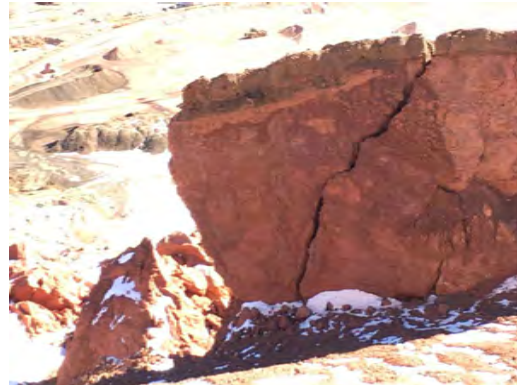
- Fill: Material is being imported and temporarily placed on the “production floor”. During the visit, different types of material including mulch and general fill were being deposited here for future placement. (Note 3)

3. LARGE PIECES OF THE SLIDE BREAKING UP

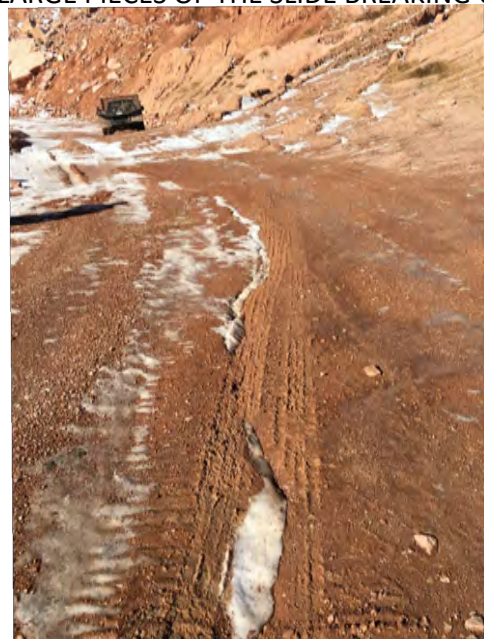
- Observed a new crack on the road on the north side of the quarry. The crack runs parallel to a fill slope and is likely the result of loose fill settling. The crack is not in the vicinity of the landslide and runs perpendicular to the landslide; therefore, it is not related to the landslide. (Note 2)

2. RECENT CRACKING LIKELY FROM SETTLEMENT

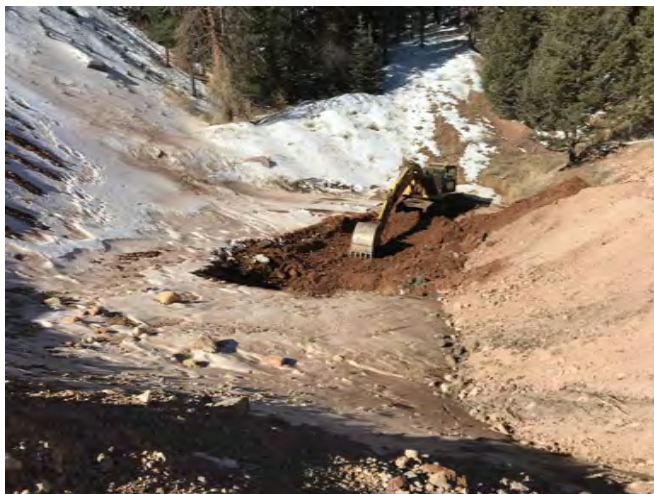
1. AREA UPSTREAM OF CULVERT GETTING CLEARED OF DEBRIS

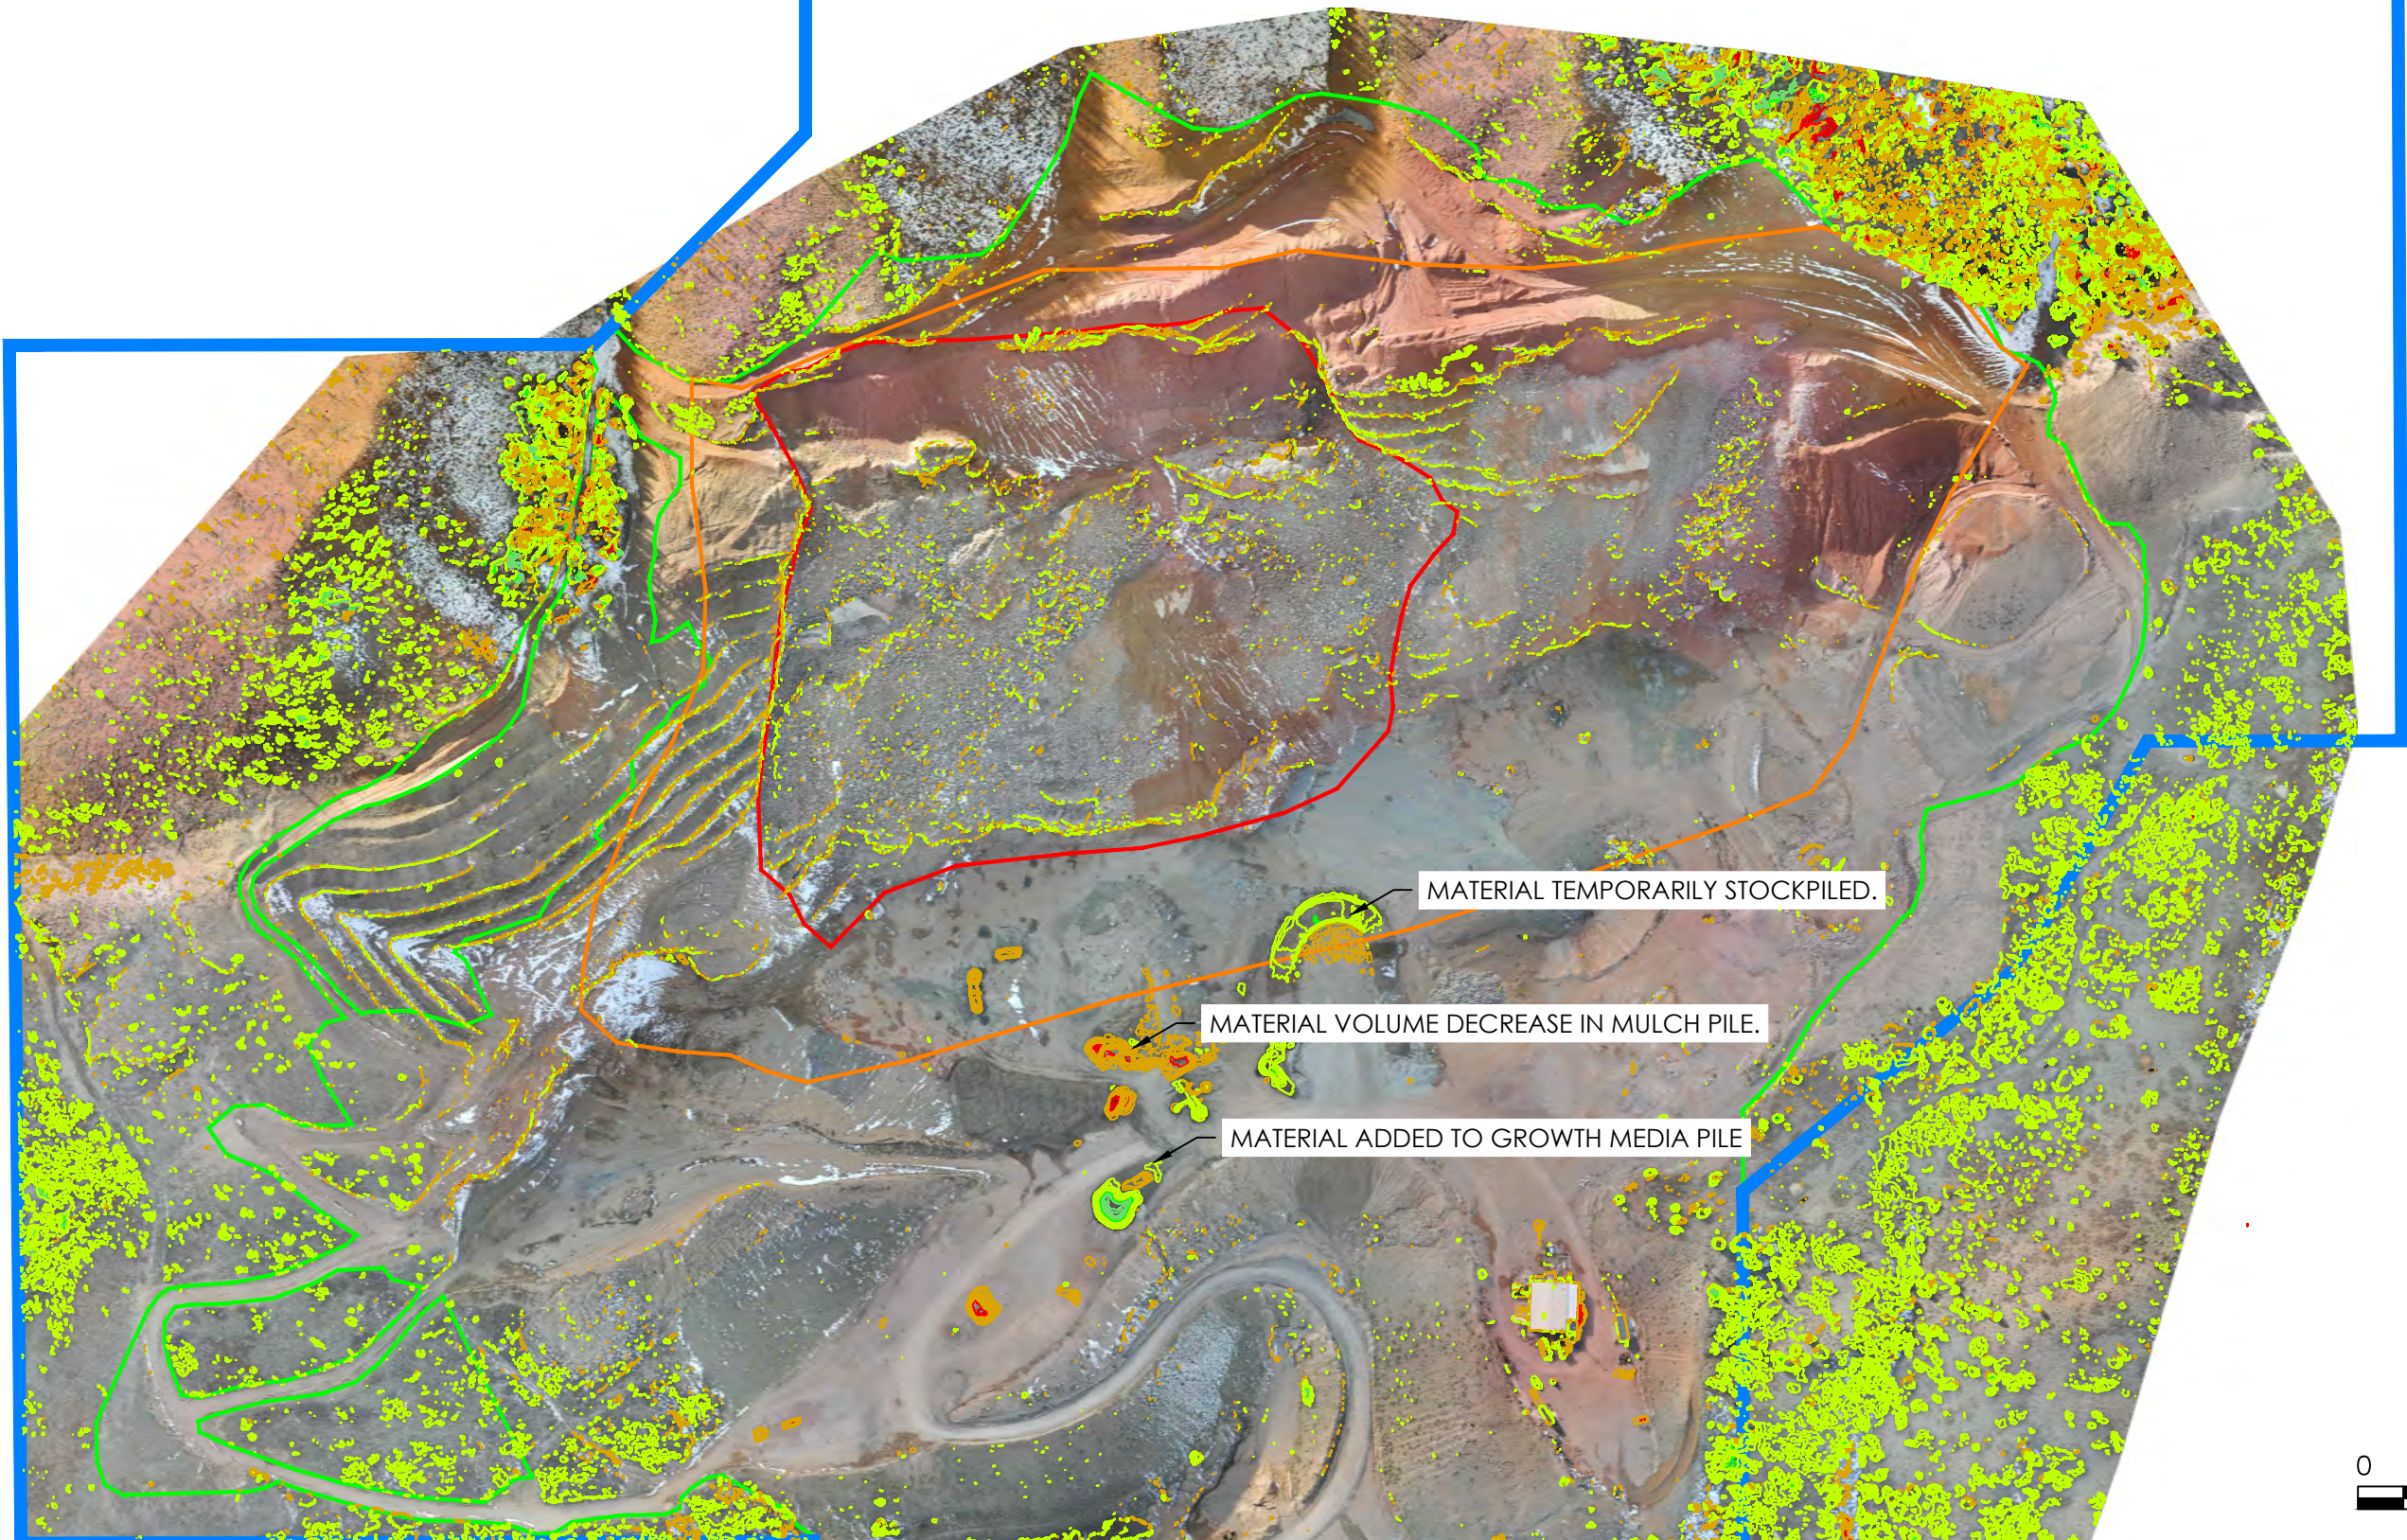
Revision #	Date 2021.03.31
Drawn By PK	Figure No. 5

The January topography was also compared to the February topography to identify changes in the site topography. Comparison of the two surveys showed that approximately 2,242 yd<sup>3</sup> of fill had been imported and temporarily placed. No slope movements or other changes in topography were identified. The current imagery and topography are included in Figures 1 and 3, and the comparison surface is included as Figure 5 in Appendix C.

As previously reported in the September 2020 monitoring report, there are limitations with the method of comparing drone surveys from different months. The drone data indicate changes in the slopes along each of the reclamation benches, buildings, and areas with trees or shrubs. These areas are stable, and the changes are the result of survey limitations on or near vertical slopes.
