**MINERALS PROGRAM INSPECTION REPORT**  
**PHONE: (303) 866-3567**

<b>MINE NAME:</b> Pueblo County Aggregate Project	<b>MINE/PROSPECTING ID#:</b> M-2016-009	<b>MINERAL:</b> Gravel	<b>COUNTY:</b> Pueblo
<b>INSPECTION TYPE:</b> Preoperation Inspection	<b>INSPECTOR(S):</b> Patrick Lennberg	<b>INSP. DATE:</b> April 6, 2021	<b>INSP. TIME:</b> 08:00
<b>OPERATOR:</b> Fremont Paving & Redi-Mix, Inc.	<b>OPERATOR REPRESENTATIVE:</b> Jodi Schreiber	<b>TYPE OF OPERATION:</b> 112c - Construction Regular Operation	
<b>REASON FOR INSPECTION:</b> Preoperation Inspection	<b>BOND CALCULATION TYPE:</b> Complete Bond	<b>BOND AMOUNT:</b> \$672,083.00	
<b>DATE OF COMPLAINT:</b> NA	<b>POST INSP. CONTACTS:</b> None	<b>JOINT INSP. AGENCY:</b> None	
<b>WEATHER:</b> Clear	<b>INSPECTOR'S SIGNATURE:</b>

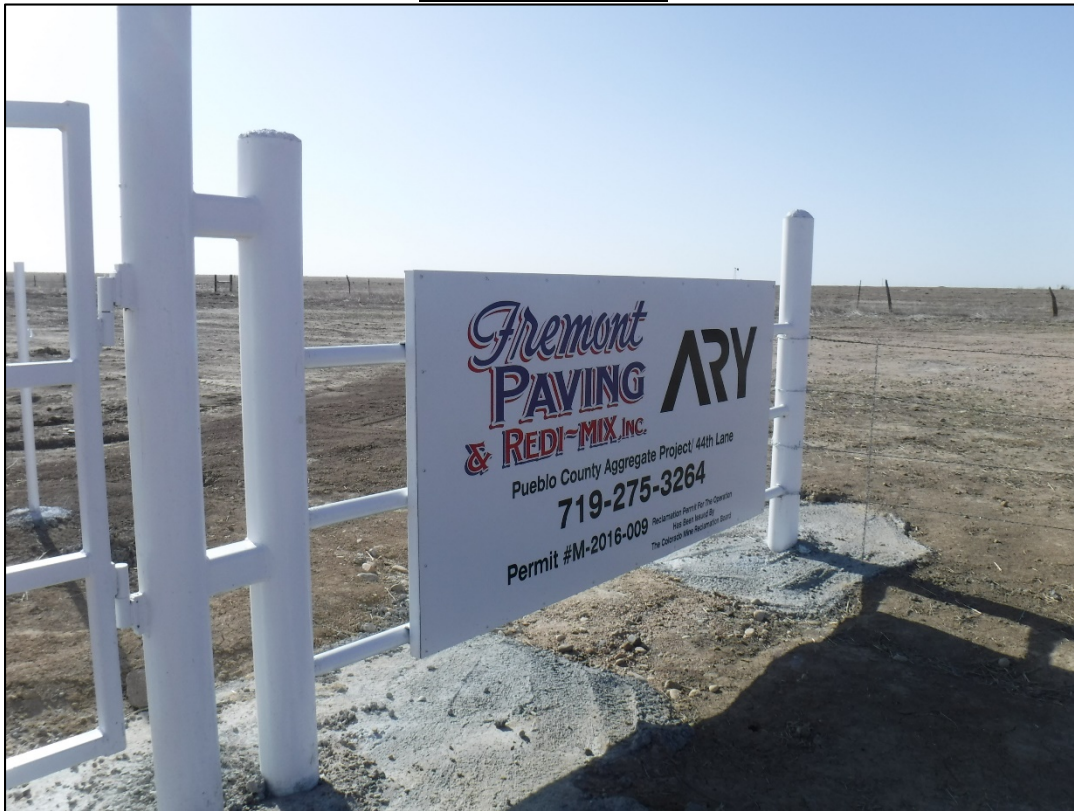
**Photo 1:** Looking east, 40<sup>th</sup> Lane crossing

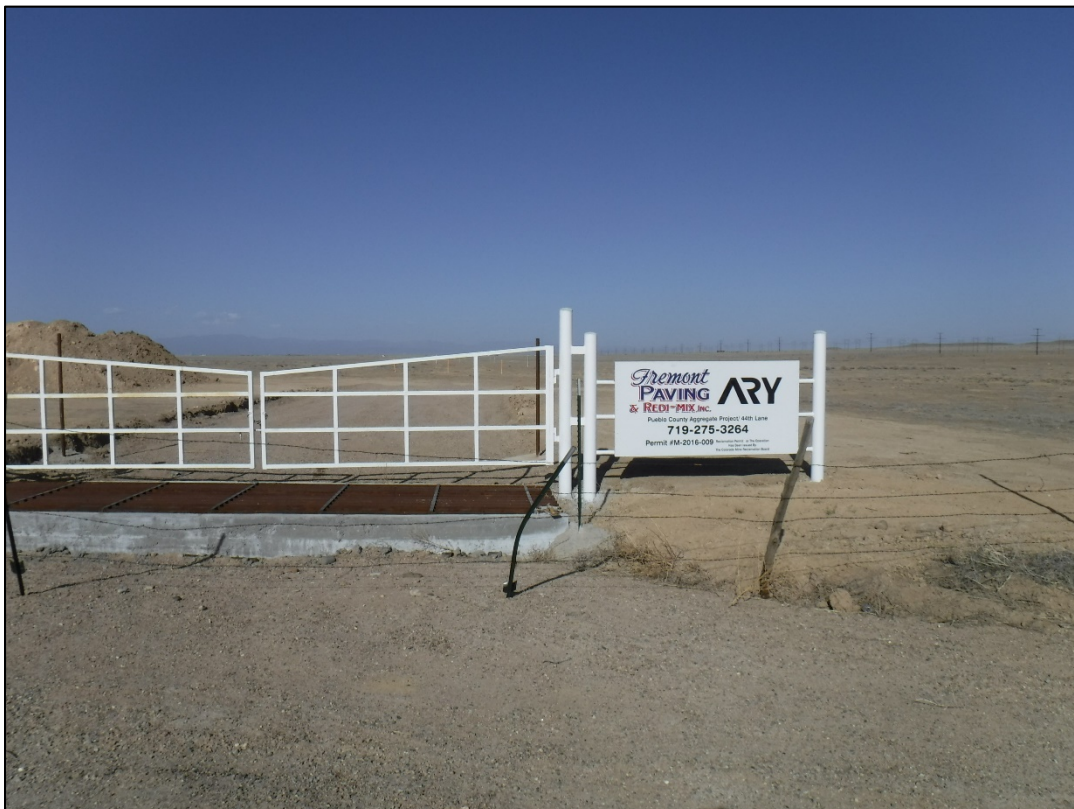
**Photo 2:** Looking west, 40<sup>th</sup> Lane crossing

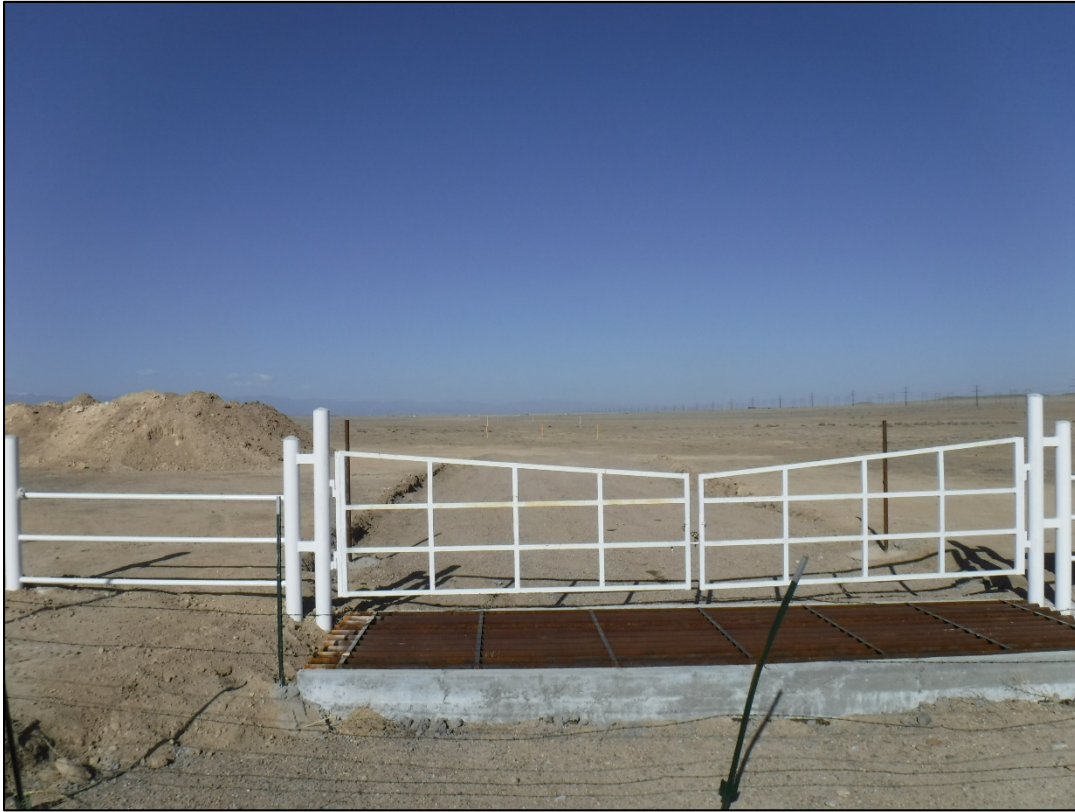
**Photo 3:** Looking west, 40<sup>th</sup> Lane crossing, PVC markers center of photo mark edges of proposed haul road

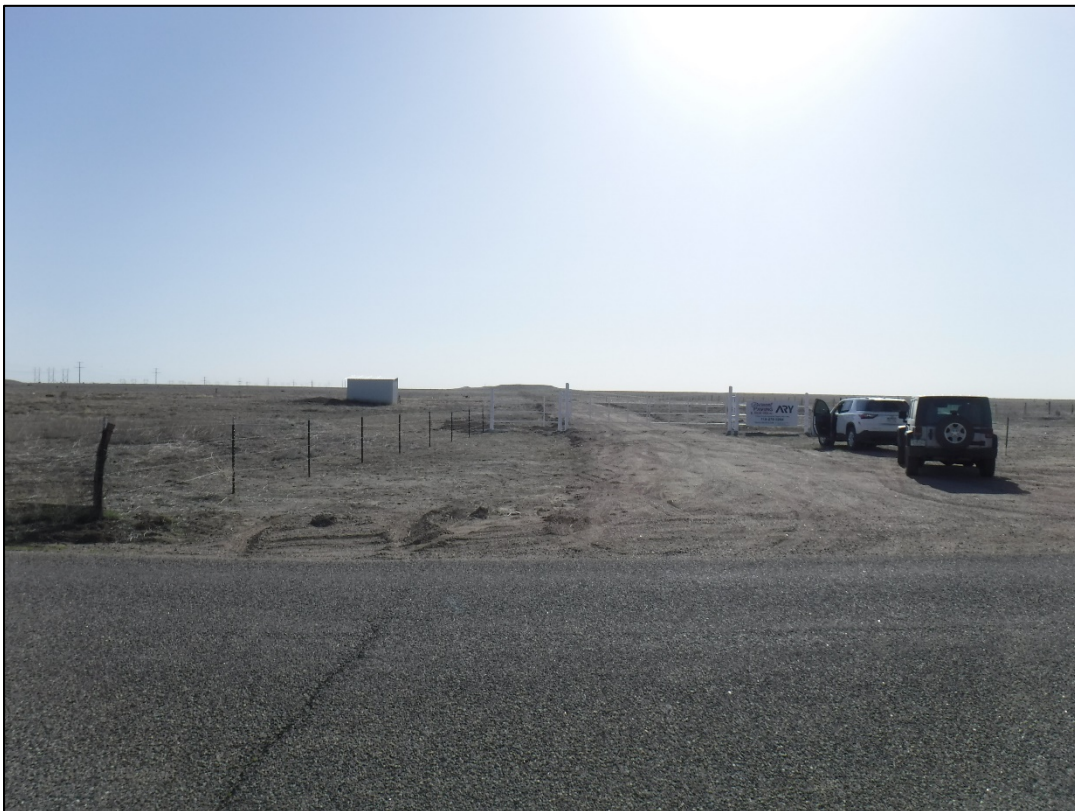
**Photo 4:** Looking east, 40<sup>th</sup> Lane crossing, from west side of road

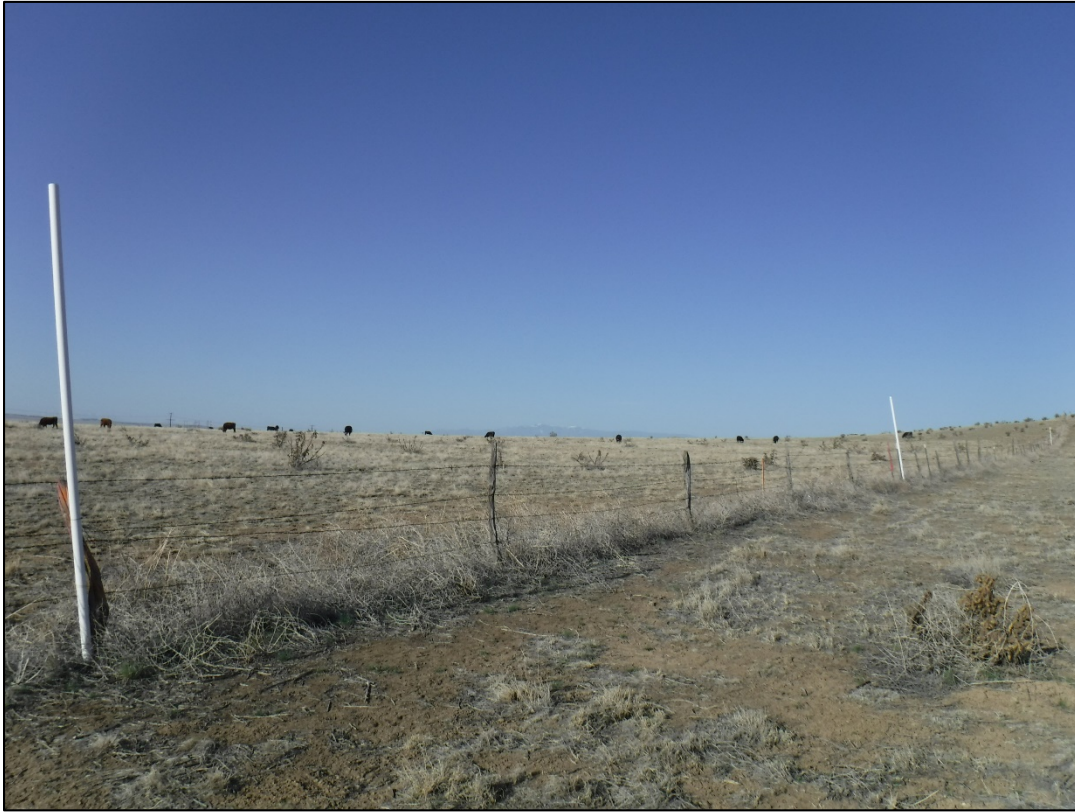
**Photo 5:** Proposed entrance of haul road into State Pit

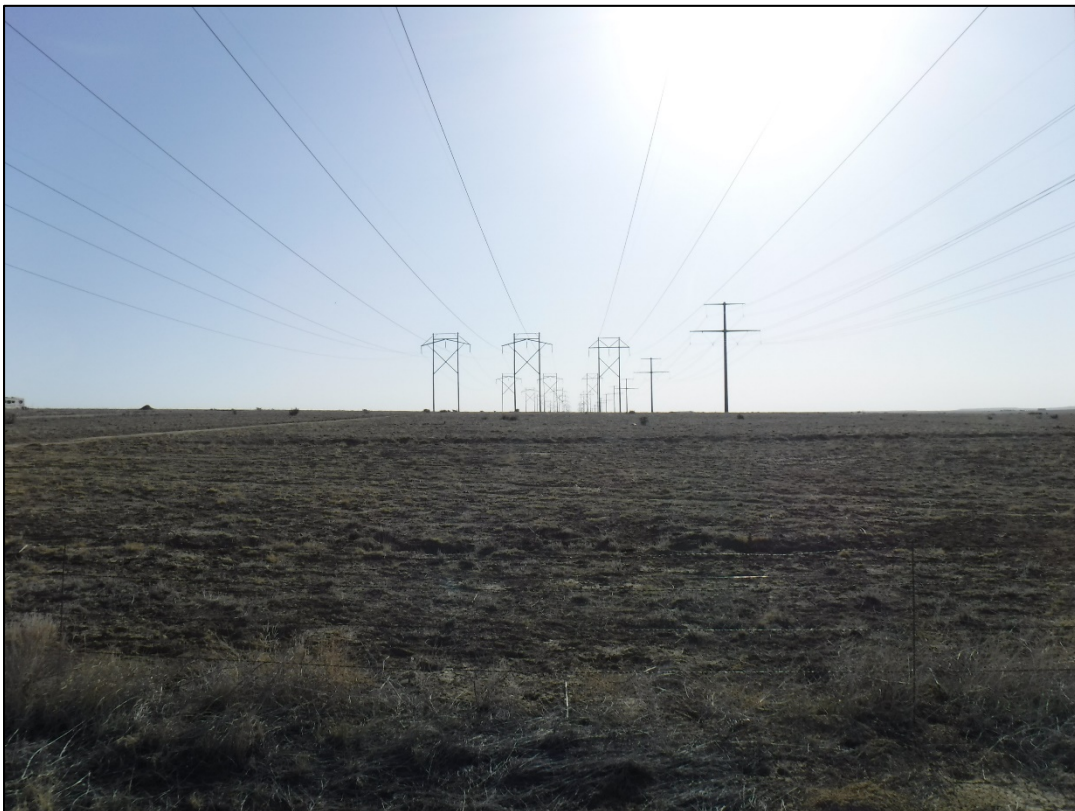
**Photo 6:** Area of the approved southern haul route where it intersects 36<sup>th</sup> Lane, unaffected

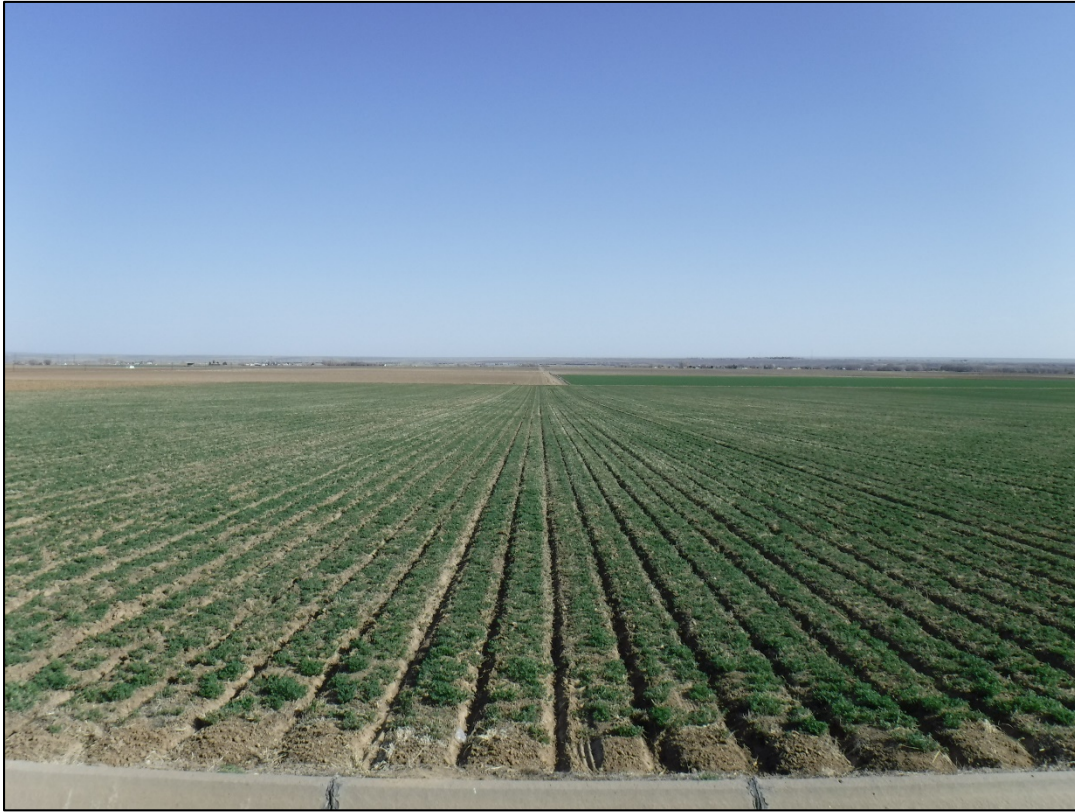
**Photo 7:** North haul route alignment looking north towards Hwy 50, unaffected by mining

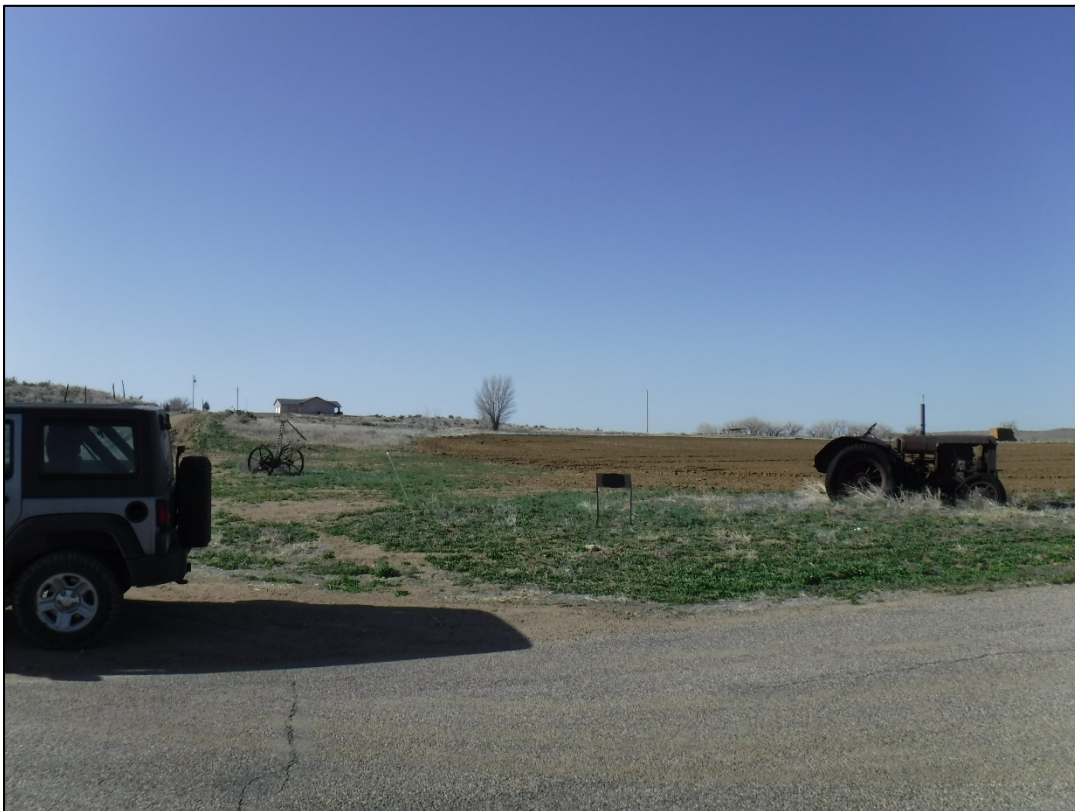
**Photo 8:** North haul route alignment looking south towards private property, unaffected by mining
