PERMIT INFORMATION

Permit Number: C-1982-056 Mine Name: Foidel Creek Mine Operator: Twentymile Coal, LLC Operator Address: Ms Miranda Kawcak 29515 Routt County Road No. 27 Oak Creek, CO 80467	County: Routt Operation Type: Underground Permit Status: Active Ownership: Private
	Operator Representative Present: Kevin Copeland
Operator Representative Signature: (Field Issuance Only)

INSPECTION INFORMATION

Inspection Start Date: March 30, 2021 Inspection Start Time: 08:00 Inspection End Date: March 31, 2021 Inspection End Time: 11:00		Inspection Type: Coal Complete Inspection Inspection Reason: Normal I&E Program Weather: Clear	
Joint Inspection Agency: None		Joint Inspection Contacts:	
Post Inspection Agency: None		Post Inspection Contacts:	
Inspector(s): Tabetha Lynch	Inspector's Signature:

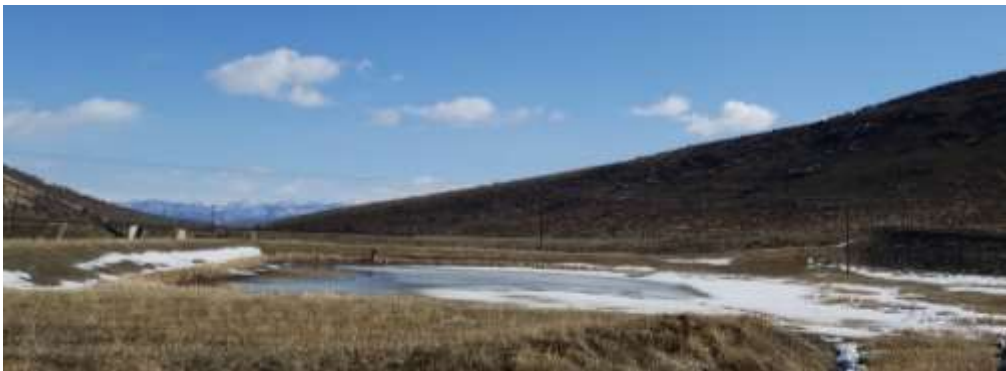
Pond G pictured below looking east

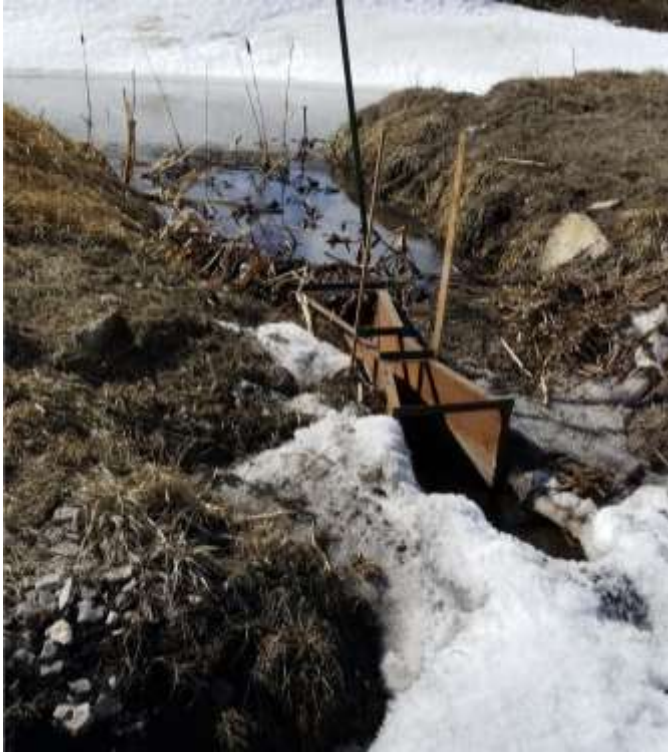
Flume at Pond B is shown below. It appears a muskrat dam and cattail debris need to be cleared from the inlet of the flume.

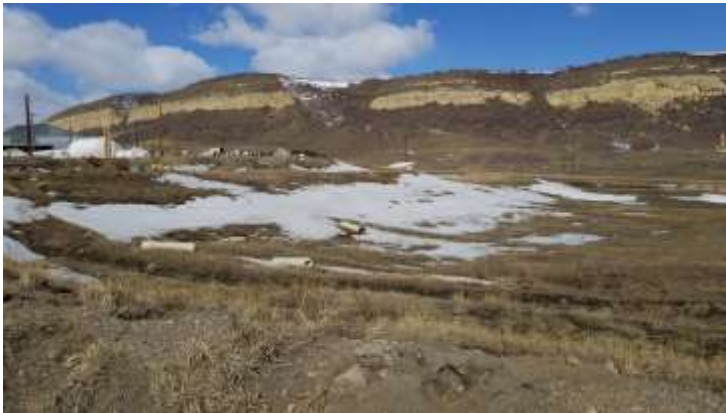
Non-coal waste to be cleaned up below shop pad. Some stacked items were blown to the area below the pad.

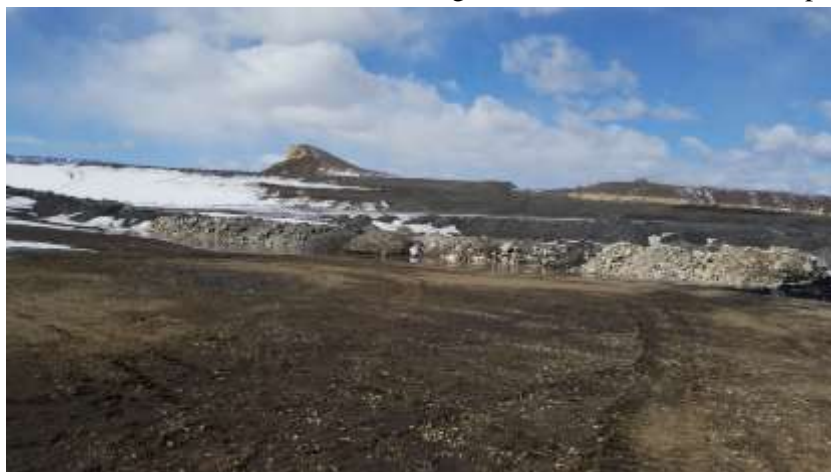
Refuse pile appears to be on the 3rd lift. Haul road to refuse pile was in good condition. The upper haul roads were not accessible. Photo below in looking northwest across the new expansion area.

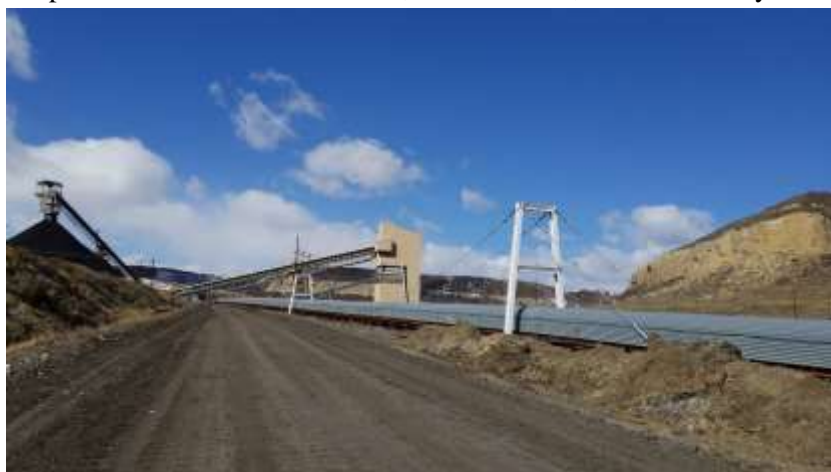
Suspension structure construction, shown below, for coal conveyor has been completed (approved with MR317).

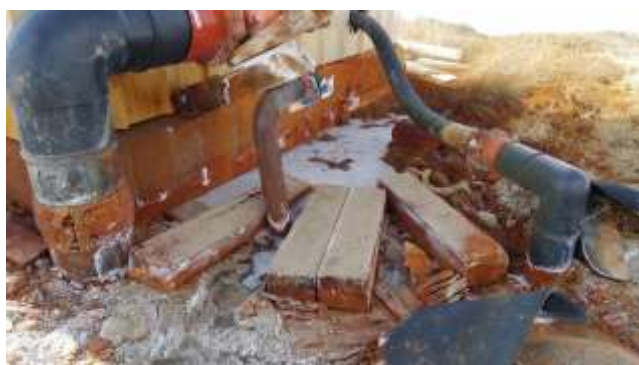
Site of previous leak at Fish Creek treatment ponds pump house. No leaking was observed at the time of inspection, frozen water is present, but it was not clear this was from an ongoing leak or snowmelt runoff

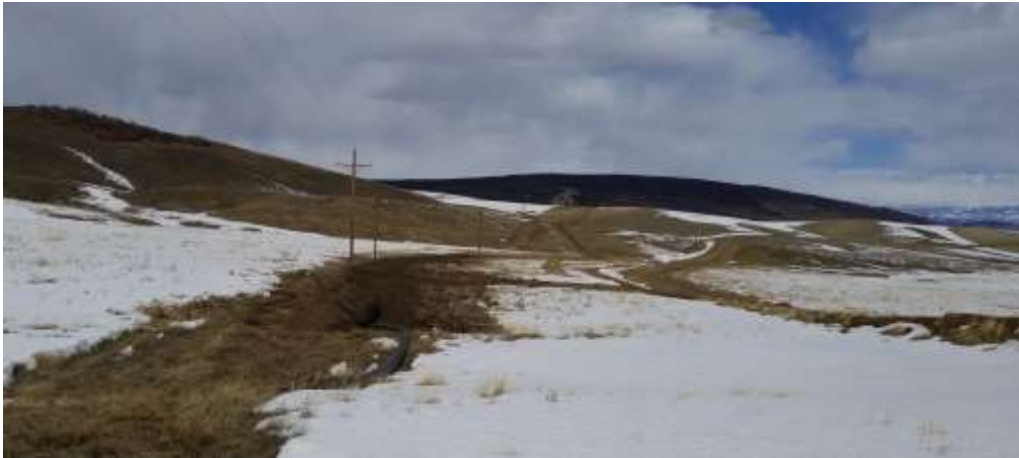
Shown below is the pipeline from the existing 16LT Utility borehole to the existing 18LT shaft pad location. This was approved with TR-95 in January of 2021. It a pipeline for de-watering purposes from the Western mine district, where it will tie into the 18LT dewatering line that runs to the Fish Creek treatment location. The pipeline is approximately 5,700 feet and consist of single walled 12 inch HDPE pipe. In order to provide power to the 16LT utility borehole, a powerline has been placed in the same corridor. The powerline appeared to have been completed at the time of inspection. The de-watering pipe is in process of completion.
