PERMIT INFORMATION

Permit Number: C-1992-081 Mine Name: Hayden Gulch Loadout Operator: Hayden Gulch Terminal, LLC Operator Address: Ms Miranda Kawcak P.O. Box 670 Hayden, CO 81639	County: Routt Operation Type: Loadout Permit Status: Active Ownership: Private Operator Representative Present: Kevin Copeland
Operator Representative Signature: (Field Issuance Only)

INSPECTION INFORMATION

Inspection Start Date: March 30, 2021 Inspection Start Time: 03:00 Inspection End Date: March 30, 2021 Inspection End Time: 04:00	Inspection Type: Coal Complete Inspection Inspection Reason: Normal I&E Program Weather: Clear	
Joint Inspection Agency: None	Joint Inspection Contacts:	
Post Inspection Agency: None	Post Inspection Contacts:	
Inspector(s): Tabetha Lynch	Inspector's Signature:

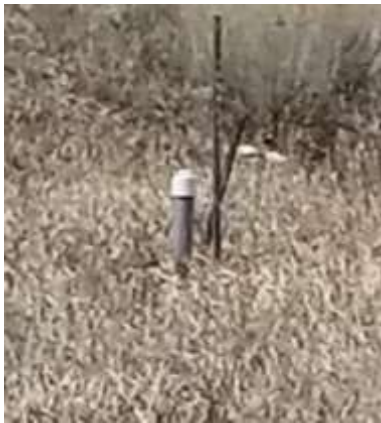
Ponds were holding water but not discharging (shown in photos section). Dry Creek was flowing. The monitoring well on site appeared competent and in good condition (first photo). Culverts were in good condition.

Alluvial monitoring well

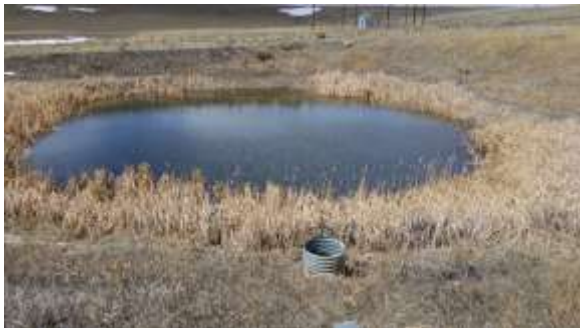
Truck load out pond

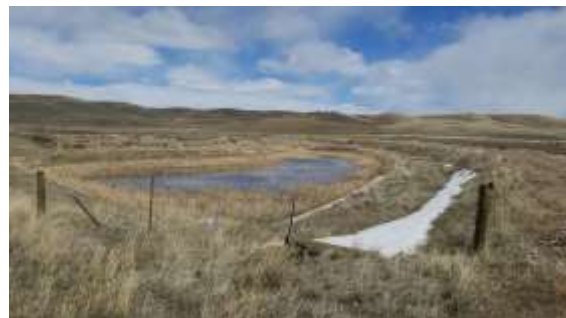
Rail loop pond
