MINERALS PROGRAM INSPECTION REPORT
PHONE: (303) 866-3567

MINE NAME: Una Pit	MINE/PROSPECTING ID#: M-1980-080	MINERAL: Sand and gravel	COUNTY: Garfield
INSPECTION TYPE: Monitoring	INSPECTOR(S): Amy Yeldell	INSP. DATE: April 8, 2021	INSP. TIME: 08:00
OPERATOR: Grand Junction Concrete Pipe Co.	OPERATOR REPRESENTATIVE: Jim Doody	TYPE OF OPERATION: 112c - Construction Regular Operation	
REASON FOR INSPECTION: Normal I&E Program	BOND CALCULATION TYPE: Complete Bond	BOND AMOUNT: \$300,071.47	
DATE OF COMPLAINT: NA	POST INSP. CONTACTS: DRMS	JOINT INSP. AGENCY: None	
WEATHER: Clear	INSPECTOR'S SIGNATURE:

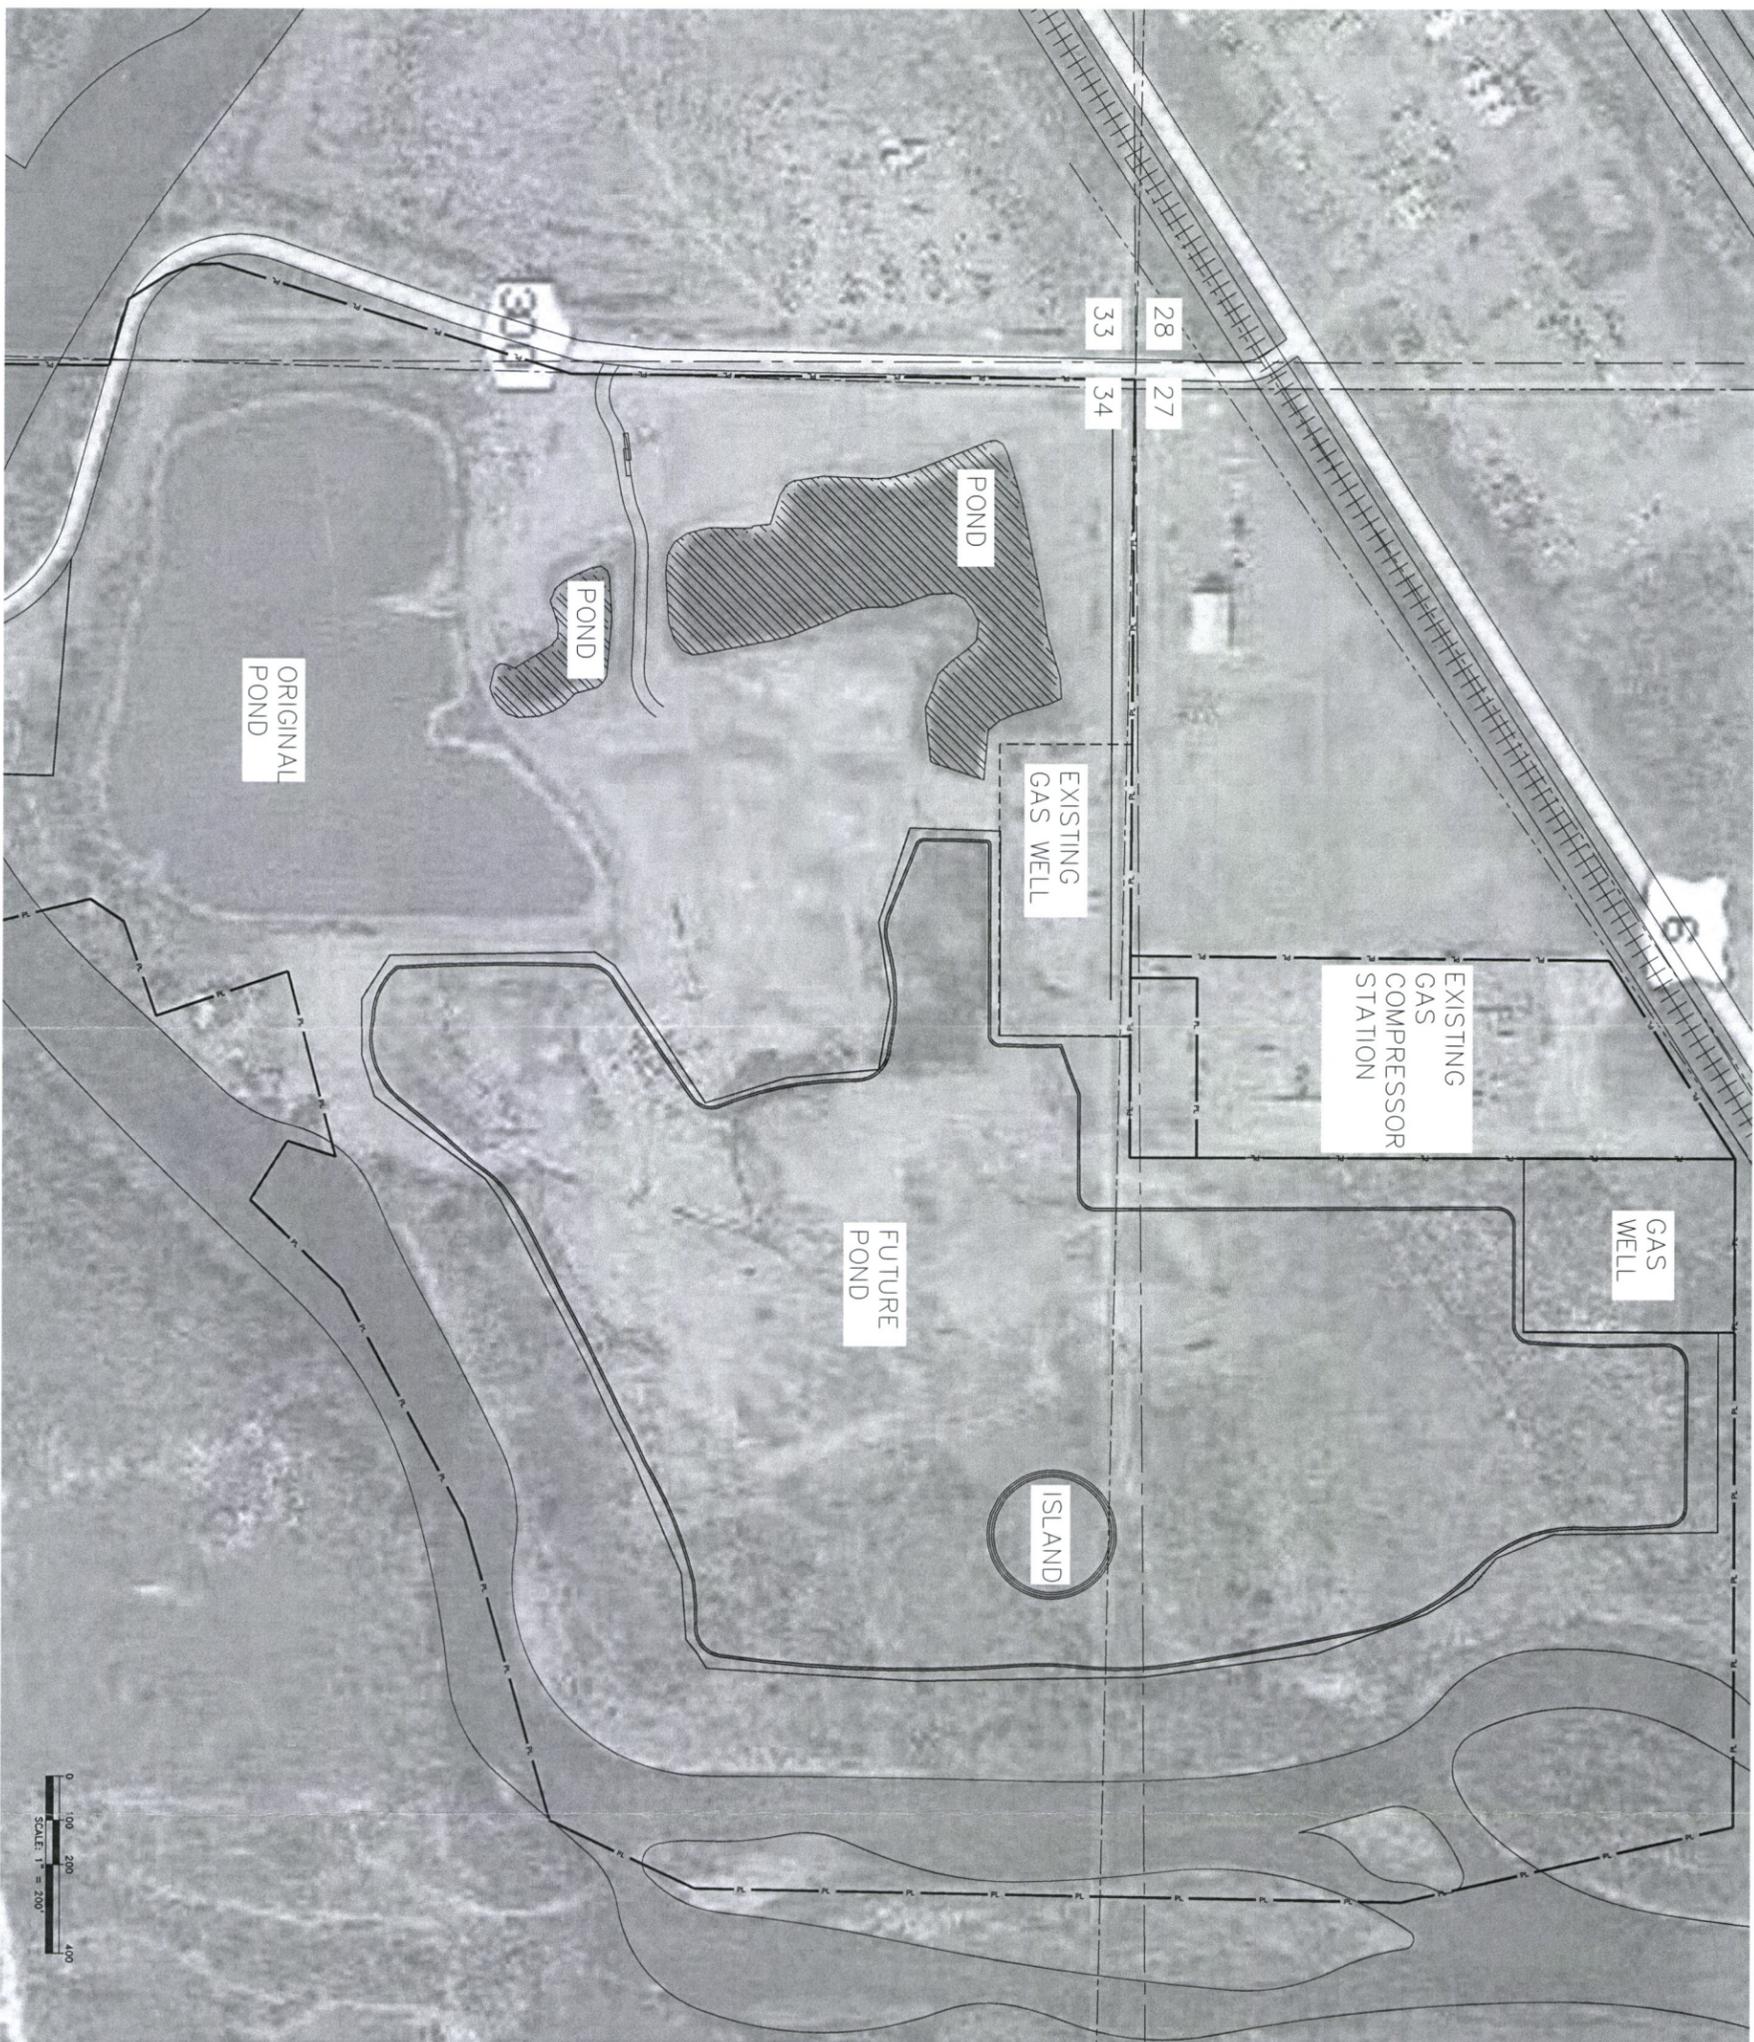
Job Number:
11GJ/P005
Sheet Number:
TR-3

Attached is a copy of TR-3 which was approved by the Division on January 23, 2012. It depicts four ponds. All areas that are not ponds are to be revegetated.

Enclosed please find two copies of a revised Reclamation Plan for Technical Revision No. 3 for the above referenced permit. The plan shows the location of four ponds, which will be the final configuration of the pit when mining has been completed. The original pond was constructed in the early eighties.
