MINERALS PROGRAM INSPECTION REPORT
PHONE: (303) 866-3567

MINE NAME: Yoder	MINE/PROSPECTING ID#: M-1980-189	MINERAL: Sand and gravel	COUNTY: El Paso
INSPECTION TYPE: Monitoring	INSPECTOR(S): Timothy Cazier, P.E.	INSP. DATE: March 24, 2021	INSP. TIME: 09:30
OPERATOR: Rocky Mountain Materials and Asphalt, Inc.	OPERATOR REPRESENTATIVE: Dave Bieber	TYPE OF OPERATION: 110c - Construction Limited Impact	
REASON FOR INSPECTION: Normal I&E Program	BOND CALCULATION TYPE: Partial Bond	BOND AMOUNT: \$28,820.00	
DATE OF COMPLAINT: NA	POST INSP. CONTACTS: None	JOINT INSP. AGENCY: None	
WEATHER: Cloudy	INSPECTOR'S SIGNATURE:

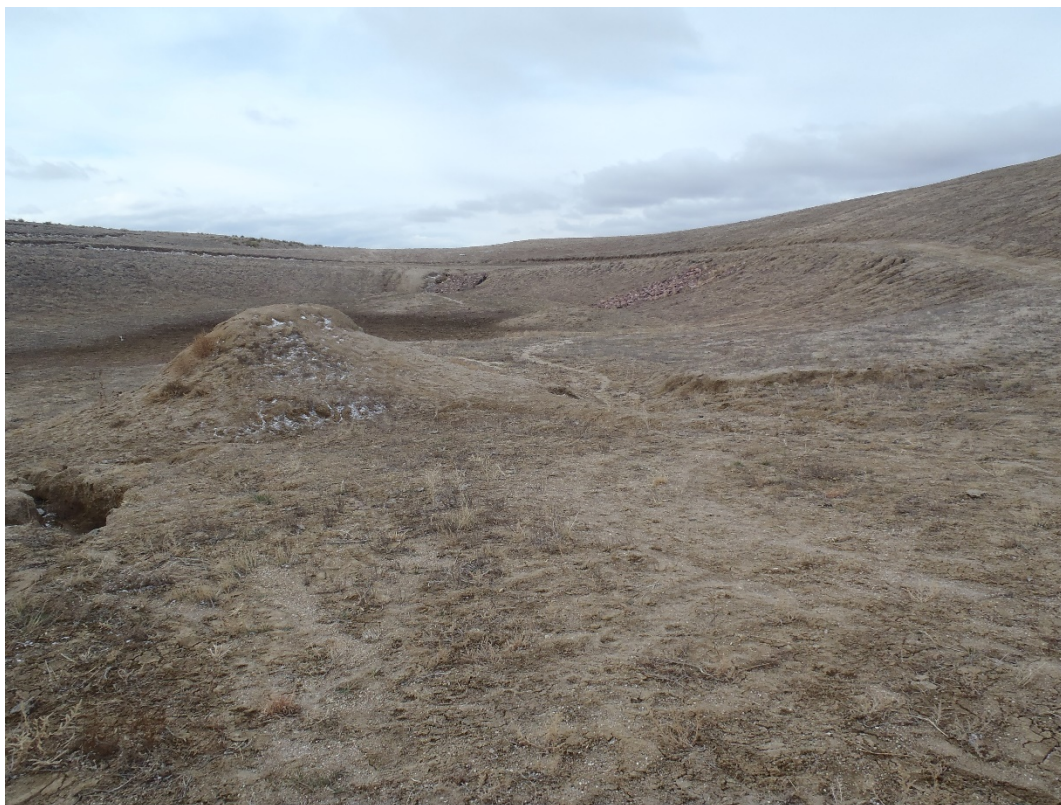
Backfilling and Grading: Grading is complete. A small material stockpile (~50 CY) was approved with TR-02 and was observed on the north side of the pit floor (see **Photo 1**).

Photo 1. Material stockpile for landowner (looking SW).

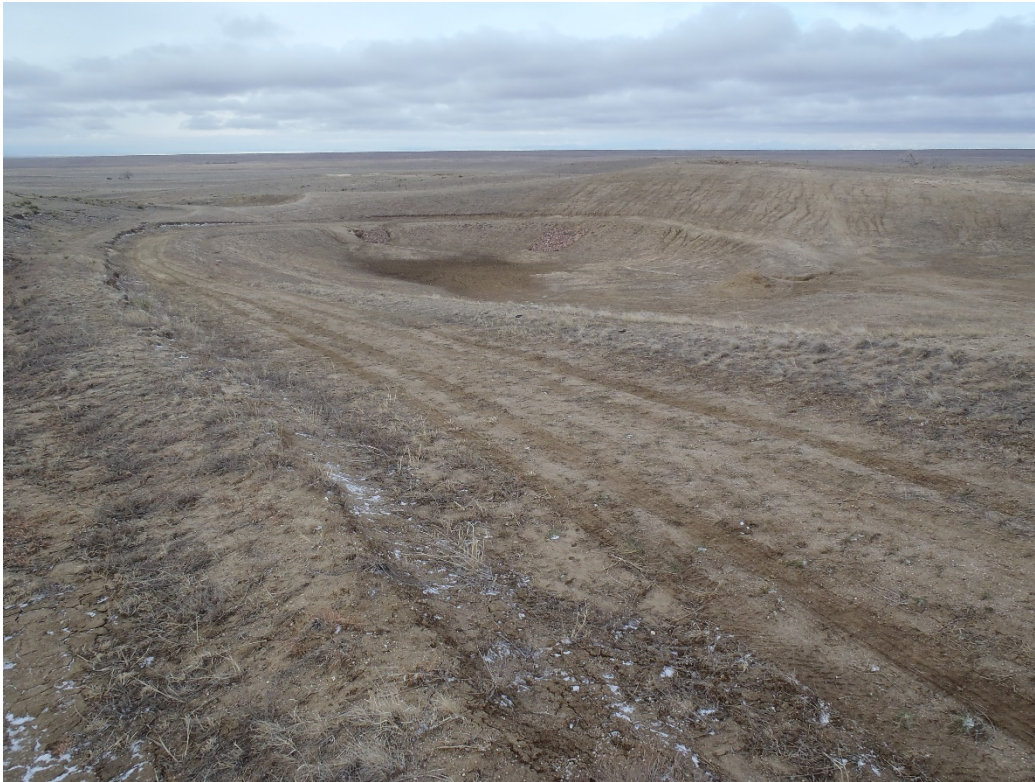
Roads: The haul and access road (see **Photo 2**) is approved to remain (per TR-02) and does not show signs of erosion.

Reclamation Success: The site has been in reclamation since 2017. Slopes have been graded to 3H:1V or flatter (see **Photos 2** and **3**) and seeded as per the approved reclamation plan.

Photo 2. Access road into pit and graded slopes: $\leq 3H:1V$ (looking south).

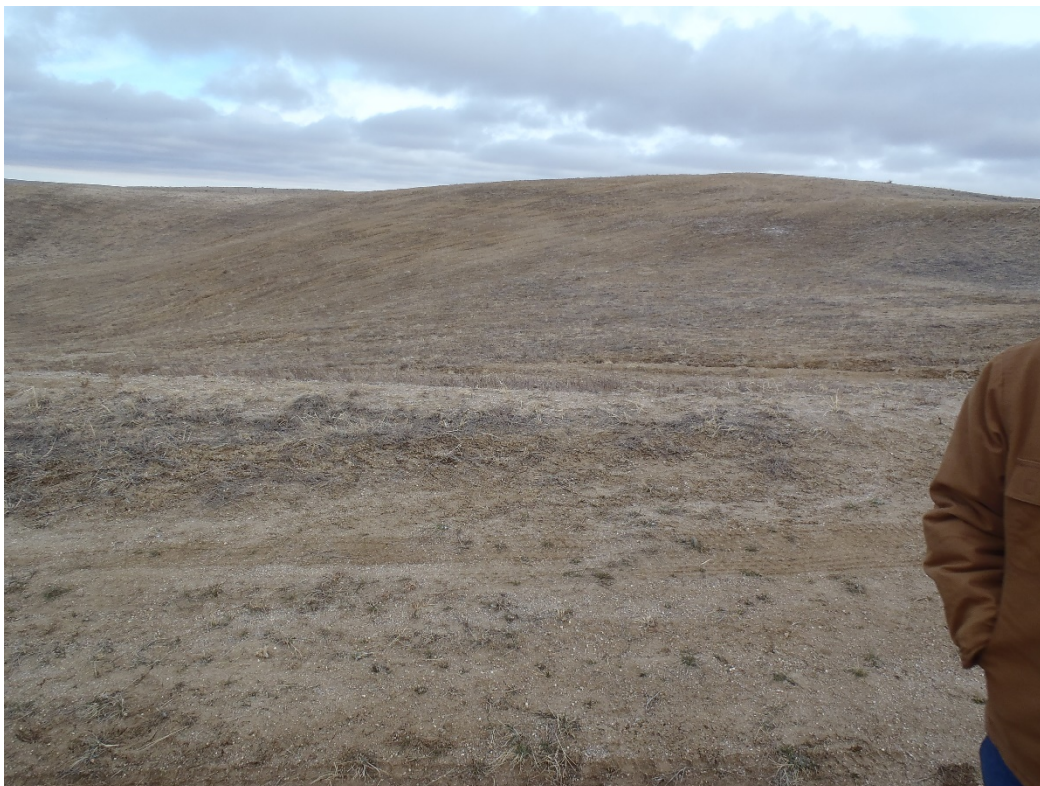
Photo 3. Typical graded slopes: $\leq 3H:1V$ (looking west).

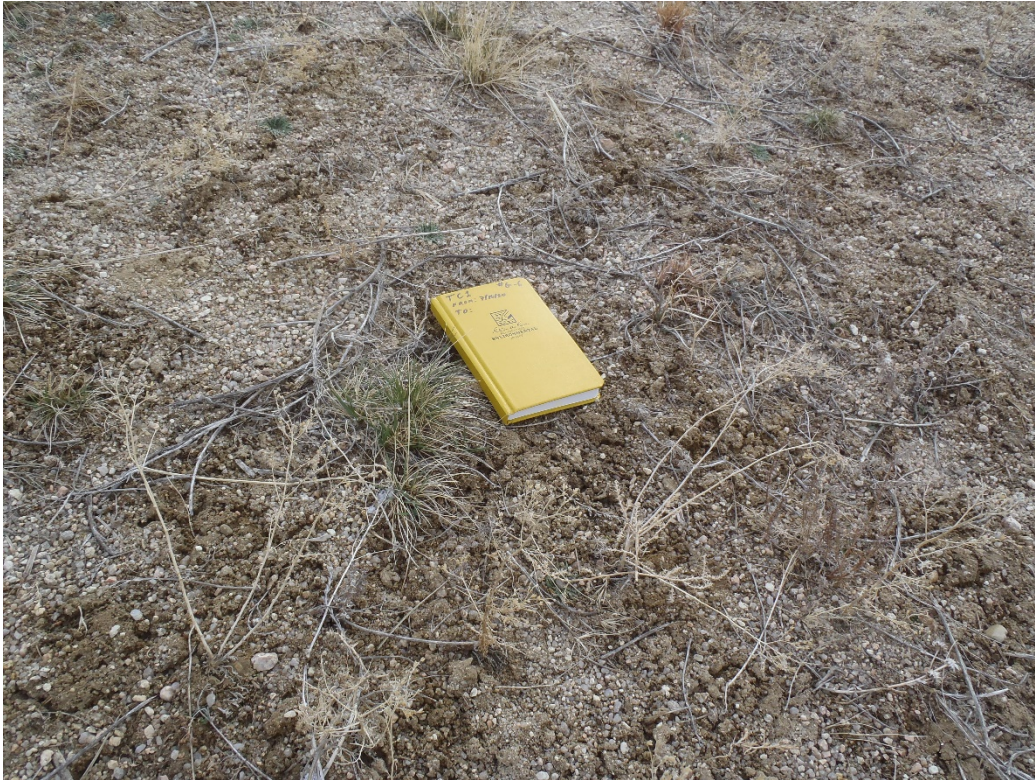
Revegetation: Mr. Bieber stated the site was seeded a second time in the April/May timeframe of 2020. The established vegetation is uniform (see **Photo 4**), but sparse due to grazing. No noxious weeds were observed.

Photo 4. Typical established vegetation.
