COLORADO
Division of Reclamation,
Mining and Safety
Department of Natural Resources

Permit Number: C-1981-028 Mine Name: Keenesburg Strip Mine Operator: Coors Energy Company Operator Address: Mr. Ben Moline PO Box 4030 Golden, CO 80402	County: Weld Operation Type: Surface Permit Status: Permanent Cessation Ownership: Private
	Operator Representative Present: None
Operator Representative Signature: (Field Issuance Only)

Inspection Start Date: April 13, 2021 Inspection Start Time: 11:30 Inspection End Date: April 13, 2021 Inspection End Time: 13:30		Inspection Type: Coal Partial Inspection Inspection Reason: Normal I&E Program Weather: Cloudy	
Joint Inspection Agency: None		Joint Inspection Contacts: 	
Post Inspection Agency: None		Post Inspection Contacts: 	
Inspector(s): Robert Zuber, P.E.	Inspector's Signature: <i>Robert D. Zuber</i>		Signature Date: 4/14/2021

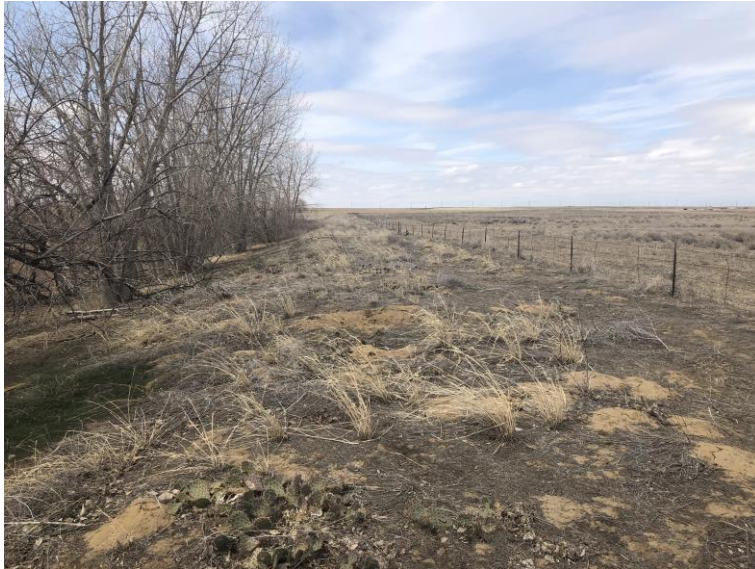
Sediment Pond 2 and the Dugout Pond contained very small amounts of water. Neither pond was discharging during the inspection. There were no signs that they had discharged recently. As usual, they both contained large amounts of riparian vegetation. No problems were observed with the two ponds.

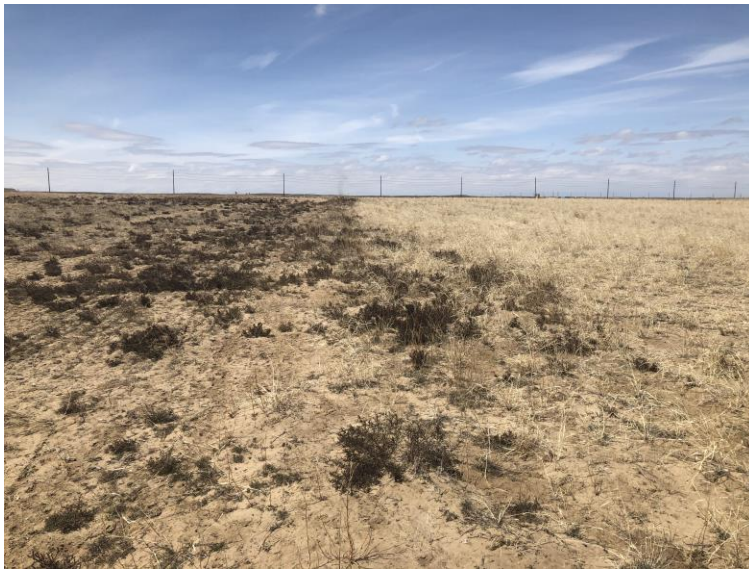
The northern portion of the reclaimed B Pit was observed to determine that drainage is to the east, towards Sediment Pond 2, and not towards the undisturbed areas. The topography of the area directs flow to the east (consistent with the drainage plan in the Permit Application Package), and no problems were identified.

Reclaimed B Pit, with older reclamation on the right

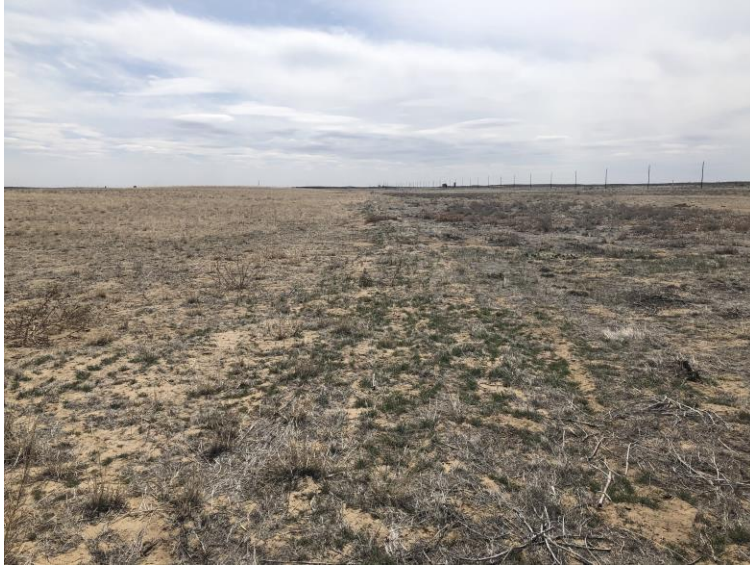
Reclaimed B Pit, looking south with undisturbed area on the right

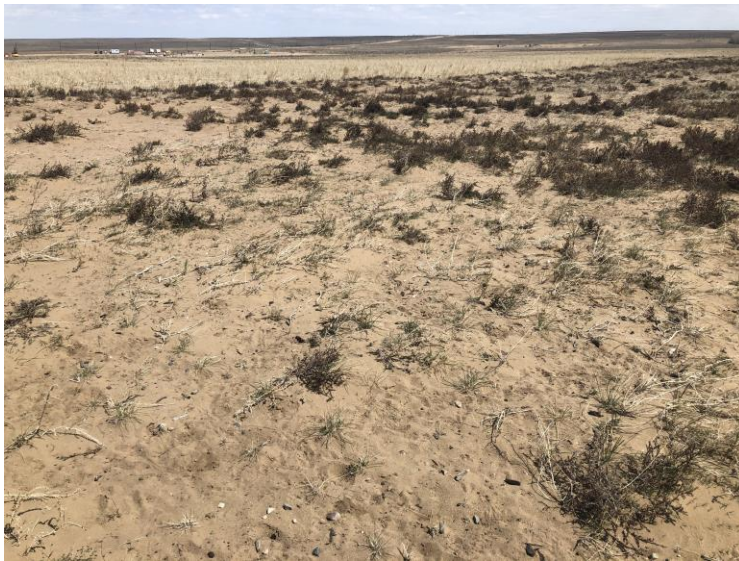
Grasses in the reclaimed areas are beginning to green, and small seedlings were observed.

Emerging vegetation (grasses and forbs) in the northern portion of B Pit reclamation

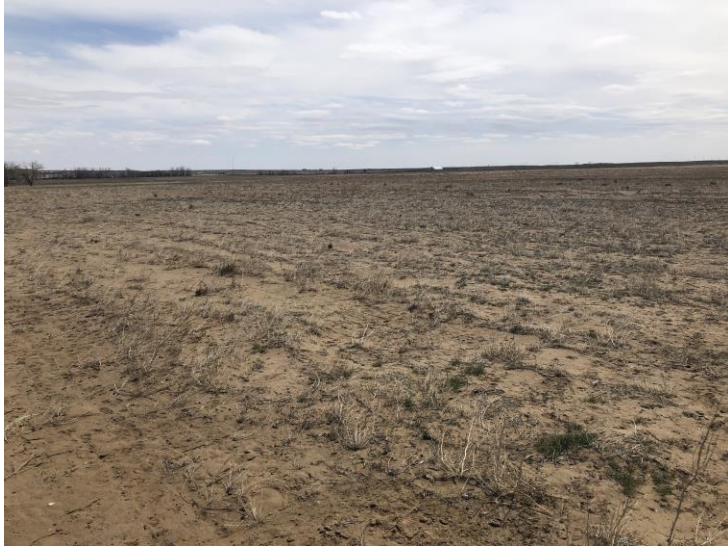
The northern half of the site was observed, and no erosion or other problems were seen. This includes the reclaimed B Pit and Long Term Spoil Area, and the reclaimed roads north and east of the Long Term Spoil Area.

Reclamation within the Long Term Spoil Area, looking southeast

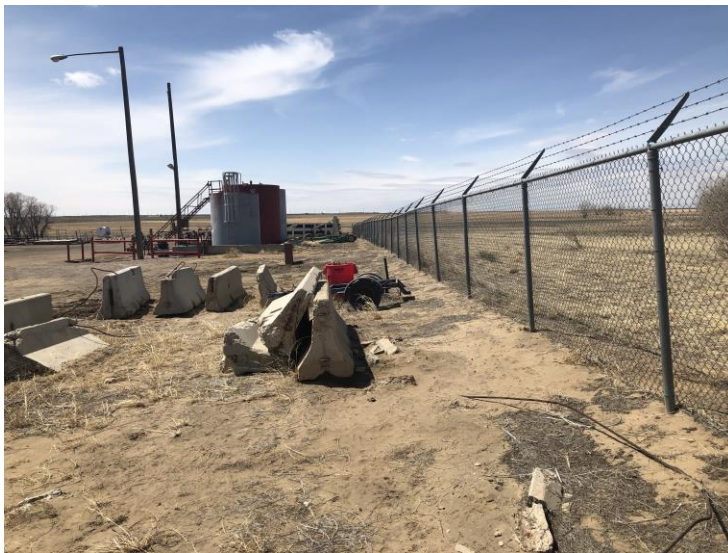
North side of facilities area

No problems were seen at the facilities area. No leaks were seen around the storage tanks, which are in a concrete containment area.
