COLORADO
Division of Reclamation,
Mining and Safety
 Department of Natural Resources

PERMIT INFORMATION

Permit Number: C1981010 Mine Name: Trapper Mine Operator: Trapper Mining, Inc. Operator Address: Mr. Graham Roberts P.O. Box 187 Craig, CO 81626	County: Moffat Operation Type: Surface Permit Status: Active Ownership: Federal Operator Representative Present: Graham Roberts
This report was issued electronically from the Divisions' Denver Office.

Inspection Start Date: 14 April 2021 Inspection Start Time: 8:30 a.m. Inspection Start Date: 14 April 2021 Inspection End Time: 4:30 p.m.	Inspection Type: Coal Partial Inspection Inspection Reason: Normal I&E Weather: Cloudy/Foggy
Joint Inspection Agency:	Joint Inspection Contacts:
Post Inspection Agency: None	Post Inspection Contacts:
Inspector(s): Robin A. Reilley, M.S. GISP	Inspector's Signature:   Signature Date: 15 April 2021

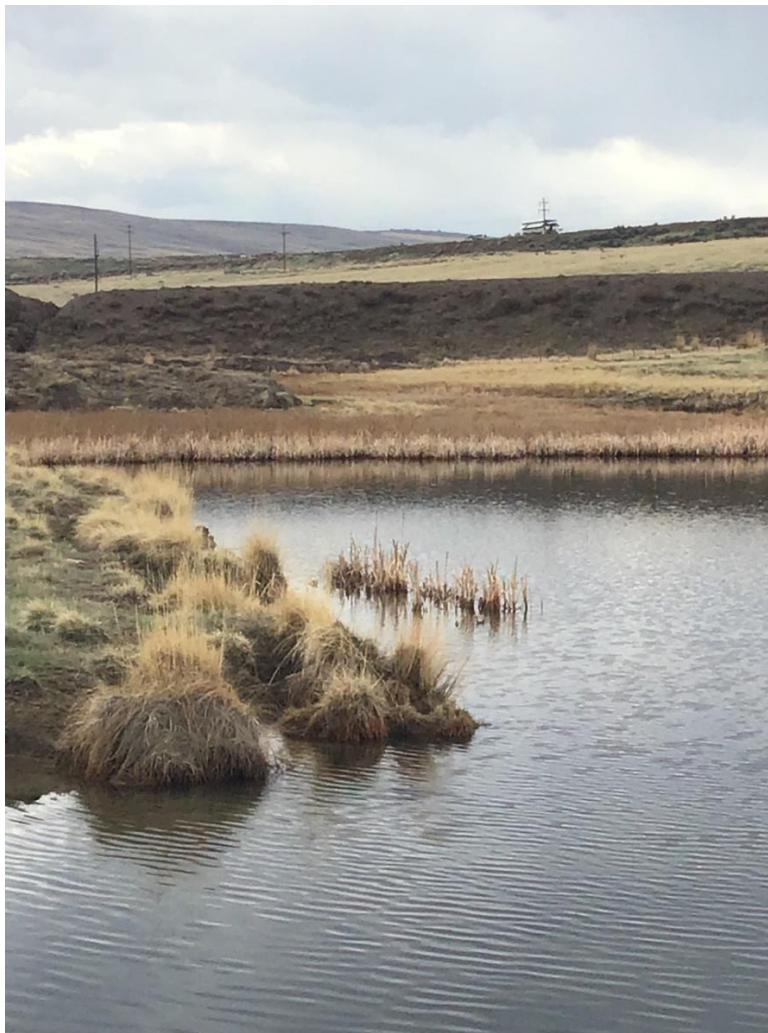
- h) Johnson 10 R full and discharging clear water.
- i) The No Name system was holding water and No Name # 5 was full and discharging water.
- j) Deal Pond #2 was dry at the time of inspection

Photo 1: Johnson 10R Pond, cattails may require excavation.

1. Ponds requiring dredging or removal of vegetation include Pyeatt #1 and #2, Johnson 10R, and Deal #1.
2. Annual maintenance of reclamation and constructed drainages.

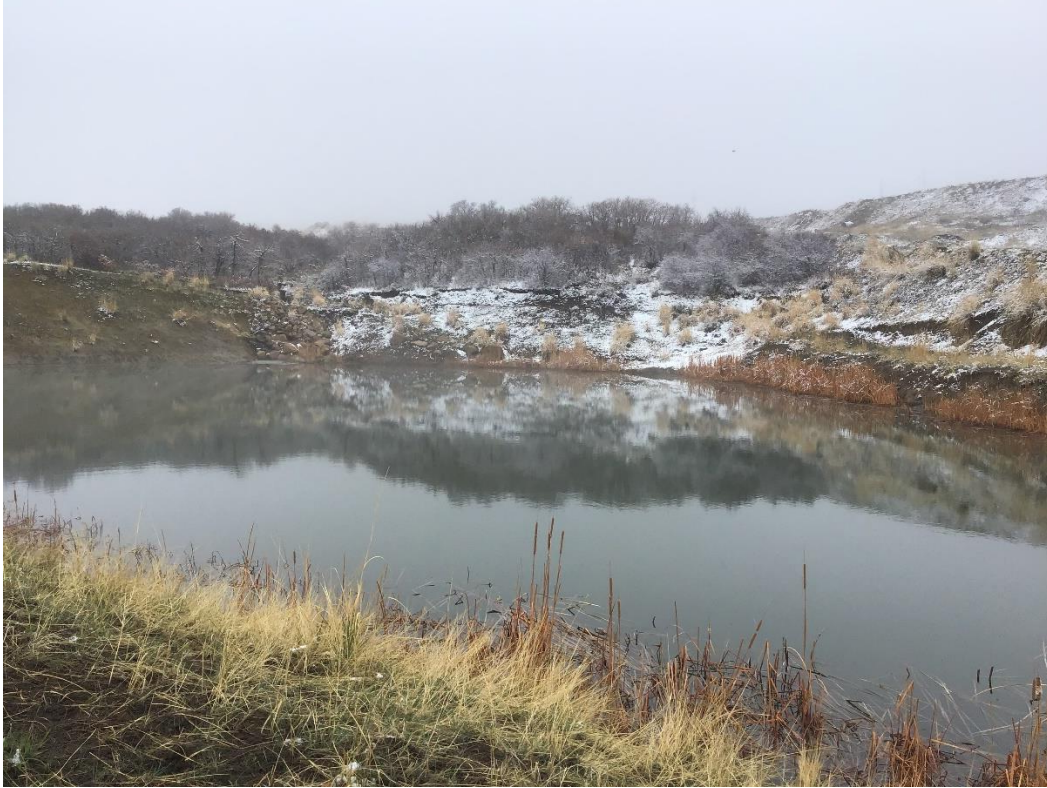
- f) Middle Flume #3 was full, and not discharging at the time of inspection.
- g) Oak Ponds were observed from the road above as the road to the ponds was not accessible at the time of inspection. Oak Pond #1 appeared approximately half full and Oak Pond #2 appeared dry.

Photo 2: Middle Flume #3 Pond.

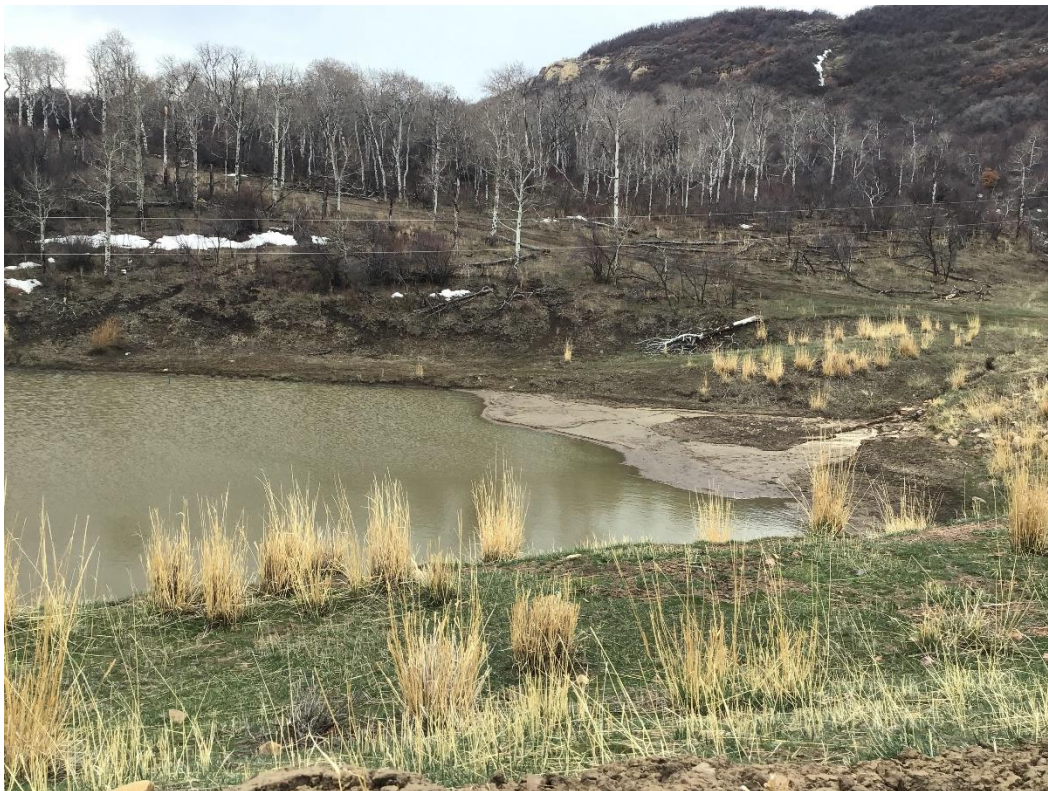
- k) Deal #1 held water and exhibits a significant delta.

Photo 3: Deal #1 Pond and significant delta.

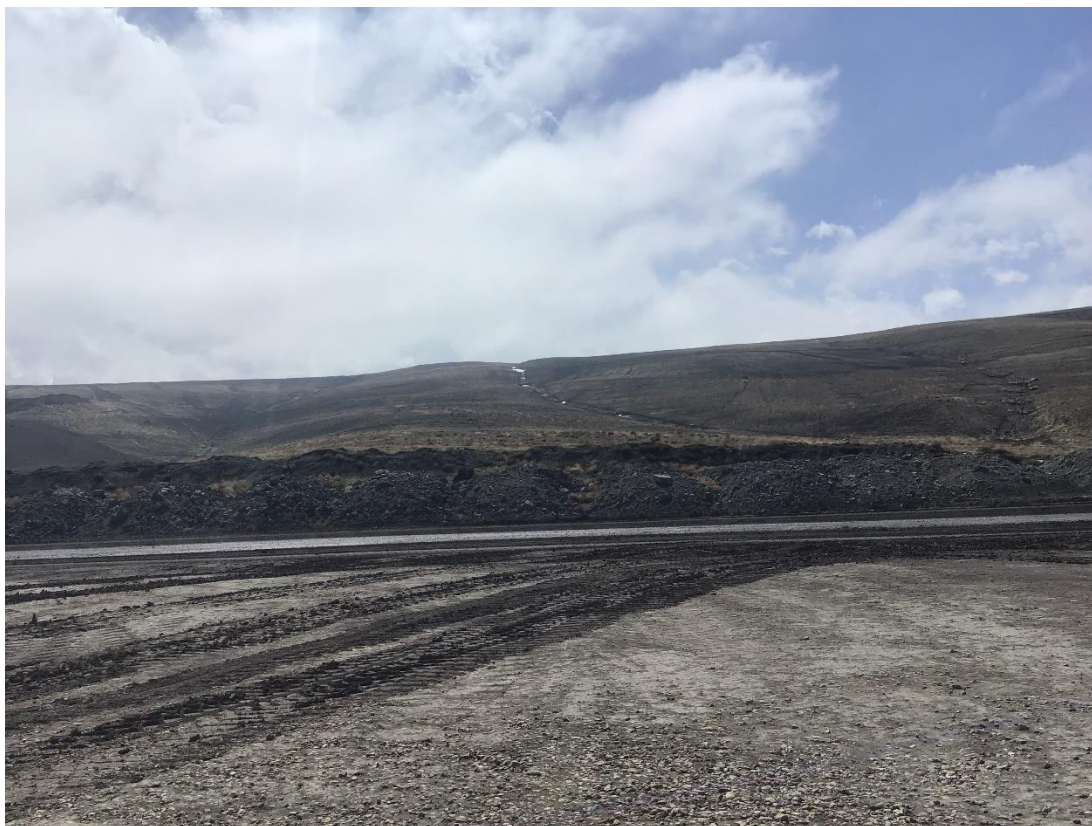
- Reclamation and revegetation appeared to be progressing adequately.
- Reclamation that took place over the past two years consisting of constructed drainages, backfilling, grading, topsoiling and seeding appeared stable now that snow has dissipated.

Several limited areas of rilling were noted as were a couple of possible repairs on check dams. This stabilization/maintenance will take place as soon as soil conditions are amenable.

Photo 4: Reclamation and constructed drainages.

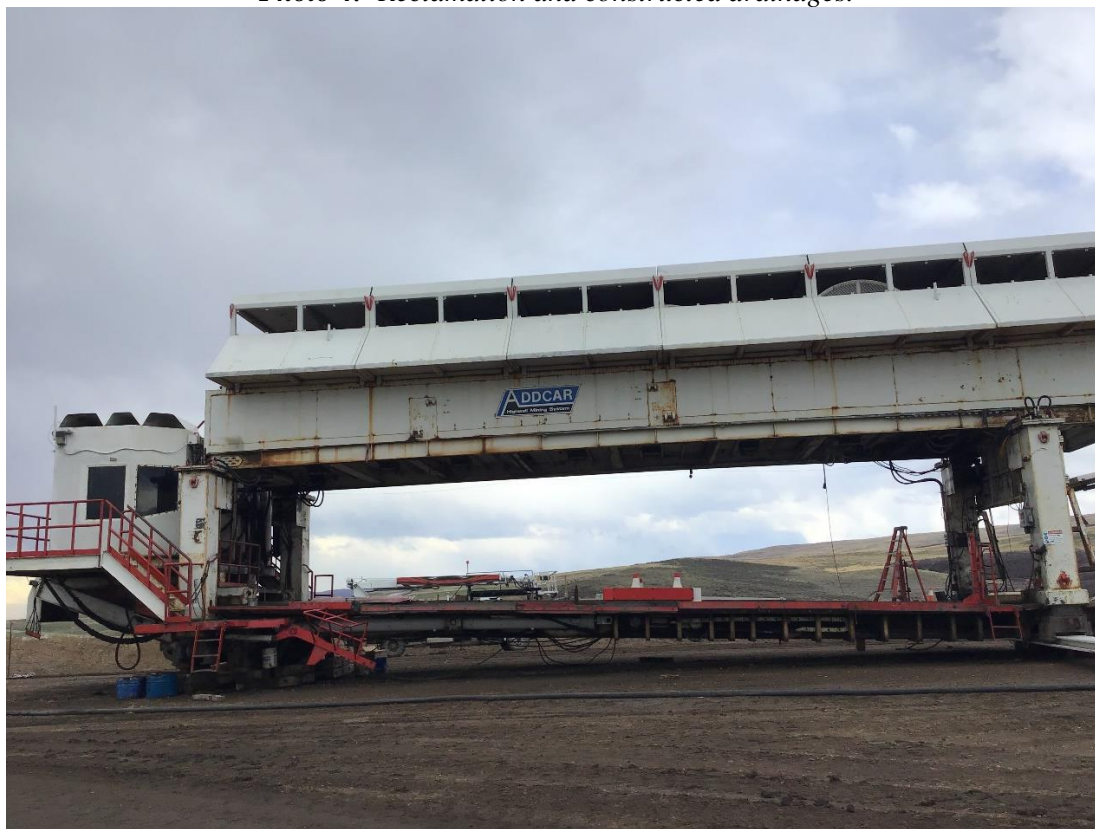
Two draglines are stationed in the L pit, one was operating at the time of inspection. One dragline, the in the L pit is undergoing maintenance. Activities in the L, N and I pits were observed and appear to be progressing as permitted. The high wall miner is in process of assembly.

Photo 5: The assembling of the highwall miner.
