MINERALS PROGRAM INSPECTION REPORT**PHONE: (303) 866-3567**

MINE NAME: Hallenbeck Pit No 1	MINE/PROSPECTING ID#: M-1977-062	MINERAL: Sand and gravel	COUNTY: Delta
INSPECTION TYPE: Monitoring	INSPECTOR(S): Stephanie J. Mitchell	INSP. DATE: April 13, 2017	INSP. TIME: 09:30
OPERATOR: Benson Brothers	OPERATOR REPRESENTATIVE: Dwight Benson	TYPE OF OPERATION: 112c - Construction Regular Operation

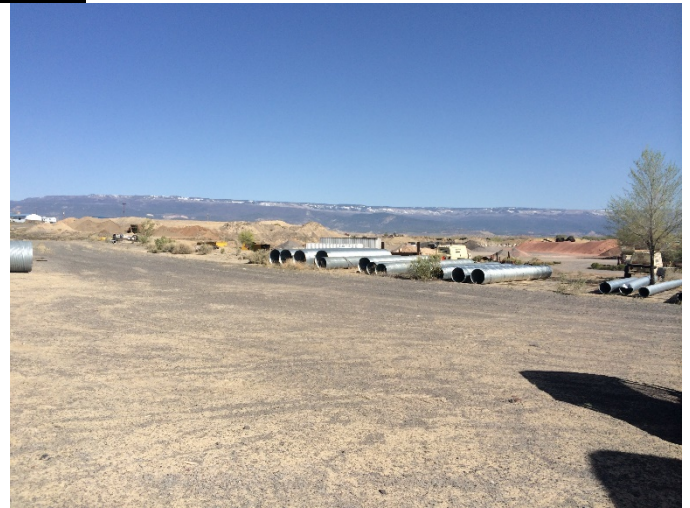
Storage Area

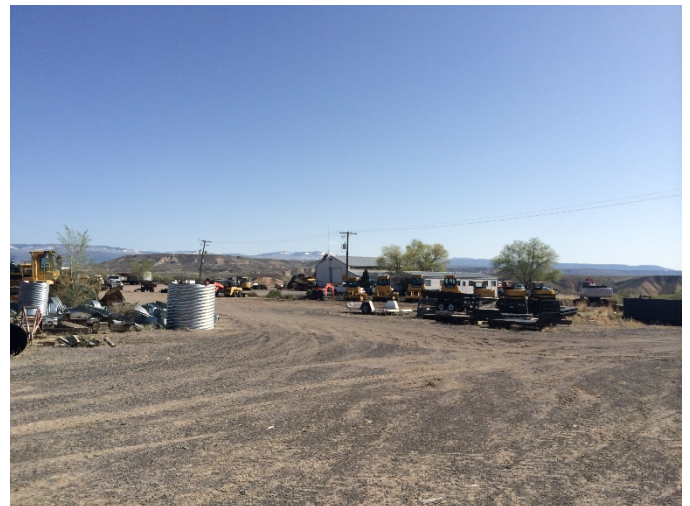
Storage Area

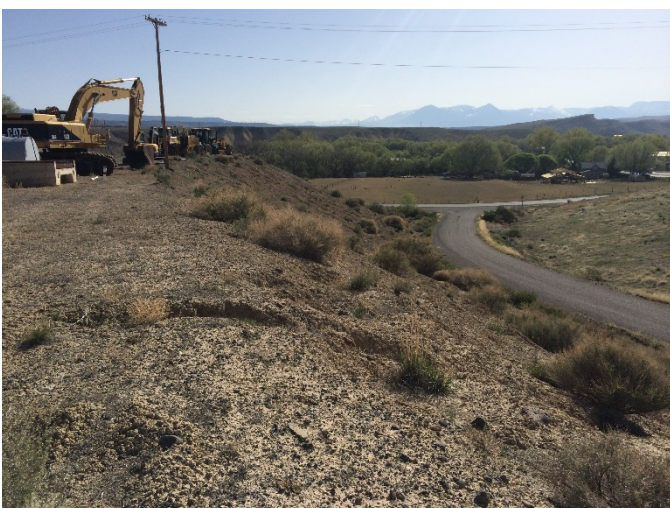
Reclaimed Slope- Looking South East

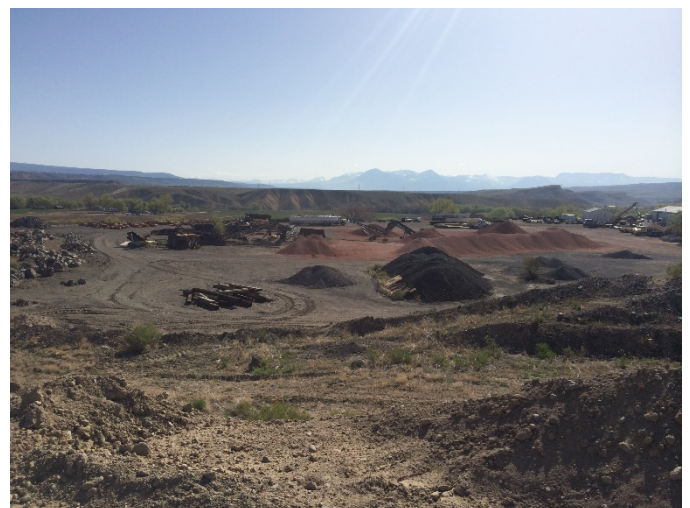
Overall Site View – Looking SE

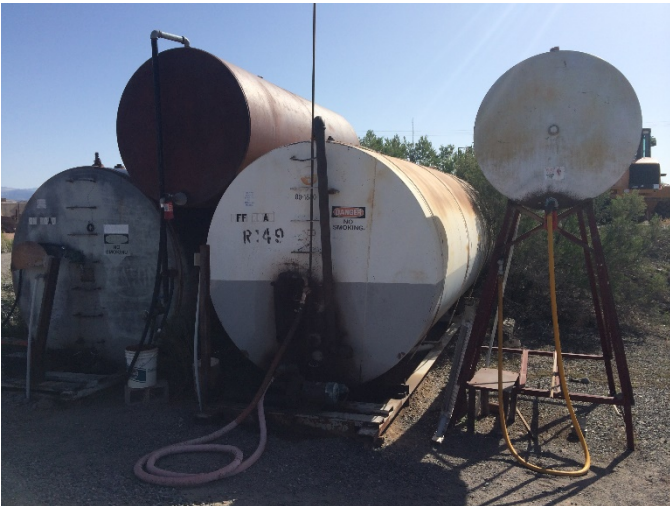
Fuel storage consists of four tanks. The tanks do not have adequate secondary containment structures. There is a small berm, but over time it appears to have weathered/eroded. **This is considered a problem at the beginning of this report.**

Inproper Fuel Storage- secondary containment

INSPECTION TOPIC: Support Facilities On-site**PROBLEM/POSSIBLE VIOLATION:** Problem: Improper storage and containment of fuels and/or other hazardous materials was present on site.**CORRECTIVE ACTIONS:** All storage tanks, petroleum and any hazardous materials on site for any period of time shall have appropriate secondary containment. The site will also have to comply with all applicable SPCC requirements. Please supply photo documentation that any fuel or hazardous materials containers are stored properly - including applicable secondary containment structures by the corrective action date. Note that secondary containment structures shall consist of an impermeable containment which could contain all contents of the tanks and various containers (when full) plus 10% of the total capacity. The operator may also provide photo documentation that all containers have been removed from the site on or before the corrective action date.**CORRECTIVE ACTION DUE DATE:** 6/19/17

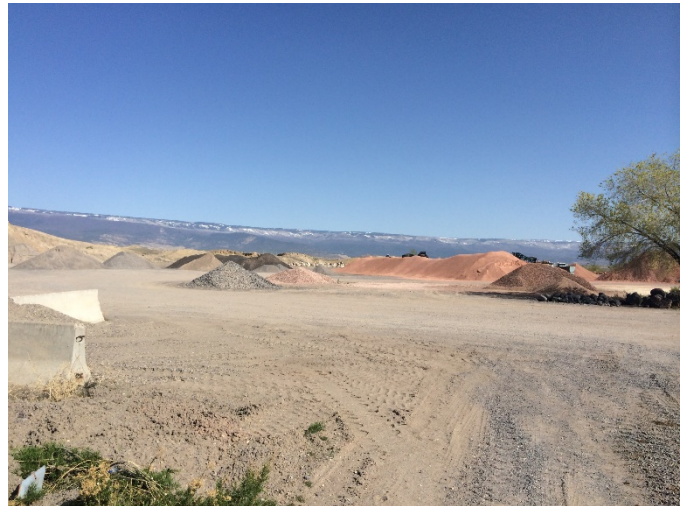
Material Stockpiles

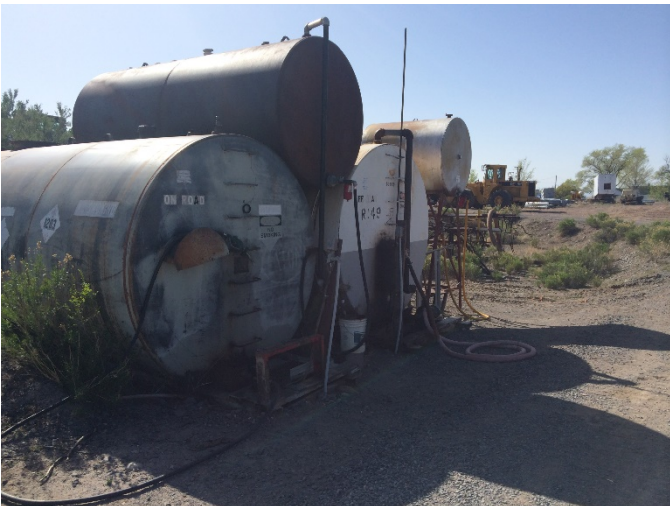
Improper Fuel Storage

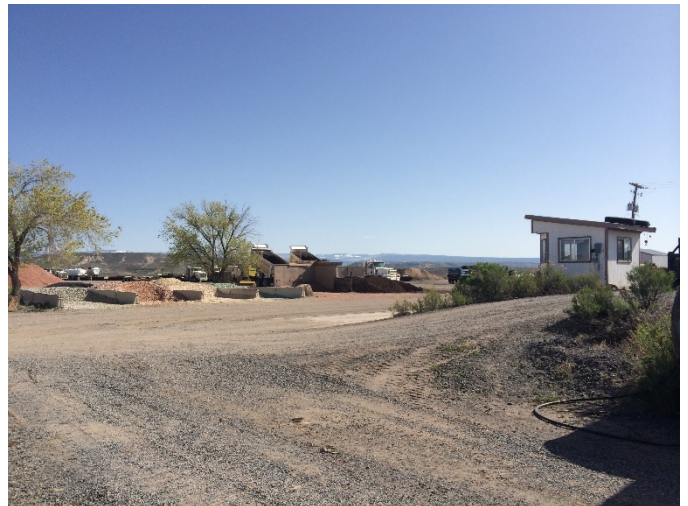
Scalehouse
