**MINERALS PROGRAM INSPECTION REPORT**  
**PHONE: (303) 866-3567**

<b>MINE NAME:</b> Big Johnson Reservoir	<b>MINE/PROSPECTING ID#:</b> M-2020-028	<b>MINERAL:</b> Sand	<b>COUNTY:</b> El Paso
<b>INSPECTION TYPE:</b> Surety Release Inspection	<b>INSPECTOR(S):</b> Timothy Cazier, P.E.	<b>INSP. DATE:</b> March 30, 2021	<b>INSP. TIME:</b> 09:25
<b>OPERATOR:</b> Fountain Mutual Irrigation Company	<b>OPERATOR REPRESENTATIVE:</b> Gary Steen	<b>TYPE OF OPERATION:</b> 111(1)(b) - Special One-Time Incidental	
<b>REASON FOR INSPECTION:</b> Surety Release Requested	<b>BOND CALCULATION TYPE:</b> None	<b>BOND AMOUNT:</b> \$75,000.00	
<b>DATE OF COMPLAINT:</b> NA	<b>POST INSP. CONTACTS:</b> None	<b>JOINT INSP. AGENCY:</b> None	
<b>WEATHER:</b> Cloudy	<b>INSPECTOR'S SIGNATURE:</b>

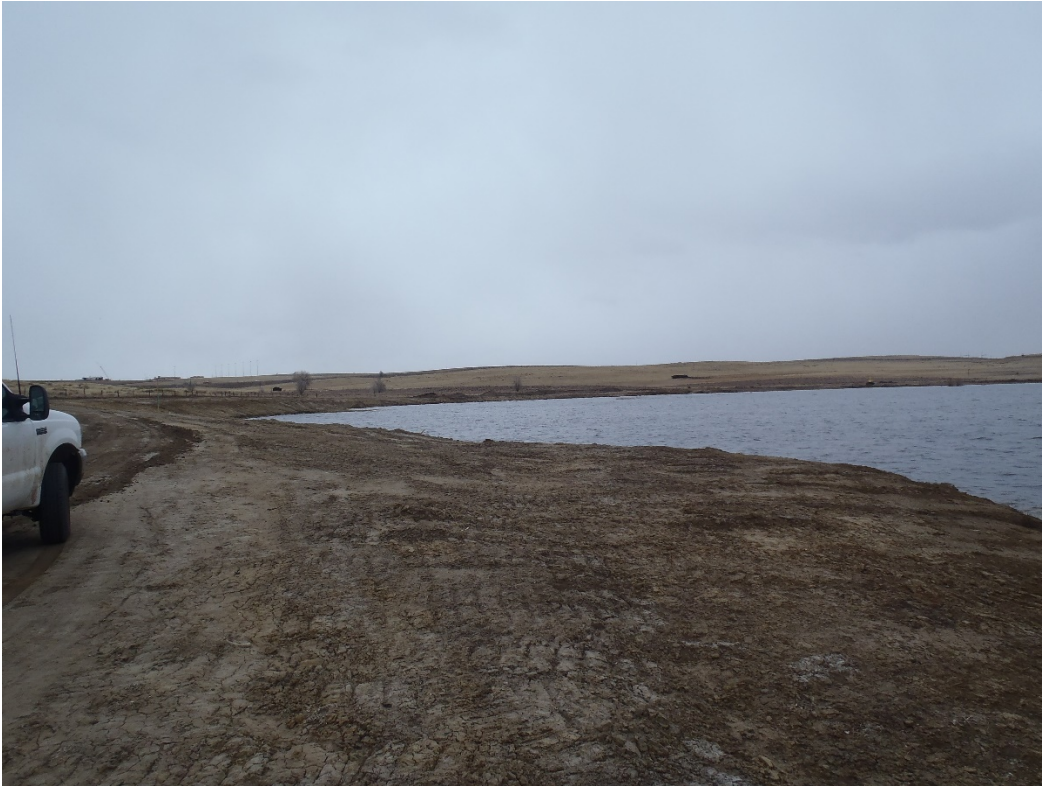
Backfilling and Grading: All grading appeared to be complete (see **Photos 1 and 2**).

Photo 1. Graded west shore (looking north).

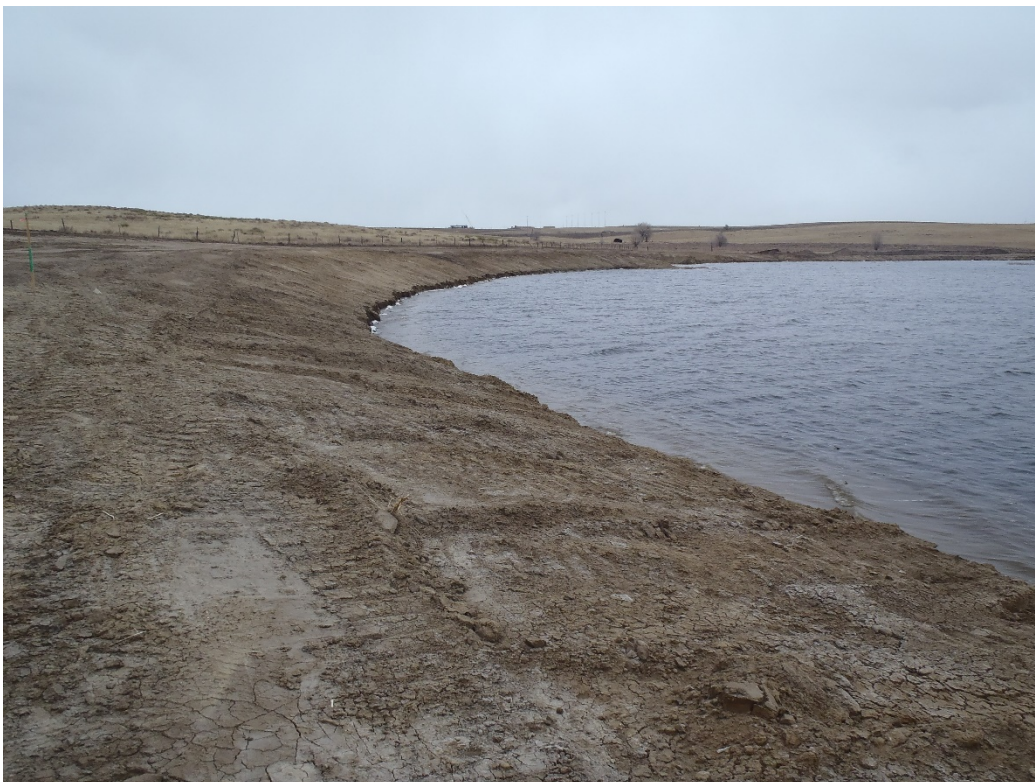
Photo 2. Graded northwest shore (looking north).

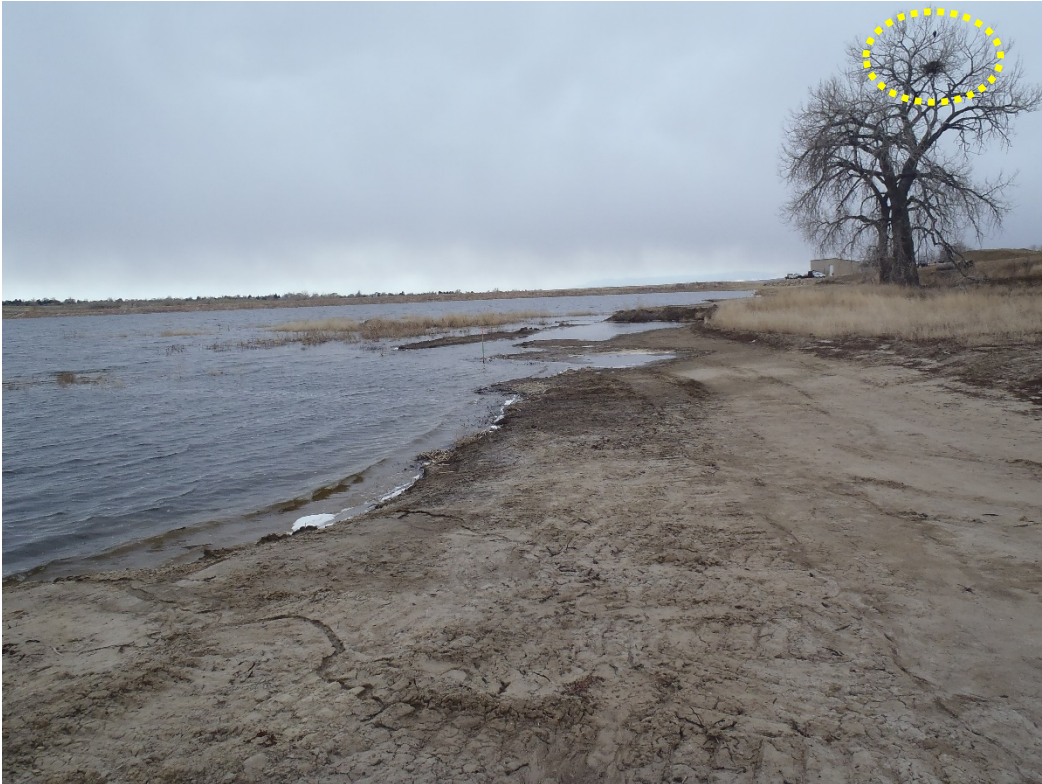
Fish and Wildlife: No impact to wildlife was observed. A pair of nesting bald eagles were observed near the reservoir edge (see **Photo 3**).

Photo 3. Graded west shore, eagle and eagle nest (looking south).

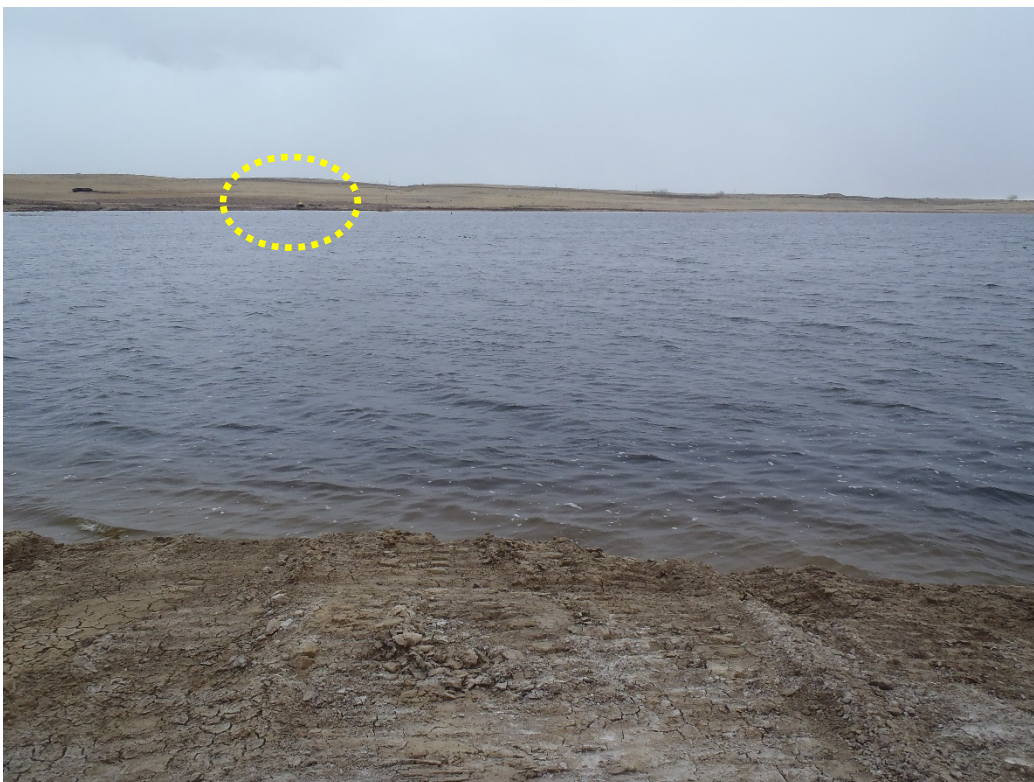
Support Facilities On-site: An excavator (see **Photo 4**) belonging to one of the contractors on site for material removal remained. Mr. Steen indicated they would be retrieving it soon.

Photo 4. Graded bank (foreground) and contractor excavator (circled, looking NE).

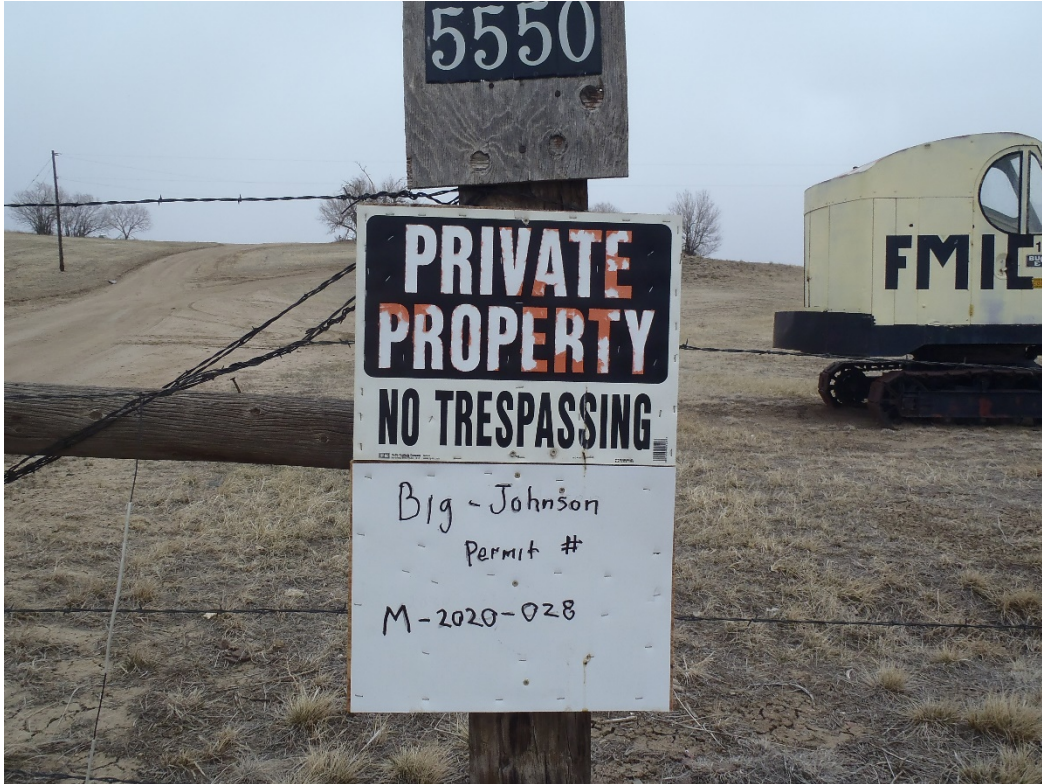
Signs and Markers: The permit sign was properly posted (see **Photo 5**).

Photo 5. Permit sign (at site entrance).
