**MINERALS PROGRAM INSPECTION REPORT**  
**PHONE: (303) 866-3567**

<b>MINE NAME:</b> Huddleson Stock Pond	<b>MINE/PROSPECTING ID#:</b> M-2019-009	<b>MINERAL:</b> Sand	<b>COUNTY:</b> El Paso
<b>INSPECTION TYPE:</b> Surety-Related Inspection	<b>INSPECTOR(S):</b> Timothy Cazier, P.E.	<b>INSP. DATE:</b> March 24, 2021	<b>INSP. TIME:</b> 11:10
<b>OPERATOR:</b> Luther E Huddleson	<b>OPERATOR REPRESENTATIVE:</b> Luther Huddleson	<b>TYPE OF OPERATION:</b> 111(1)(b) - Special One-Time Incidental	
<b>REASON FOR INSPECTION:</b> Surety Release Requested	<b>BOND CALCULATION TYPE:</b> Complete Bond	<b>BOND AMOUNT:</b> \$5,000.00	
<b>DATE OF COMPLAINT:</b> NA	<b>POST INSP. CONTACTS:</b> None	<b>JOINT INSP. AGENCY:</b> None	
<b>WEATHER:</b> Cloudy	<b>INSPECTOR'S SIGNATURE:</b>

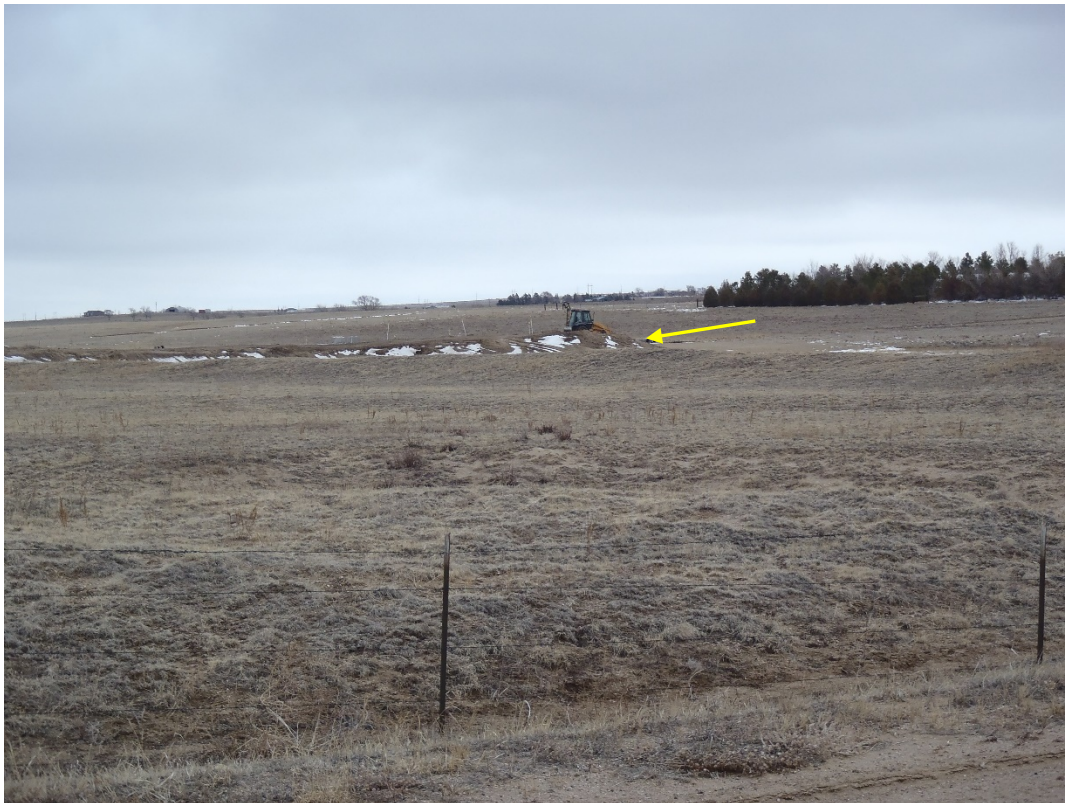
Backfilling and Grading: All grading appeared to be complete. Mr. Huddleson had the external (south end) slopes surveyed confirming they were at 4H:1V (see **Photo 1**). Interior slopes were also graded (see **Photo 2**)

Photo 1. South berm of pond from Hwy 110 (looking NE).

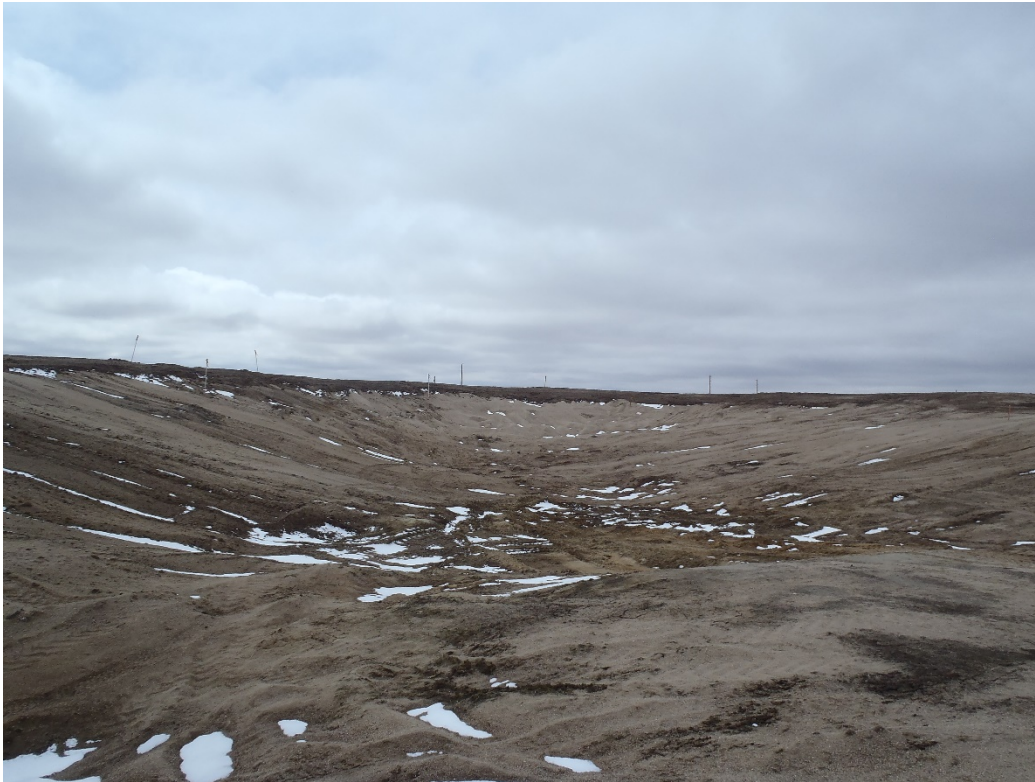
Photo 2. Graded interior pond slopes (from small island in north end of main pond).

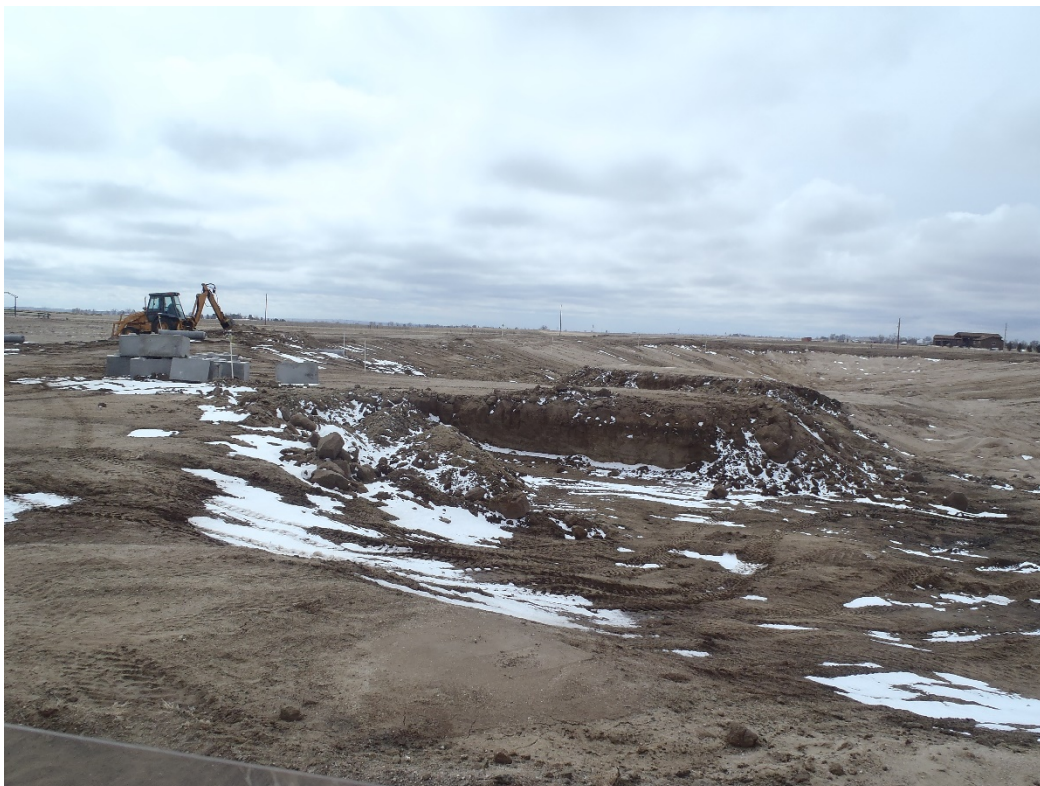
Hydrologic Balance: No water was observed in the graded pond. Mr. Huddleson was in the process of placing pre-cast concrete blocks (see **Photo 3**) as part of an access point. An overflow pipe was installed on the east side (see **Photo 4**)

Photo 3. Access point where pre-cast concrete blocks are being placed (east side, looking south).

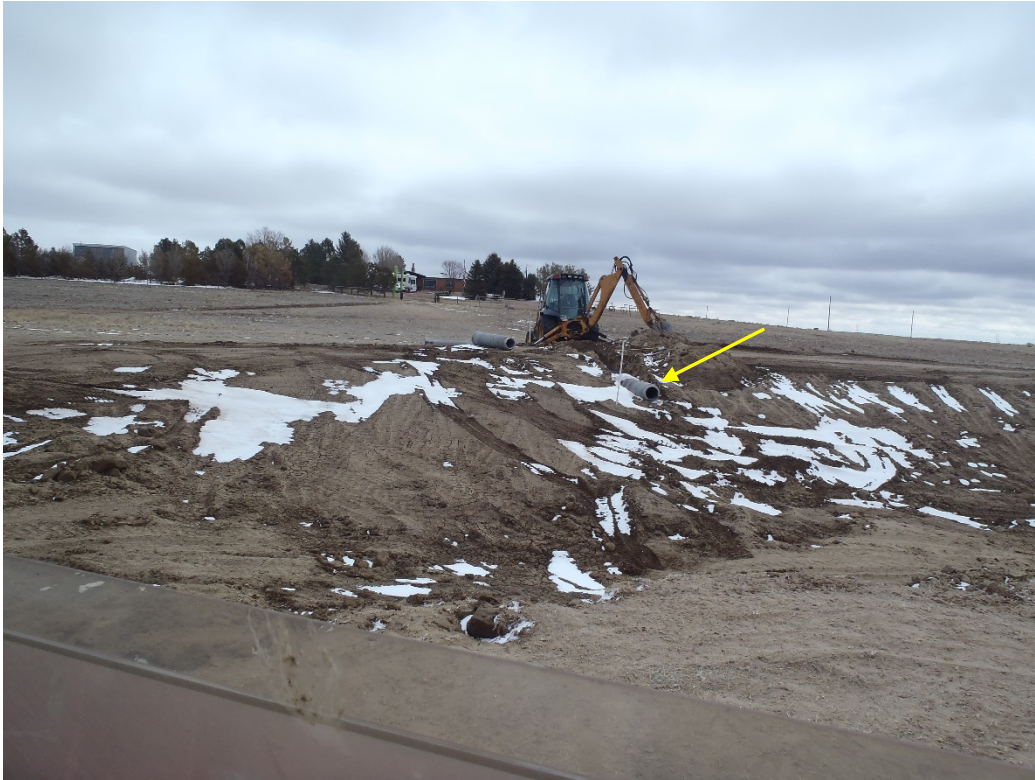
Photo 4. Overflow pipe on east side (looking east).

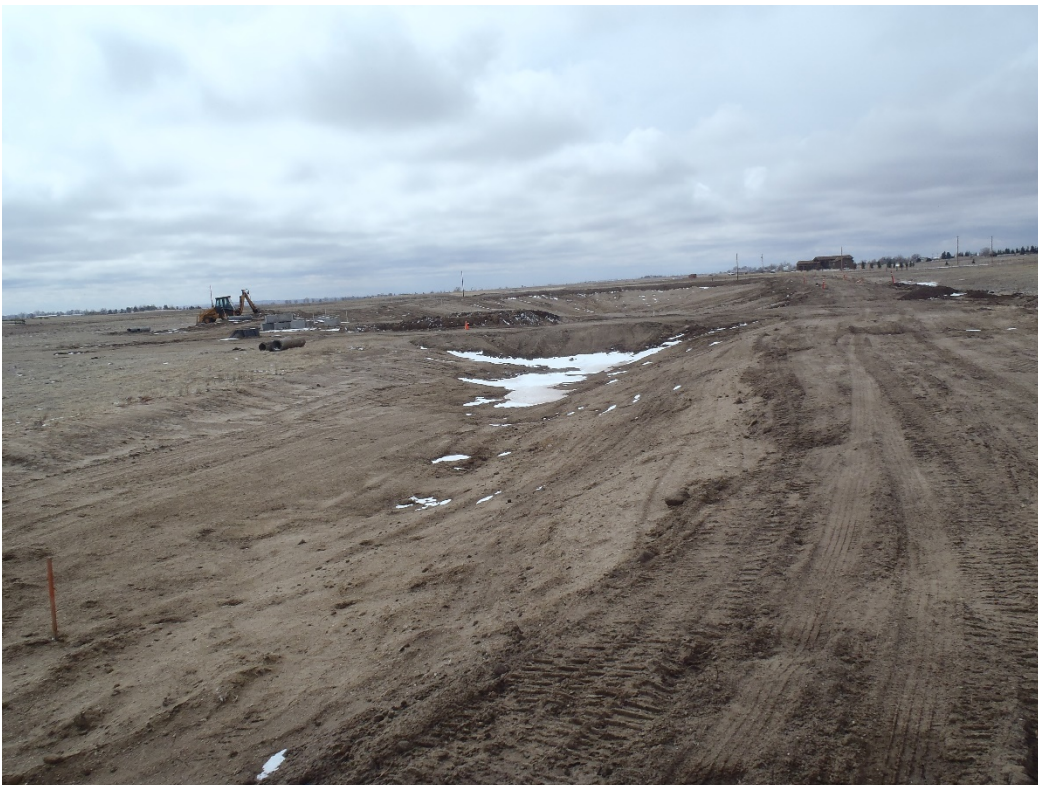
Gen. Compliance with Mine Plan: The operation appeared to have been completed in compliance with the approved mine plan. (see **Photo 5**).

Topsoil: Topsoil had been placed (see **Photos 5 and 7**).

Photo 5. Graded forebay, topsoil placed on west pond crest (looking south from north end).

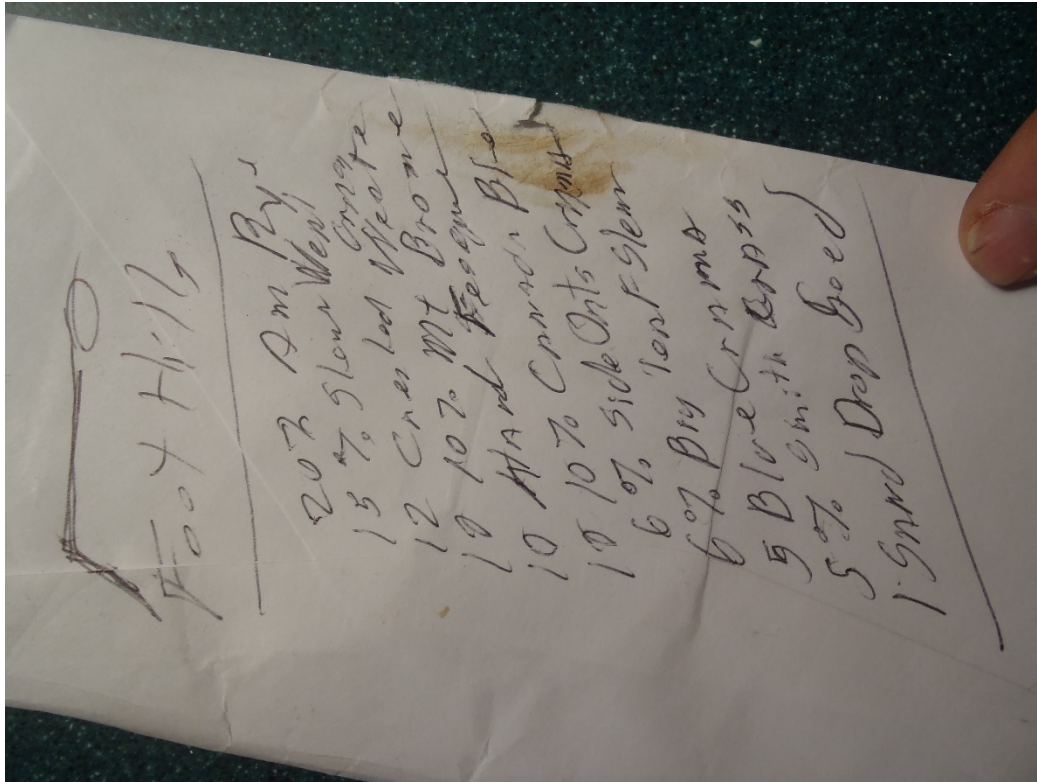
Revegetation: Mr. Huddleson stated he planned to seed the exterior slopes on April 15<sup>th</sup> with a foothills seed mix (see **Photo 6**) and agreed to provide documentation to the DRMS demonstrating he had done so. No noxious weeds were observed.

Photo 6. Foothills seed mix.

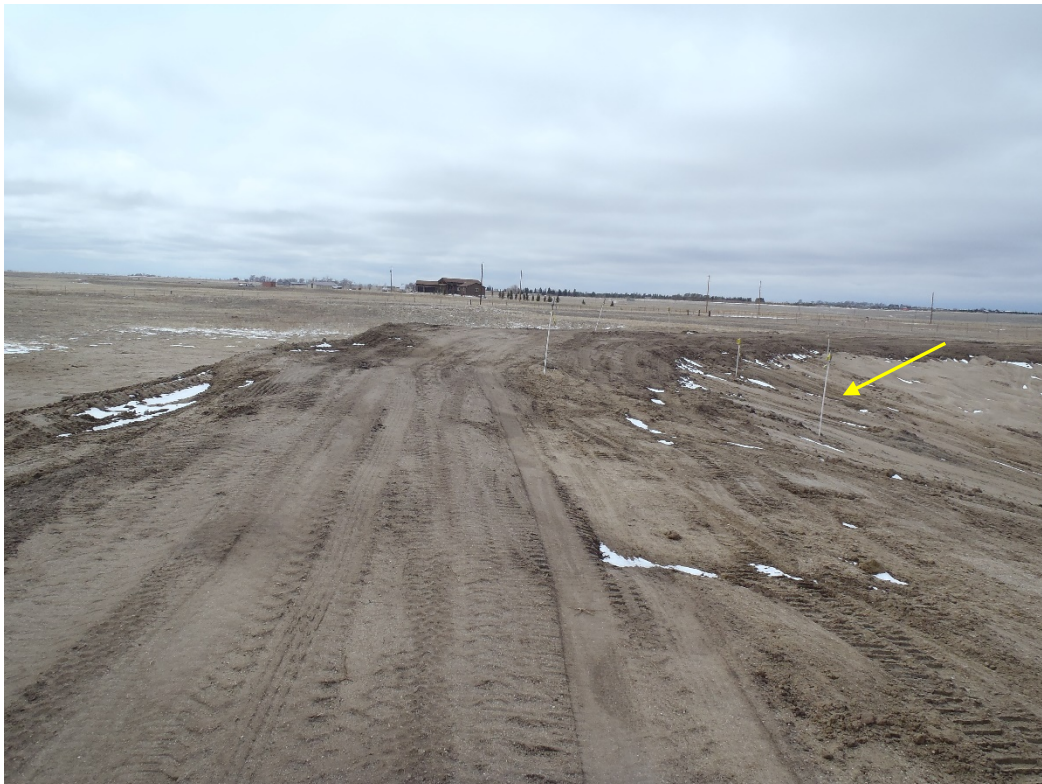
Photo 7. Topsoil placed on southeast pond crest (looking SW, interior markers are high water level).
