MINERALS PROGRAM INSPECTION REPORT
PHONE: (303) 866-3567

MINE NAME: Sievers Pit	MINE/PROSPECTING ID#: M-1977-098	MINERAL: Sand and gravel	COUNTY: Garfield
INSPECTION TYPE: Monitoring	INSPECTOR(S): Amy Yeldell	INSP. DATE: April 14, 2021	INSP. TIME: 09:00
OPERATOR: Oldcastle SW Group, Inc. dba United Companies of Mesa County	OPERATOR REPRESENTATIVE: Jason Burkey	TYPE OF OPERATION: 112c - Construction Regular Operation	
REASON FOR INSPECTION: Normal I&E Program	BOND CALCULATION TYPE: Complete Bond	BOND AMOUNT: \$794,357.00	
DATE OF COMPLAINT: NA	POST INSP. CONTACTS: DRMS	JOINT INSP. AGENCY: None	
WEATHER: Clear	INSPECTOR'S SIGNATURE:

RE: Sievers Pit, Permit No. M-1977-098, Reclamation Cost Estimate

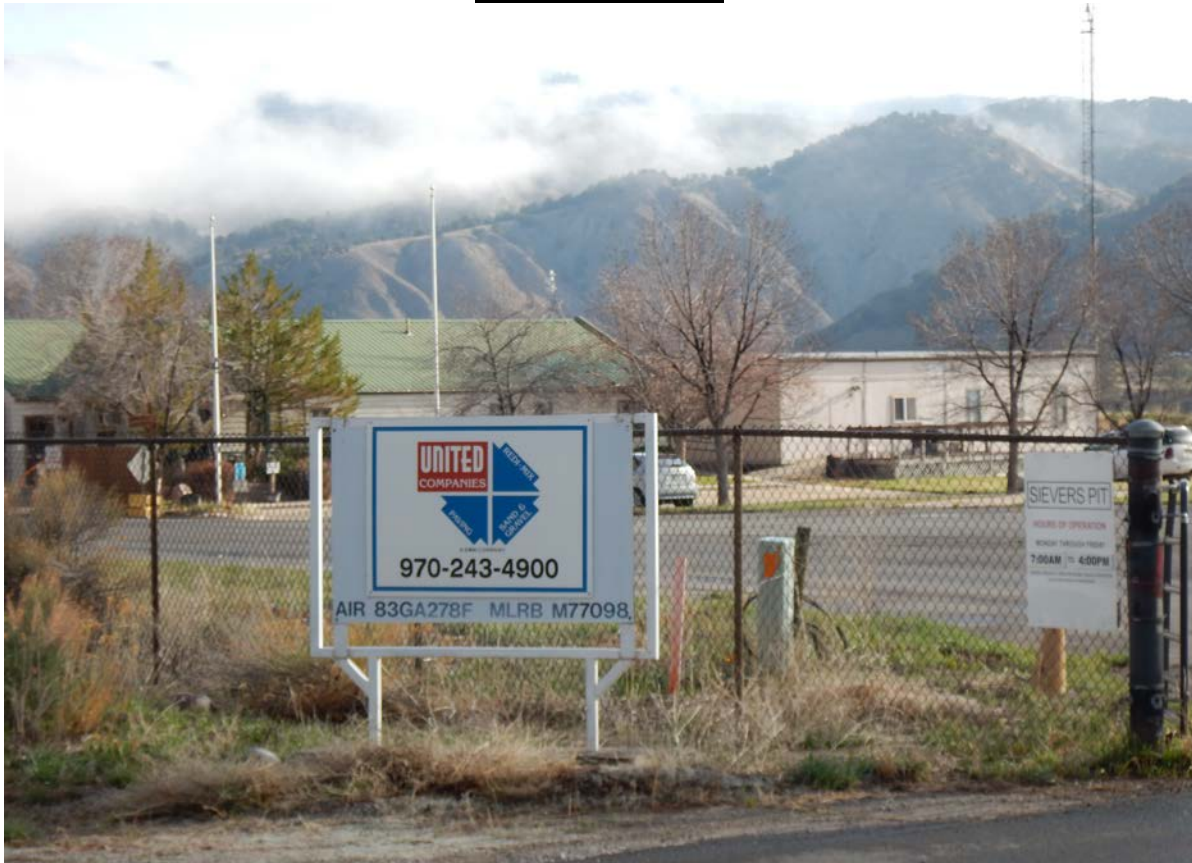
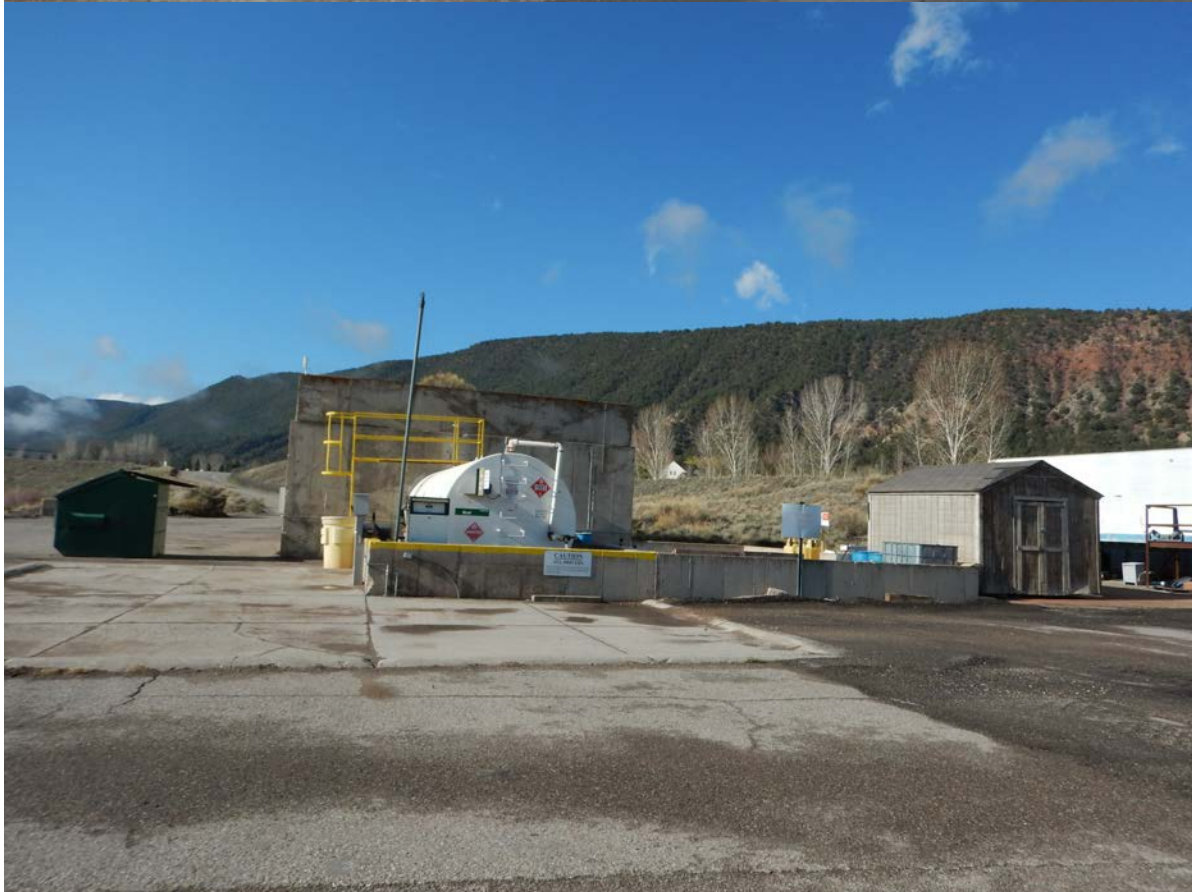
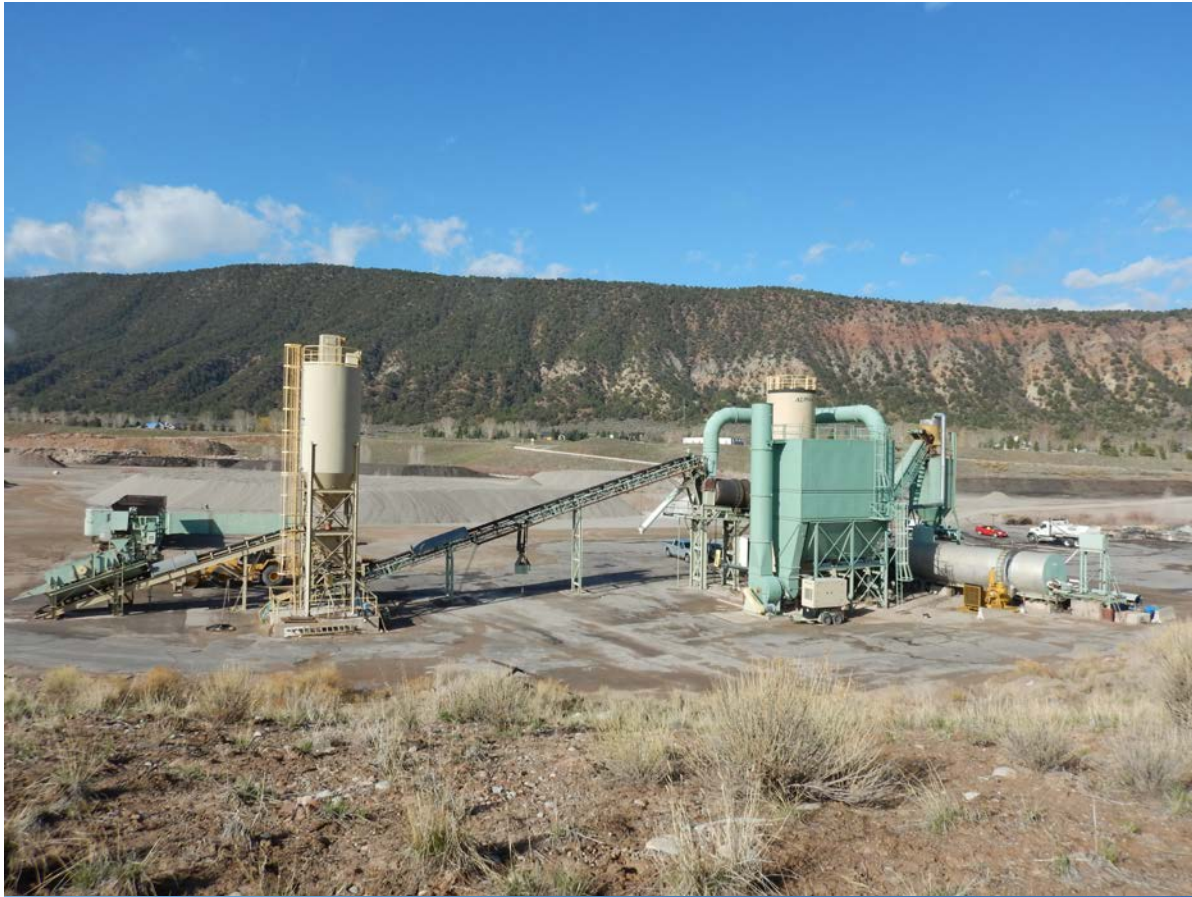
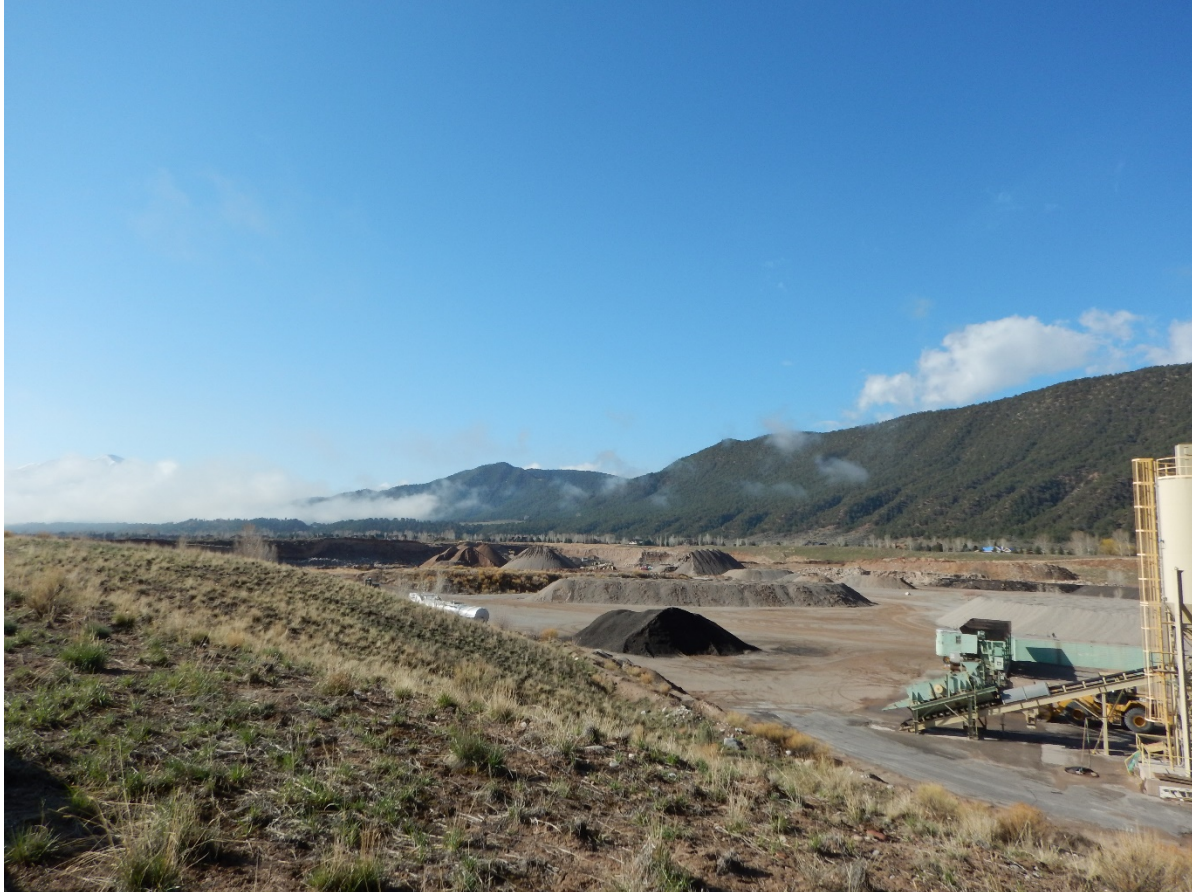
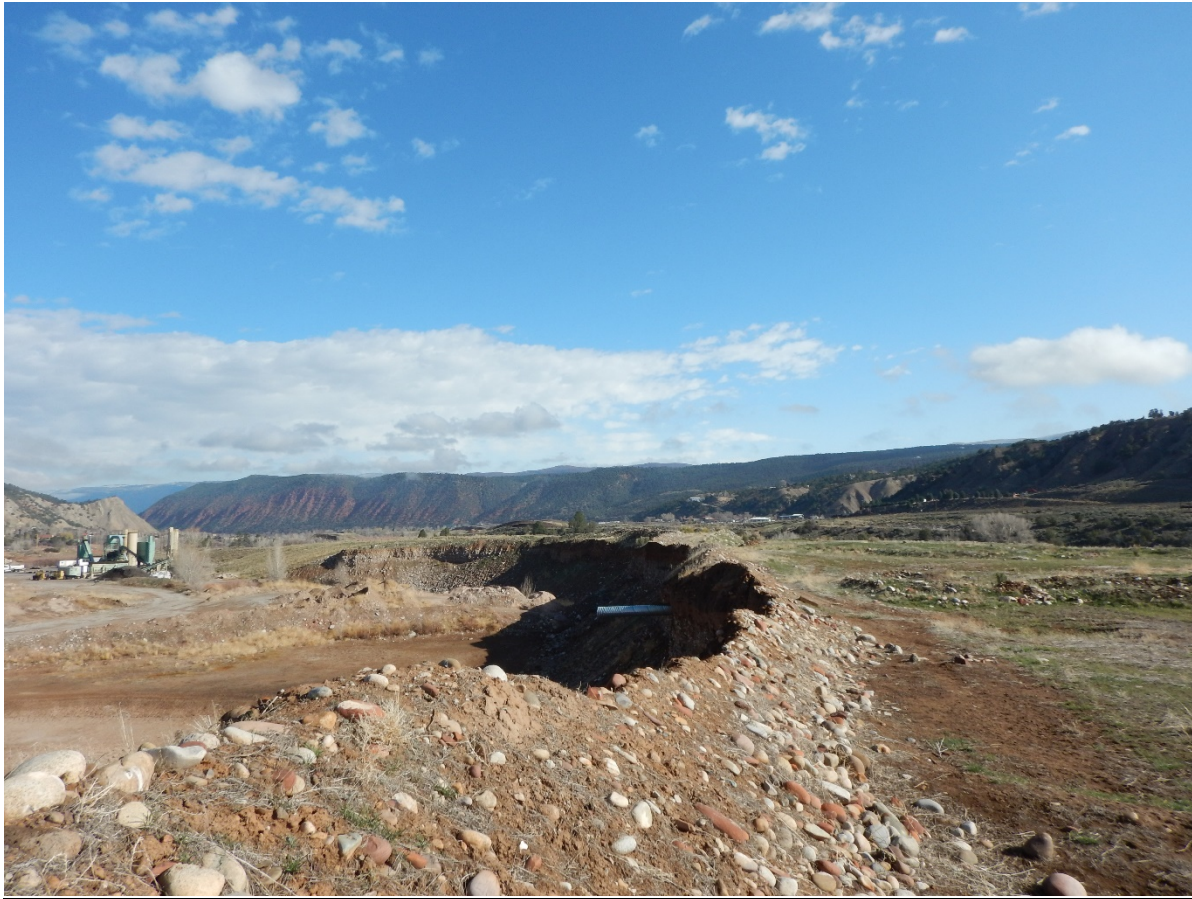
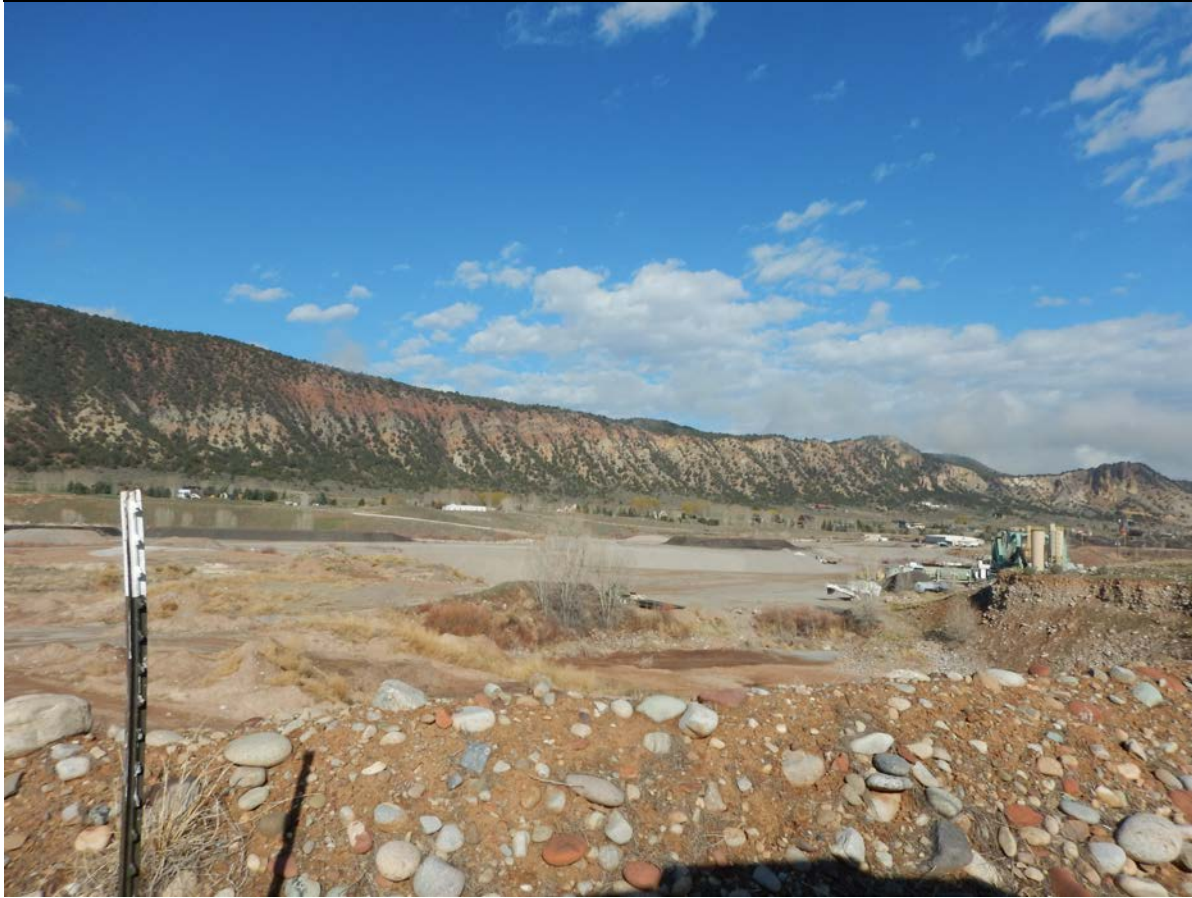
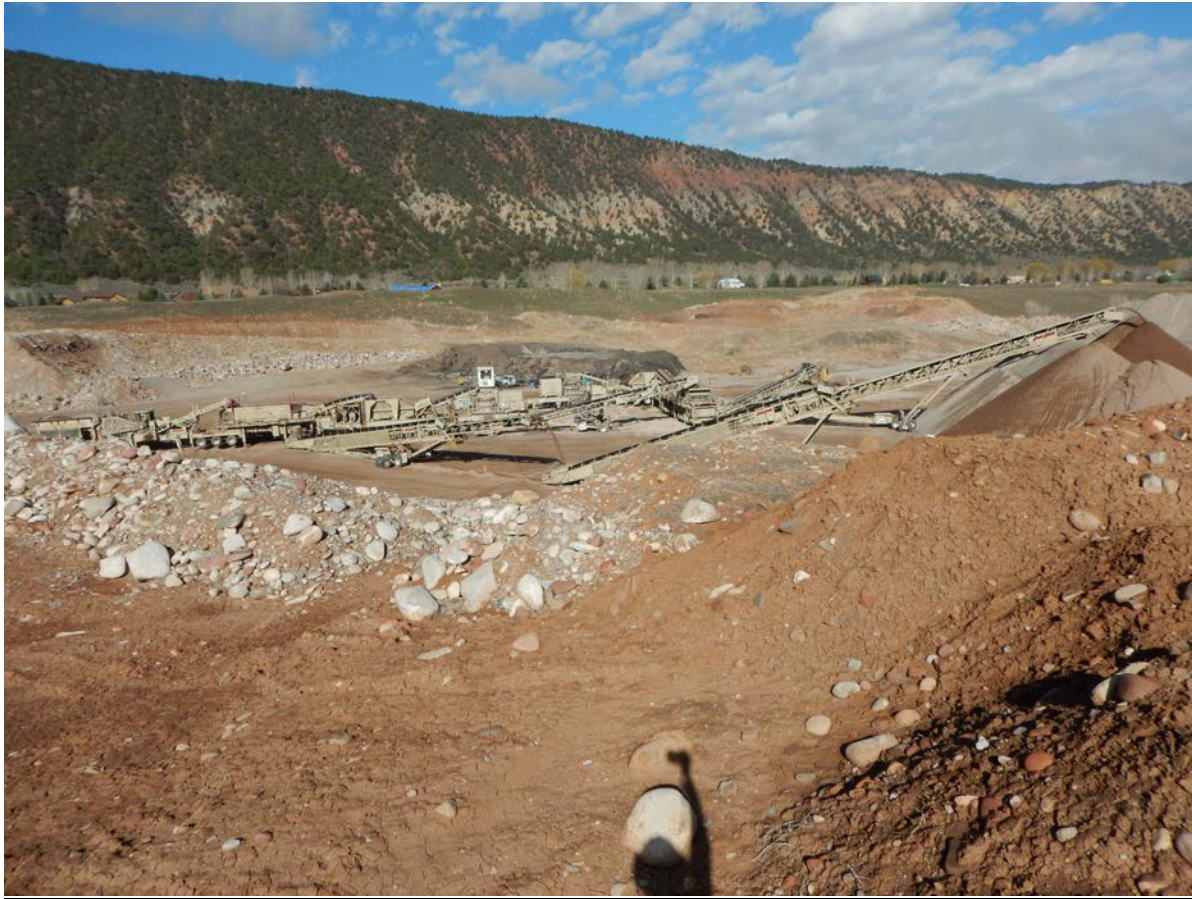
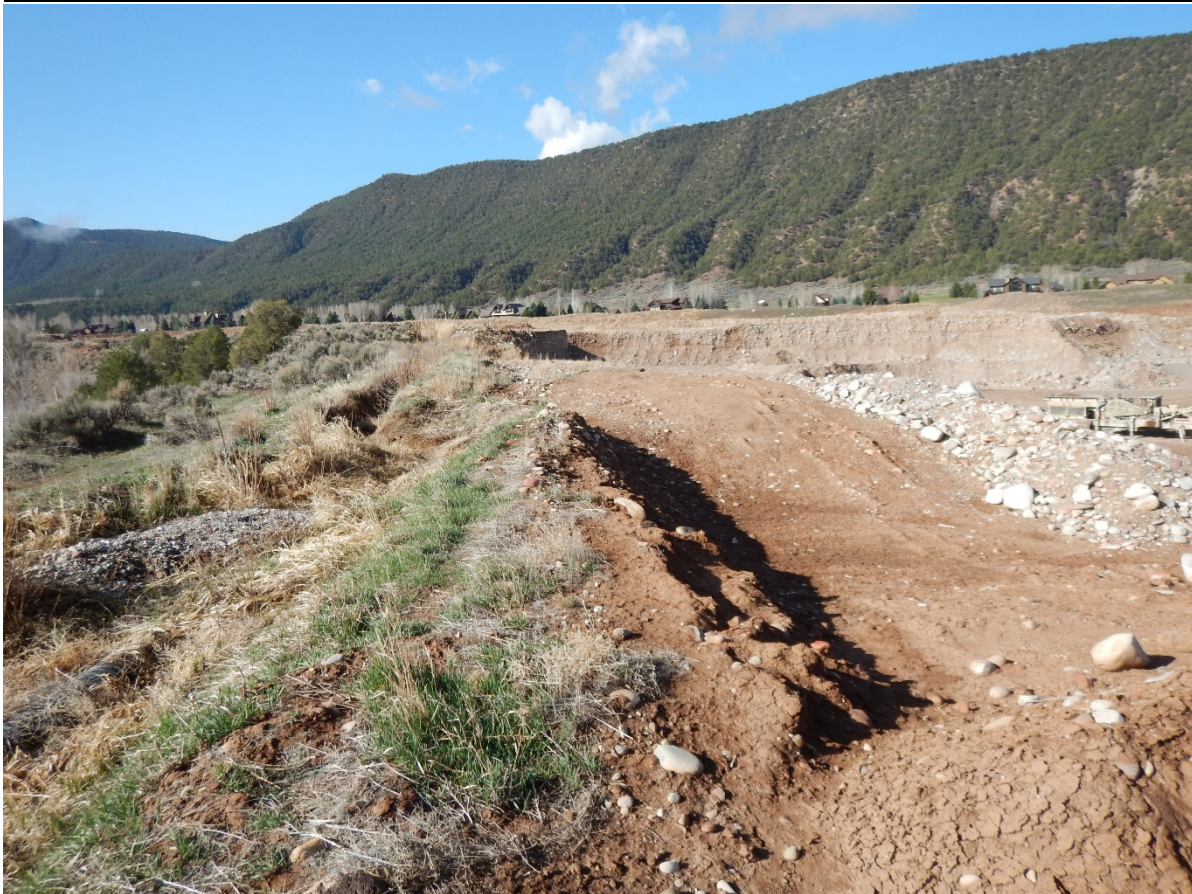
PHOTOGRAPHS

The mine identification sign and affected area boundary markers remain in place and in compliance with Rule 3.1.12. The sign is located at the entrance of the permit boundary. T-posts have been placed to clearly delineate permit boundaries.

The office, shop and fuel storage areas remain in place and in good working order. All hydrocarbons were observed in secondary containment. Excess equipment and parts were all stored neatly.

The pit was active at the time of the inspection. Trucks were observed hauling material off site. Material was actively being crushed and sorted. Several large stockpiles were located throughout the pit floor and appeared to be stable. The leased plant in the bottom of the pit remains in place and active.

The main highwall is being mined further back as mining progresses to the south. Approximately 1500 linear feet of vertical highwall is currently exposed along the southeast side of the pit. A small portion of the highwall along the west side of the pit will need to be backfilled. Once the highwall reaches the far southern end of the mine permit the operation will come back to the north taking out the remaining material along the east side of the pit. The pit floor will then daylight out along the east side. Mining the remaining material on site is anticipated to take at least another ten years.

The visual berm screen located on the west side of the permit boundary is contoured and reclaimed concurrently up to the active portions of the mine. Stockpiles and previously reclaimed slopes remain stable with adequate vegetation cover.
