**COLORADO**  
Division of Reclamation,  
Mining and Safety  
Department of Natural Resources

<b>Permit Number:</b> C-1981-015 <b>Mine Name:</b> Fruita No 1 & 2 <b>Operator:</b> Dorchester Coal Company <b>Operator Address:</b> Greg Lewicki 9054 South Forrest Drive Highlands Ranch, CO 80126	<b>County:</b> Mesa <b>Operation Type:</b> Underground <b>Permit Status:</b> Revoked <b>Ownership:</b> Private
	<b>Operator Representative Present:</b>  NA
<b>Operator Representative Signature:</b> (Field Issuance Only)

<b>Inspection Start Date:</b> April 27, 2021 <b>Inspection Start Time:</b> 13:00 <b>Inspection End Date:</b> April 27, 2021 <b>Inspection End Time:</b> 13:35		<b>Inspection Type:</b> Coal Complete Inspection <b>Inspection Reason:</b> Normal I&E Program <b>Weather:</b> Cloudy	
<b>Joint Inspection Agency:</b>  None		<b>Joint Inspection Contacts:</b>  None	
<b>Post Inspection Agency:</b>  None		<b>Post Inspection Contacts:</b>  None	
<b>Inspector(s):</b>  Clayton Wein	<b>Inspector's Signature:</b>  <i>Clayton Wein</i>		<b>Signature Date:</b>  4/30/2021

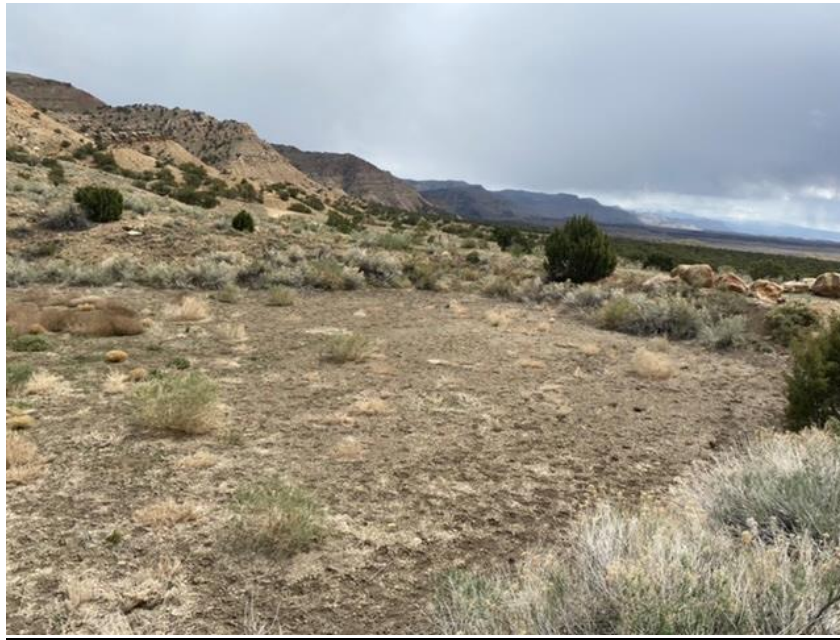
There is one pond located at the southern portion of the permit area (Photo 1). The sediment pond is permitted to remain as a permanent feature. The pond was dry at the time of the inspection. The outlet was stable and clear of debris. The riprap lining was in good condition. The embankment was stable with mature vegetation. There were no indications of erosional features observed.

**Photo 1:** The dry sediment pond. Photo taken looking to the southeast.

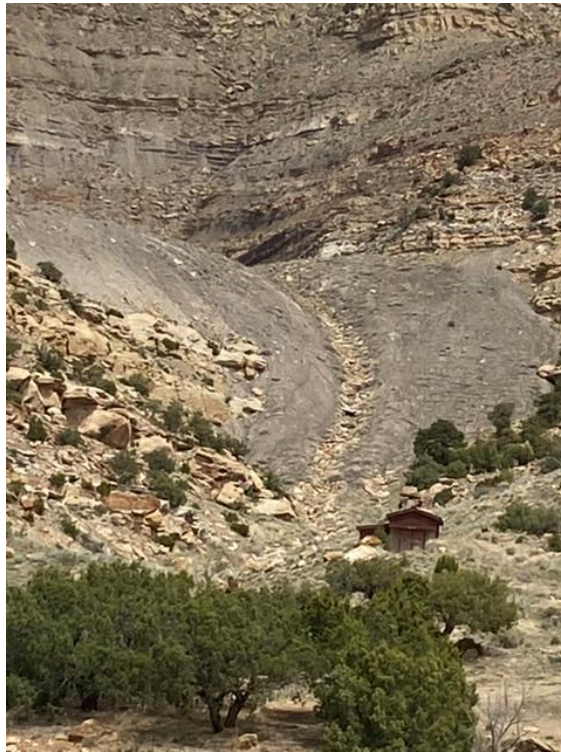
There is a riprap lined channel starting at the edge of the mine bench that leads to the bottom of the drainage below (Photo 2). Water that flows in this channel will end up in the sediment pond. The channel was dry during the inspection. The riprap was in good condition and stable. The channel; was observed to be stable. There did not appear to be any down-cutting within the channel.

**Photo 2:** The riprap channel leading off of the bench.

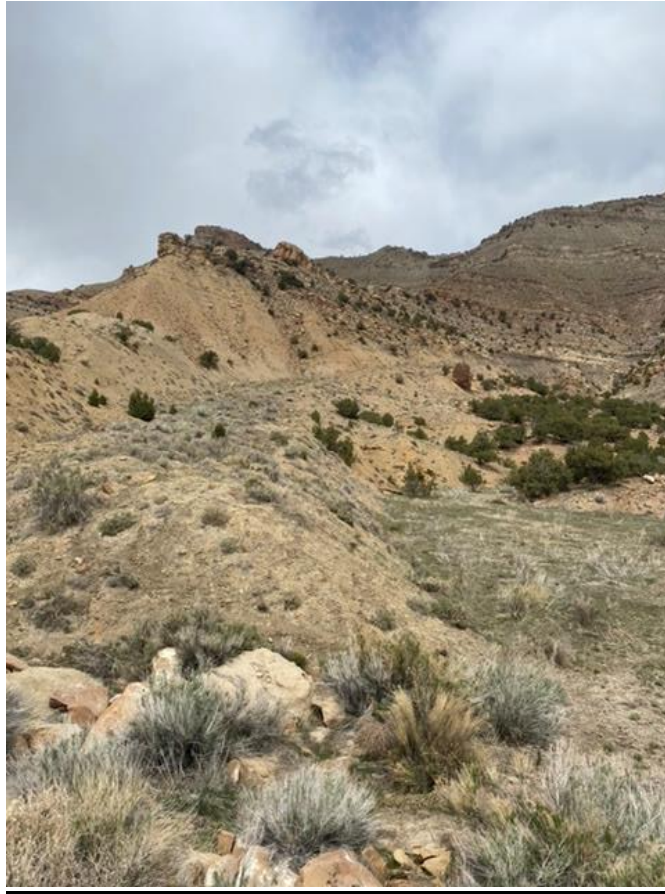
The reclaimed haul road was vegetated and stable (Photo 3). There were no new erosional features observed. The cut slopes and fill slopes of the road were observed to be stable. There were no indications of sloughage. On the southwestern portion of the reclaimed road, rills and one large gully remain in place. The features have been noted in previous Division inspection reports. The rills and gully are in a stabilized state. There are no off site impacts from these features. Any water that travels through the features ends up in the wash below and is transported to the sediment pond. The surface of the reclaimed road remains roughened and provides

micro-climates for vegetation. Vegetation including grasses and shrubs were beginning to green. Some small purple flowers were also seen on this reclaimed area.

**Photo 3:** The base of the reclaimed haul road.
