**COLORADO**Division of Reclamation,
Mining and Safety

Permit Number: C-1980-004 Mine Name: McClane Canyon Mine Operator: ARC McClane Canyon, LLC Operator Address: Jim E Stover 2352 N 7th Street, Unit C Grand Junction , CO 81501	County: Garfield Operation Type: Underground Permit Status: Temporary Cessation Ownership: Private
	Operator Representative Present: Chuck Selingo
Operator Representative Signature: (Field Issuance Only)

Inspection Start Date: April 27, 2021 Inspection Start Time: 10:30 Inspection End Date: April 27, 2021 Inspection End Time: 12:30		Inspection Type: Coal Complete Inspection Inspection Reason: Other Agency Request Weather: Cloudy	
Joint Inspection Agency: Colo. Wildlife		Joint Inspection Contacts: Danielle Neumann Danielle Johnston	
Post Inspection Agency: None		Post Inspection Contacts: None	
Inspector(s): Clayton Wein	Inspector's Signature: <i>Clayton Wein</i>		Signature Date: 5/3/2021

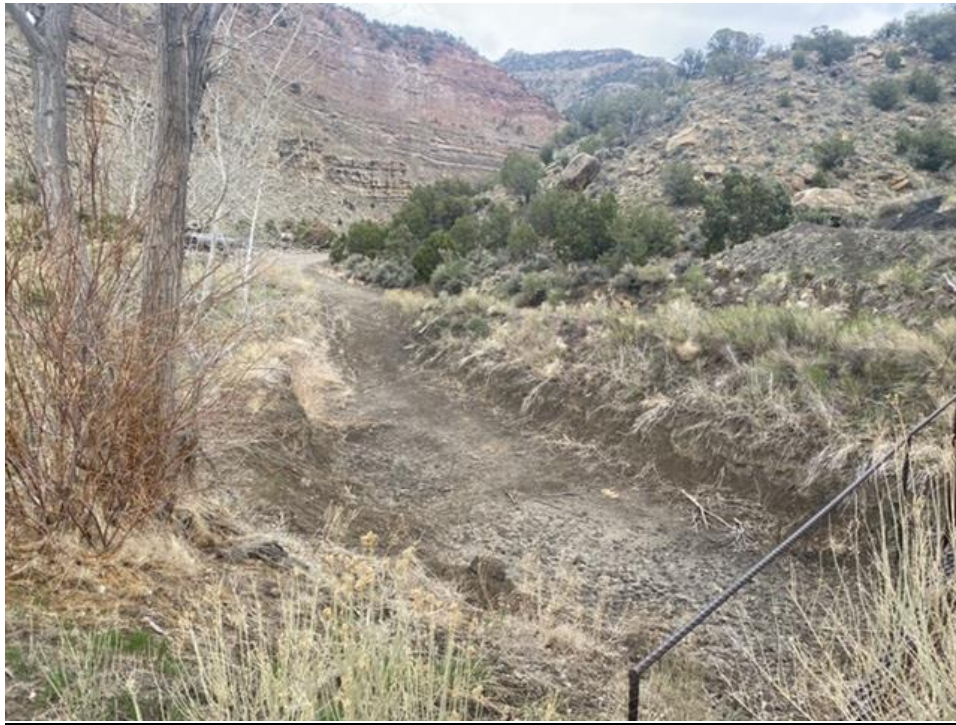
During the inspection the sediment pond was dry (Photo 1). The outlet riser pipe was clear of debris. The embankment of the pond was stable with vegetative cover. There were no indications of erosional features.

Photo 1: The sediment pond. Photo taken looking to the northeast.

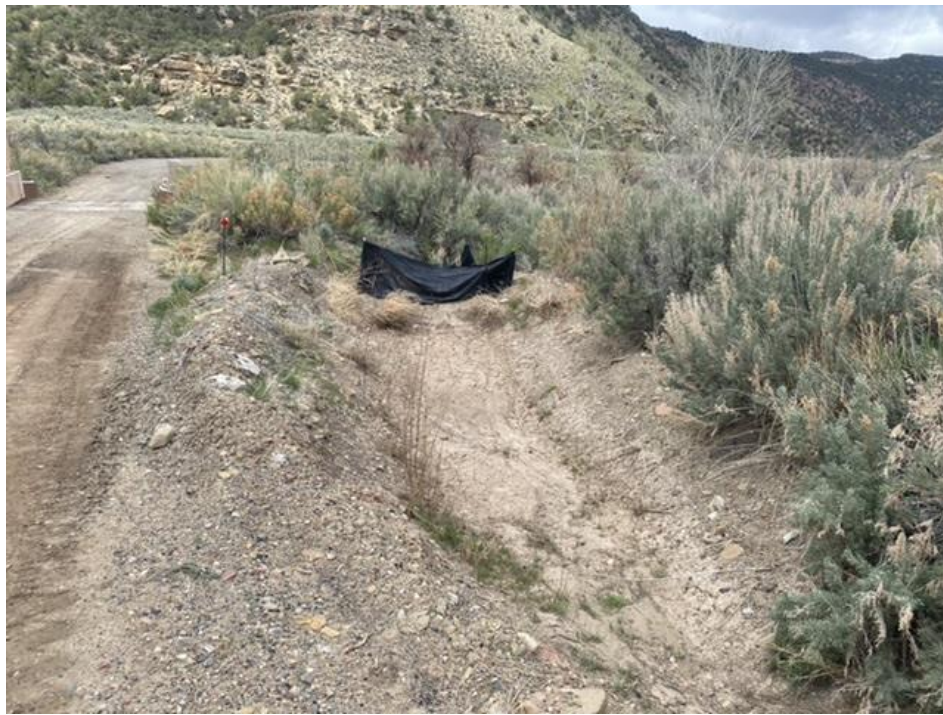
There are two sumps located on the western end of the mine office pad. Both sumps were dry. The silt fences placed at the outlets were in good repair (Photo 2). There were no off-site impacts observed. The sumps were stable with no erosional concerns noted.

Photo 2: The sump located on the northwest side of the office pad.

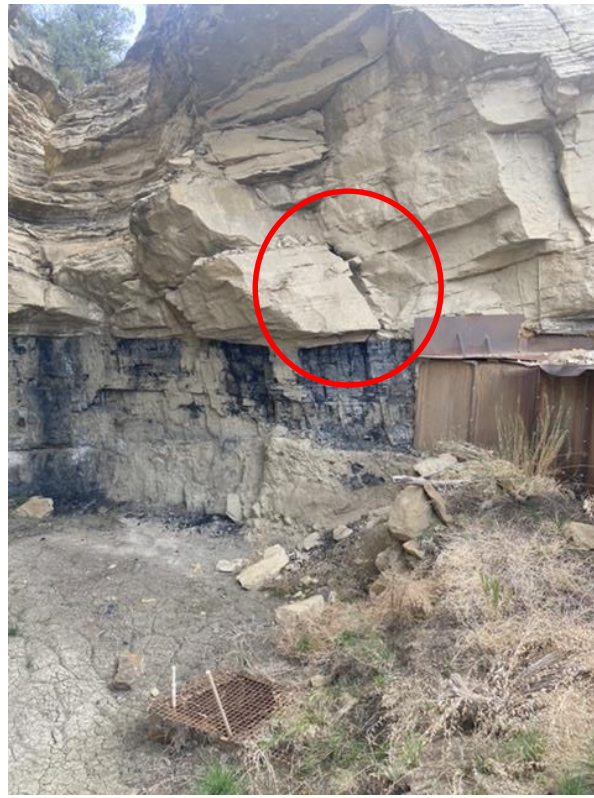
Two sumps are located at the portals area. One is located at the eastern portion of the portals area. The sump was dry and the outlet was clear. There were no indications of erosion. There is a large portion of the bedrock on the canyon wall that has a large crack in it. This large rock may fall into the sump in the near future (Photo 3). Chuck Selingo stated to the Division that when it falls, he will use equipment to break up the rock and remove it from the sump. The second sump is located on the northeast portion of the portals area. The sump was also dry during the inspection. There were no erosional features identified.

Photo 3: The eastern sump at the portals bench. The large crack in the bedrock above the sump is identified in a red circle.

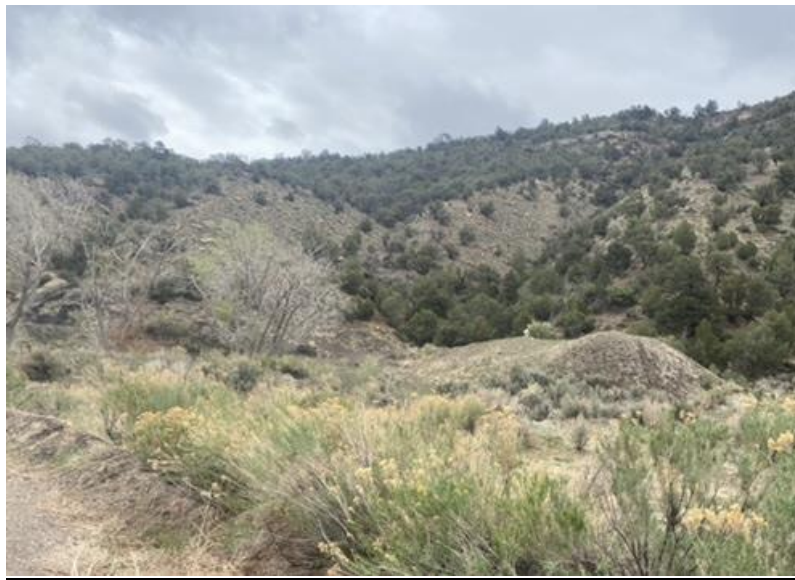
The topsoil stockpile was stable with vegetative cover. The topsoil pile marker was located on top of the pile in a clearly marked location. There were no erosional issues identified. There was a young whitetop plant seen on top of the pile. Danielle Johnston removed the plant on the spot. A conversation with Chuck Selingo about weed spraying occurred on top of the stockpile. Mr. Selingo stated that he sprays for weeds including whitetop every year in the spring. Mr. Selingo had stated that he plans to spray for weeds in the next week or so as conditions permit. A conversation about Cheatgrass also occurred at that time. Cheatgrass is common in the Western Slope area including the area around and in the McClane Canyon Mine. Some techniques including specialized herbicides were discussed by CPW as well as other options to try to help control Cheatgrass including the roughening of the surface to trap the plants seed. The seed become trapped in the low spots and have to compete with themselves, slowing the spread of the plant.

Photo 4: The topsoil pile.
