MINERALS PROGRAM INSPECTION REPORT**PHONE: (303) 866-3567**

MINE NAME: Hatchery Pit	MINE/PROSPECTING ID#: M-2014-043	MINERAL: Gravel, sand and bor for construction	COUNTY: Adams
INSPECTION TYPE: Monitoring	INSPECTOR(S): Jared L. Ebert	INSP. DATE: July 19, 2018	INSP. TIME: 10:30
OPERATOR: Albert Frei & Sons Inc.	OPERATOR REPRESENTATIVE: Ben Frei and Steve O'Brian	TYPE OF OPERATION: 112c - Construction Regular Operation

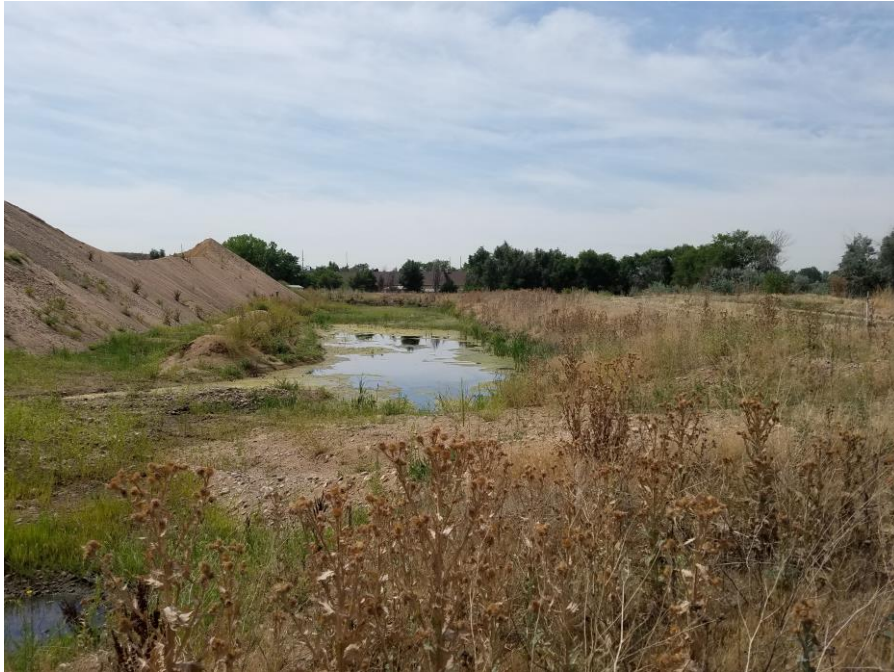
The Operator has mined the plant area and has setup a processing plant onsite. Mining has also begun in the Phase 1 mining area and they have installed the slurry wall around this phase. Mr. Frei indicated they have about four or five months remaining to complete the mining in the Phase 1 area. Also according to Mr. Frei, they may not install the slurry wall around the Phase II mining area.

AFS has placed survey markers to delineate the 200 foot offset from the City of Thornton dam and slurry wall. The Phase 1 pit excavation has begun and the top of the pit excavation is outside the 200 foot setback.

Figure 1. From the northwest corner of the Phase 1 area looking south.

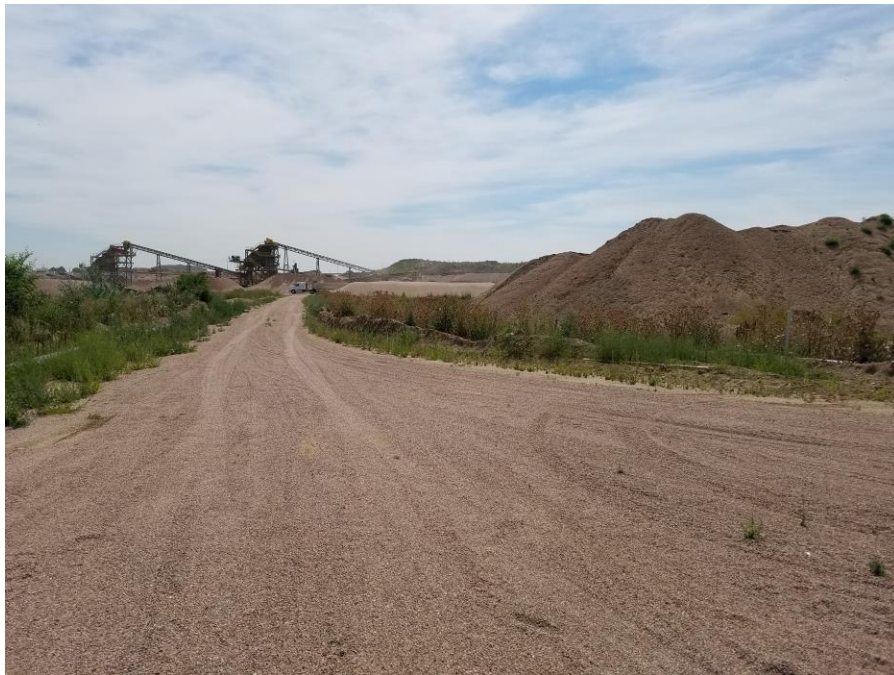
Figure 2. From the northwest corner of the Phase 1 area looking east.

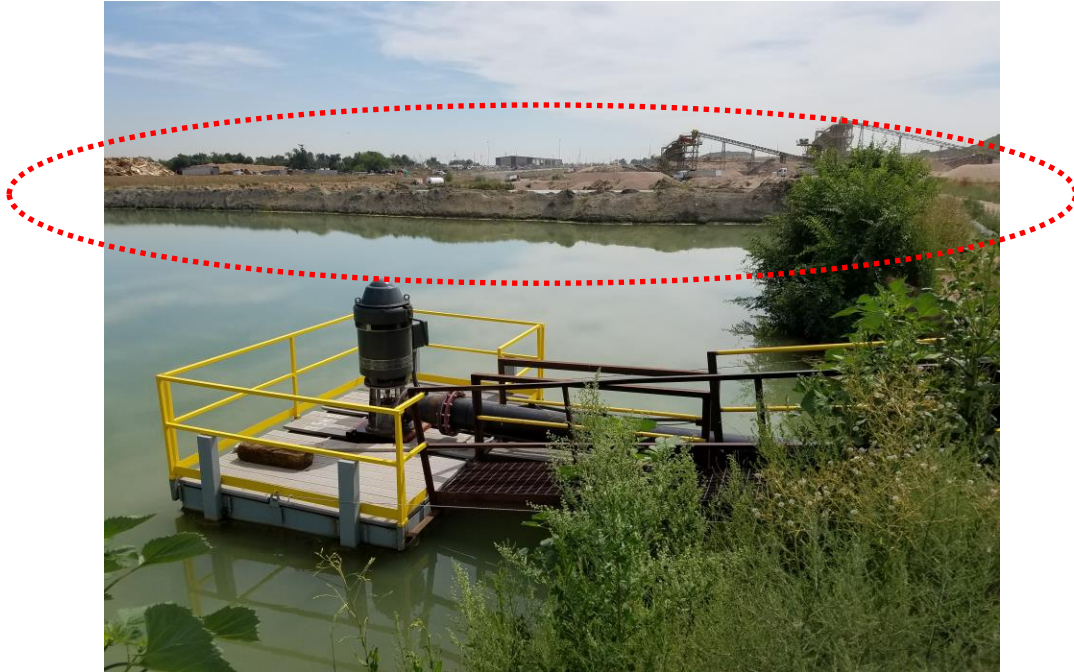
The Operator is utilizing the northwest pre-existing lake for processing operations at the site. AFS had dewatered the northwest lake to construct a berm separating the lake into a west and east cell. The two cells have filled back in with water. It appears water from the processing plant flows into the east cell to settle out the wash fines. A small break in the berm allows water to flow into the west cell. Water is then pumped from the west cell back to the processing plant and recycled creating a closed loop system.

As discussed in the Hydrologic Balance section of this report, the Operator is utilizing the pre-existing northwest lake for processing water and has modified the lake to create two cells. This activity was not

approved with the original permit application. AFS will need to submit an updated mining and reclamation plan to address this change in operations.

Figure 3. From the southwest corner of the pre-existing northwest lake looking northeast. Berm between the west and east cell within dotted line.

CORRECTIVE ACTIONS: The Operator shall submit a Technical Revision, with the required \$216 revision fee, to update and clarify the current approved mine plan and reclamation plan to reflect the change in use of the northwest lake for process water utilization and treatment.

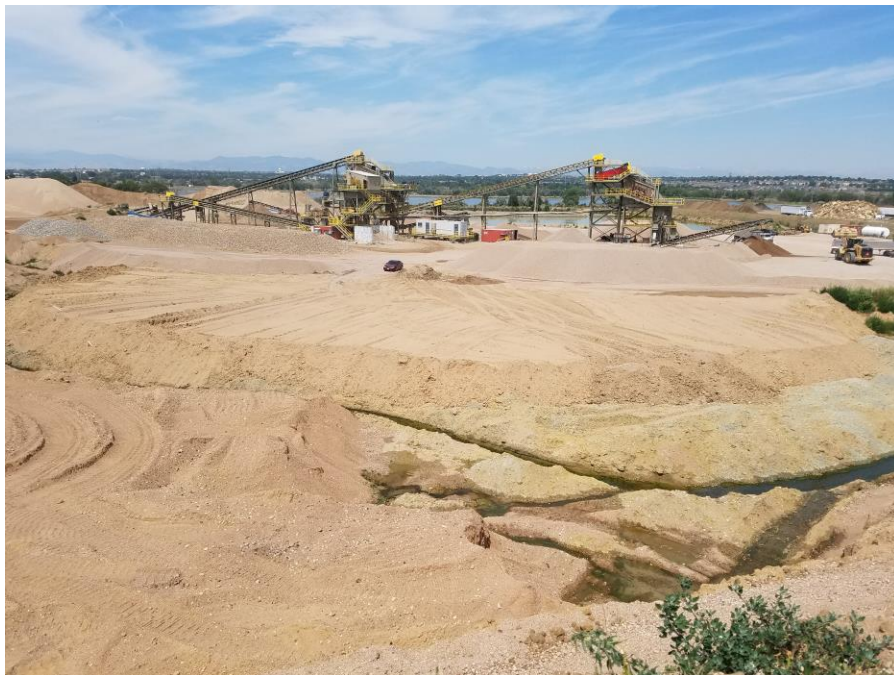
Figure 4. From the east side of the processing area on top of the Phase II hillside looking west.

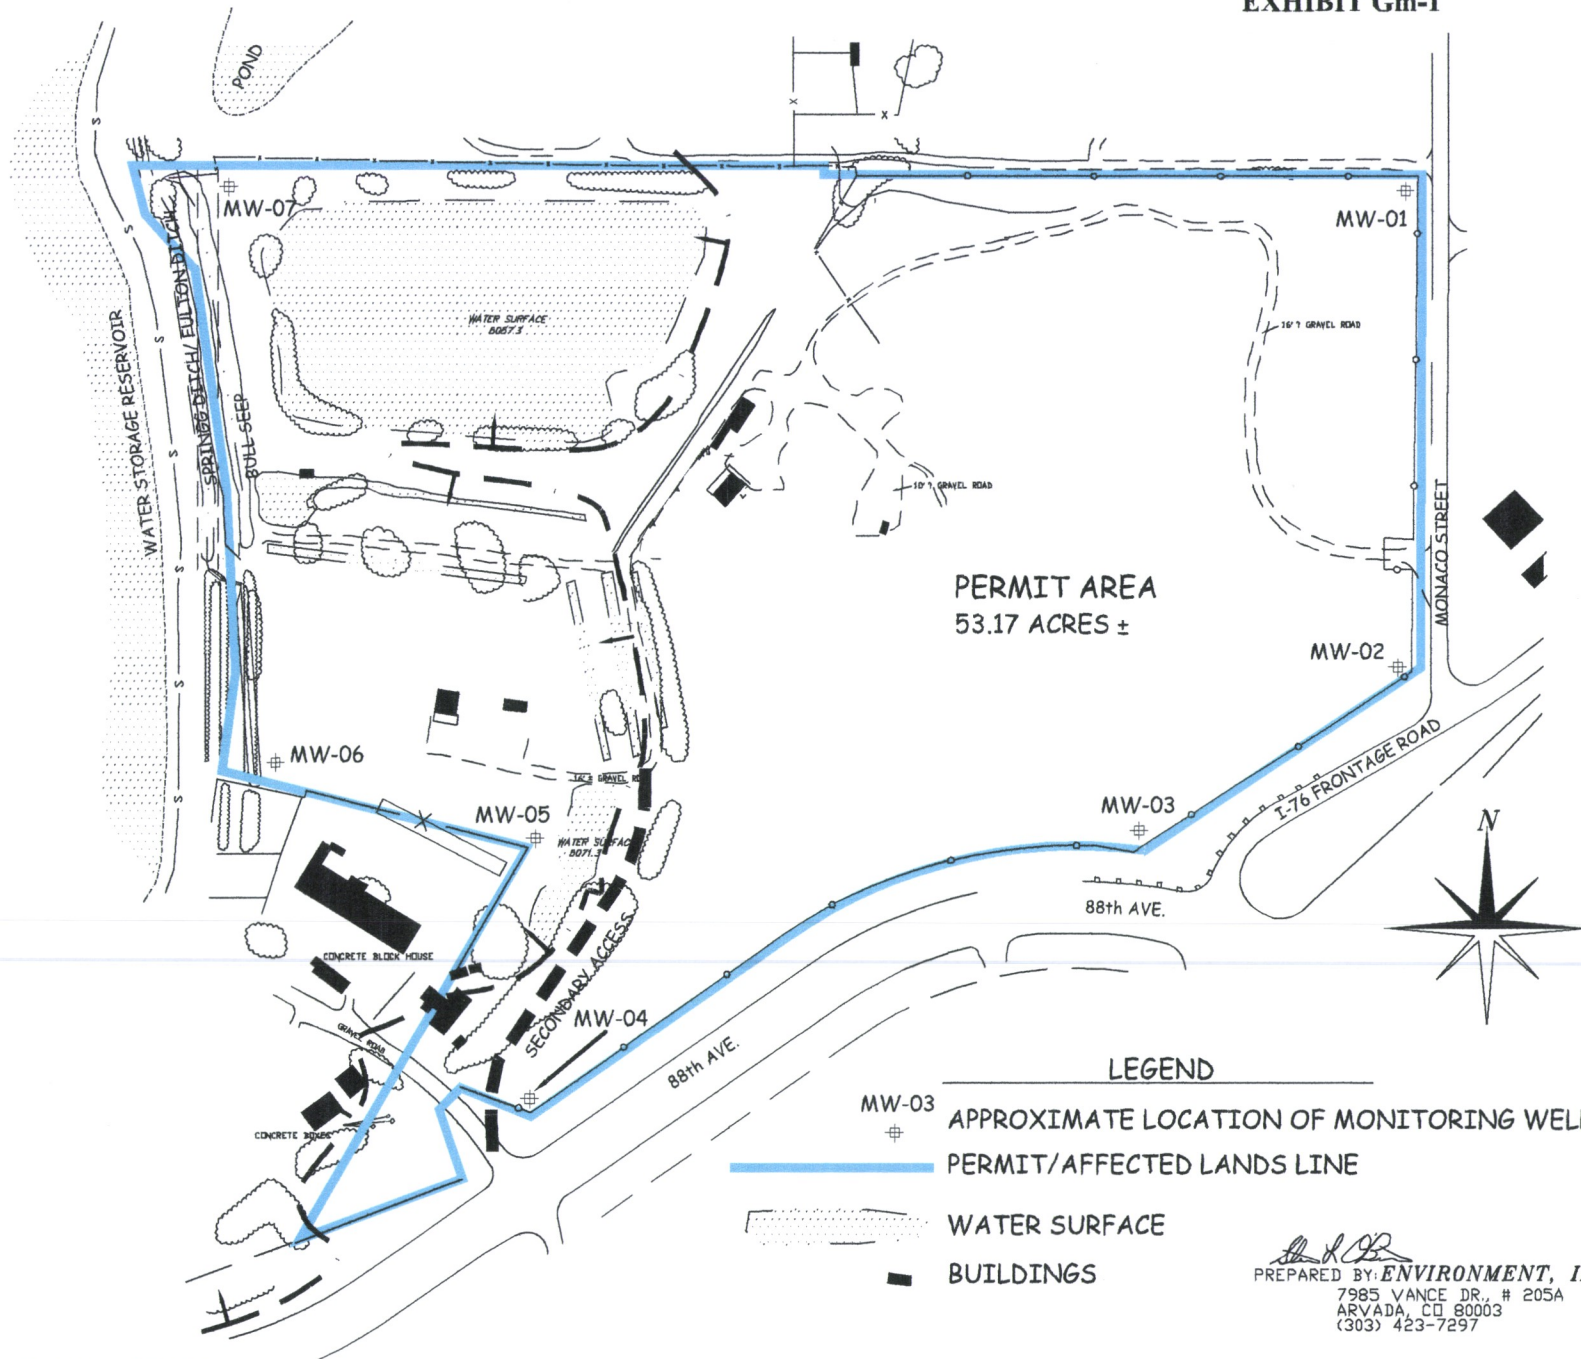
Albert Frei and Sons, Inc.
Hatchery Pit
Proposed Monitoring Well Locations
EXHIBIT Gm-1

During the review process of the permit, AFS committed to conducting baseline water level monitoring and operations water level monitoring. The monitoring plan consisted of monitoring 7 piezometers shown on the attached map. The plan called for monthly monitoring of the water levels for one year prior to initiating mining and then quarterly monitoring after that. The results of the water monitoring is to be submitted with the annual report each year. The annual report received on November 15, 2016 for the 2016 monitoring year included monitoring results for June, July and November of 2016. The annual report received on November 16, 2017 did not include water monitoring results. This issue is cited as a problem at the beginning of this report.

CORRECTIVE ACTIONS: Submit all the results of the groundwater monitoring program to the Division that has been collected to date.
