Re: GCC Energy, LLC, King II Mine  
CDRMS Permit # C-1981-035  
Stoner Engineering: Quarterly Inspection: Water Quality Improvements  
1<sup>st</sup> Quarter 2021

Date: March 31, 2021

Re: King Coal I – Quarterly Water Quality Improvements Inspection

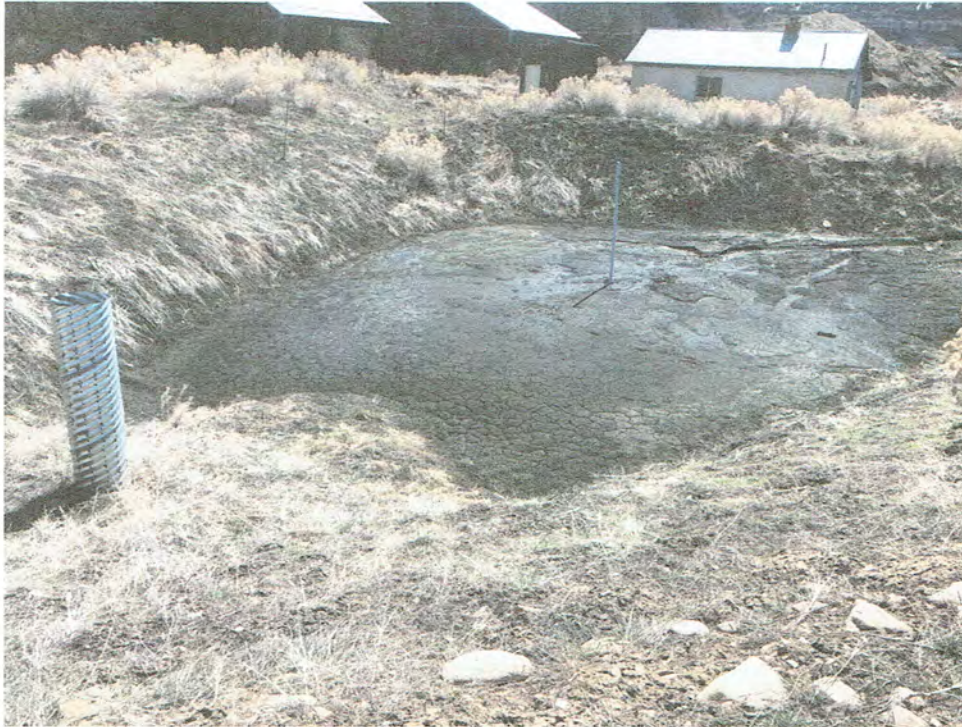
While both ponds were generally free of snow at the time of the inspection and appeared to generally be in good condition, they were wet and muddy (see Pic. 1). The sedimentation gages show the ponds are not yet it need of cleaning though they are near the required level (see Pic. 2). A large storm event could result in the sediment ponds reaching the level requiring the built-up sediment removed in order to continue to function as originally designed. The Surface Manager confirmed that the current plan is to clean out both ponds as soon as the weather improves and the ponds dry out and equipment can access the pond bottoms. The ponds should continue to be monitored after storm events to ensure that excess sediment does not reduce the required storage capacity available for storm water runoff.

Pic. 1 – East pond.

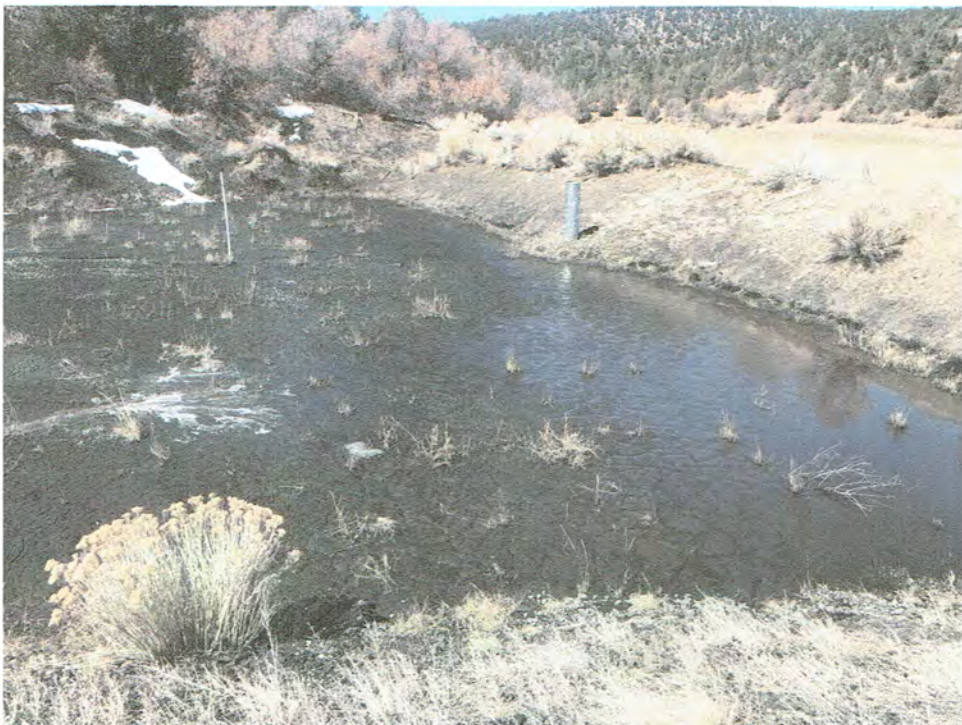
Pic. 2 – West pond sediment gage appears near the required maintenance mark.

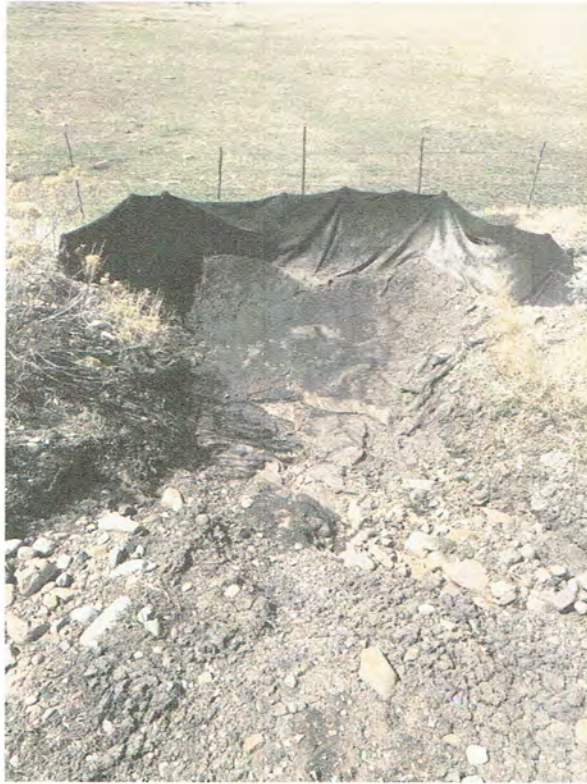
The sedimentation traps at the entrance to the site are generally in good condition (see Pic. 3). There was no stockpiled material on the site at the time of the inspection (see Pic. 4). The grading of the lower waste embankment pile directs surface runoff generally to the south and west as required in the design documents. The replacement culvert located near the top of the main waste embankment pile under the haul road (at the new switchback) has been installed but the section of ditch from the outlet to the treated water ditch (Reach 10) has experienced some soil sloughing which requires maintenance to keep runoff flowing unrestricted (see Pic. 5).

Pic. 3 – Sediment trap at driveway.

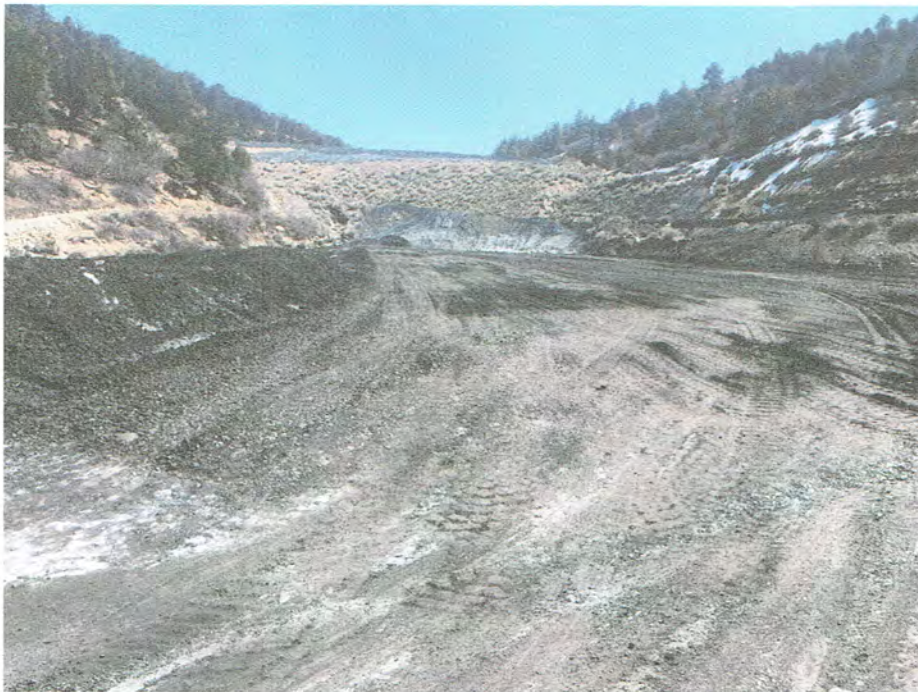
Pic. 4 – Lower waste embankment pile, not stockpiled material.

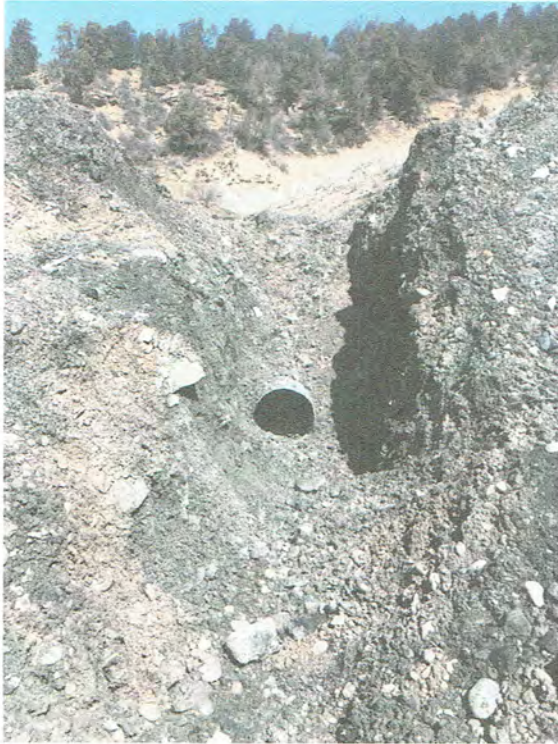
Pic. 5 – New switchback culvert with soil sloughing (downstream end).

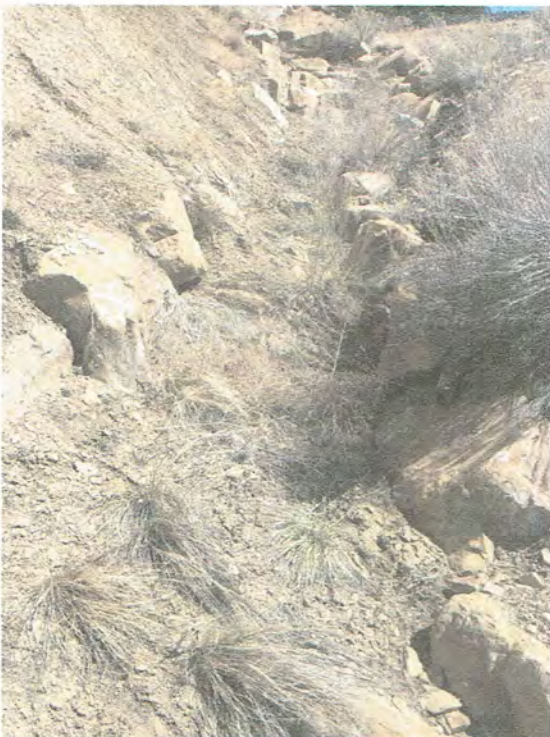
The clear water and the treated water ditches appeared to be in generally good condition. There do not appear to be any issues with any of the ditches or culverts at the time of the inspection, with the exception of a section of the clean water ditch (Reach 1) located near the steeper section of the adjoining grade is in need of some maintenance/cleaning (see Pic. 6).

Pic. 6 –Clean water ditch (Reach 1) with sediment.
