Re: GCC Energy, LLC, King II Mine
CDRMS Permit # C-1981-035
Stoner Engineering: Quarterly Inspection: Refuse Pile
1st Quarter 2021

Date: March 31, 2021

Re: King Coal I – Quarterly Waste Pile/Embankment Inspection

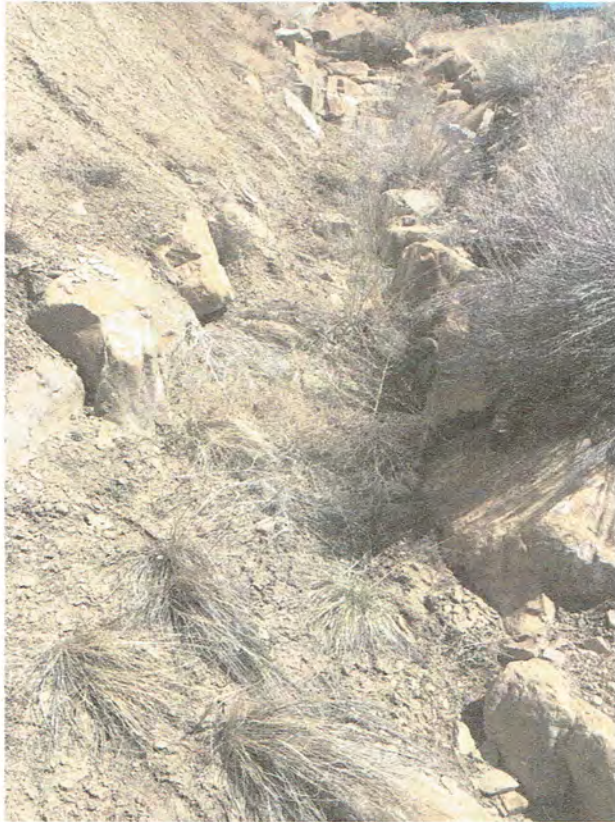
The site was generally free of snow at the time of the inspection. The south treated water ditch (Reach 10) and the north clear water ditch (Reach 1) appeared to be in generally good condition. Reach 1 is in need of some cleaning below the steeper section of the adjoining hillside (see Pic. 1). The face of the embankment appeared to be in good condition. There were no signs of excessive erosion, instability, sloughing or weakness (see Pic. 2). The downstream end of the new culvert located at the corner of the new switchback needs to be cleaned/regraded to the treated water ditch due to sloughing from the adjacent slopes (see Pic. 3).

Pic. 1 –Reach 10 treated water channel needs cleaning.

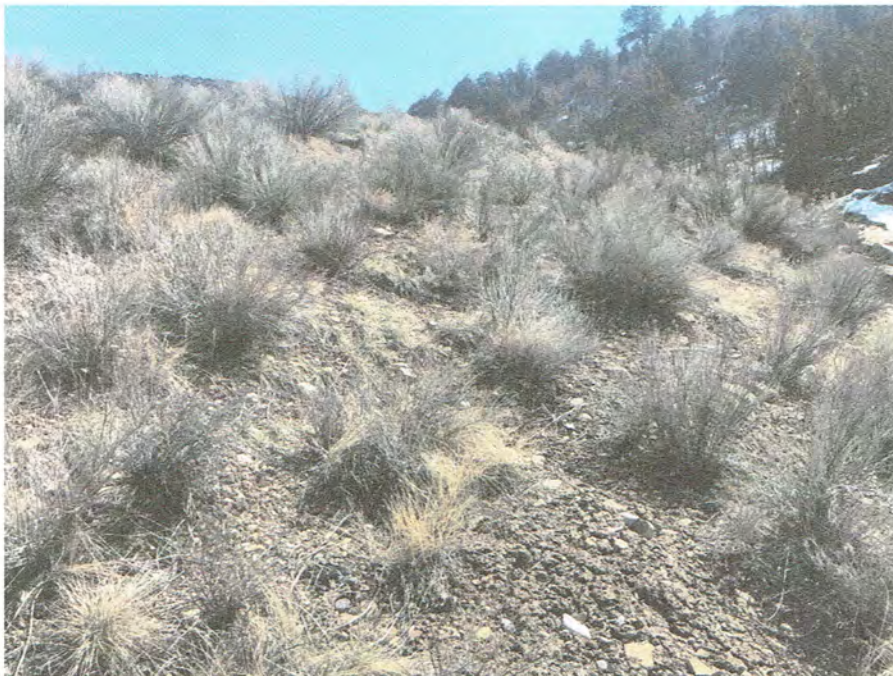
Pic. 2 – Face of waste pile in good condition.

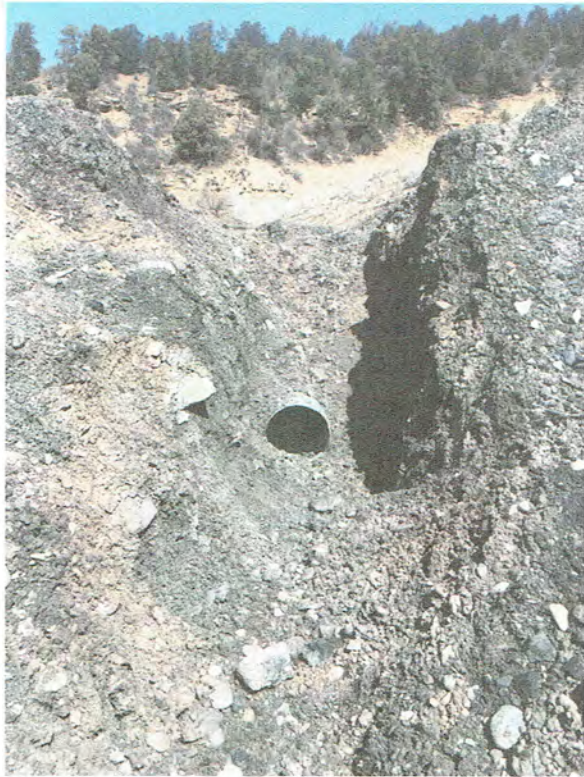
Pic. 3 – Culvert at new switchback with soil sloughing needing repair.

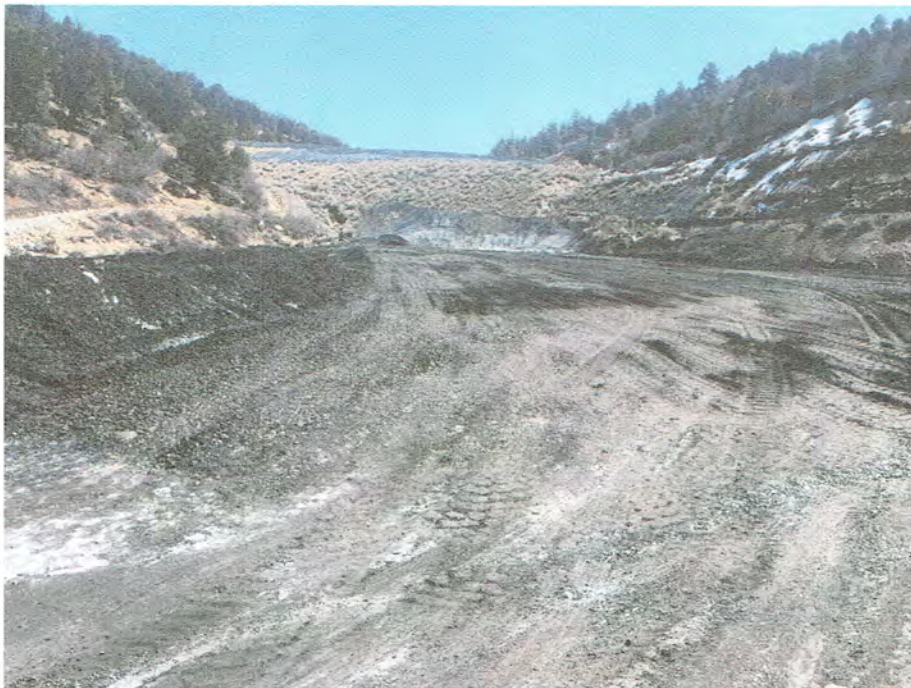
There does not appear to have been any additional waste material placed at the top of the main waste embankment pile since the previous inspection. There has been some additional material installed on the lower pile (see Pic. 4). The slope of the top of the existing pile is now much closer to that defined in the Waste Bank Design produced by Don May, 1997. The construction of the new switchback has allowed the cross slope along the top of the pile, from north to south, to be flattened significantly with the installation of additional waste material from that which was present during the previous inspection.

Pic 4 – Lower waste embankment pile has had some additional waste material installed.
