Keenesburg inspection report

Permit Number: C-1981-028 Mine Name: Keenesburg Strip Mine Operator: Coors Energy Company Operator Address: Mr. Ben Moline PO Box 4030 Golden, CO 80402	County: Weld Operation Type: Surface Permit Status: Permanent Cessation Ownership: Private
	Operator Representative Present: None
Operator Representative Signature: (Field Issuance Only)

Inspection Start Date: May 4, 2021 Inspection Start Time: 12:30 Inspection End Date: May 4, 2021 Inspection End Time: 14:00		Inspection Type: Coal Partial Inspection Inspection Reason: Normal I&E Program Weather: Cloudy	
Joint Inspection Agency: None		Joint Inspection Contacts:	
Post Inspection Agency: None		Post Inspection Contacts:	
Inspector(s): Robert Zuber, P.E.	Inspector's Signature:

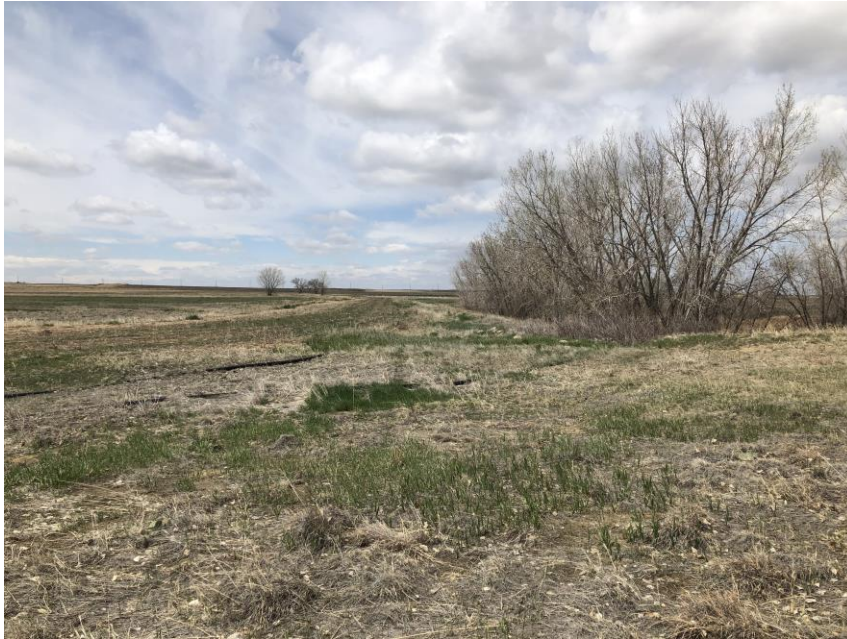
Sediment Pond 2 and the Dugout Pond contained significant amounts of water, but levels were several feet below spillways. Neither pond was discharging during the inspection. There were no signs that they had discharged recently. As usual, they both contained large amounts of riparian vegetation. No problems were observed with the two ponds.

Sediment Pond 2 (on right) and reclaimed road

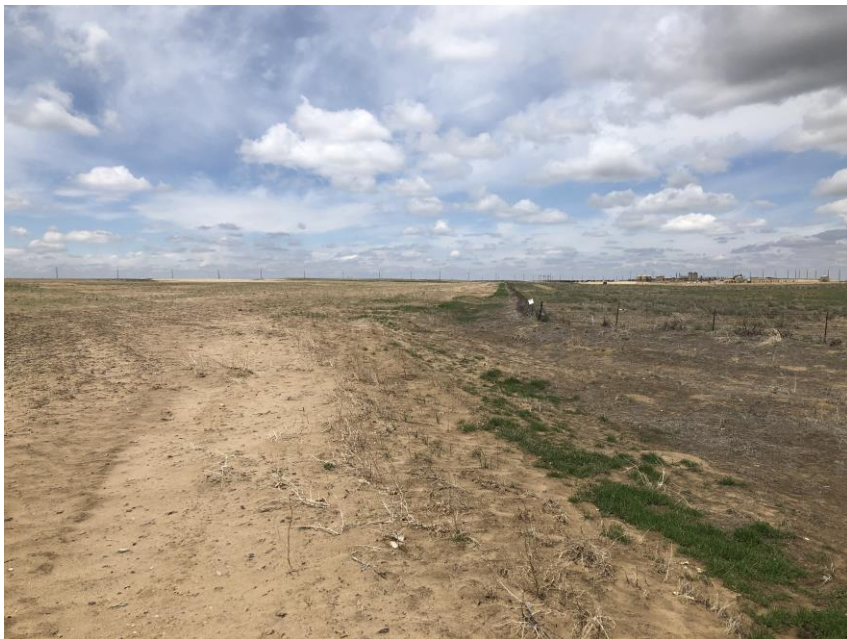
The northern boundary of the site (including the ditch to Sediment Pond 2) was observed, and no signs of pollutant loading from the mine site, or any other problems, were seen.

North side of site, looking northwest

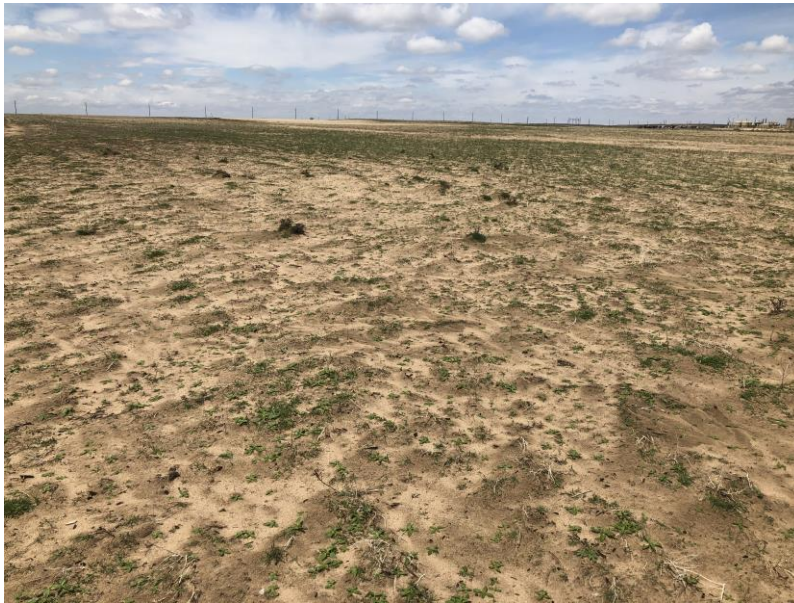
Emerging vegetation on reclaimed topsand pile (north side)

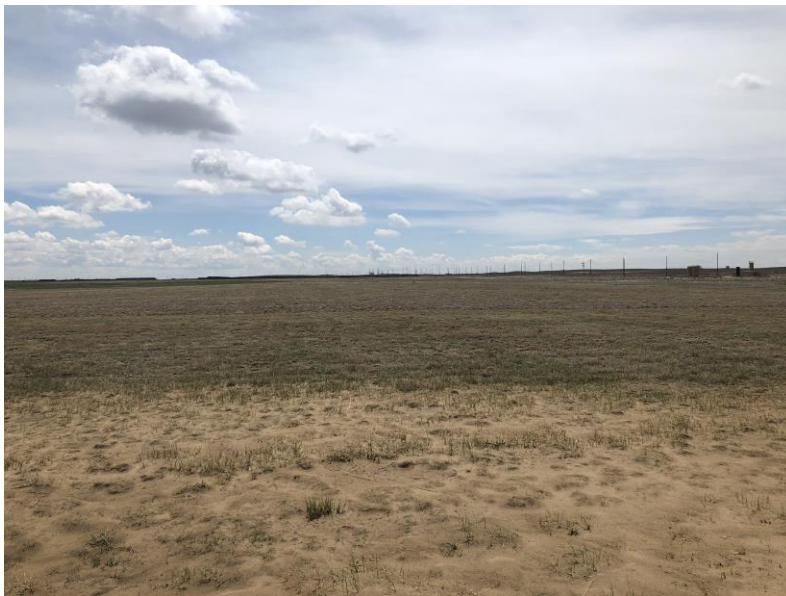
Most of the mature reclamation held up well during recent winds and runoff. This includes the majority of the areas impacted by wind (Area 33 and Area 25 mentioned above), Area 34 (southeast corner), and the parcels south of the B Pit area.

Mature reclamation south of the B Pit area

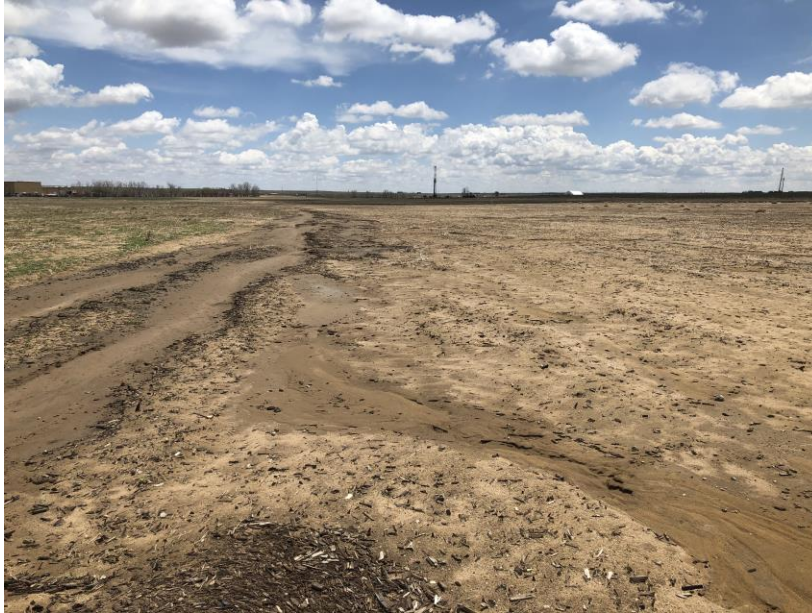
Shallow erosion was seen on large areas of the recently reclaimed B Pit area and the Long Term Spoil Area. This movement of soil may well have washed seeds and seedlings of grass and other desired species off of significant areas of the reclamation. These areas could also become problematic if rills develop after future storms. The area may need to be re-seeded, and it may be beneficial to employ erosion prevention practices in these areas.

Erosion on Long Term Spoil Area

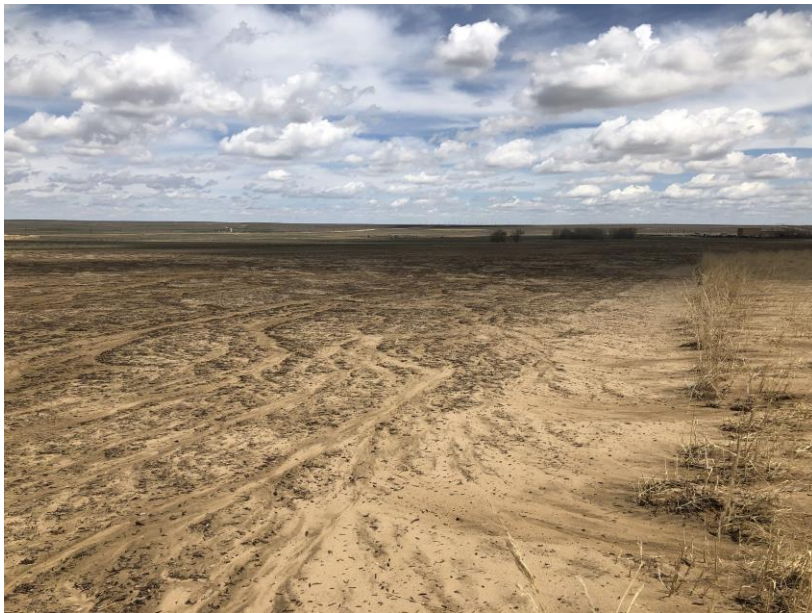
Erosion on south end of the B Pit area

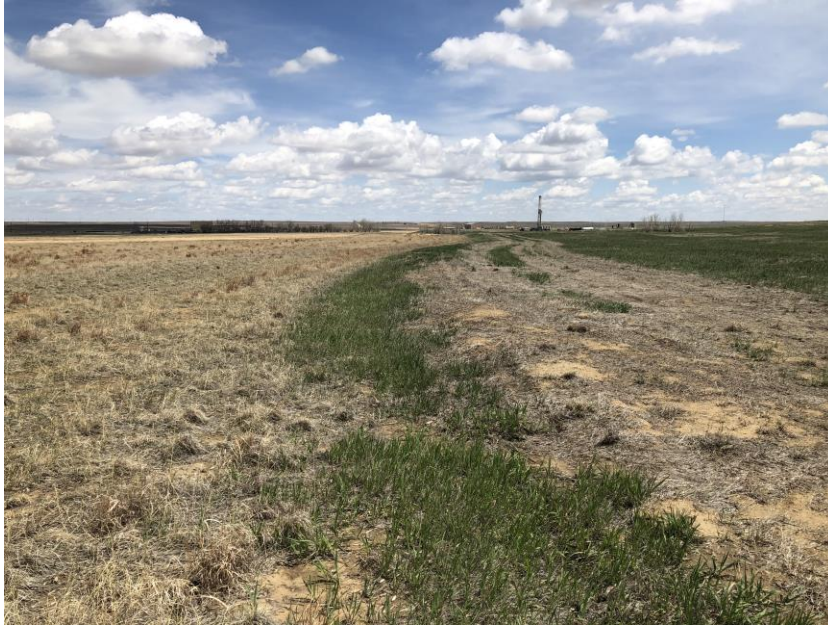
Area 33 on left (area on right is outside current permit)

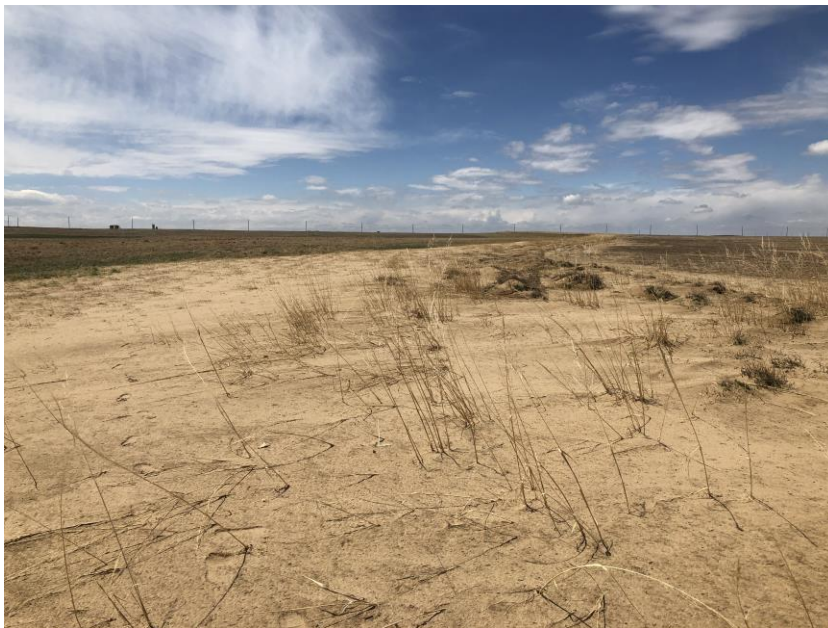
Another issue appears to be the movement of sand by wind. Portions of Area 33 (south central part of site) and Area 25 (west of the Dugout Pond) have been covered with sand. These areas should be monitored to see if the vegetation emerges from below the sand.

Sand blown onto east side of Area 33

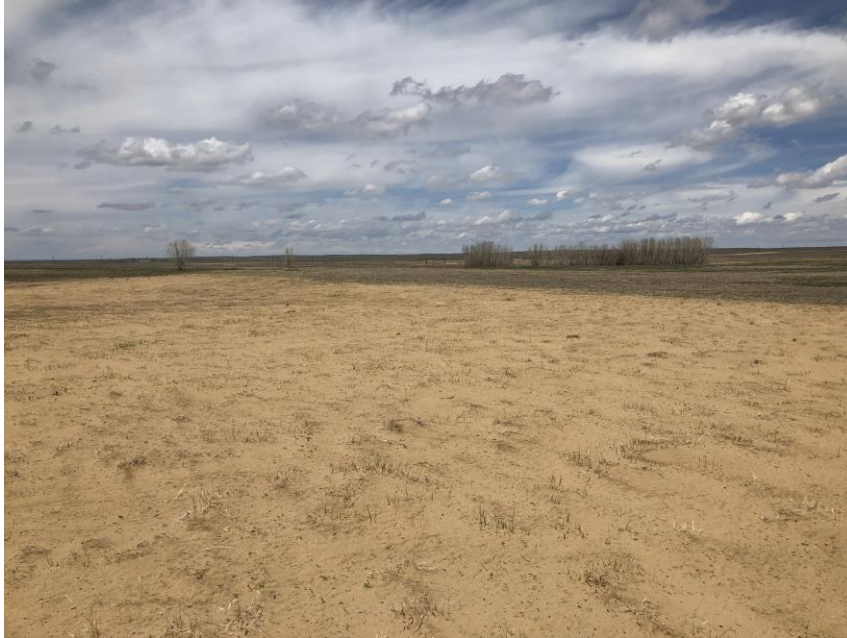
Sand blown onto west side of Area 25

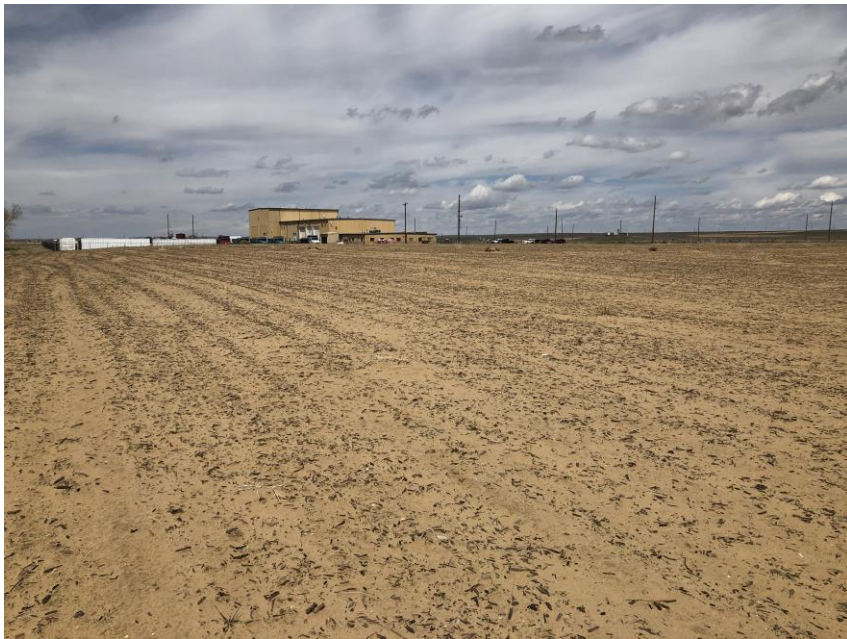
Reclaimed topsoil south of facilities area
