To: Jerald Schnabel From: Paul Kos  
Continental Materials Corp. Denver, CO 80222  
File: March 31, 2021 Monitoring Summary Date: April 30, 2021

**Reference: March 2021 Geotechnical Monitoring Summary Pikeview Quarry**

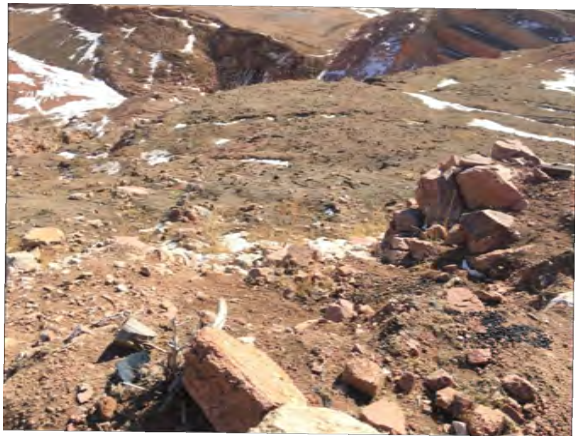
- Crack Free: No cracking was observed on the native granite slopes above the extents of the disturbed area. The hummocky field in the area immediately above the southern extent of the slide shows evidence of cracking but they are not fresh or active. No new or open cracks were found immediately inside or next to the slide area.

6. AREA ABOVE THE SLIDE

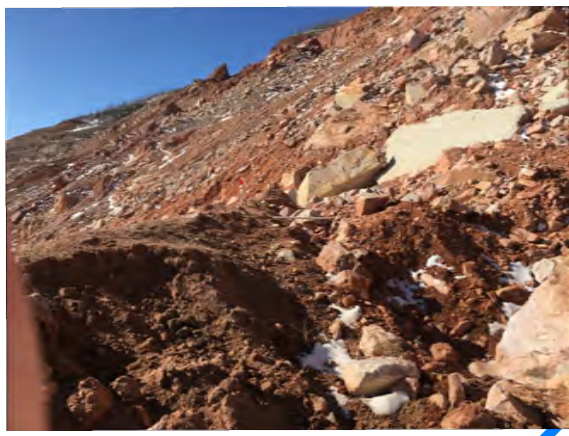
5. A NEW PRISM AT THE TOE

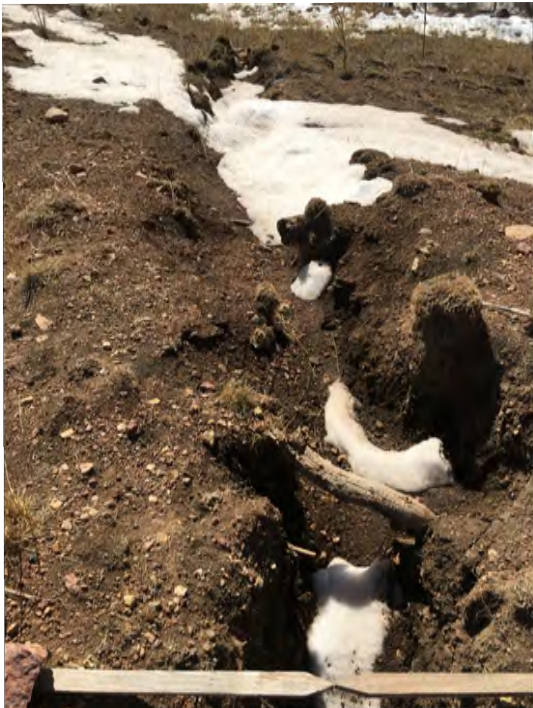
- Healed Cracks: A crack was observed on the slope adjacent to the slide where cracking had previously been observed. This crack runs parallel to the slide and appears to be “healed” and did not indicate any recent movement. (Note 7)

7. HISTORIC CRACK PARALLEL TO SLIDE

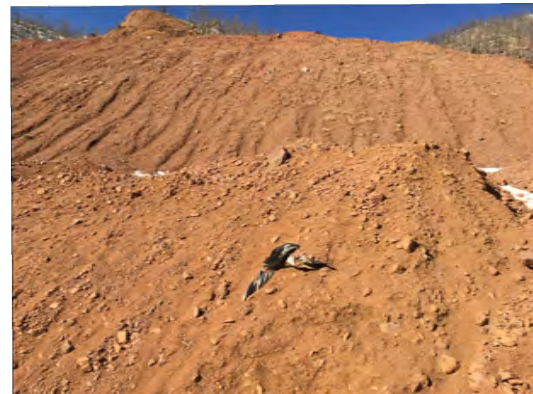
- Gullies and Rills: Gullies and rills have formed on the slopes above the slide area as well as in the burn areas above the quarry. (Note 8)
- Open Cracks: An open crack was observed during this visit. This feature is in an area where cracking is expected to occur as a result of ongoing slope settlement and relaxation. The edges of the crack have eroded suggesting it is not a new feature. (Note 7)

8. RILLS ON SLOPE UNDER PEAK

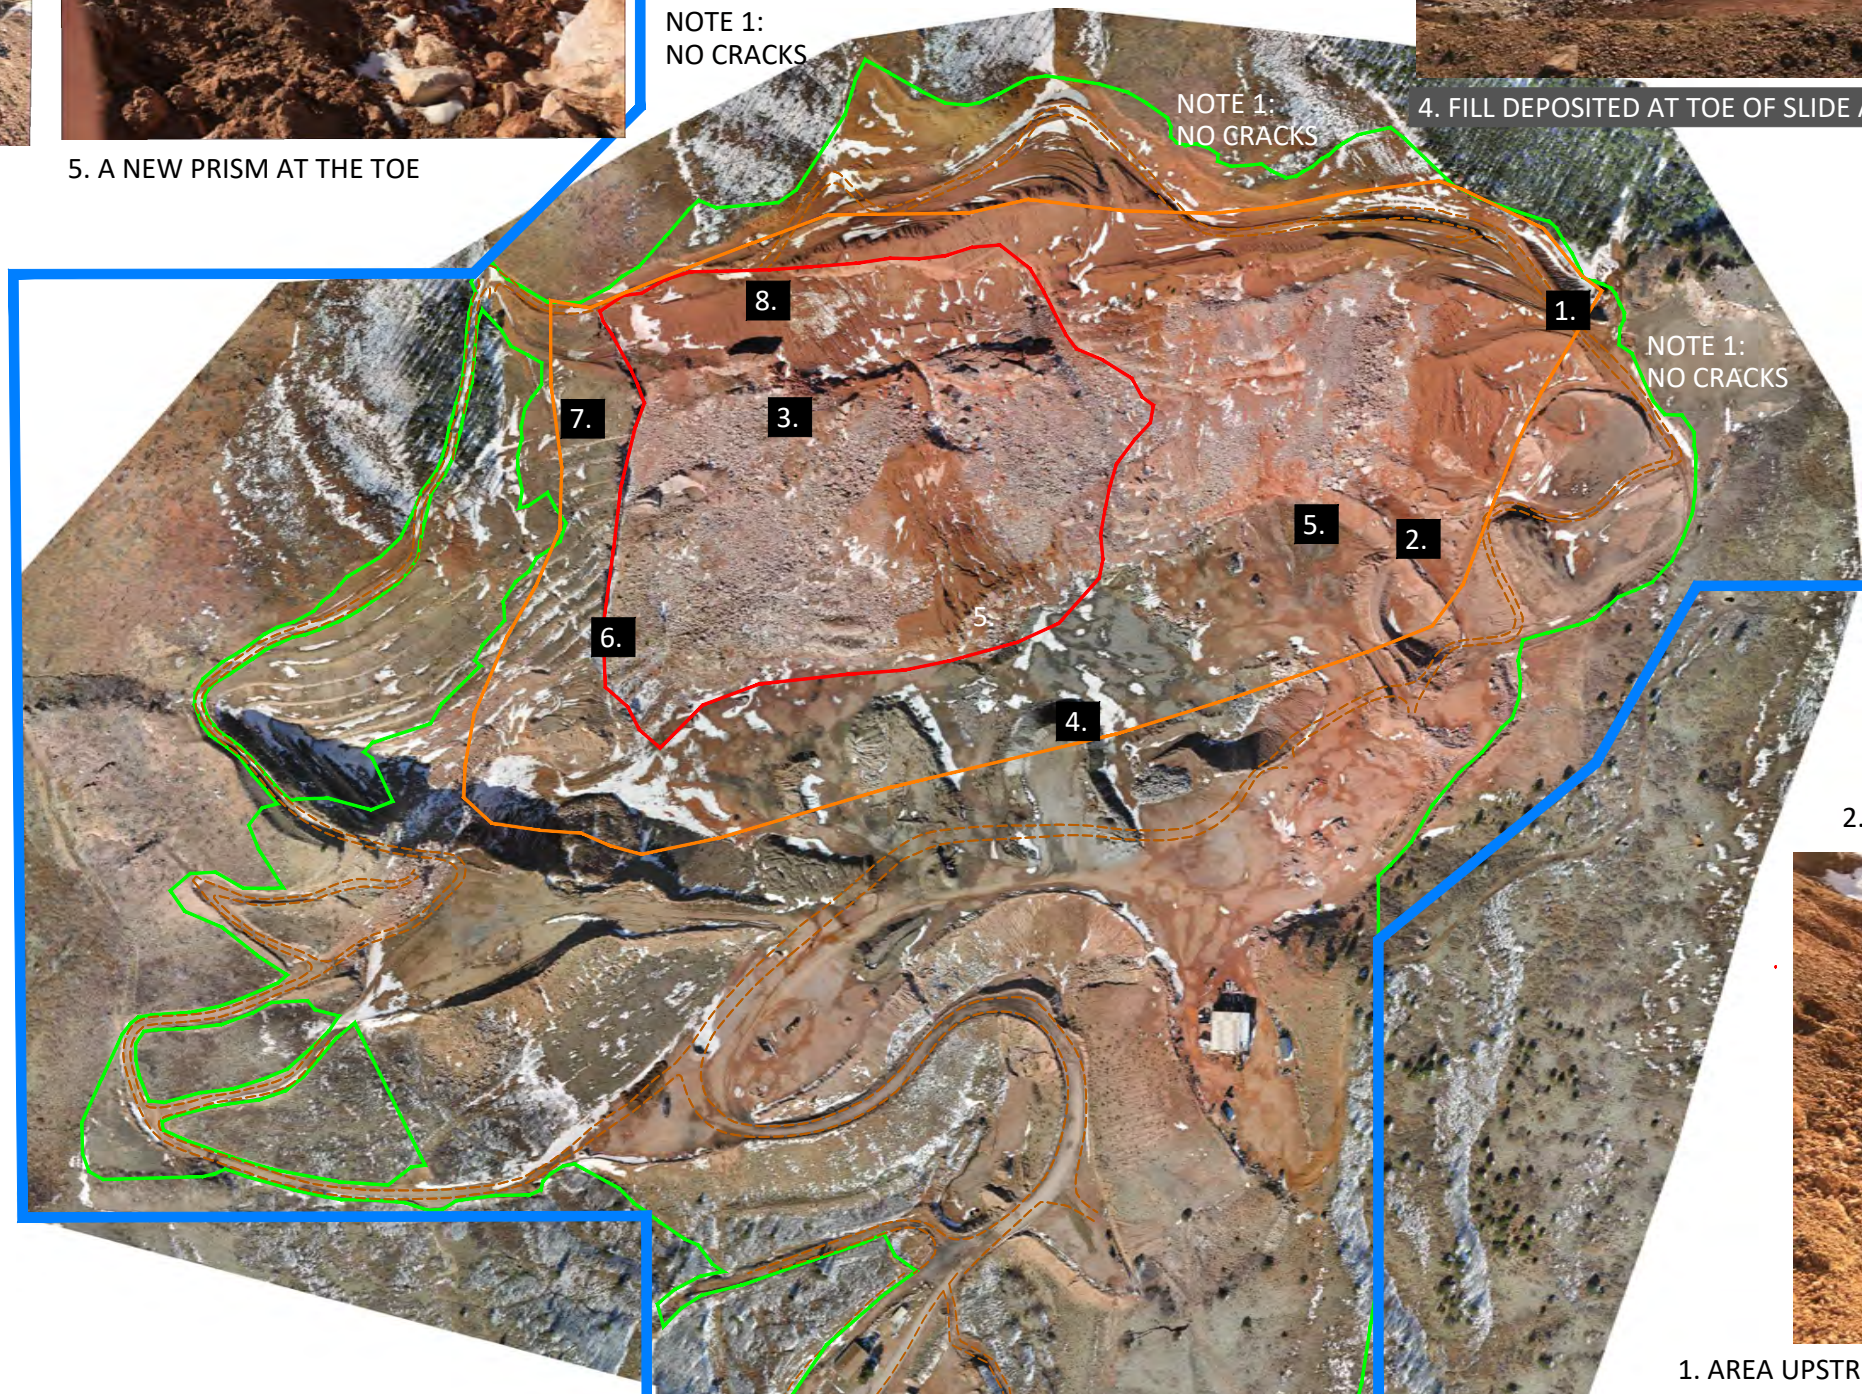
OBSERVATIONS FROM  
MARCH INSPECTION

- The previously observed crack on the road on the north side of the quarry remains with no visible change. The crack runs parallel to a fill slope and is likely the result of loose fill settling. The crack is not in the vicinity of the landslide and runs perpendicular to the landslide; therefore, it is not related to the landslide. (Note 2)

- The area upstream of the culvert has been excavated to clear the pipe for storm water. (Note 1)
- Survey Station: Based on the survey data, the total station is in operating condition.

4. FILL DEPOSITED AT TOE OF SLIDE AREA

3. LARGE PIECES OF THE SLIDE BREAKING UP

2. RECENT CRACKING LIKELY FROM SETTLEMENT

1. AREA UPSTREAM OF CULVERT GETTING CLEARED OF DEBRIS

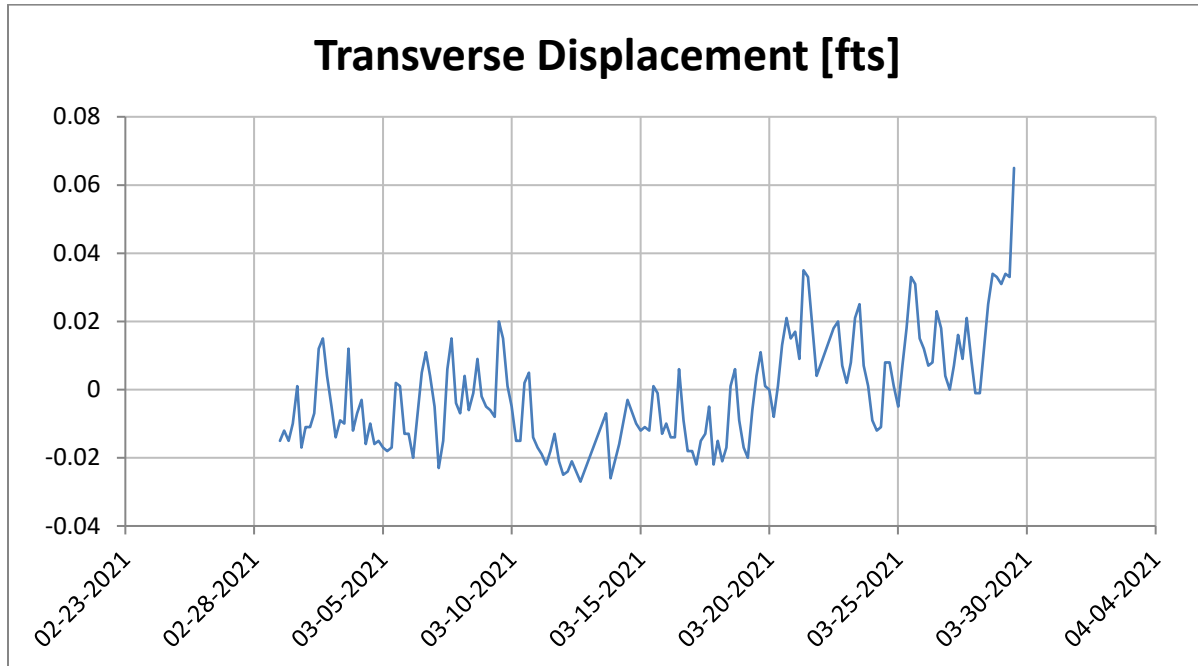
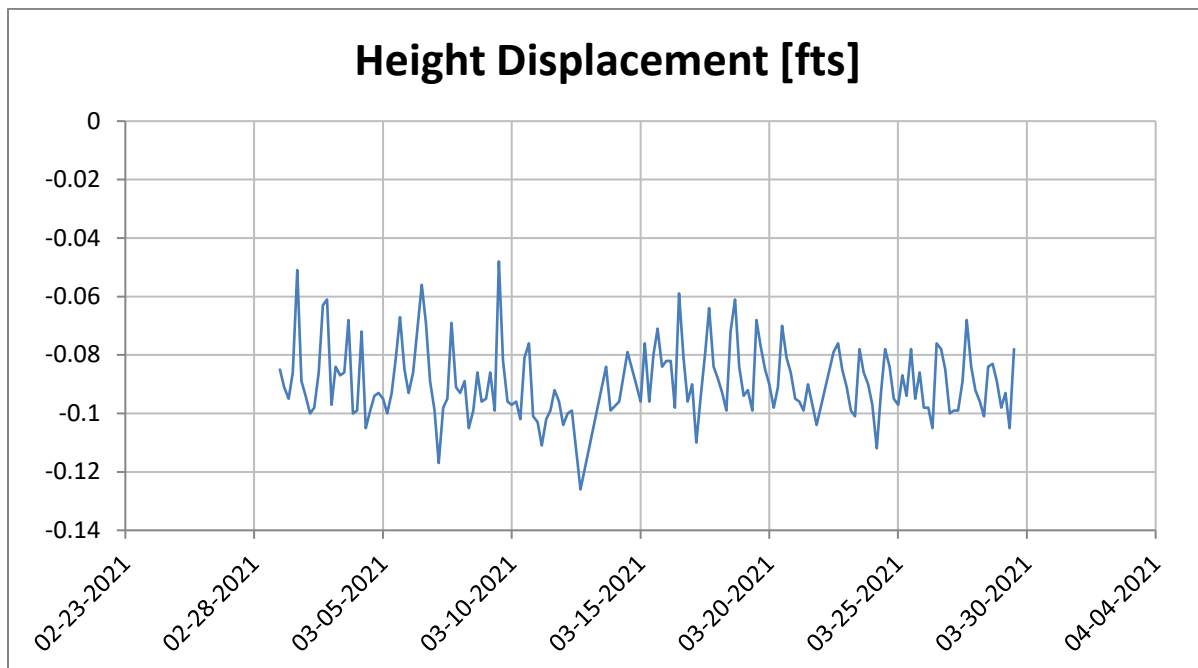
## Prism NP2

| 03/29/2021 | Prism NP2 missing after scan | Prism NP2 Back in Position and Glass Replaced | 04/03/2021 |

| <b>Prism ID</b> | <b>Cumulative Transverse Displacement (ft)</b> | <b>Cumulative Height Displacement (ft)</b> | <b>Monthly Delta (ft)</b> | <b>Cumulative Delta (ft)</b> | <b>Needs / Recommendations</b> |
|---|---|---|---|---|---|
| NP2 | 0.042 | -0.196 | 0.0050 | 0.4296 | Prism was moved to replace damaged glass |

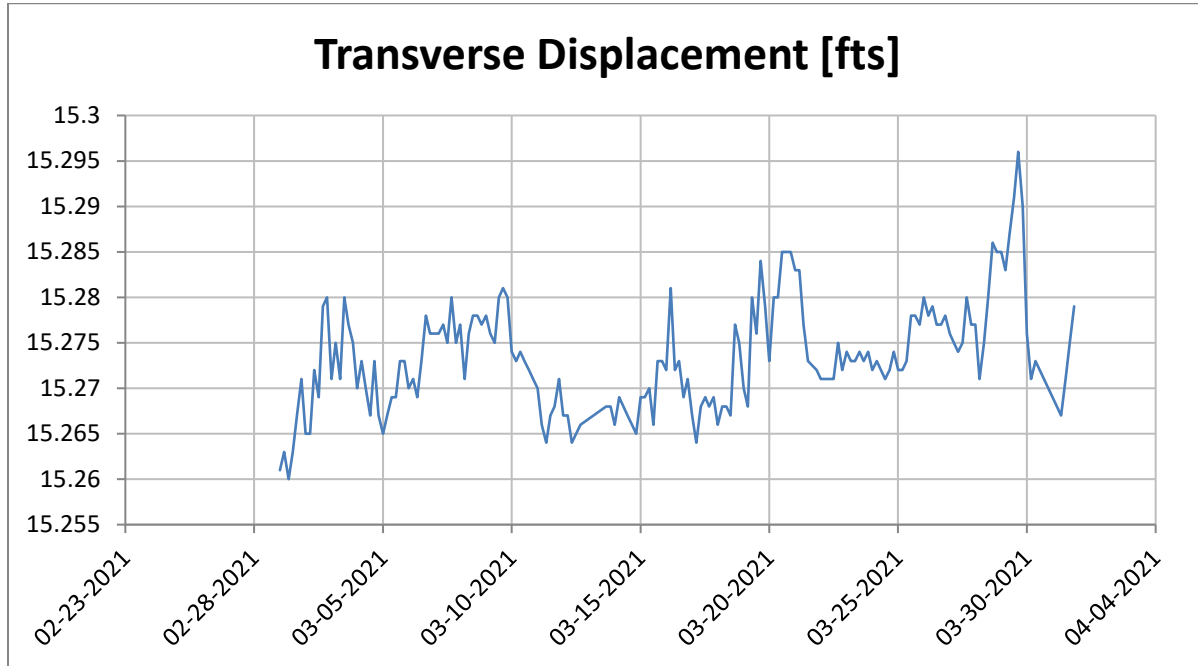
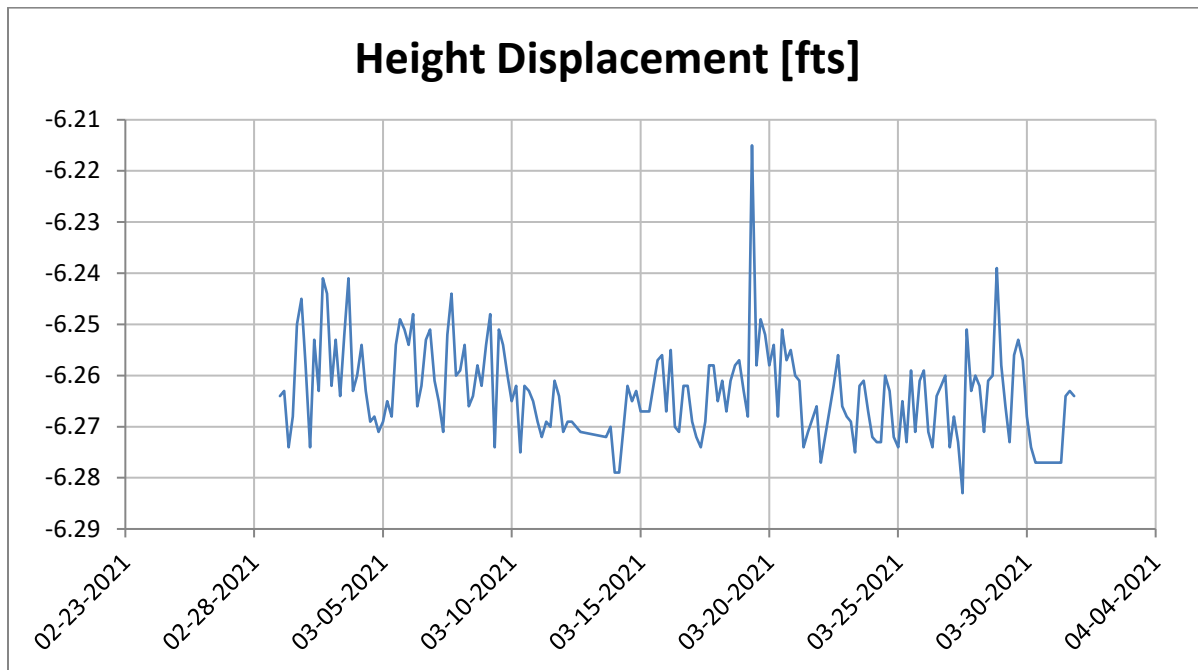
## Prism P63

| <b>Prism ID</b> | <b>Cumulative Transverse Displacement (ft)</b> | <b>Cumulative Height Displacement (ft)</b> | <b>Monthly Delta (ft)</b> | <b>Cumulative Delta (ft)</b> | <b>Needs / Recommendations</b> |
|---|---|---|---|---|---|
| P63 | 0.065 | -0.078 | 0.0267 | 0.1195 | Prism at toe of slide. Movements are within expected range. |

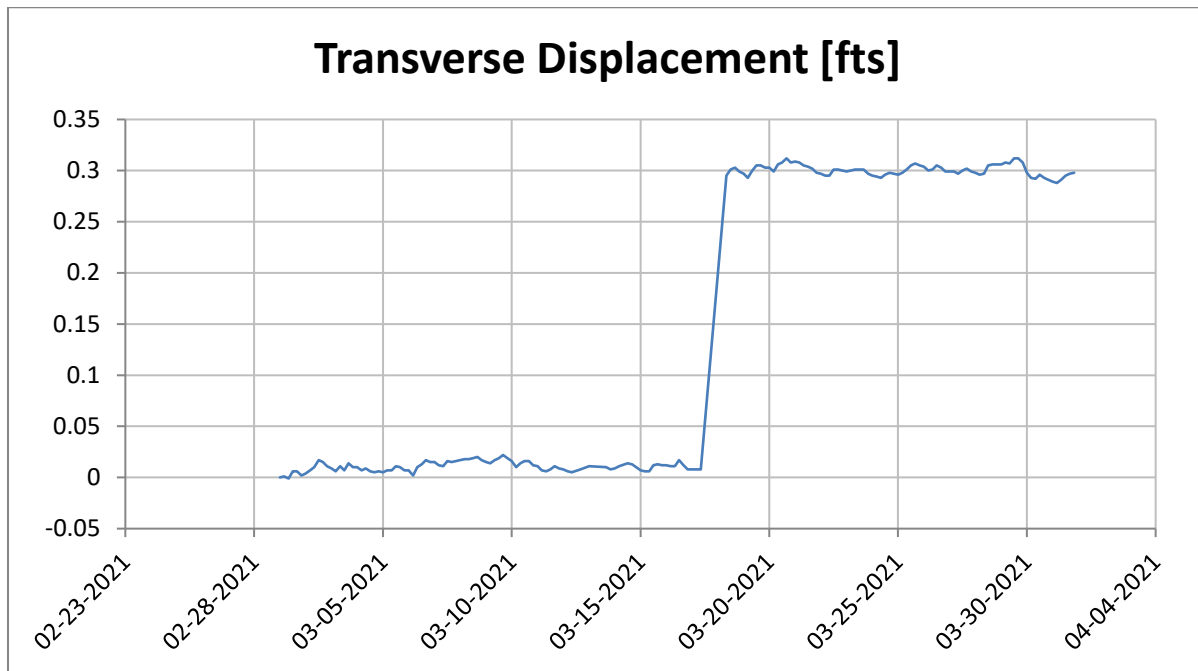
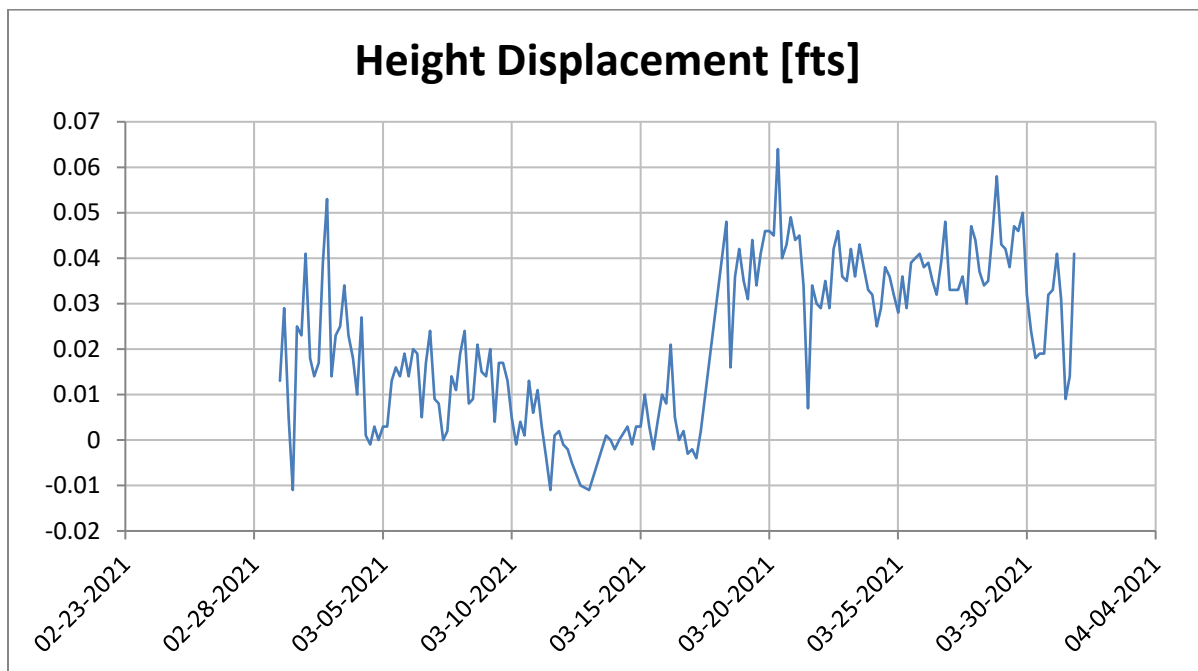
## Prism TOE1

| 03/17/2021 | Prism TOE1 missing after multiple scans | Sheep Moved Prism | 03/18/2021 |

| <b>Prism ID</b> | <b>Cumulative Transverse Displacement (ft)</b> | <b>Cumulative Height Displacement (ft)</b> | <b>Monthly Delta (ft)</b> | <b>Cumulative Delta (ft)</b> | <b>Needs / Recommendations</b> |
|---|---|---|---|---|---|
| TOE1 | 0.298 | 0.041 | 0.4559 | 0.4707 | Movements due to wildlife moving prism. |

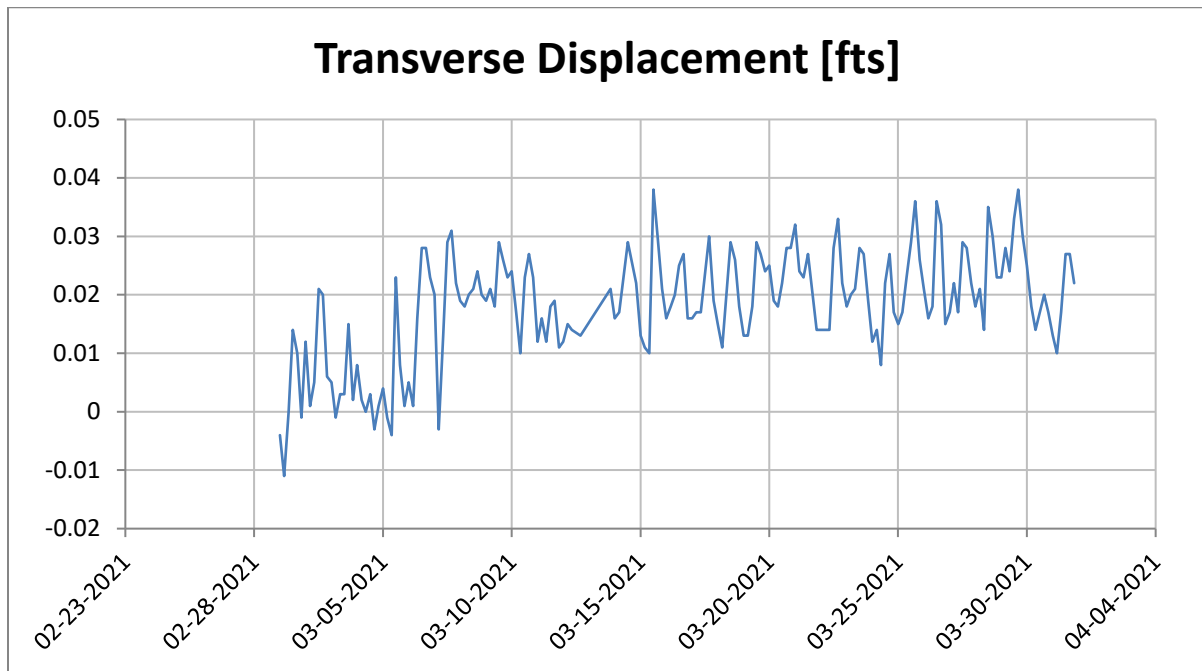
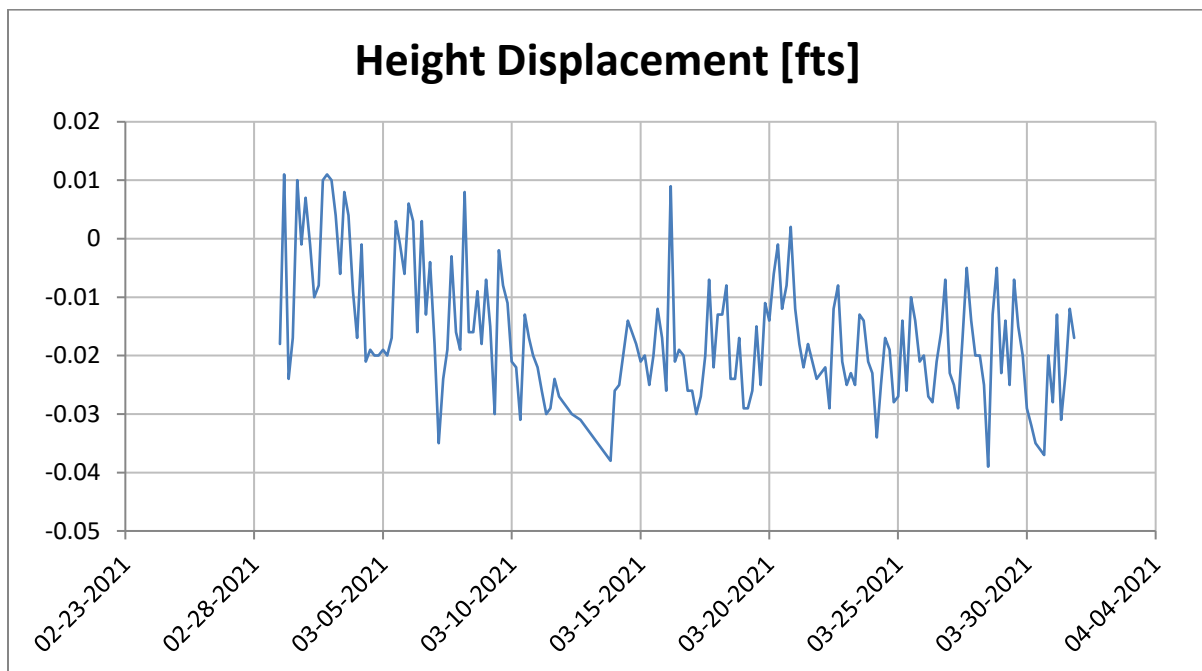
## Prism TOE2

| <b>Prism ID</b> | <b>Cumulative Transverse Displacement (ft)</b> | <b>Cumulative Height Displacement (ft)</b> | <b>Monthly Delta (ft)</b> | <b>Cumulative Delta (ft)</b> | <b>Needs / Recommendations</b> |
|---|---|---|---|---|---|
| TOE2 | 0.022 | -0.017 | 0.0262 | 0.0447 | Prism at toe of slide. Movements are within expected range. |

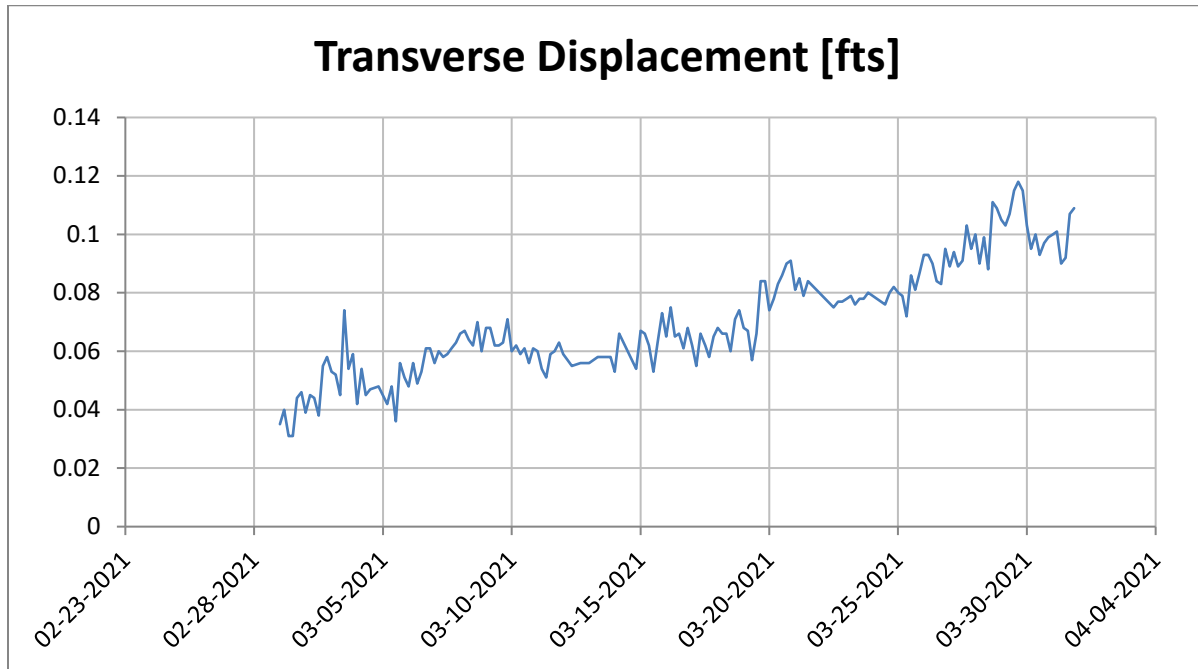
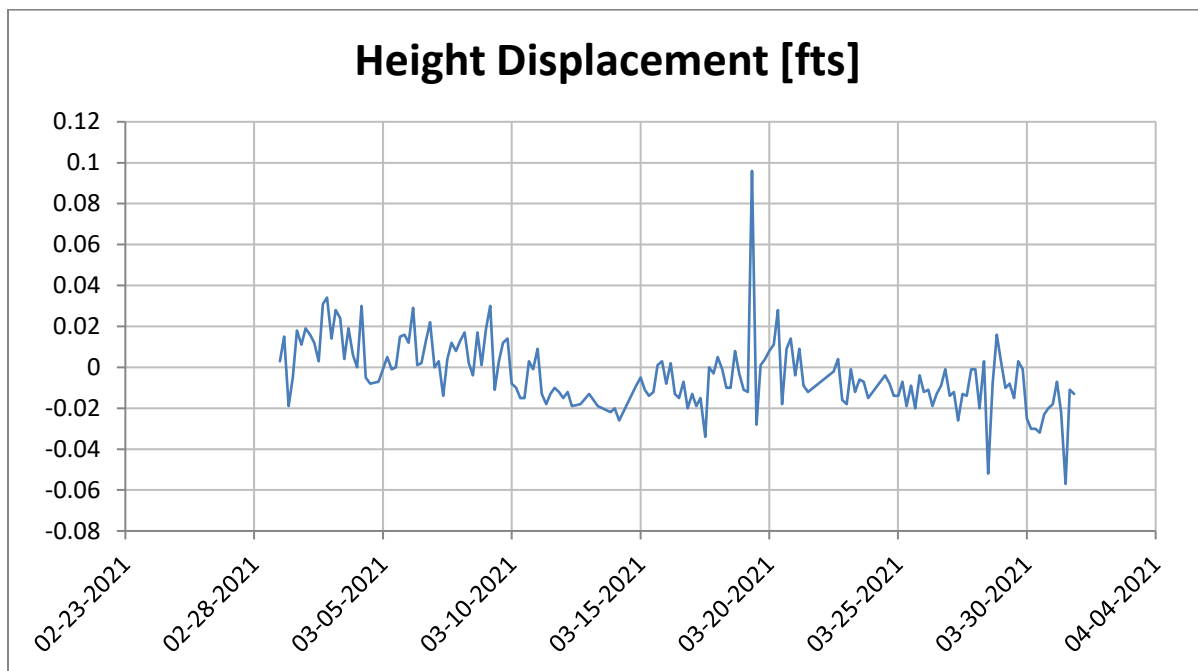
## Prism TOE3

| <b>Prism ID</b> | <b>Cumulative Transverse Displacement (ft)</b> | <b>Cumulative Height Displacement (ft)</b> | <b>Monthly Delta (ft)</b> | <b>Cumulative Delta (ft)</b> | <b>Needs / Recommendations</b> |
|---|---|---|---|---|---|
| TOE3 | 0.109 | -0.013 | 0.0716 | 0.1107 | Prism at toe of slide. Movements are within expected range. |

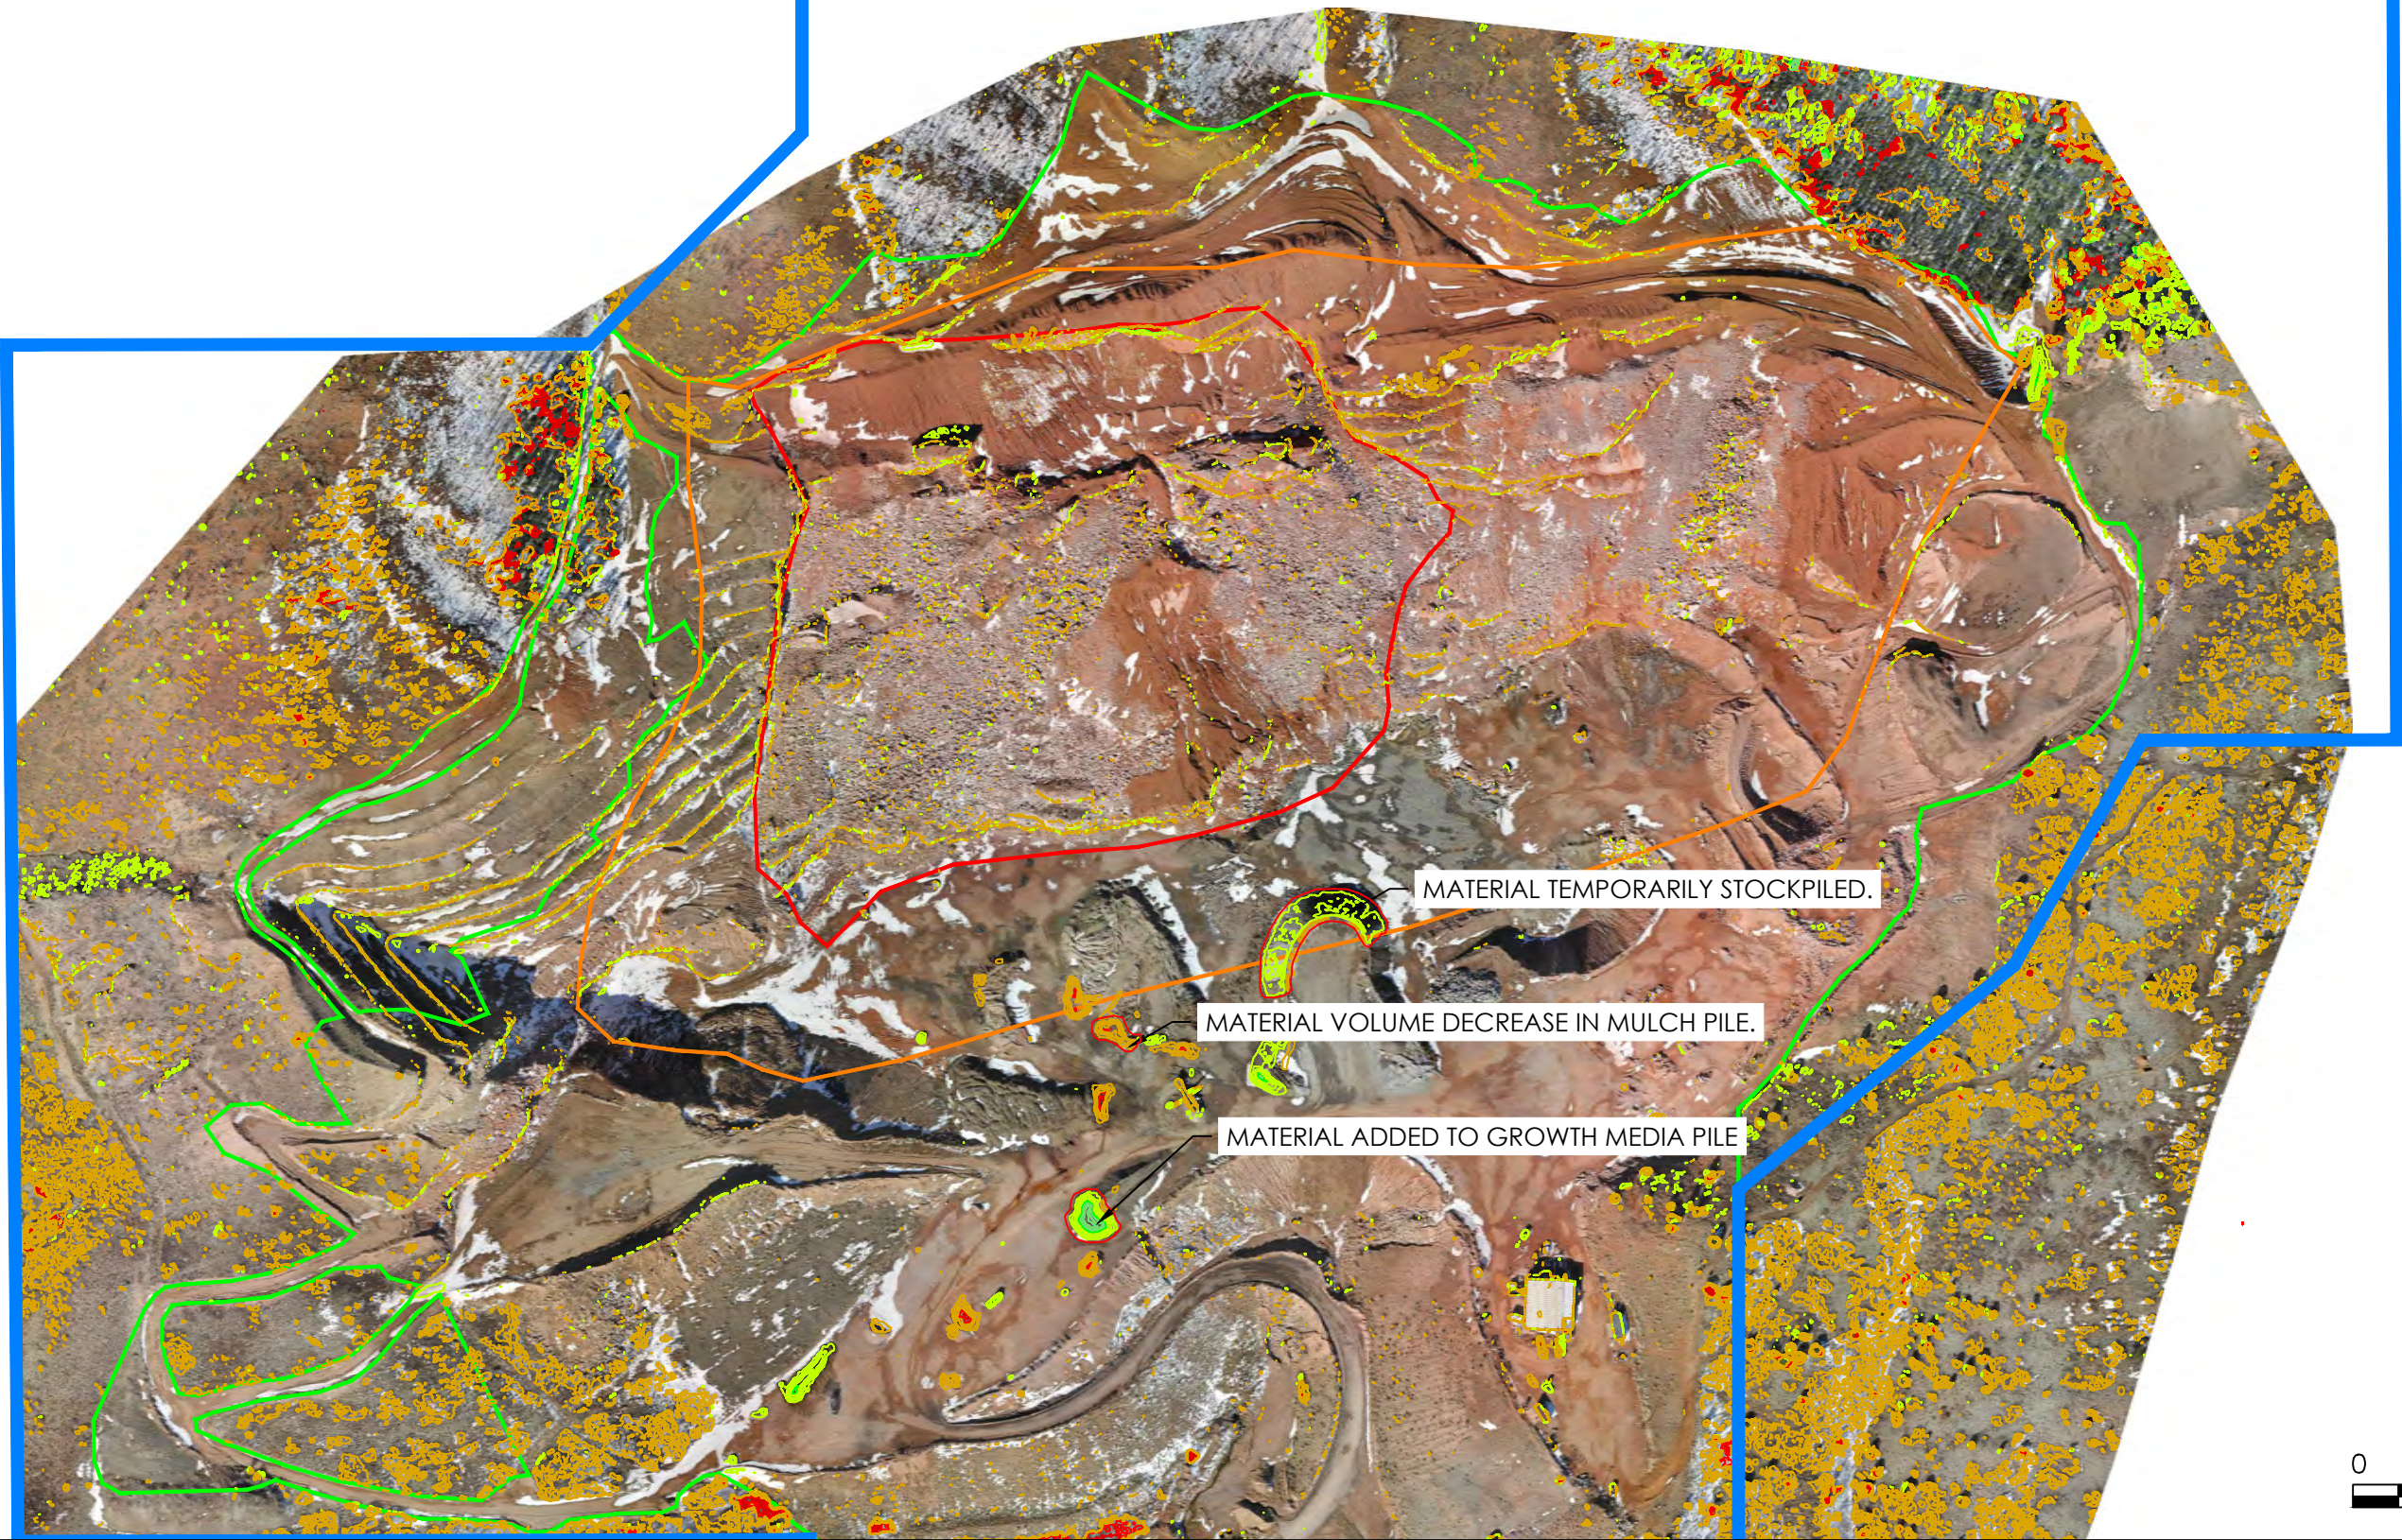
The February topography was also compared to the March topography to identify changes in the site topography. Comparison of the two surveys showed that approximately 2,255 yd<sup>3</sup> of fill had been imported and temporarily placed. No slope movements or other changes in topography were identified. The current imagery and topography are included in Figures 1 and 3, and the comparison surface is included as Figure 5 in Appendix C.

As previously reported in the September 2020 monitoring report, there are limitations with the method of comparing drone surveys from different months. The drone data indicate changes in the slopes along each of the reclamation benches, buildings, and areas with trees or shrubs. These areas are stable, and the changes are the result of survey limitations on or near vertical slopes.
