Bowie #2 inspection report

PERMIT INFORMATION

Permit Number: C-1996-083 Mine Name: Bowie No. 2 Mine Operator: Bowie Resources, LLC Operator Address: Mr. Basil Bear P.O. Box 1488 Paonia, CO 81428	County: Delta Operation Type: Underground Permit Status: Active Ownership: Private
	Operator Representative Present: Basil Bear
Operator Representative Signature: (Field Issuance Only)

Inspection Start Date: May 6, 2021 Inspection Start Time: 09:30 Inspection End Date: May 6, 2021 Inspection End Time: 14:00		Inspection Type: Coal Partial Inspection Inspection Reason: Normal I&E Program Weather: Clear	
Joint Inspection Agency: None		Joint Inspection Contacts:	
Post Inspection Agency: None		Post Inspection Contacts:	
Inspector(s): Robert Zuber, P.E. Michael Cunningham	Inspector's Signature:

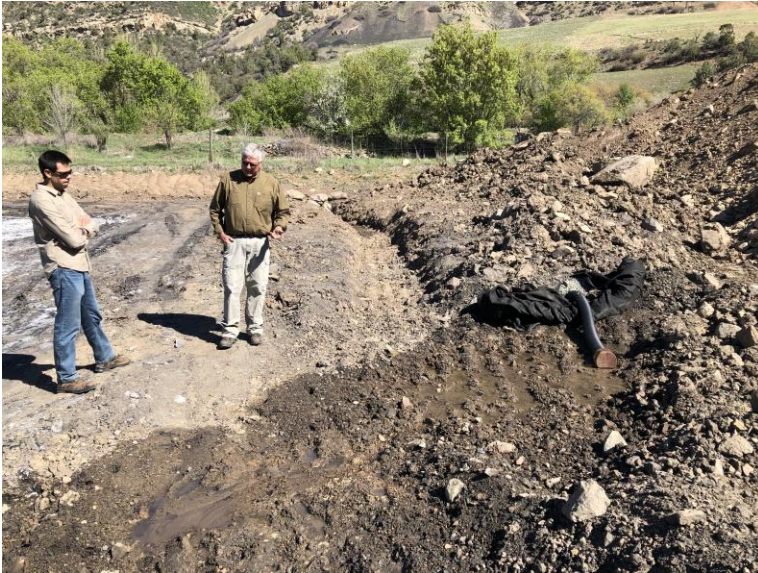
BRL continues to focus their efforts on Gob Pile #3. Construction of the new underdrain has been completed, as well as a temporary diversion channel next to the underdrain. During the inspection, a sheepsfoot roller compactor was being used on the west side of the pile.

Basil Bear (on right) and Michael Cunningham discuss the newly constructed underdrain at Gob Pile #3

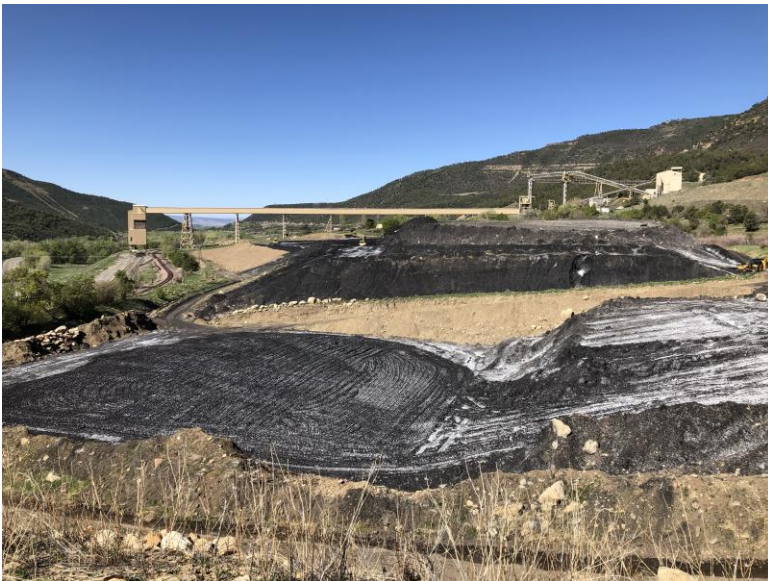
Gob Pile #3

No issues were identified with Gob Pile #3.

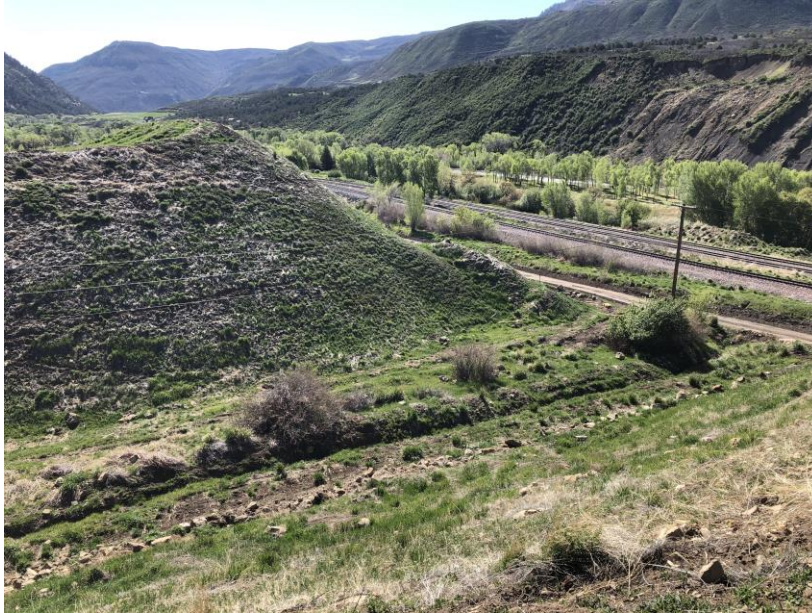
Topsoil pile east of Gob Pile #3

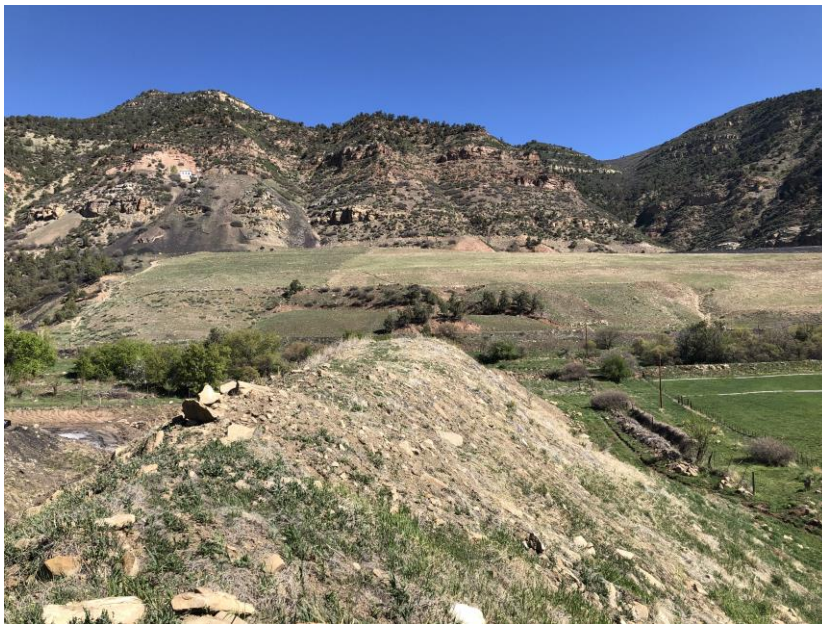
Gob Piles #1 and #4 were viewed from below and from the road to the portals. Gob Pile #4 was also viewed from Gob Pile #2. They both looked stable and well vegetated.

Gob Piles 1, 2, and 4 (from coverfill pile beside Gob Pile #3)

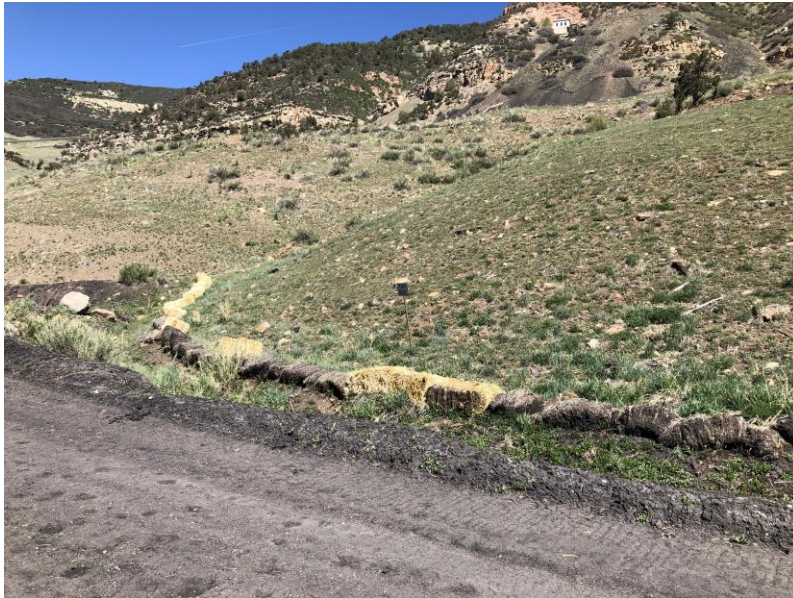
- Berms, vegetation, and silt fence are keeping these resources in place.
- New erosion bales have been installed near the topsoil stockpiles by Gob Piles #1 and #4 (Topsoil Stockpiles D and E on Map 15-3 of the PAP).

New and improved BMPs at Topsoil Stockpile D (near Gob Pile #1)

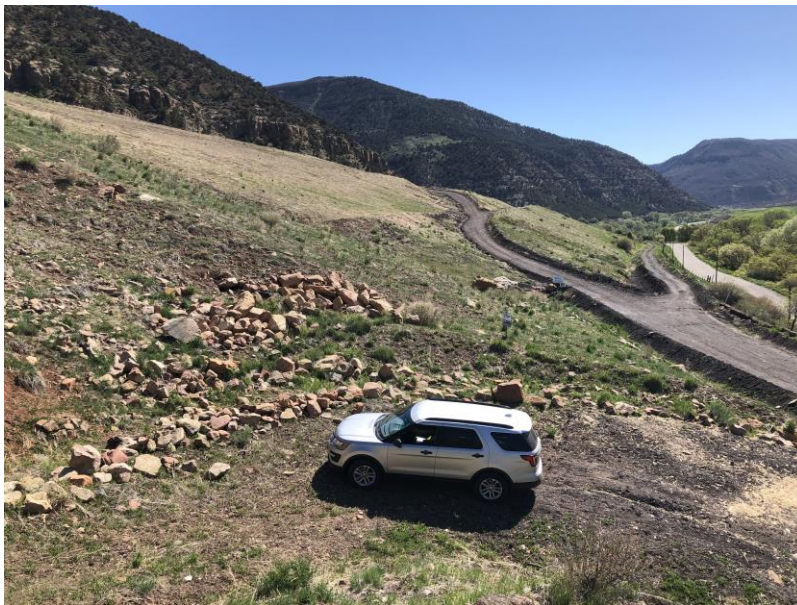
No problems were seen with the road to the portals or the hillsides above and below this road. The ditches beside this road appeared to be in good condition. The roads to Gob Pile #2 and Pond F were in good condition.

Roads to Gob Pile #2 and to Pond F

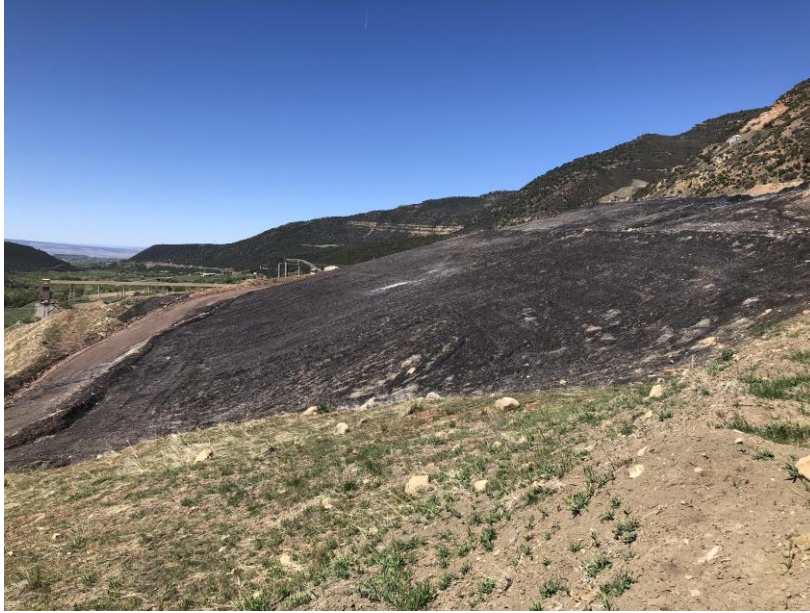
All lifts of Gob Pile #2 appeared stable. Only small rills were observed. The drainage control practices on the upper (un-reclaimed) portion of this pile appear to be functioning well, and no puddles or other problems were observed.

Gob Pile #2 – partially reclaimed lift

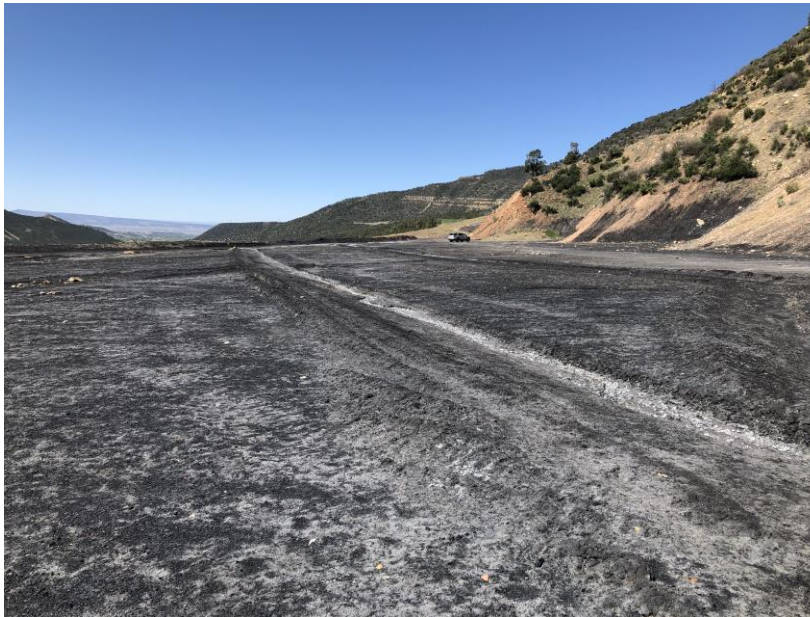
Gob Pile #2 – upper (un-reclaimed) portion

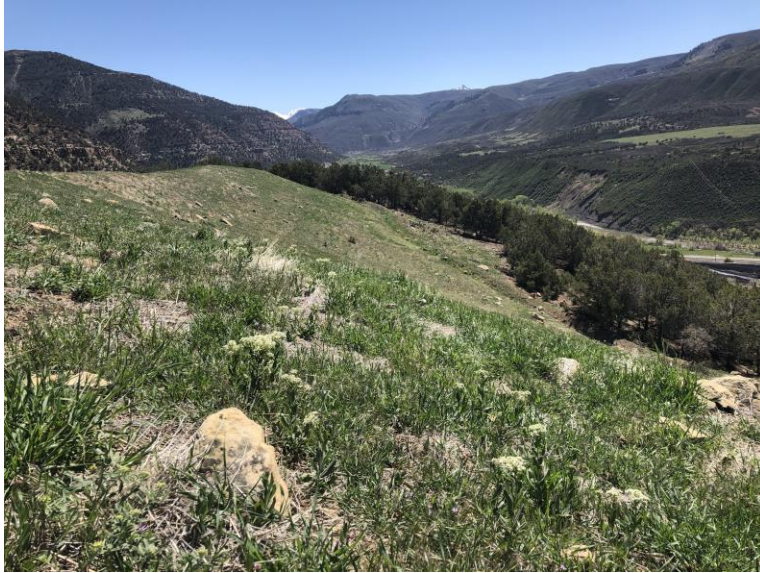
- The coverfill pile east of Gob Pile #3 (white top and others)
- Topsoil Stockpile D near Gob Pile #1 (cheat grass and bindweed)
- Along Ditch D-F4, east of Gob Pile #2 (thistle, cheat grass, and bindweed)
- West side of Gob Pile #2 (thistle)
- Area behind the Preparation Plant (thistle)
- The south side of Topsoil Stockpile A (great deal of white top) and rest of pile (thistle, mullein, cheat grass).

White top on Topsoil Stockpile A

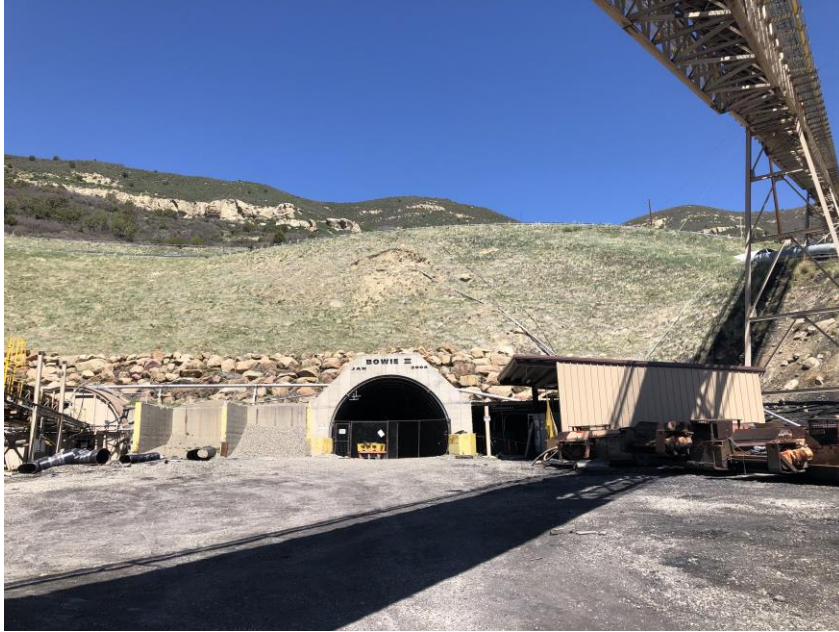
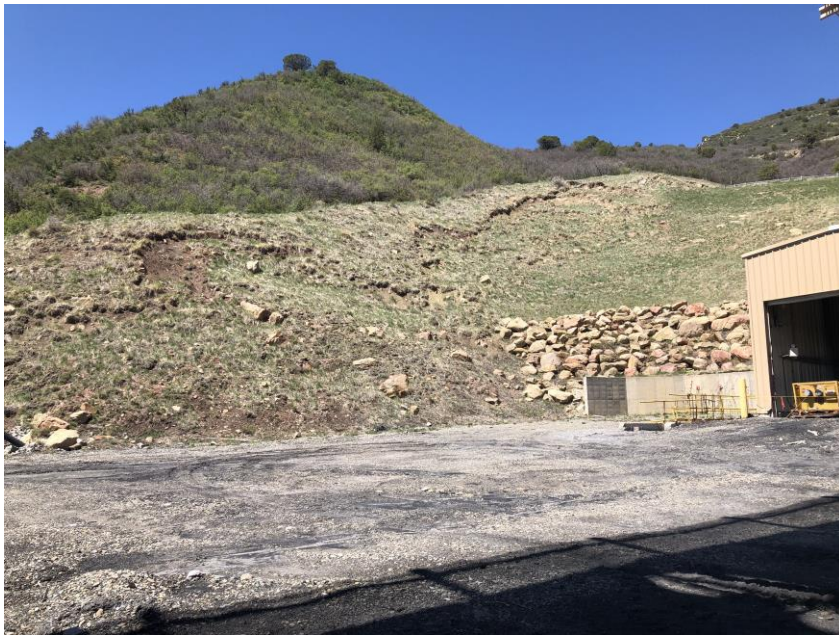
Slumps have not moved significantly in the recent past. These include slumps by the B Portal and by Curve Number 11 along the road to the portals. (This was confirmed by looking at photographs from 2019.)

Slump above B Portal bench

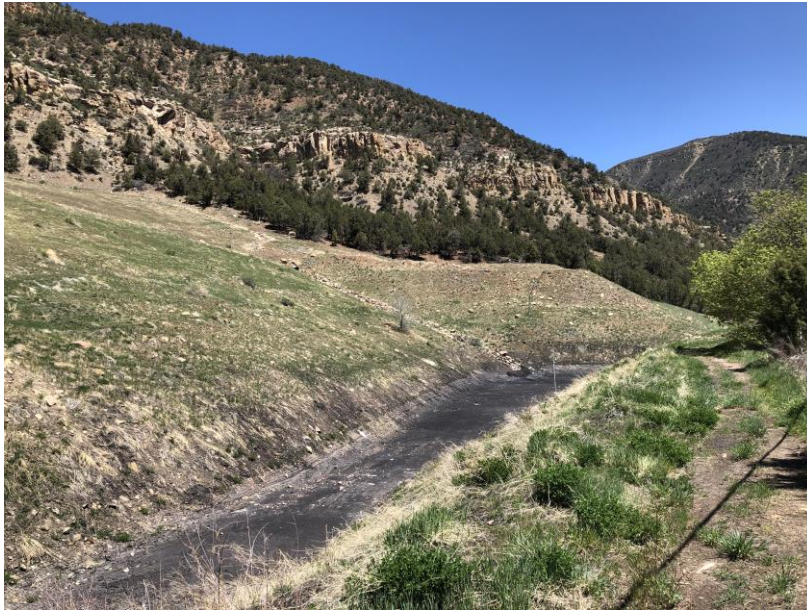
Pond F

Six sediment ponds were inspected: B, C, D, F, J, and K. None of the ponds were discharging, and all but Pond J were dry. Pond J held water, but it was well below the spillways. No significant problems were identified with embankments, spillways, inlet channels, or other features of the ponds.

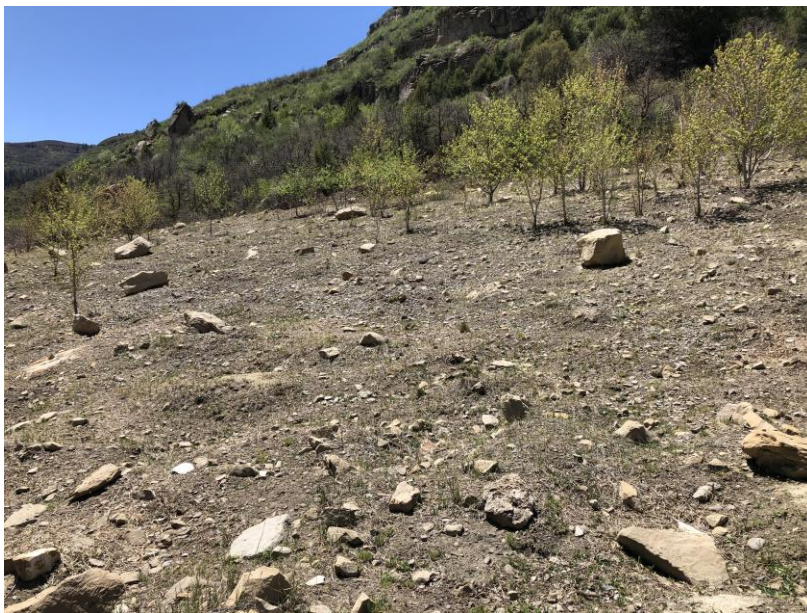
The grass and other ground vegetation is sparse at the reclaimed pad for the former Hubbard Creek Vent Shaft. Feces in this area suggest that the area has been grazed by sheep.

Sparse vegetation at reclaimed vent shaft area (Hubbard Creek)
