MINERALS PROGRAM INSPECTION REPORT

MINE NAME: Lyons Quarry	MINE/PROSPECTING ID#: M-1977-141	MINERAL: Quartz (quartzite/quartzose sandstone)	COUNTY: Boulder
INSPECTION TYPE: Monitoring	INSPECTOR(S): Amy Eschberger, Tim Cazier	INSP. DATE: April 28, 2021	INSP. TIME: 09:30
OPERATOR: Aggregate Industries - WCR, Inc.	OPERATOR REPRESENTATIVE: Jeremy Deuto, Joel Krech	TYPE OF OPERATION: 112c - Construction Regular Operation

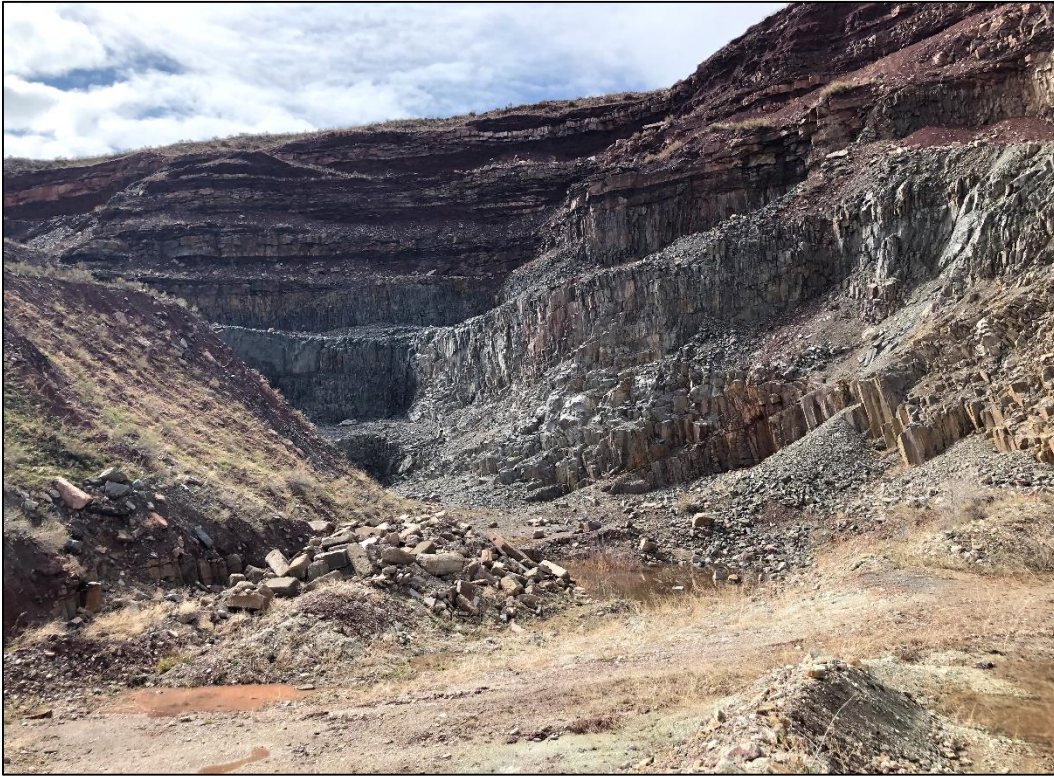
Photo 1. View looking southeast at Quarry 1, with approximately 300 foot tall highwalls and slope gradients ranging from near vertical (dacite) to 1.5H:1V (sedimentary overburden). Note western edge of Quarry 1 backfill visible at left edge of photo. Ponding shown in photo was from recent storm event.

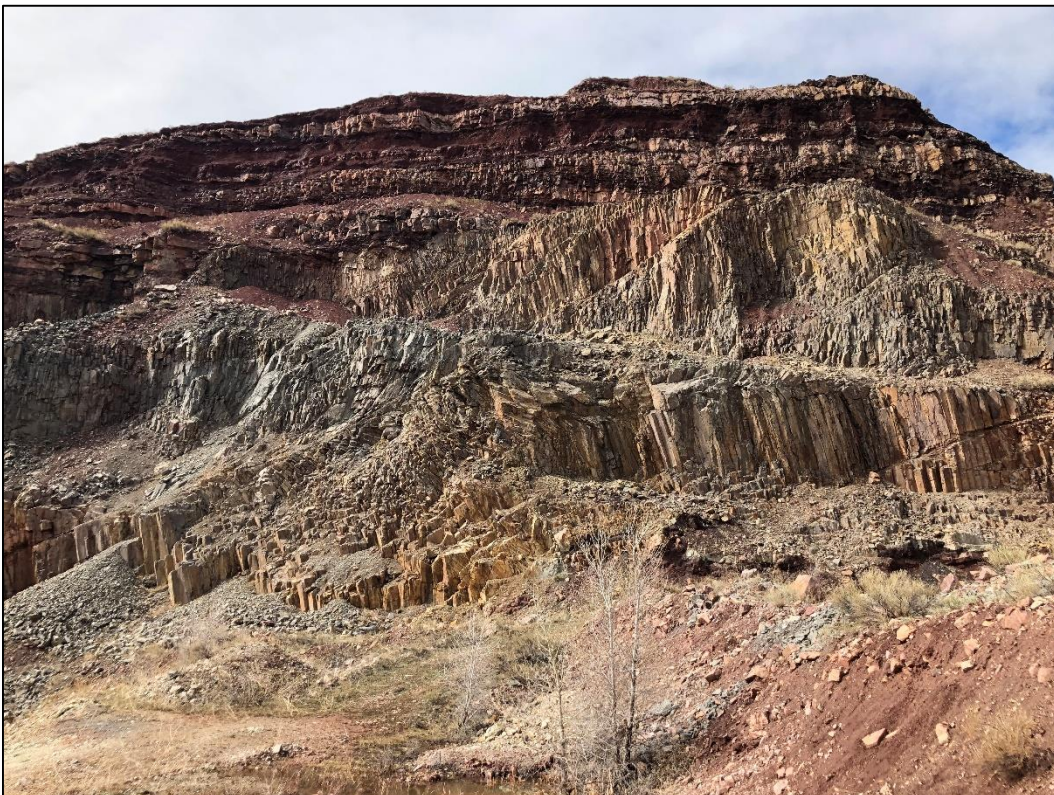
Photo 2. View looking south at Quarry 1, with approximately 300 foot tall highwalls and slope gradients ranging from near vertical (dacite) to 1.5H:1V (sedimentary overburden).

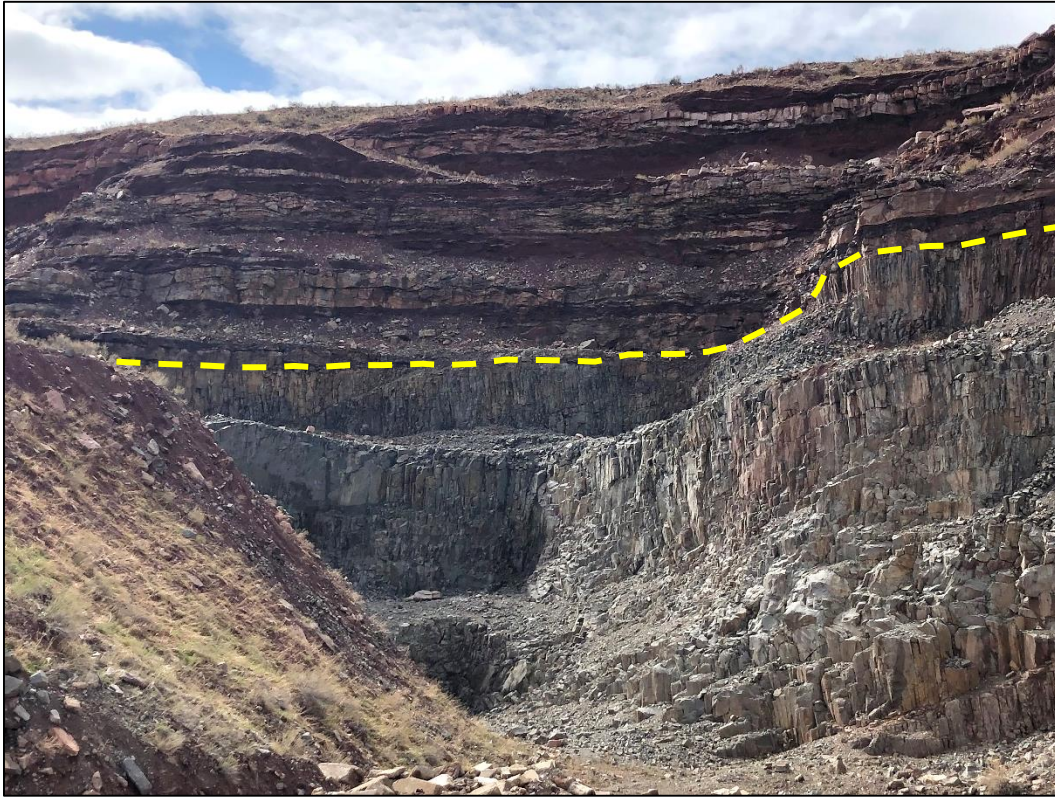
Photo 3. View looking southeast at Quarry 1, showing closer view of its eastern (north-facing) highwall. Note dacite rocks (lower half of highwall) are heavily fractured (making rock bolt use for stabilization challenging) and dipping toward the quarry in some areas. The approximate contact between the lower dacite and the upper sedimentary rock units is delineated with a yellow dashed line.

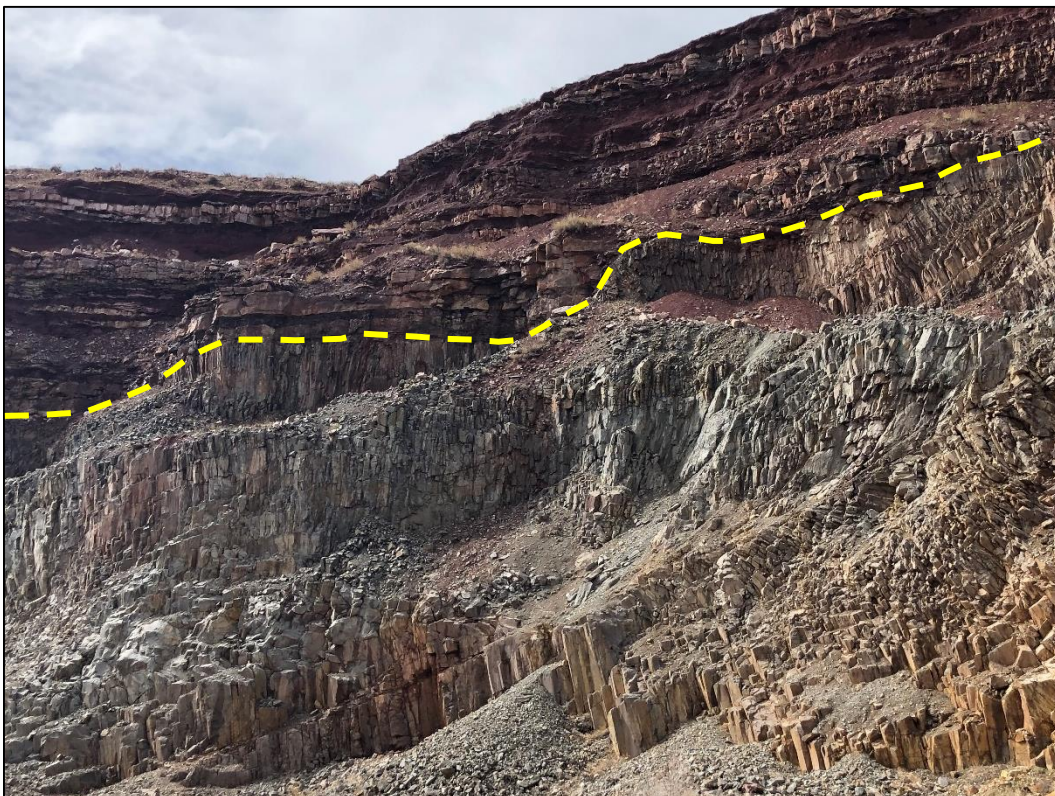
Photo 4. View looking south at Quarry 1, showing closer view of its western (northeast-facing) highwall. Note dacite rocks (lower half of highwall) are heavily fractured and dipping toward the quarry in some areas. The approximate contact between the lower dacite and the upper sedimentary rock units is delineated with a yellow dashed line.

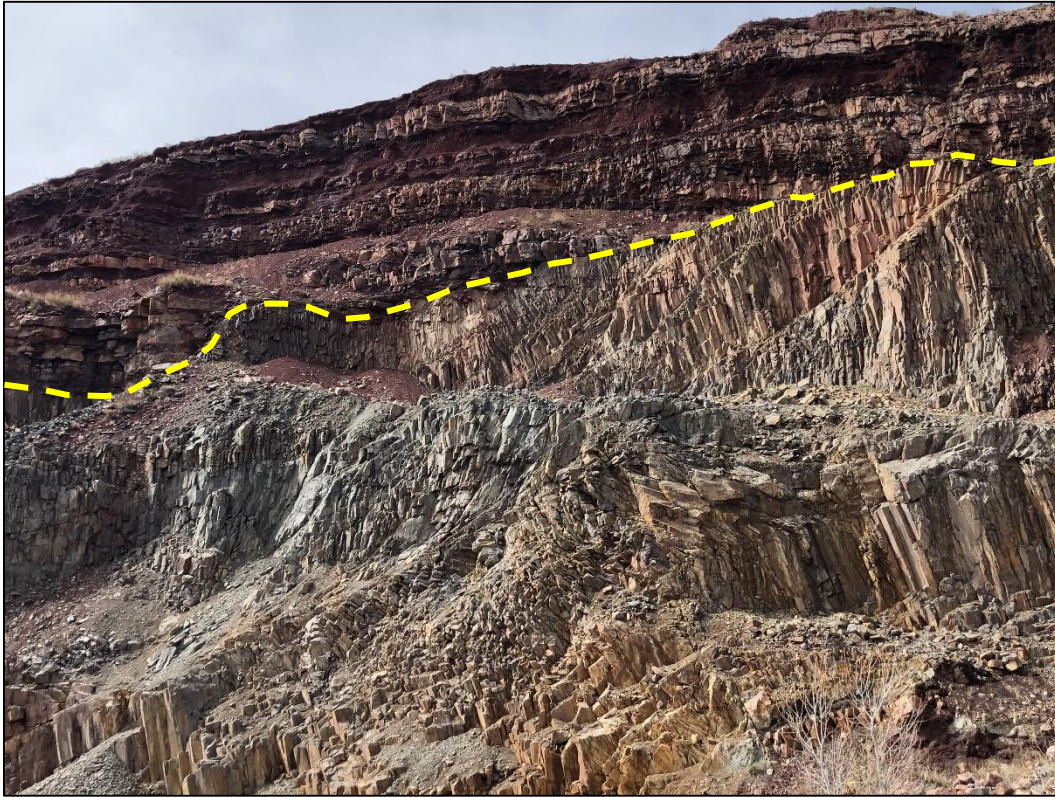
Photo 5. View looking southwest at Quarry 1, showing closer view of its western (northeast-facing) highwall. Note dacite rocks (lower half of highwall) are heavily fractured and dipping toward the quarry in some areas. The approximate contact between the lower dacite and the upper sedimentary rock units is delineated with a yellow dashed line.

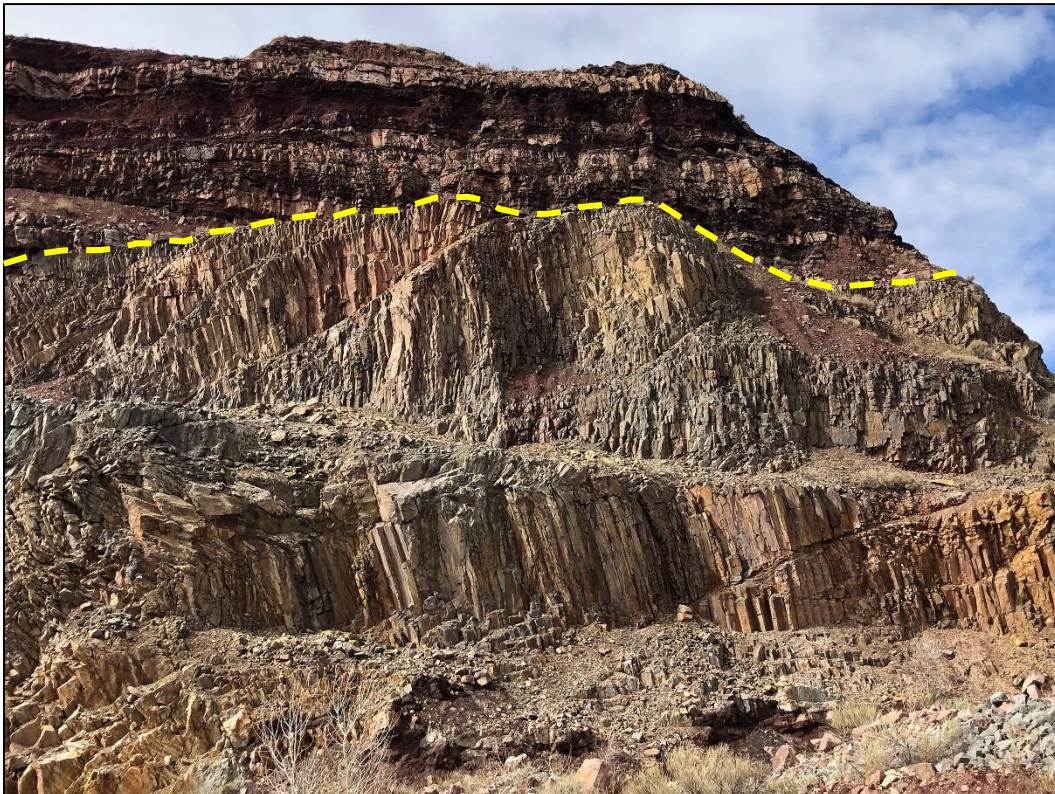
Photo 6. View looking southwest at Quarry 1, showing closer view of its western (northeast-facing) highwall. Note dacite rocks (lower half of highwall) are heavily fractured and dipping toward the quarry in some areas. The approximate contact between the lower dacite and the upper sedimentary rock units is delineated with a yellow dashed line.

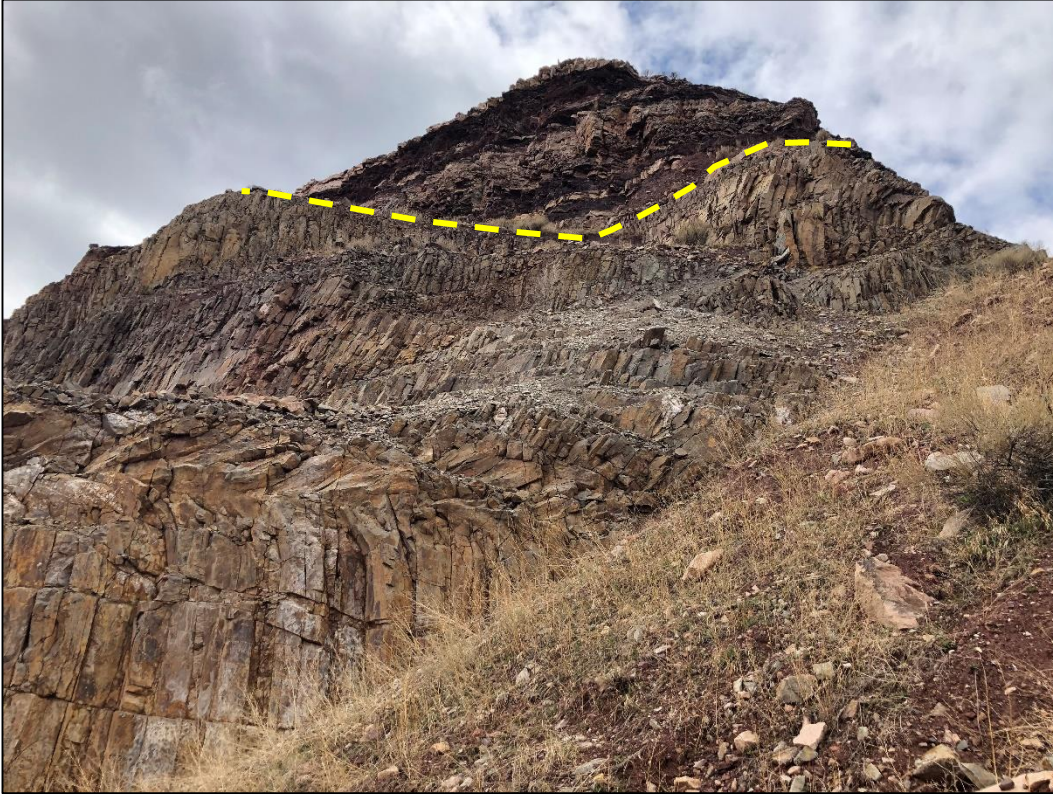
Photo 7. View looking south at Quarry 1, showing western edge of its northeast-facing highwall. Note dacite rocks (lower half of highwall) are heavily fractured but dip mainly away from the quarry in this area. The approximate contact between the lower dacite and the upper sedimentary rock units is delineated with a yellow dashed line.

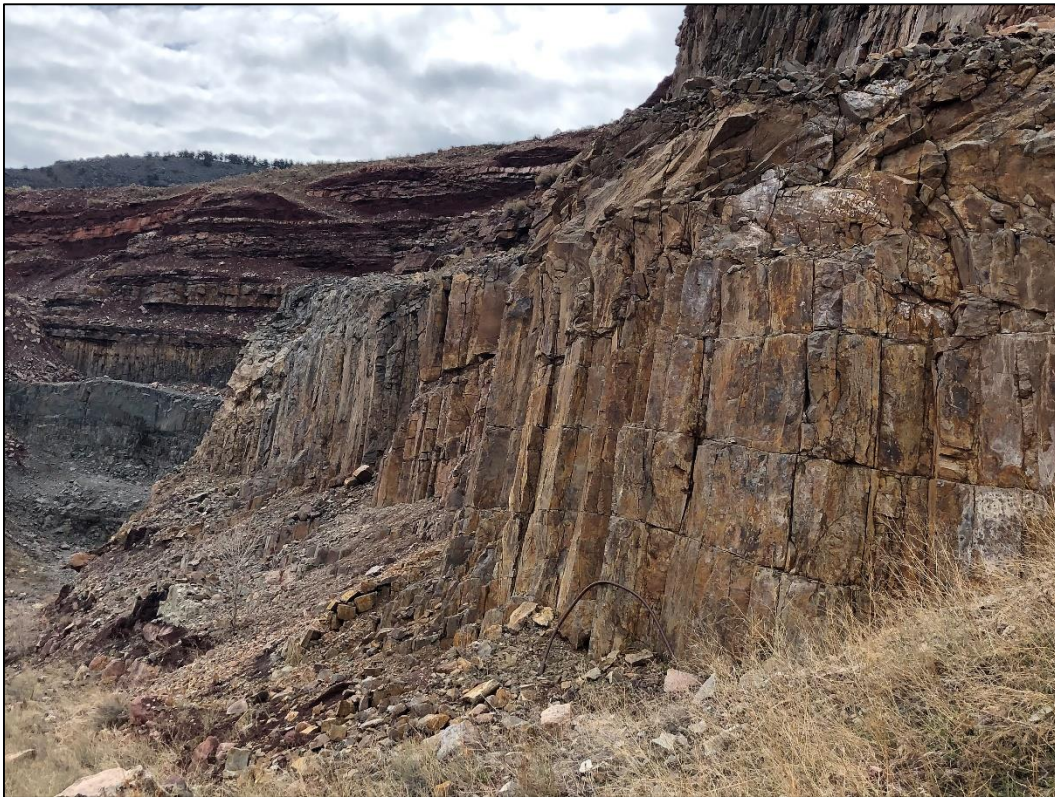
Photo 8. View looking southeast at Quarry 1 across lower (dacite) portion of its western (northeast-facing) highwall. Note dacite rocks are heavily fractured but dip mainly away from the quarry in this area, with slope gradients of near vertical to 0.5H:1V. Talus at foot of highwall includes rocks of various sizes, with larger boulders (up to 5 feet in length) typically derived from sandstone unit above dacite. Dacite rocks are typically smaller than 2 feet in length.

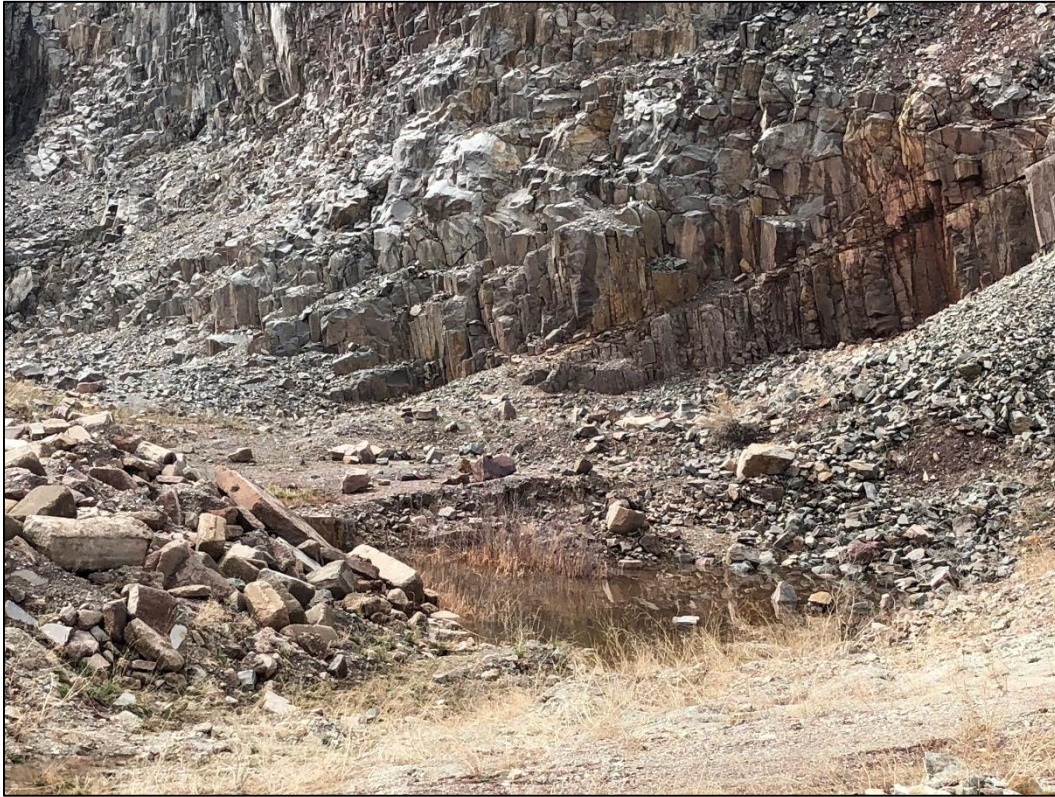
Photo 9. View looking southeast at Quarry 1 pit floor, showing talus present beneath highwall. Larger boulders (up to 5 feet in length) are typically derived from sandstone unit above dacite. Dacite rocks are typically smaller than 2 feet in length. Ponding shown in photo was from recent storm event.

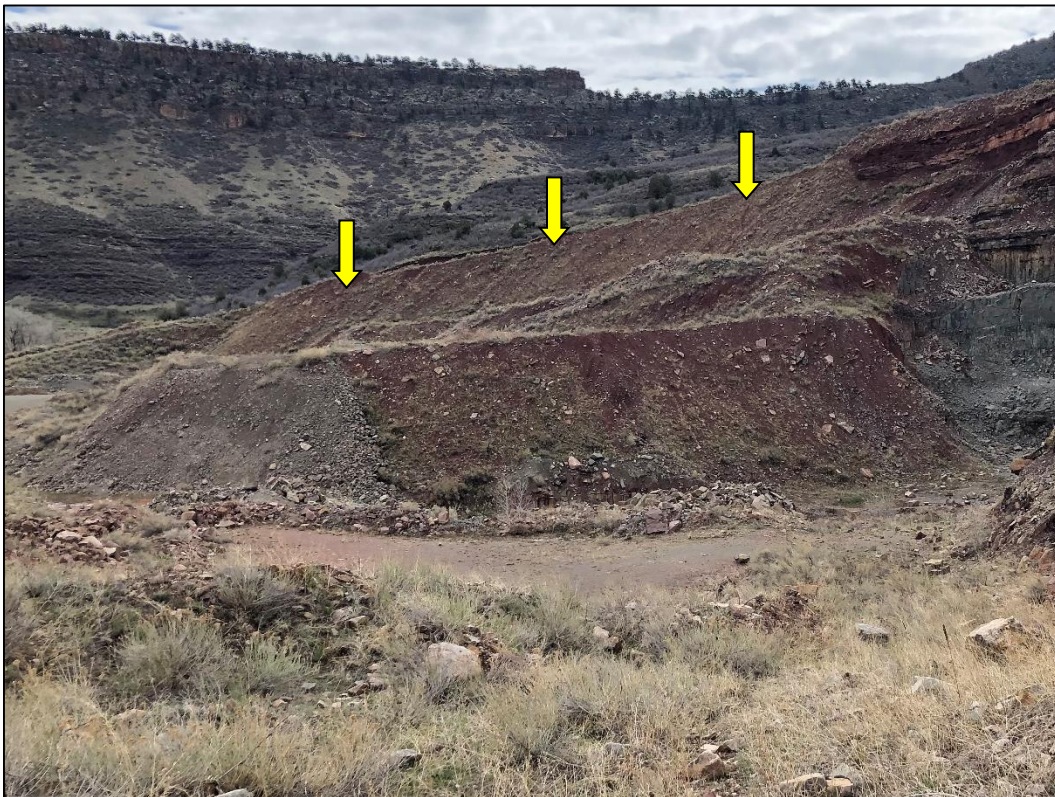
Photo 10. View looking east at Quarry 1, showing backfilled portion of its eastern highwall (indicated), with slope gradients of 1H:1V to 1.5H:1V. In TR-5, the operator proposes connecting the backfill material on the Quarry 1 pit floor (visible at center of photo) with the Quarry 2 access ramp (not visible in photo) to create a rockfall catchment berm.

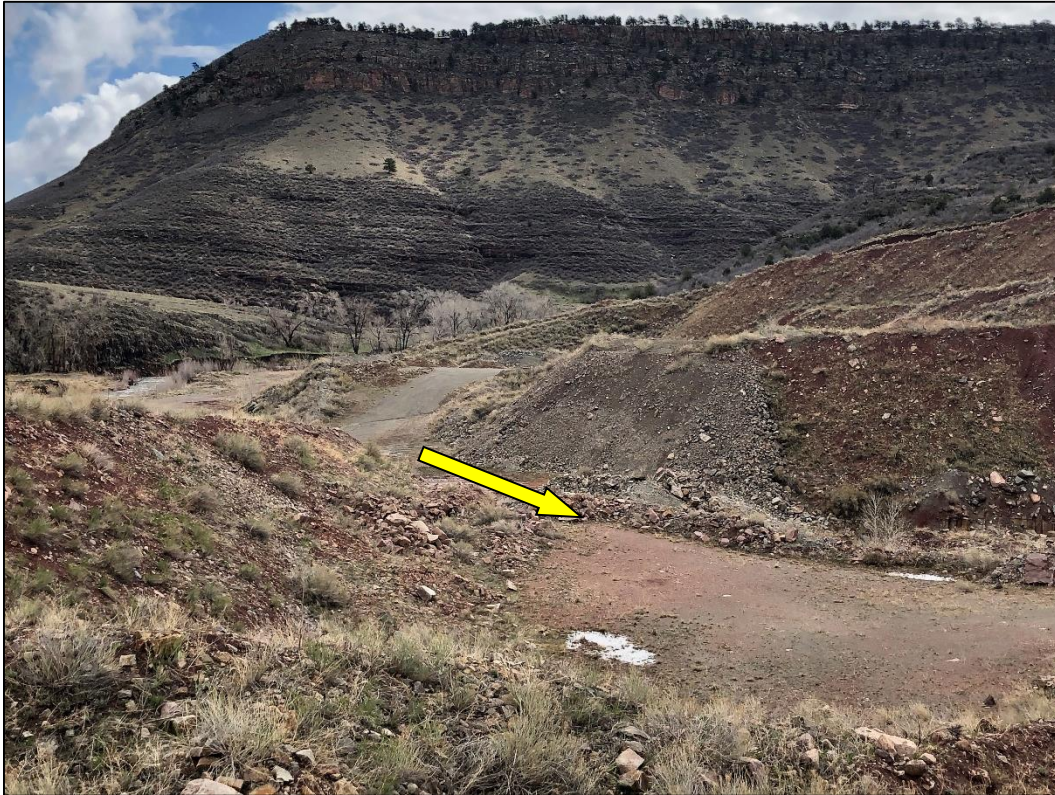
Photo 11. View looking east at Quarry 1, showing "swale"/quarry access (indicated with arrow) that exists between Quarry 1 backfill material on pit floor (at right) and Quarry 2 access ramp (at left). In TR-5, the operator proposes backfilling this "swale" to create a rockfall catchment berm.

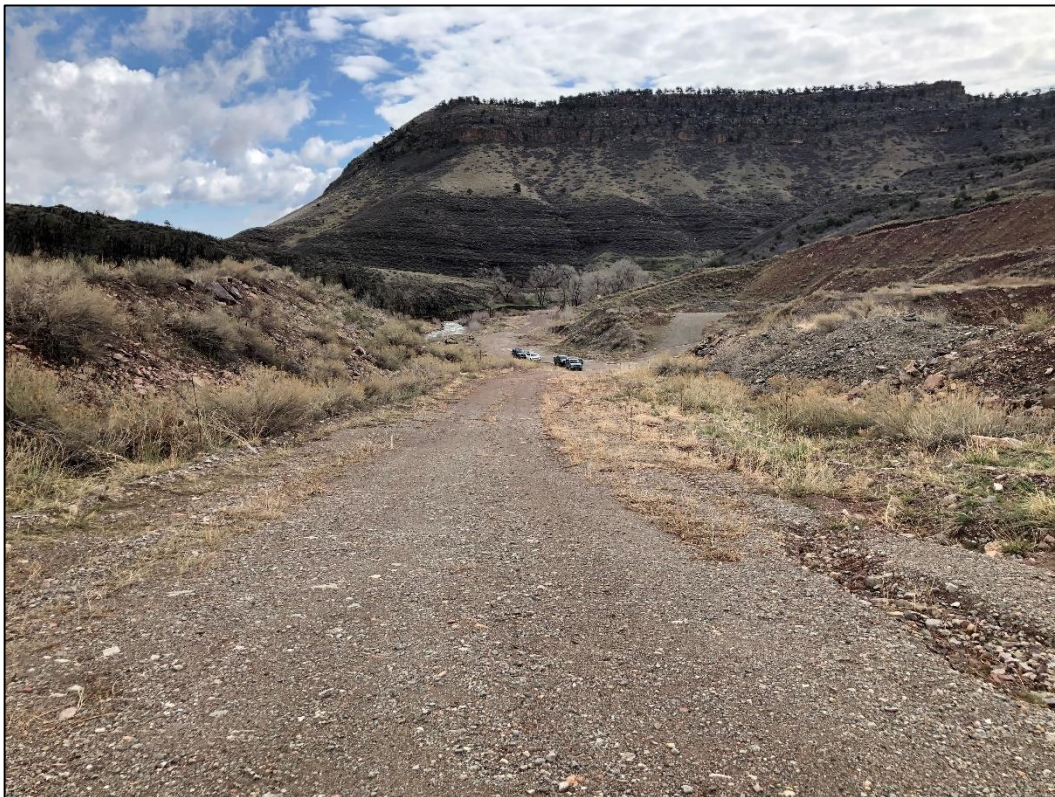
Photo 12. View looking east (toward Quarry 1) down road ramp constructed out of overburden material in early 2000's for Quarry 2 access.

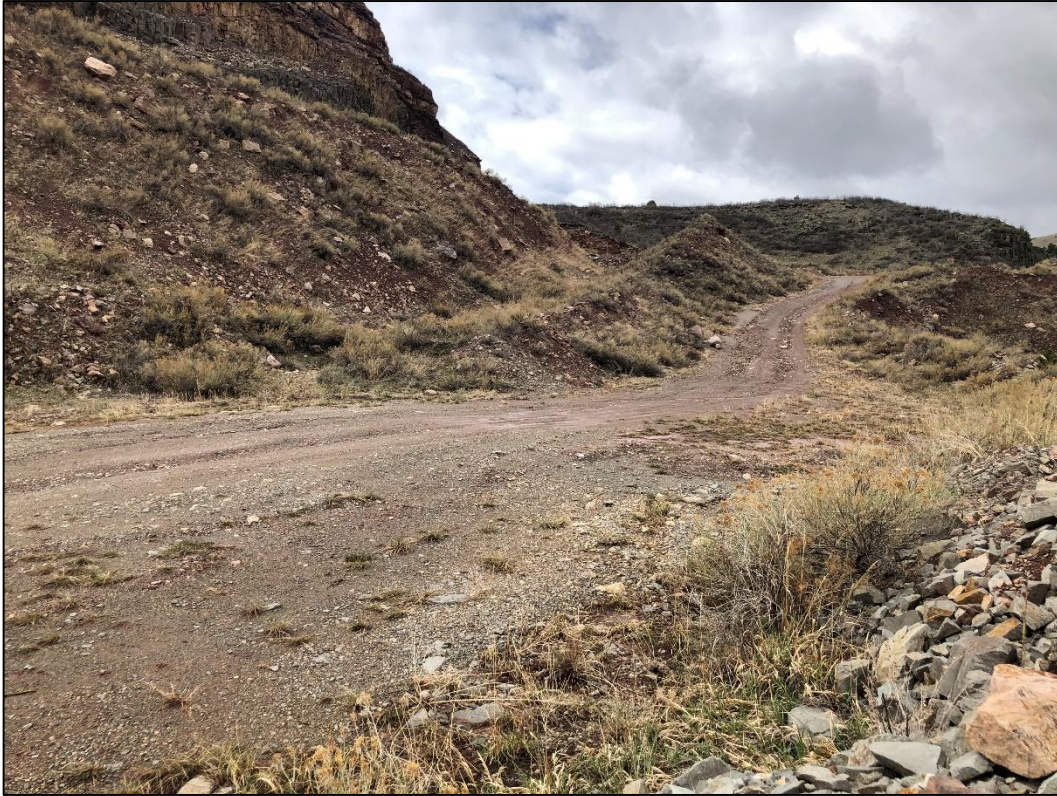
Photo 13. View looking west (toward Quarry 2) up road ramp constructed out of overburden material in early 2000's for Quarry 2 access.

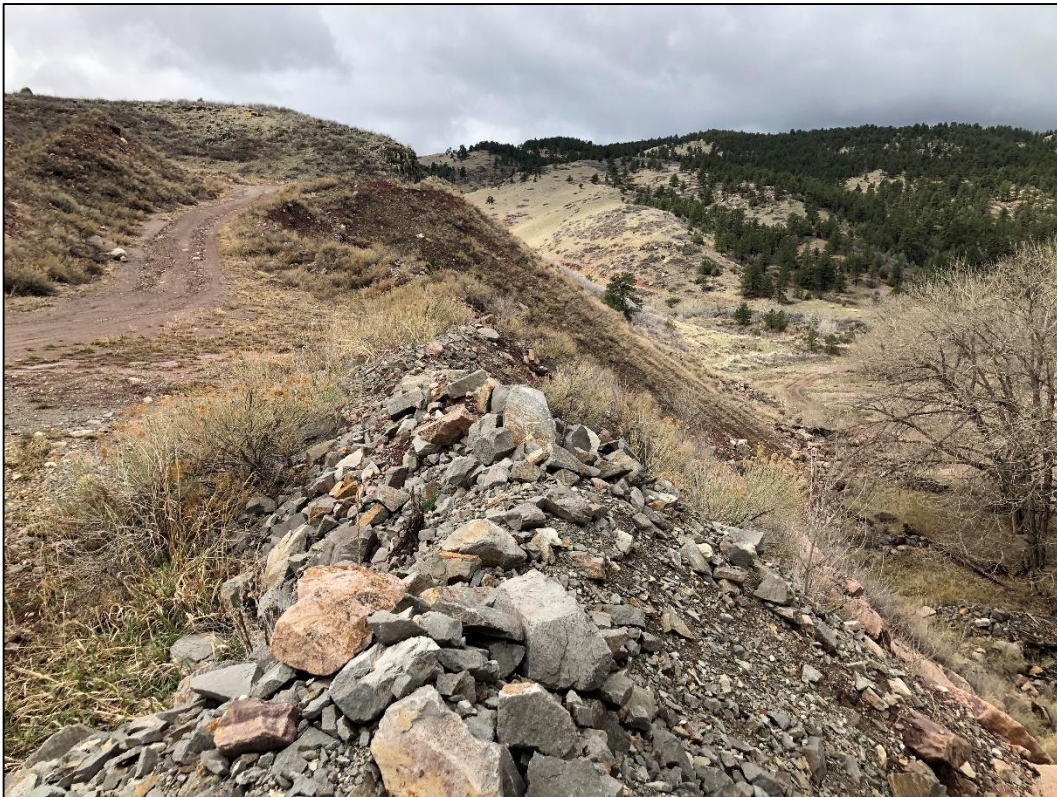
Photo 14. View looking west at northern side slope of road ramp constructed out of overburden material in early 2000's for Quarry 2 access, with slope gradients of approximately 1.5H:1V.

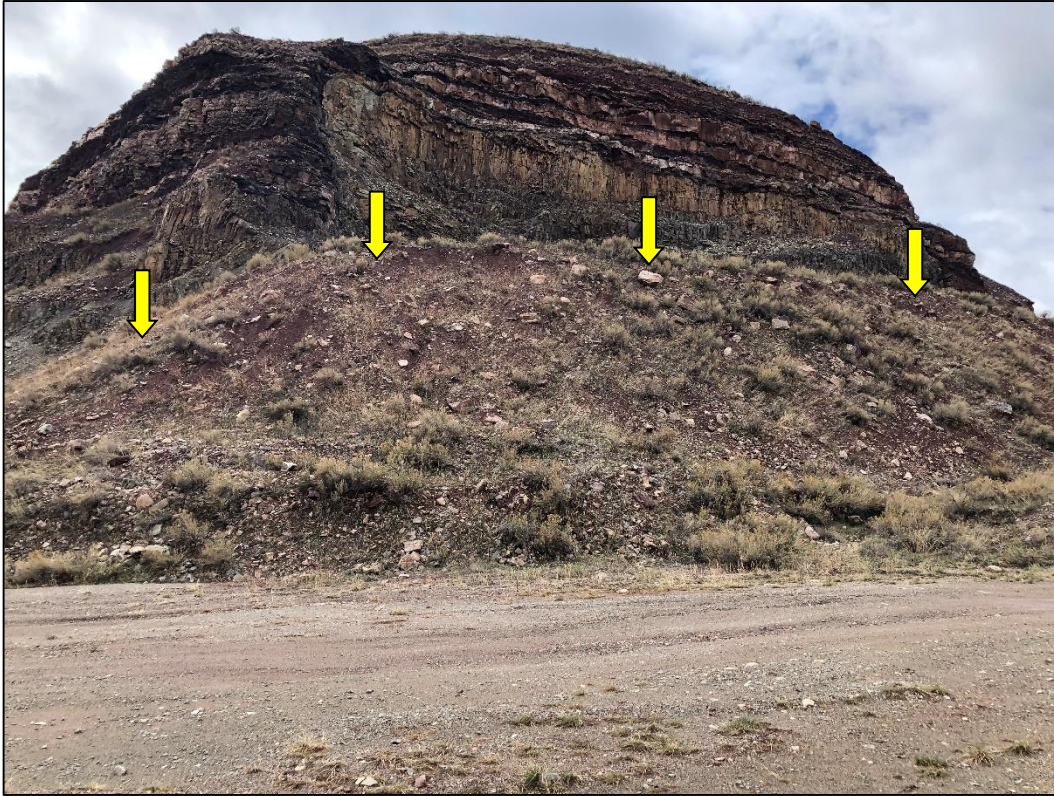
Photo 15. View looking south at northwest-facing highwall that exists between the two quarries. This highwall was partially backfilled (indicated) in the early 2000's during construction of the Quarry 2 access road ramp (road visible in foreground). In TR-5, the operator proposes constructing a rockfall catchment berm and chain-link fencing along the top of this backfill.

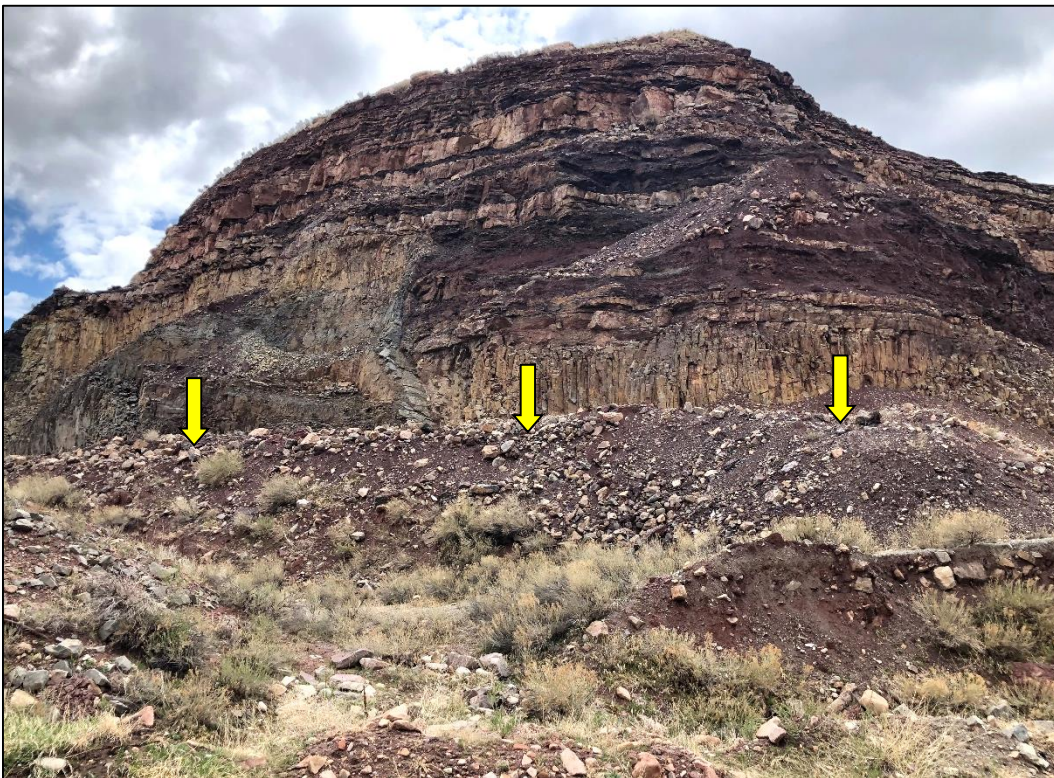
Photo 16. View looking southeast, showing closer view of northwest-facing highwall that exists between the two quarries. This highwall was partially backfilled (indicated) in the early 2000's during construction of the Quarry 2 access road ramp. In TR-5, the operator proposes constructing a rockfall catchment berm and chain-link fencing along the top of this backfill.

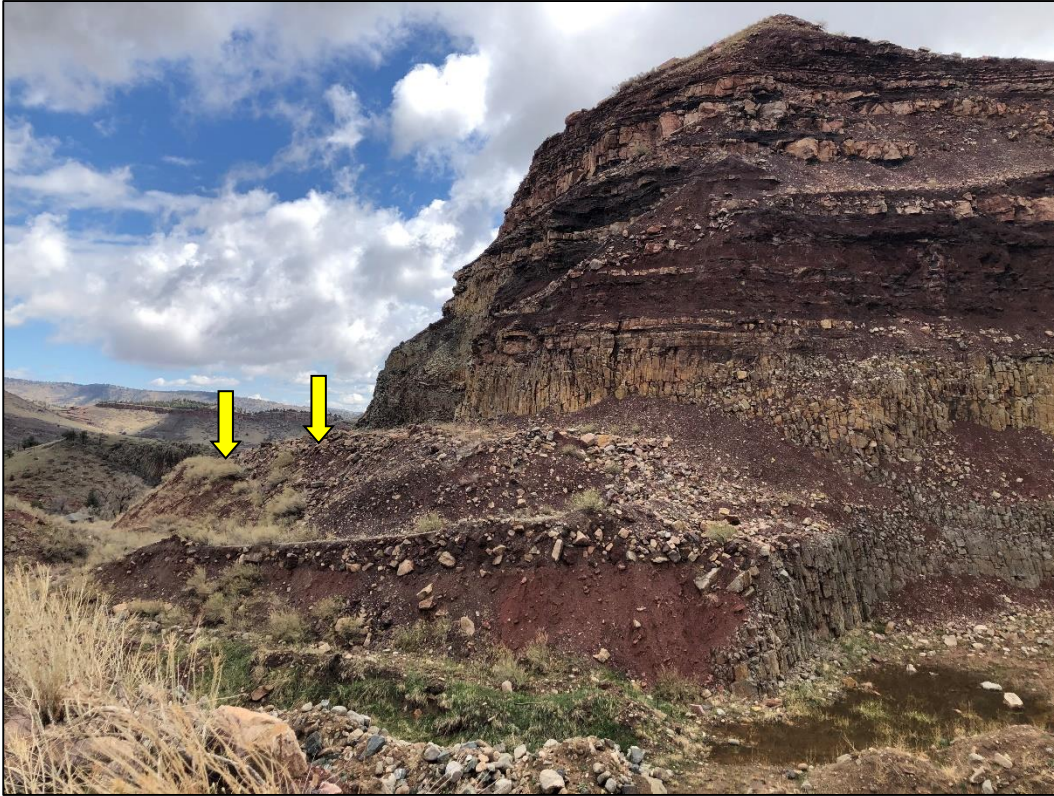
Photo 17. View looking east at western edge of northwest-facing highwall. In TR-5, the operator proposes constructing a rockfall catchment berm (for which space appears limited) and chain-link fencing along the top of the backfill area (indicated).

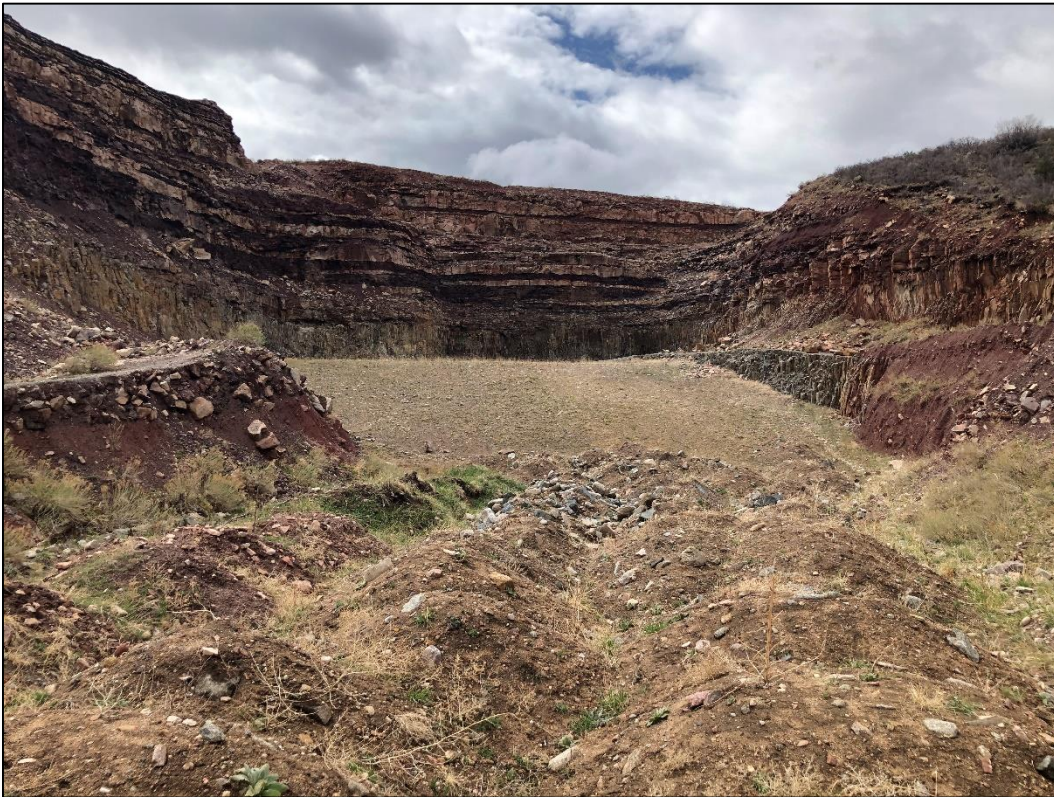
Photo 18. View looking southeast at Quarry 2, which was partially backfilled with imported material in 2017/2018. Highwalls above the backfill are approximately 100 feet tall with slope gradients ranging from near vertical (dacite) to 1.5H:1V (sedimentary overburden). Note majority of remaining highwalls consists of sedimentary overburden rocks.

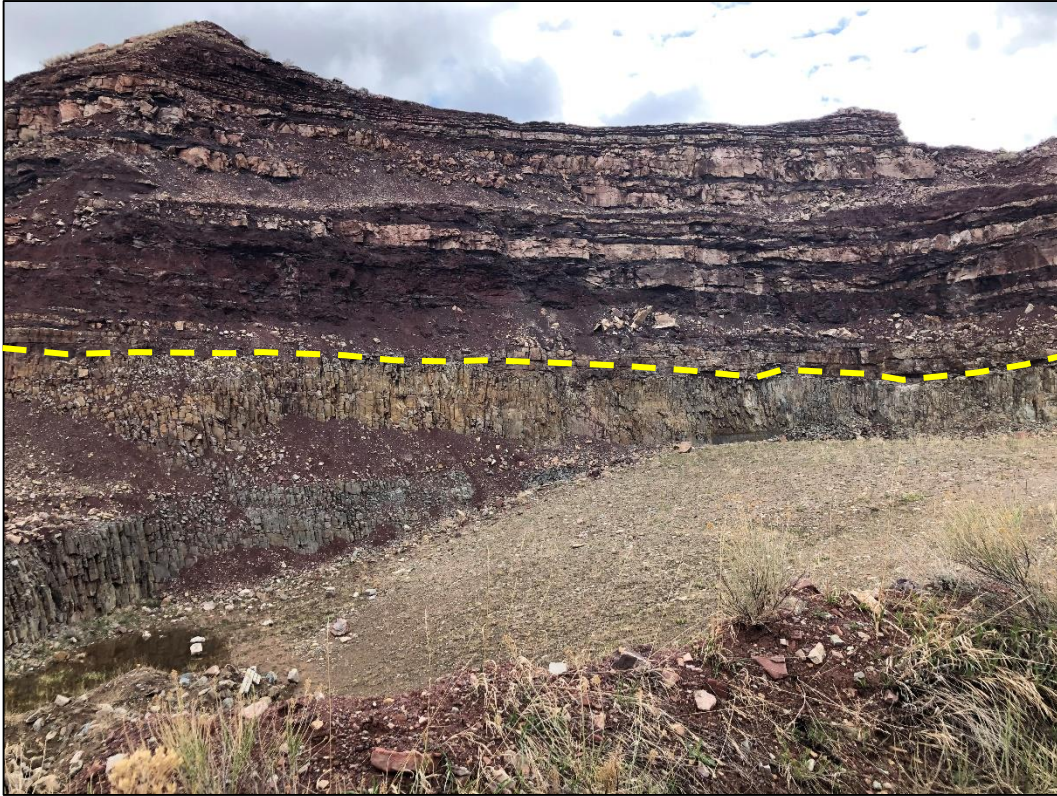
Photo 19. View looking east at Quarry 2, showing its eastern (southwest-facing) highwall. The approximate contact between the lower dacite and the upper sedimentary rock units is delineated with a yellow dashed line.

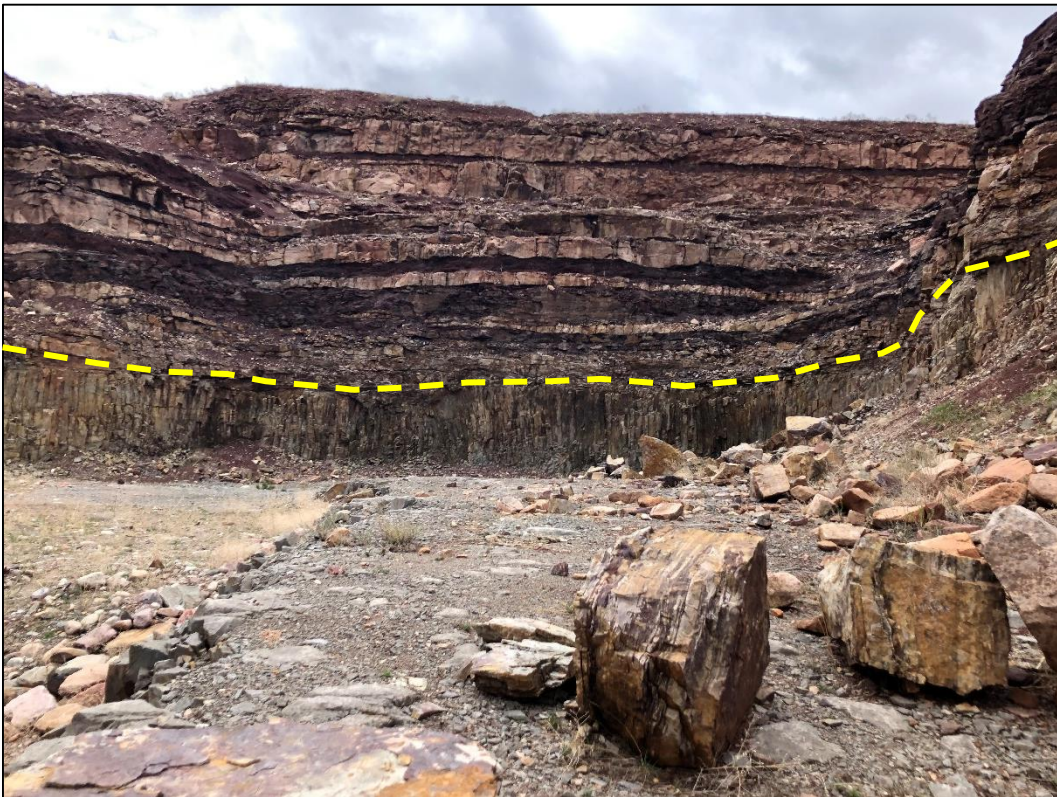
Photo 20. View looking southeast at Quarry 2, showing its southern (northwest-facing) highwall. The approximate contact between the lower dacite and the upper sedimentary rock units is delineated with a yellow dashed line. Note rocks in foreground which fell from western highwall. Larger boulders are derived from overburden sandstone unit.

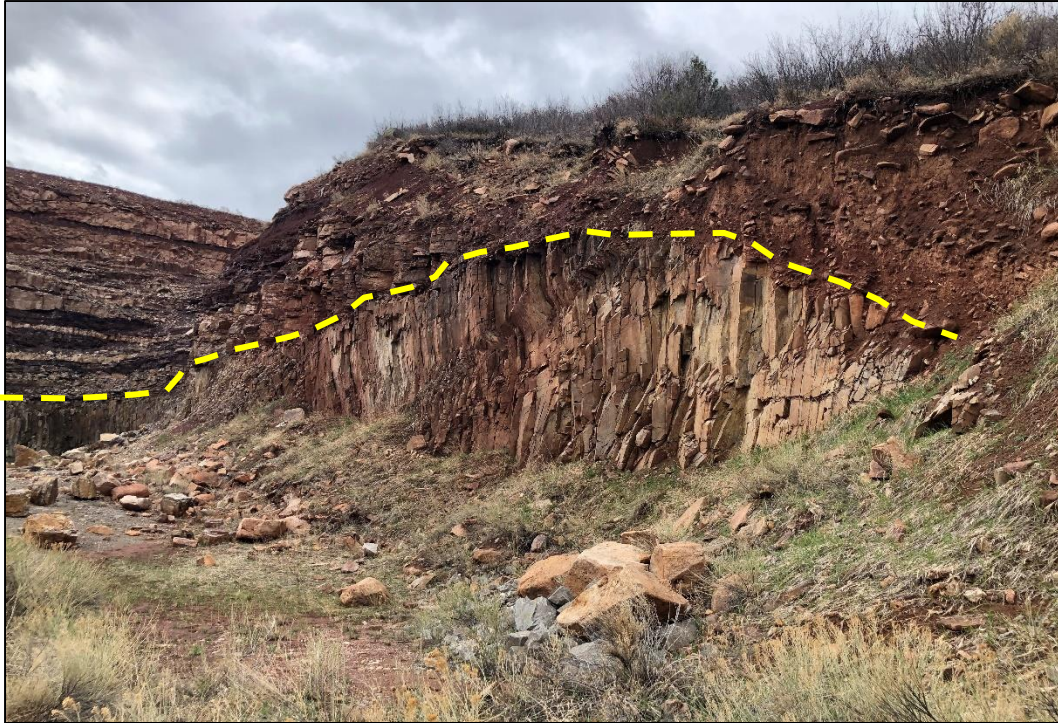
Photo 21. View looking southwest at Quarry 2, showing its western (northeast-facing) highwall. Note dacite rocks (lower portion of highwall) are heavily fractured. The approximate contact between the lower dacite and the upper sedimentary rock units is delineated with a yellow dashed line. Talus at foot of highwall includes rocks of various sizes, with larger boulders (up to 5 feet in length) typically derived from sandstone unit above dacite. Dacite rocks are typically smaller than 2 feet in length.

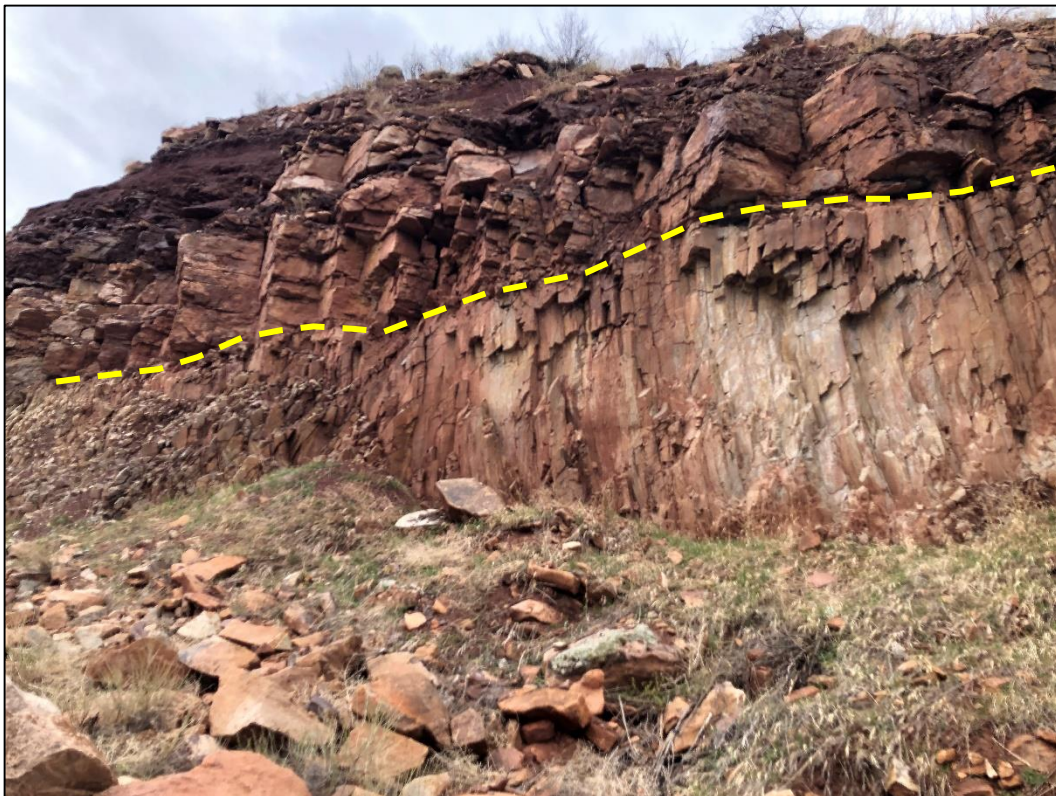
Photo 22. View looking southwest at Quarry 2, showing closer view of western (northeast-facing) highwall. Note dacite rocks (lower portion of highwall) are heavily fractured, and overburden sandstone rocks are overhanging the dacite. The approximate contact between the lower dacite and the upper sedimentary rock units is delineated with a yellow dashed line. Talus at foot of highwall includes rocks of various sizes, with larger boulders (up to 5 feet in length) typically derived from sandstone unit above dacite. Dacite rocks are typically smaller than 2 feet in length.

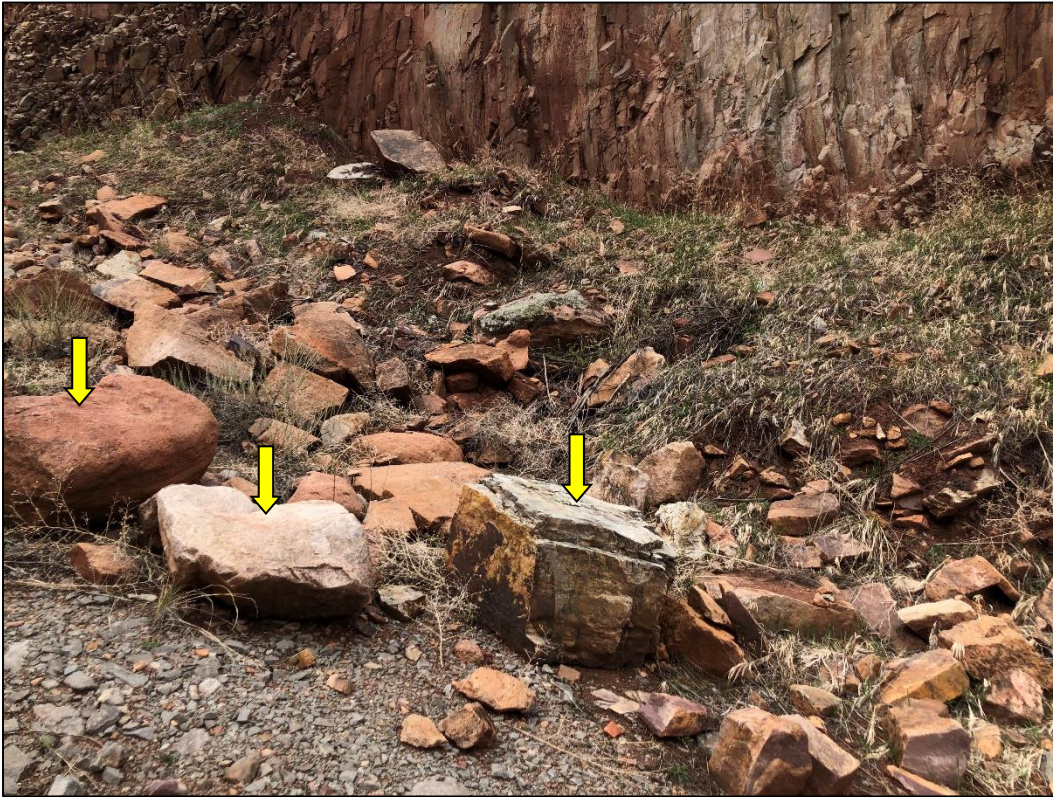
Photo 23. View looking southwest at Quarry 2, showing talus at foot of western highwall including rocks of various sizes, with larger boulders (up to 5 feet in length) typically derived from sandstone unit above dacite (a few of the larger sandstone boulders are indicated). Dacite rocks are typically smaller than 2 feet in length.

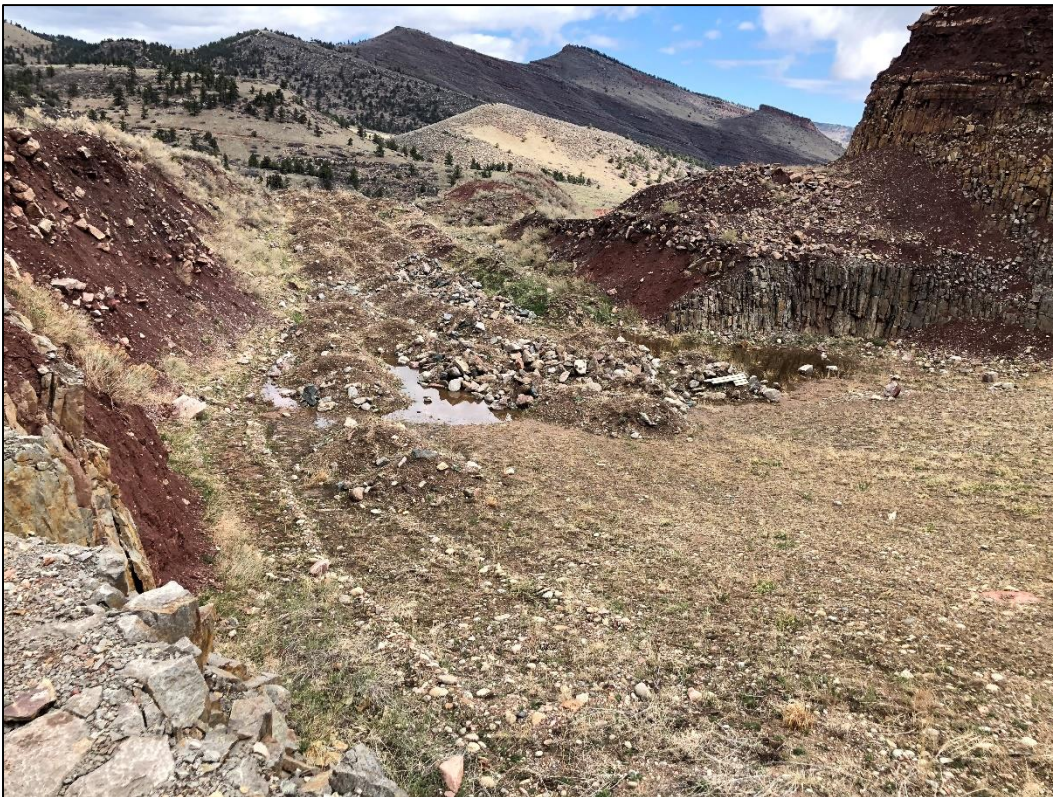
Photo 24. View looking north at Quarry 2 entrance (from inside quarry) where imported backfill material was placed in 2017/2018. Ponding shown in photo was from recent storm event.
