MINERALS PROGRAM INSPECTION REPORT

MINE NAME: Lyons Quarry	MINE/PROSPECTING ID#: M-1977-141	MINERAL: Quartz (quartzite/quartzose sandstone)	COUNTY: Boulder
INSPECTION TYPE: Monitoring	INSPECTOR(S): Amy Eschberger, Tim Cazier	INSP. DATE: April 28, 2021	INSP. TIME: 09:30
OPERATOR: Aggregate Industries - WCR, Inc.	OPERATOR REPRESENTATIVE: Jeremy Deuto, Joel Krech	TYPE OF OPERATION: 112c - Construction Regular Operation

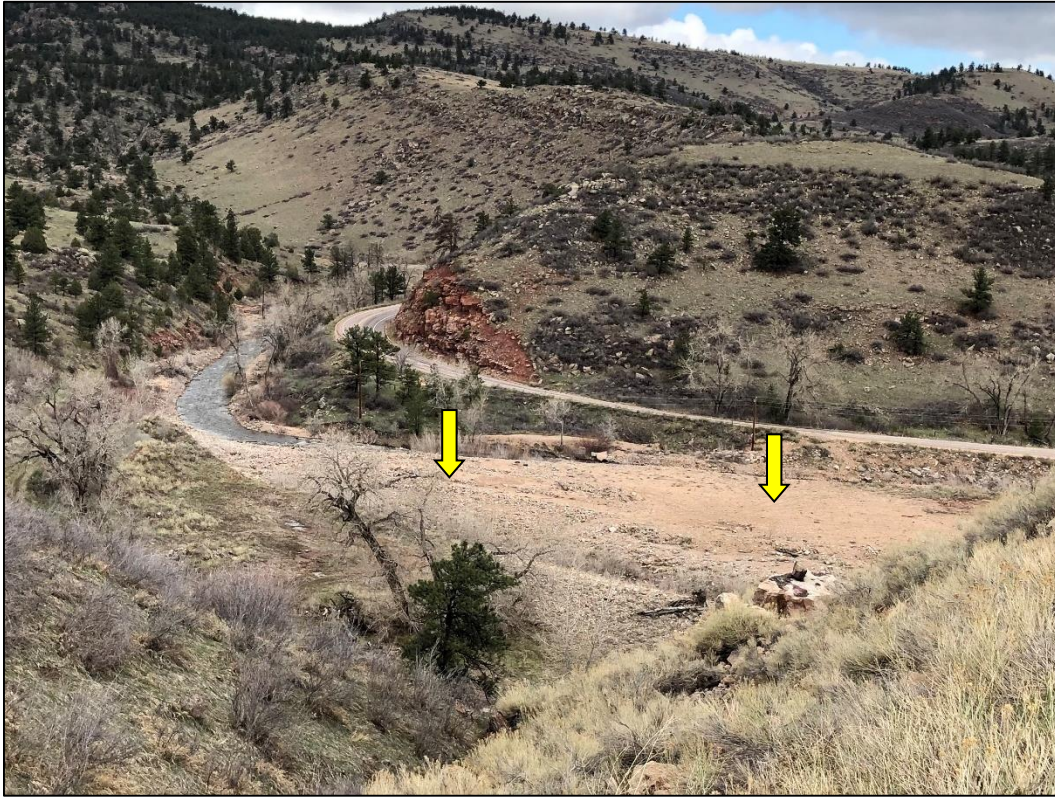
Photo 25. View looking northwest from western edge of Quarry 2, showing western edge of former stockpiling/processing/storage area (Reclamation Area 2) below (indicated), located adjacent to creek. This area was significantly impacted by the September 2013 flooding. Reclamation of this area was partially addressed in TR-4.

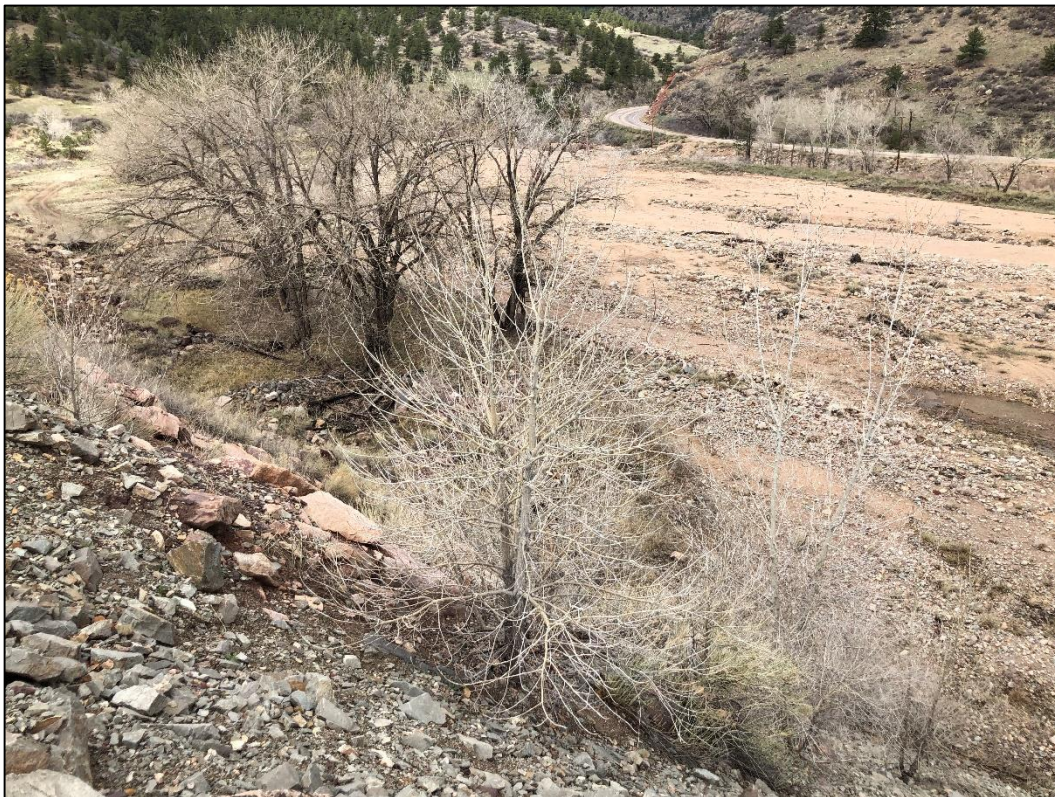
Photo 26. View looking northwest from top of Quarry 2 access ramp, across former stockpiling/processing/storage area (Reclamation Area 2) below, located adjacent to creek. This area was significantly impacted by the September 2013 flooding. Reclamation of this area was partially addressed in TR-4.

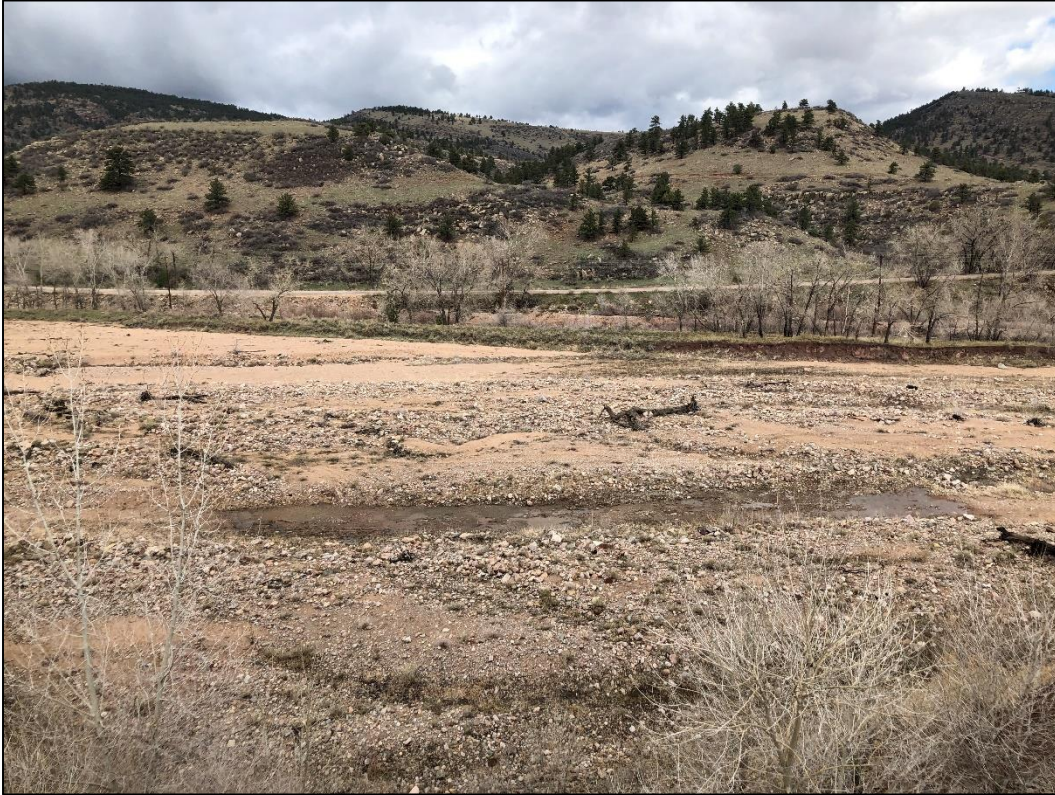
Photo 27. View looking north from top of Quarry 2 access ramp, across former stockpiling/processing/storage area (Reclamation Area 2) below, located adjacent to creek. This area was significantly impacted by the September 2013 flooding. Reclamation of this area was partially addressed in TR-4.

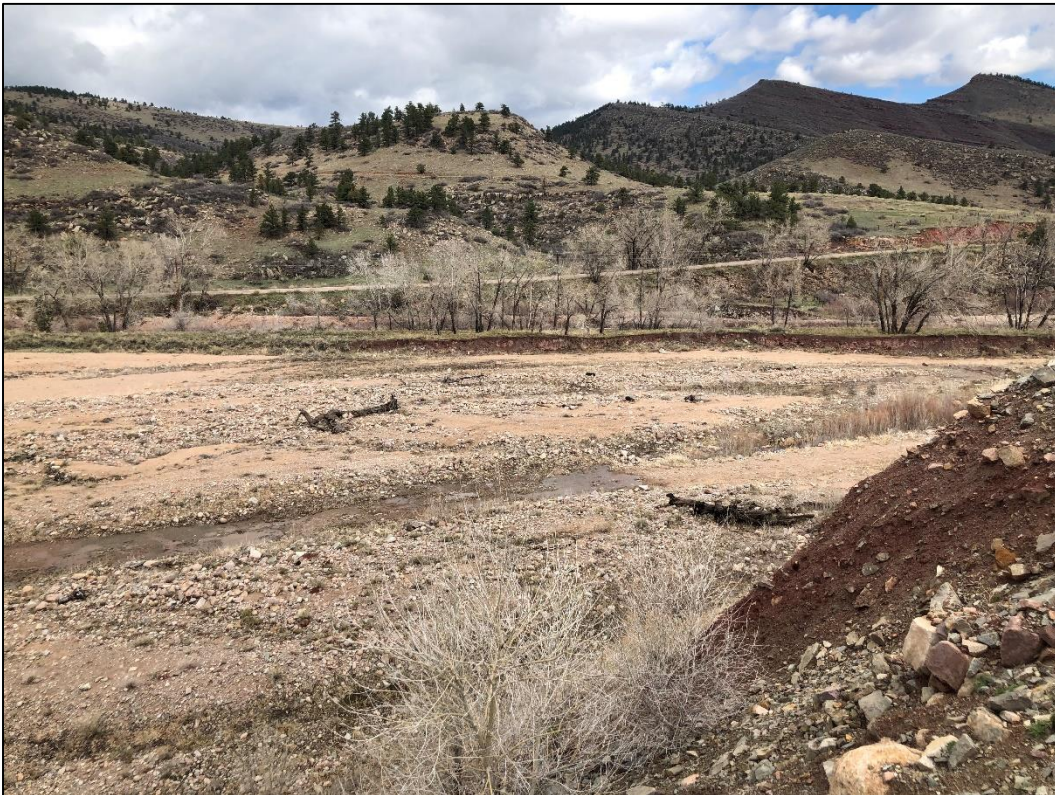
Photo 28. View looking northeast from top of Quarry 2 access ramp, across former stockpiling/processing/storage area (Reclamation Area 2) below, located adjacent to creek. This area was significantly impacted by the September 2013 flooding. Reclamation of this area was partially addressed in TR-4.

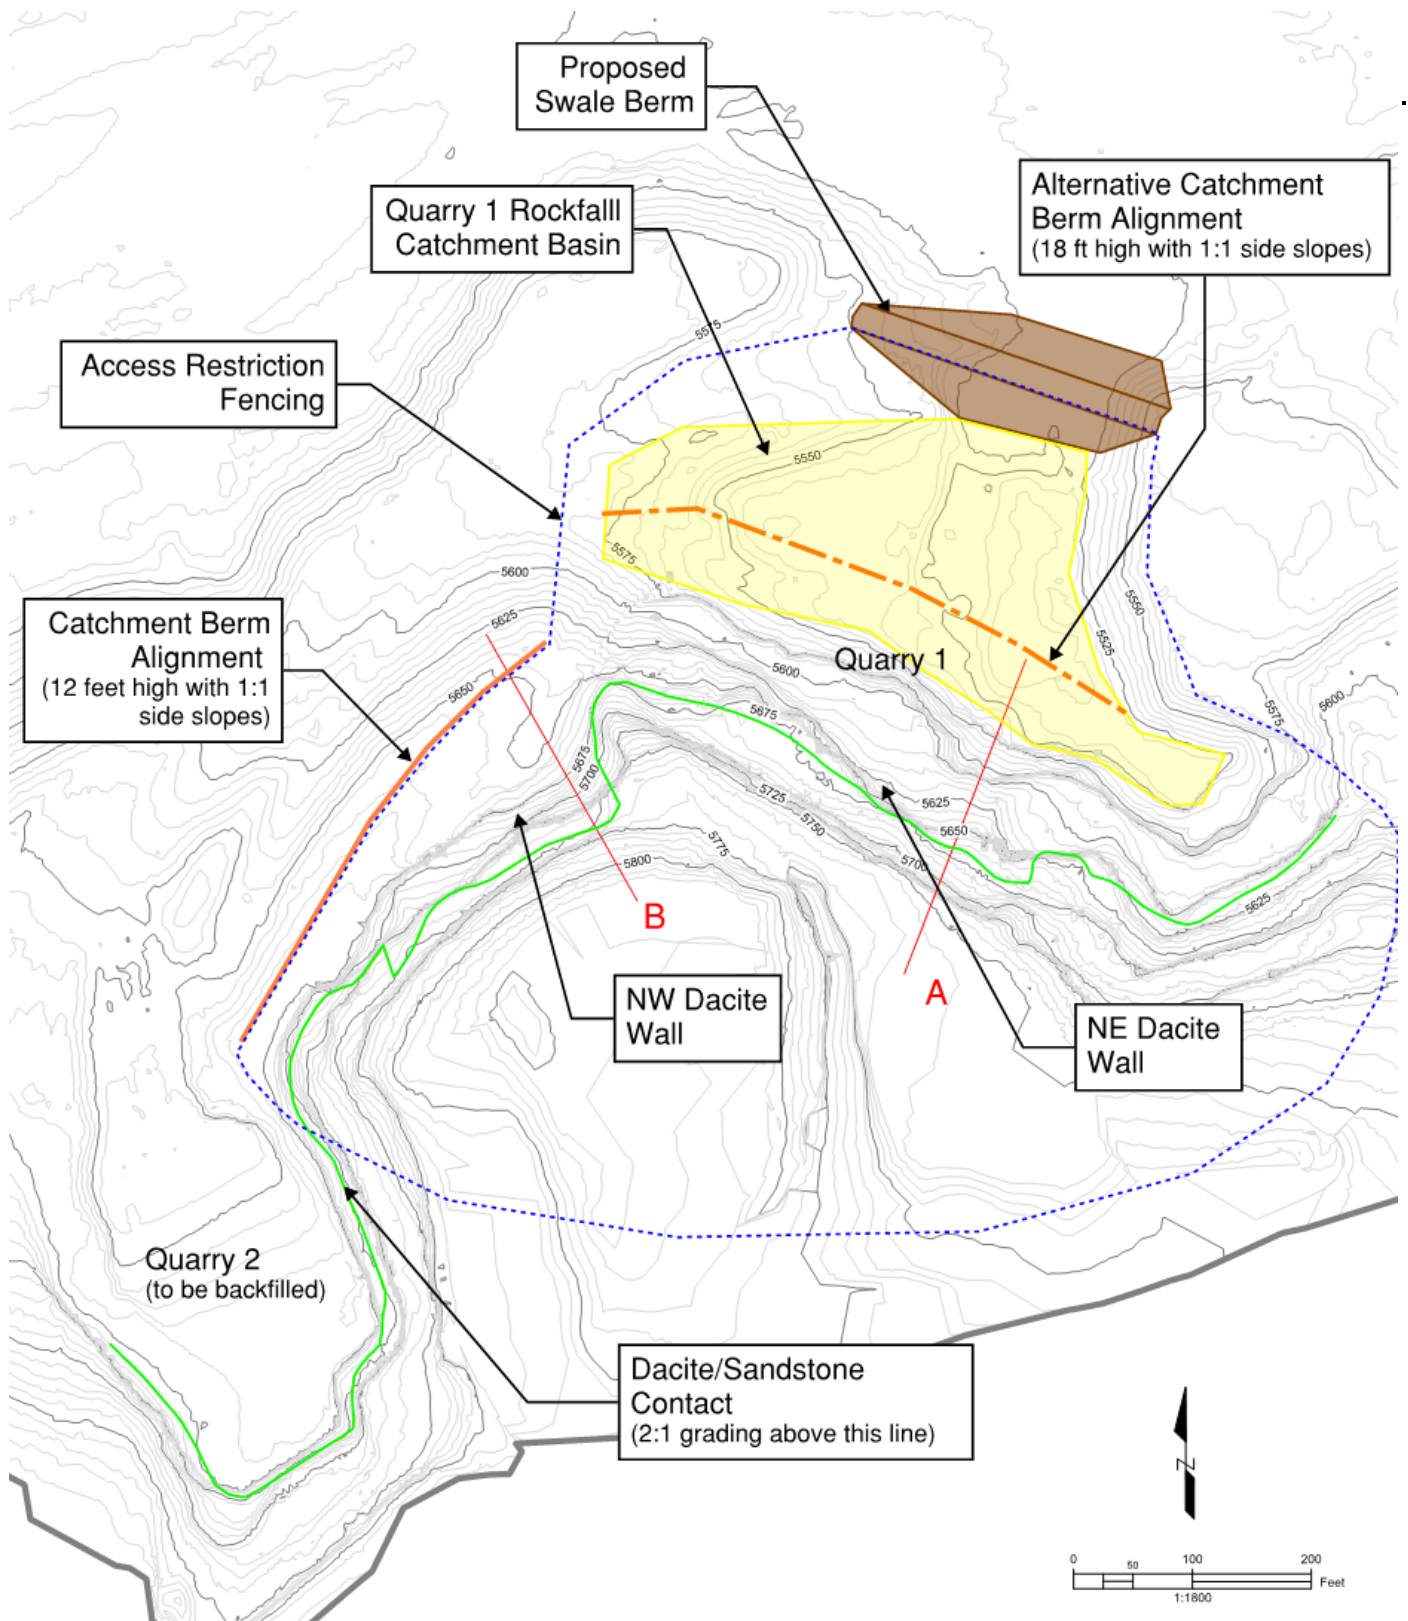
Figure 1. Plan view of Lyons Quarry showing dacite walls and proposed rockfall mitigation

As mentioned above, the Division is currently reviewing TR-5, which proposes a revised reclamation plan for the quarry area (see enclosed Figure 1 – Plan view of Lyons Quarry showing dacite walls and proposed rockfall mitigation, submitted with TR-5). This plan includes using heavy equipment or blasting to grade the overburden sedimentary rocks to an overall slope gradient of 2H:1V (from the northeast corner of Quarry 2 to the eastern extent of Quarry 1; see enclosed Final Grading Plan map and Final Grading Profile, Section & Details, submitted with TR-5), scaling and removing any loose rock from the dacite highwalls (from the northeast corner of Quarry 2 to the eastern extent of Quarry 1) and stabilizing these highwalls with rock bolts, constructing a rockfall catchment basin and/or berm coupled with restricted access (chain-link fencing) at the toe areas of the highwalls, backfilling Quarry 2 to achieve 50 foot high x 15 foot wide benches sloped at 2H:1V,

and contouring the Quarry 2 backfill area to form a swale (as existed in the area prior to mining) which will convey runoff from the Quarry 2 area via a riprap lined drainage channel to the large catchment basin in Quarry 1. Runoff from quarry highwalls will be conveyed to the rockfall catchment basin and a secondary earthen berm around the scour berm to capture potentially suspended sediments. Surface flows would then be directed through the Quarry 1 rockfall catchment berm and the scour berm via a 24-inch reinforced concrete pipe (RCP) culvert. The culvert outlet will tie into the drainage channel at the toe of the scour berm and direct flow to the east. A runoff control channel will be constructed along the eastern perimeter of the quarry area, running along the existing access road grade and tying in with the scour berm toe drainage channel before discharging through a 24-inch RCP culvert (installed under the access road) to discharge into the creek (under a CDPHE permit). Areas where slopes are 2H:1V or flatter will be retopsoiled and revegetated with a native plant seed mix developed in consultation with the county (see enclosed Overall Reclamation Plan & Details map, submitted with TR-5). As approved in TR-2, the sediment pond located at the northeastern edge of the quarry area will be backfilled for reclamation, and the area retopsoiled and revegetated.
