MINERALS PROGRAM INSPECTION REPORT
PHONE: (303) 866-3567

MINE NAME: Schoen Farm	MINE/PROSPECTING ID#: M-2020-062	MINERAL: Stone	COUNTY: Rio Grande
INSPECTION TYPE: Preoperation Inspection	INSPECTOR(S): Lucas West	INSP. DATE: April 28, 2021	INSP. TIME: 11:57
OPERATOR: O'Rourke Excavating, Inc.	OPERATOR REPRESENTATIVE: Tom O'Rourke	TYPE OF OPERATION: 110c - Construction Limited Impact	
REASON FOR INSPECTION: Preoperation Inspection	BOND CALCULATION TYPE: Complete Bond	BOND AMOUNT: No Bond Held	
DATE OF COMPLAINT: NA	POST INSP. CONTACTS: None	JOINT INSP. AGENCY: None	
WEATHER: Clear	INSPECTOR'S SIGNATURE:

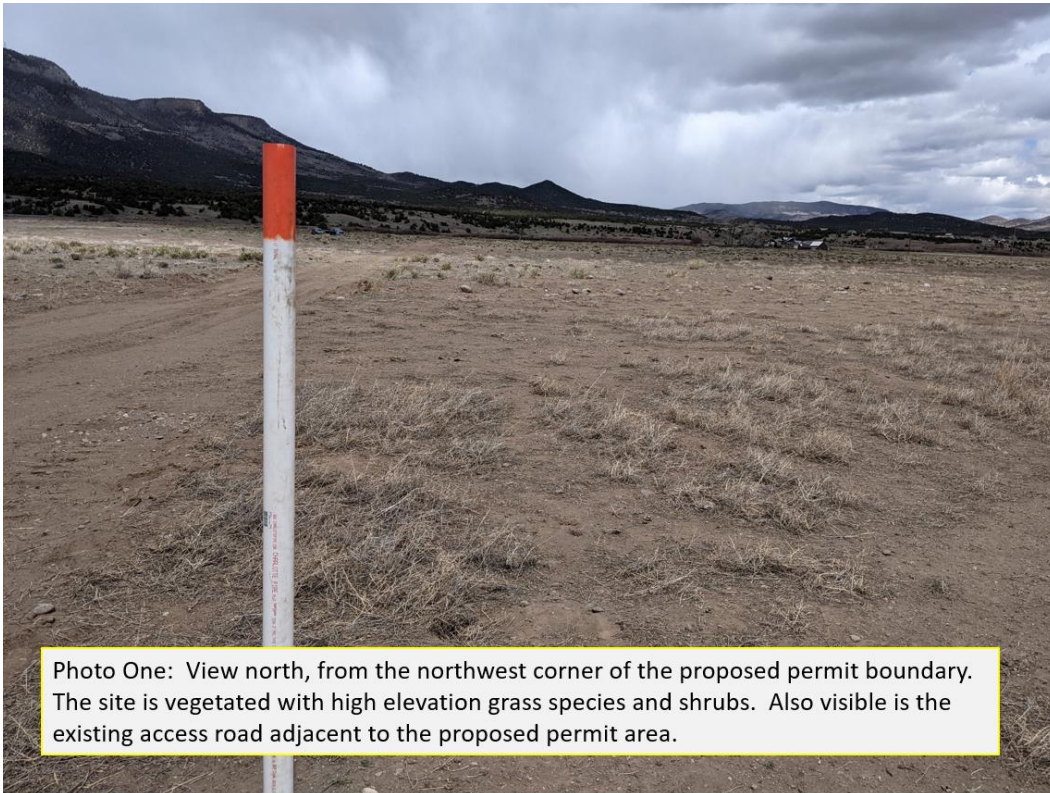
Photo One: View north, from the northwest corner of the proposed permit boundary. The site is vegetated with high elevation grass species and shrubs. Also visible is the existing access road adjacent to the proposed permit area.

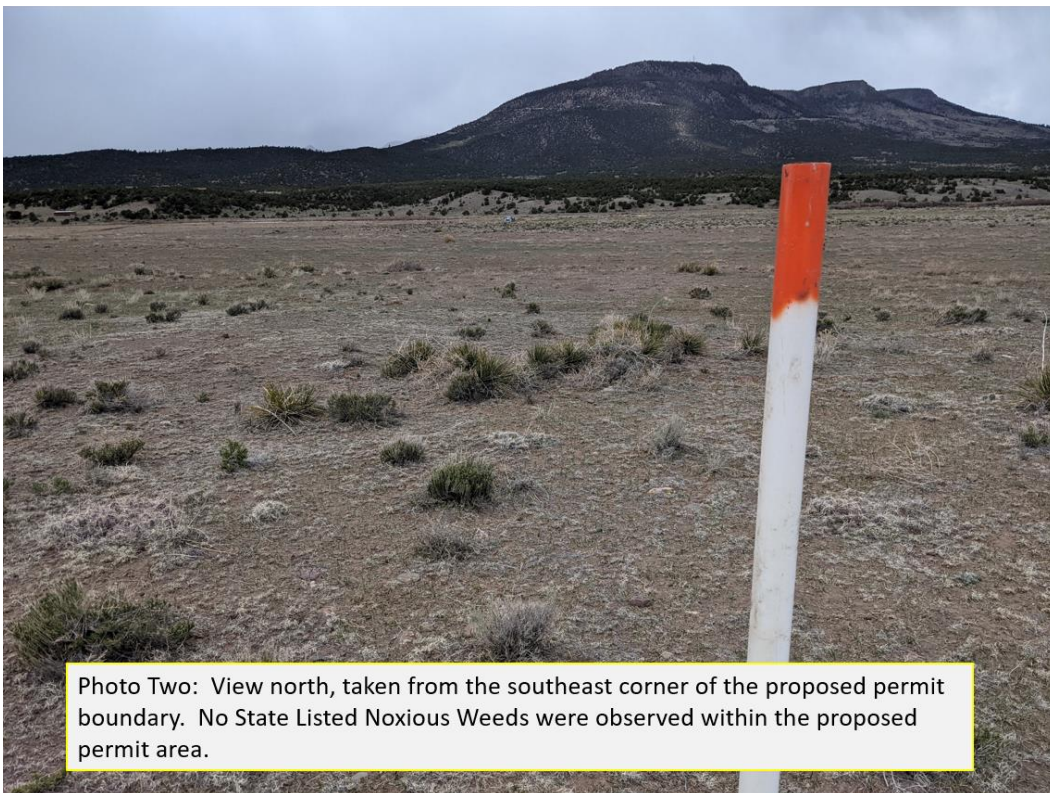
Photo Two: View north, taken from the southeast corner of the proposed permit boundary. No State Listed Noxious Weeds were observed within the proposed permit area.
