**MINERALS PROGRAM INSPECTION REPORT**  
**PHONE: (303) 866-3567**

<b>MINE NAME:</b> Hatchery Pit	<b>MINE/PROSPECTING ID#:</b> M-2014-043	<b>MINERAL:</b> Borrow material	<b>COUNTY:</b> Adams
<b>INSPECTION TYPE:</b> Monitoring	<b>INSPECTOR(S):</b> Patrick Lennberg	<b>INSP. DATE:</b> May 5, 2021	<b>INSP. TIME:</b> 12:30
<b>OPERATOR:</b> Albert Frei & Sons Inc.	<b>OPERATOR REPRESENTATIVE:</b> Ben Frei, Steve O'Brian, Jole Bolduc	<b>TYPE OF OPERATION:</b> 112c - Construction Regular Operation	
<b>REASON FOR INSPECTION:</b> Normal I&E Program	<b>BOND CALCULATION TYPE:</b> Partial Bond	<b>BOND AMOUNT:</b> \$1,056,100.00	
<b>DATE OF COMPLAINT:</b> NA	<b>POST INSP. CONTACTS:</b> None	<b>JOINT INSP. AGENCY:</b> None	
<b>WEATHER:</b> Cloudy	<b>INSPECTOR'S SIGNATURE:</b>

## **OBSERVATIONS**

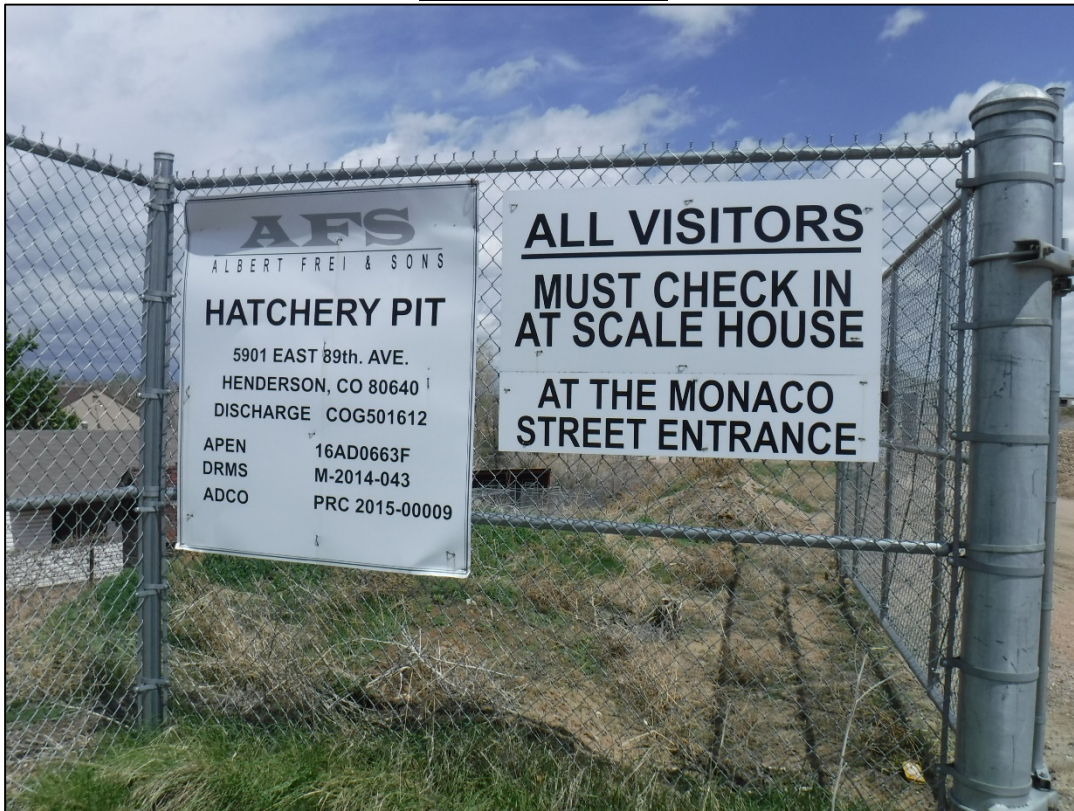
**Photo 1:** Mine sign located at the 89<sup>th</sup> Ave entrance

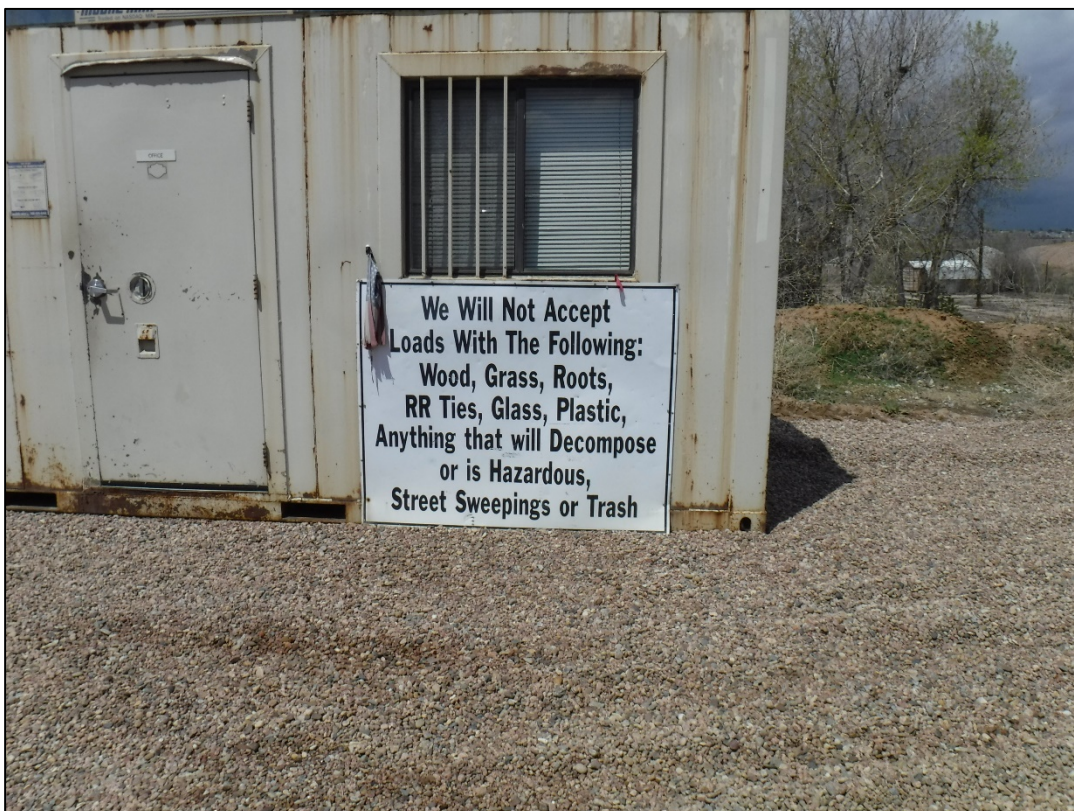
**Photo 2:** Warning sign at truck entrance off of 89<sup>th</sup> Ave

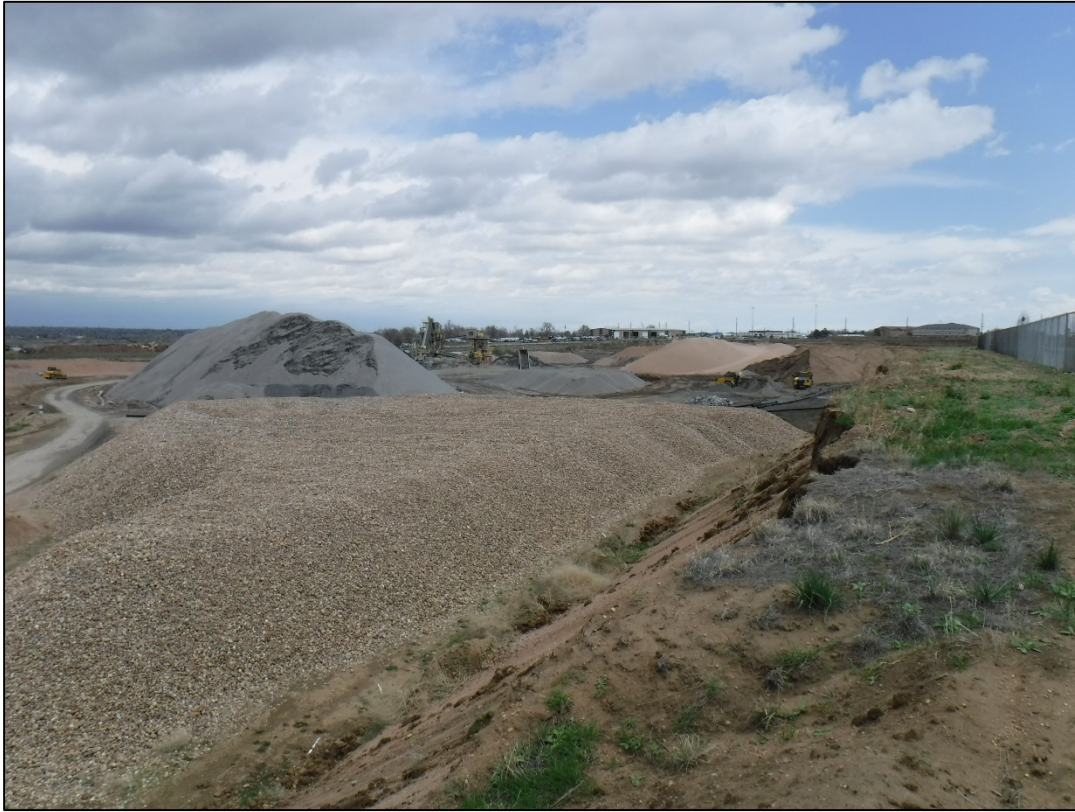
**Photo 3:** Looking northeast across the site from near the mine entrance

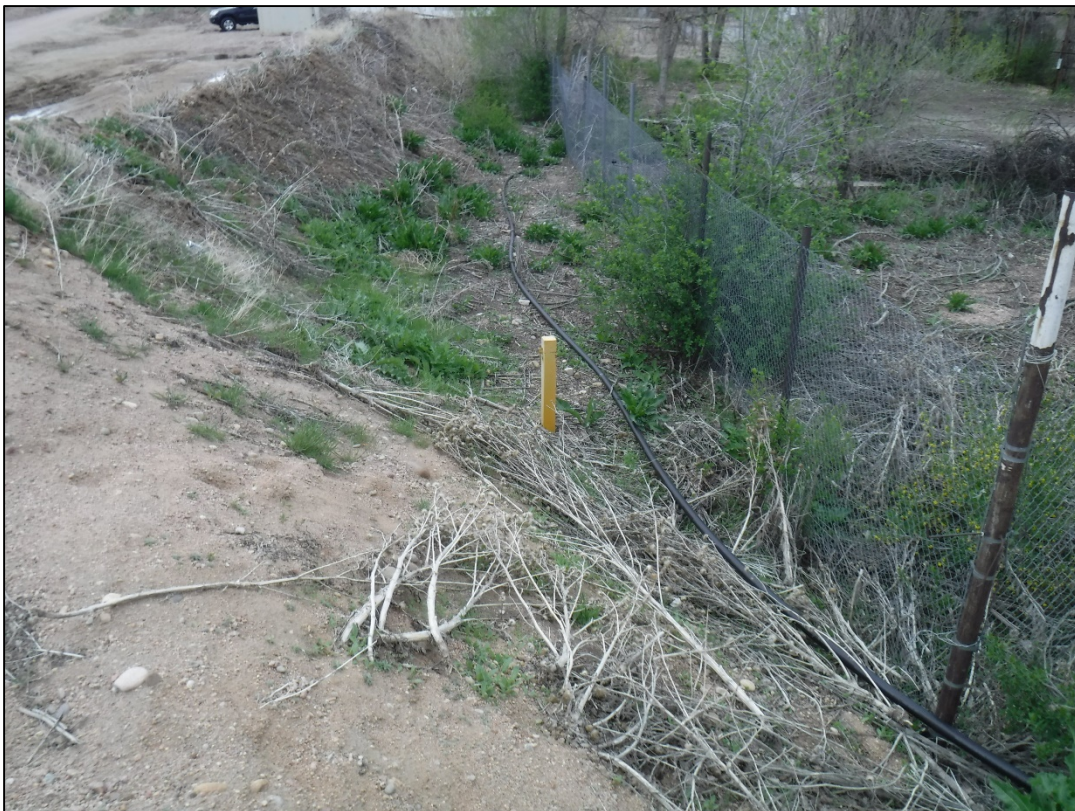
**Photo 4:** Monitoring well MW-5

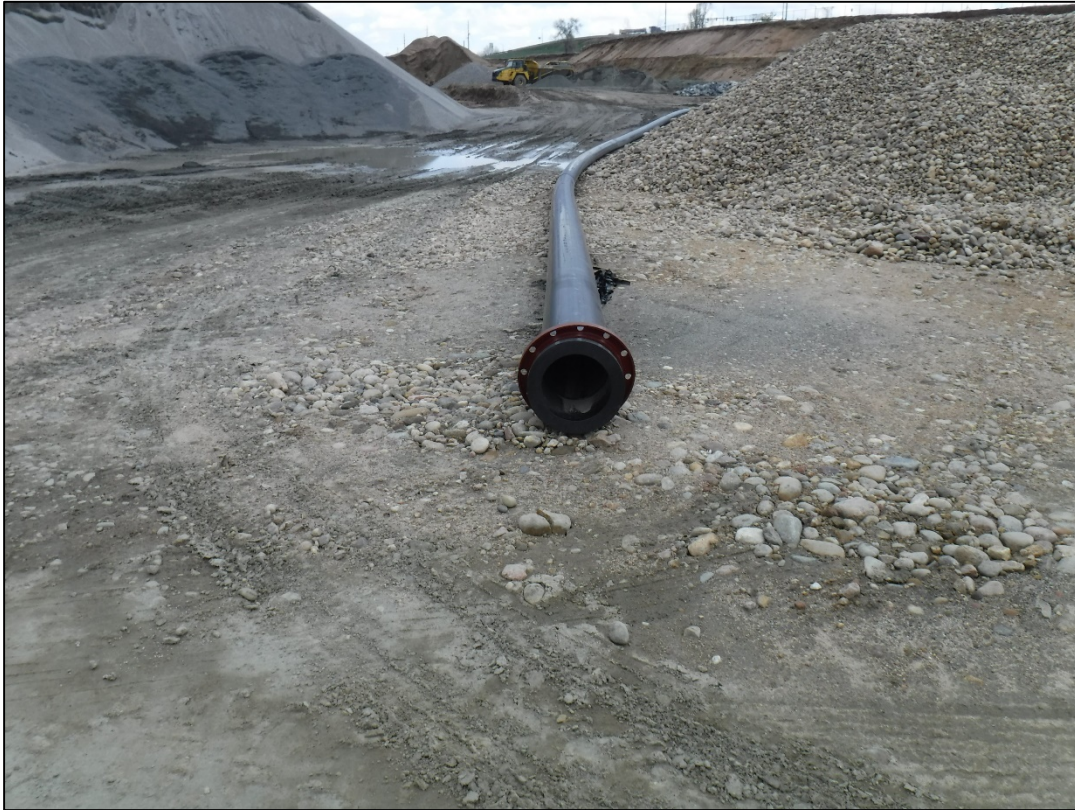
**Photo 5:** Non-perforated drain pipe going to be used for portions of the French Drain

Ben confirmed the pipe diameters are 14" perforated and 12" straight.

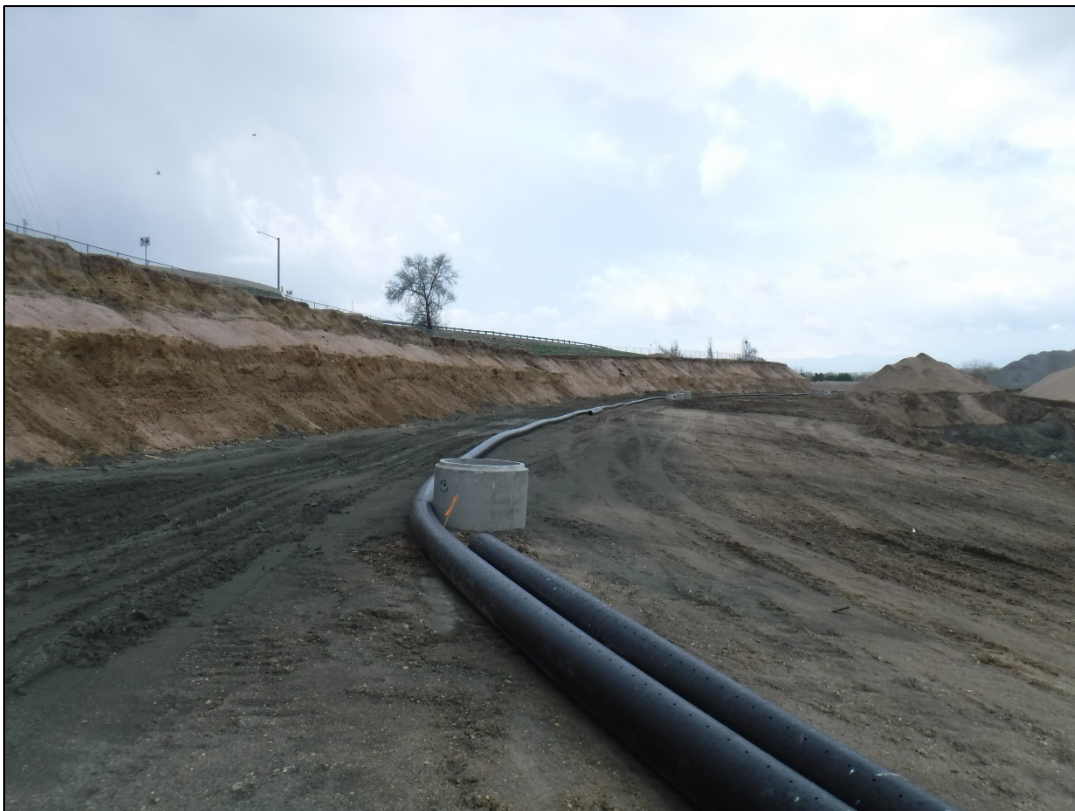
In January 2019 TR-01 was approved. In the revision the operator committed to install a clay liner and French Drain system to prevent groundwater from interacting with inert fill material planned to be used as backfill in the pit area of Phase 2 and the drain will help mitigate impacts to groundwater flow around the pit. The revision also clarified the use of the pre-1981 pond located in the northwestern area of the permit. The Division of Water Resources does not require a leak test of liners or slurry walls if the lined area will not hold water, see attachment 2 letter from DWR. At the time of the inspection the clay liner had been completed and the manholes were in various stages of installation. The pipe for the drain had been field placed and welded. The pipe was 14-inch diameter for the perforated runs and 12-inch in diameter for the non-perforated runs. When the construction is complete the operator stated they would submit as-built drawings of the project to DRMS for inclusion into the permit file.

**Photo 6:** Looking southeast along the southern permit area, drain pipe and manholes staged and compacted clay liner completed

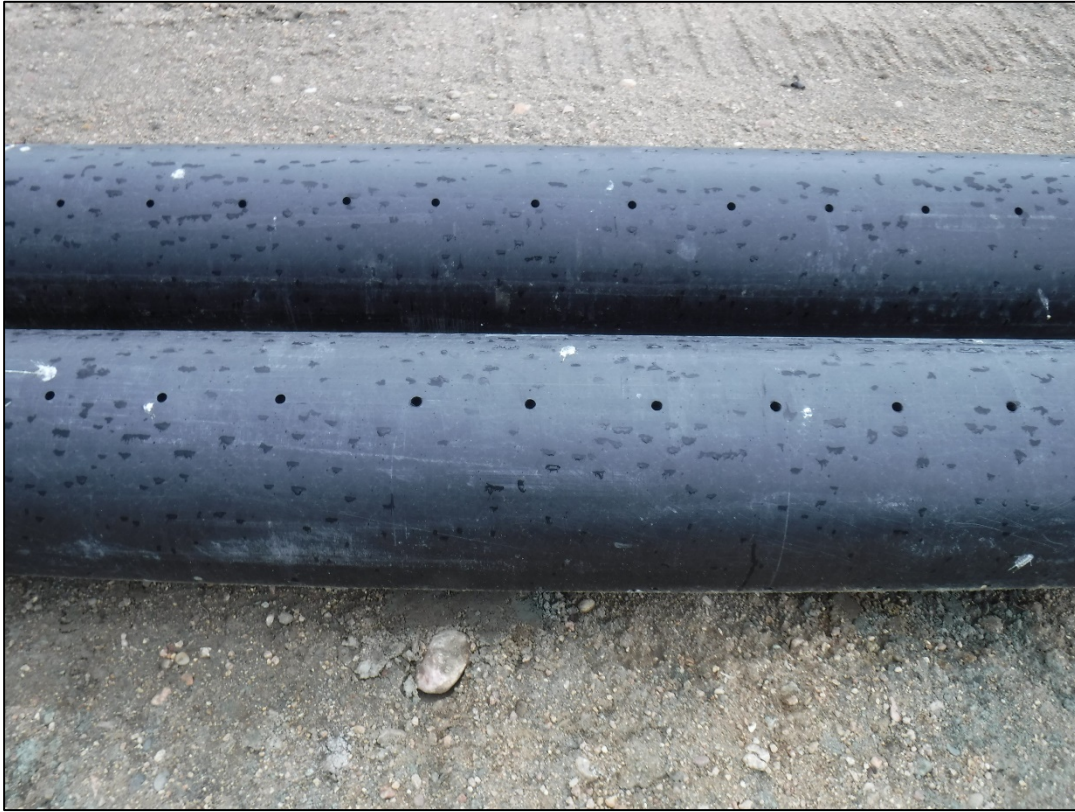
**Photo 7:** Perforated drain pipe for French Drain

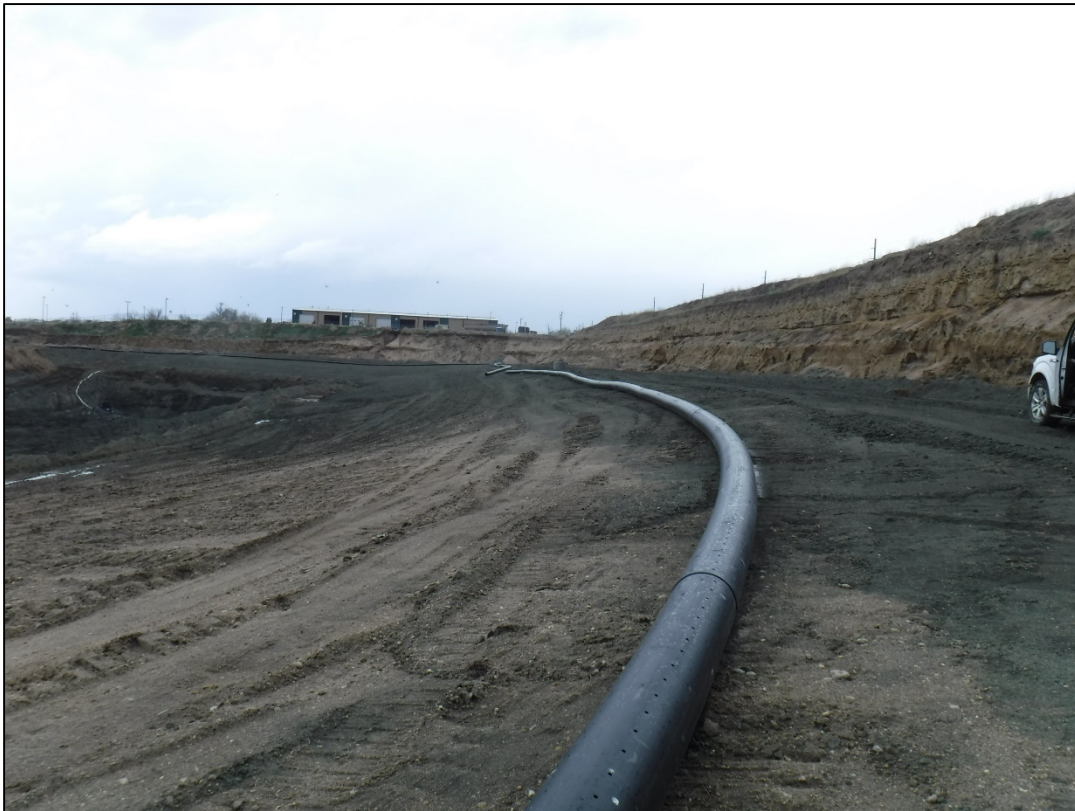
**Photo 8:** Looking north along east side of pit towards MW-1

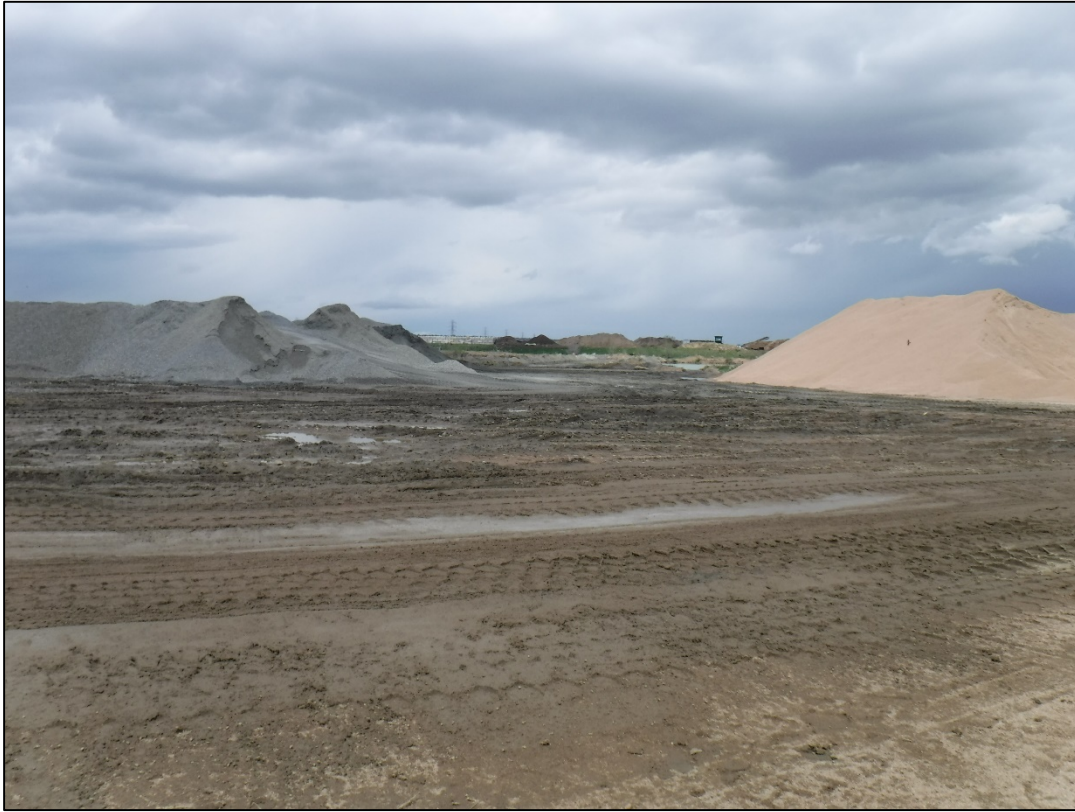
The site was active at the time of inspection and there was a large processing plant working. Trucks were entering the site off of 89<sup>th</sup> Avenue and exiting via a scale house to Monaco Street. The Phase 1 area was completely backfilled using material from the mine site, no offsite inert material was used, and is currently being used as a product stockpile location.

**Photo 9:** Looking north from the Phase 1 area, stockpiles are staged on Phase 1 fill areas

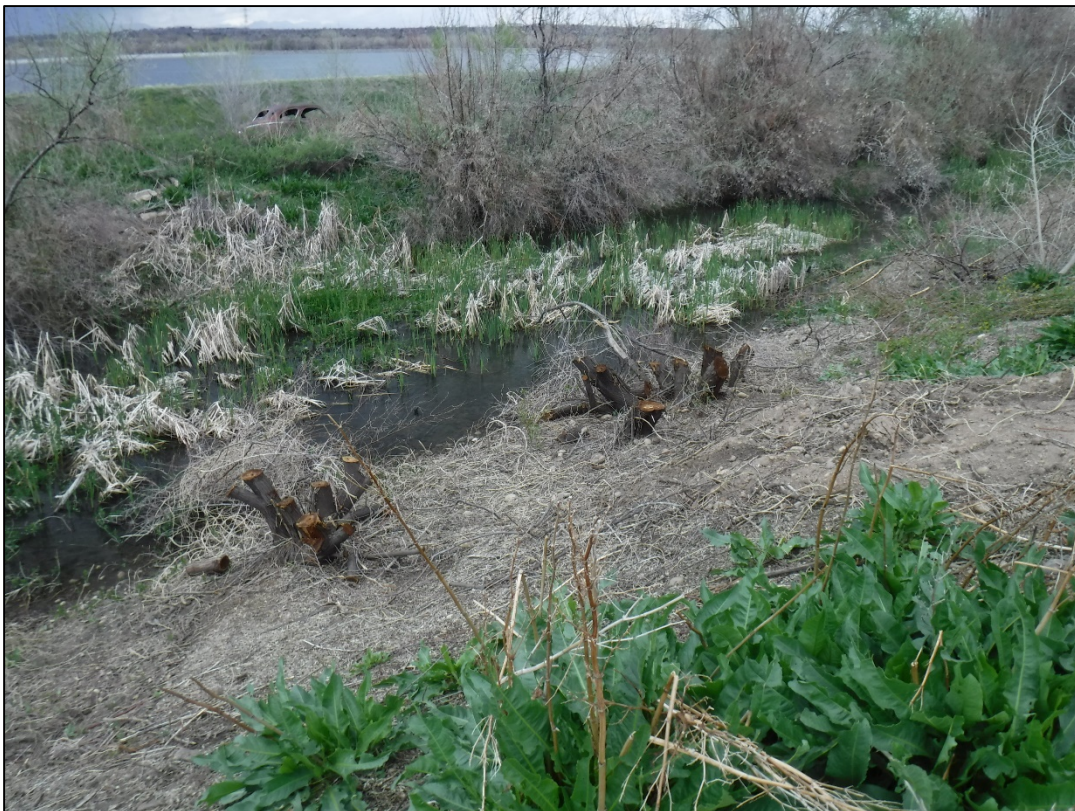
In April 2021 the operator removed approximately 20 Russian Olive trees from 13 locations along the north western permit boundary with the Bull Seep. The operator provided documentation of their efforts see attachment 4. During the inspection several stumps were observed where the trees used to be located.

**Photo 10:** Russian Olive tree stumps from recent removal along Bull Seep

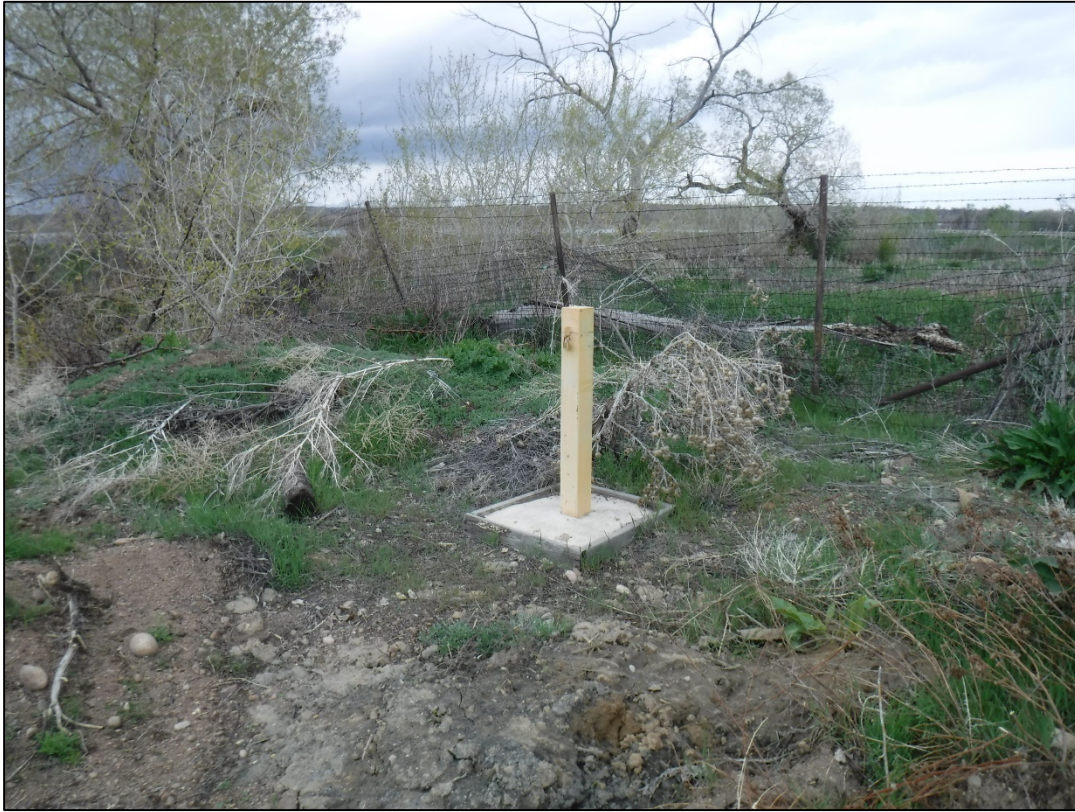
**Photo 11:** Monitoring well MW-7

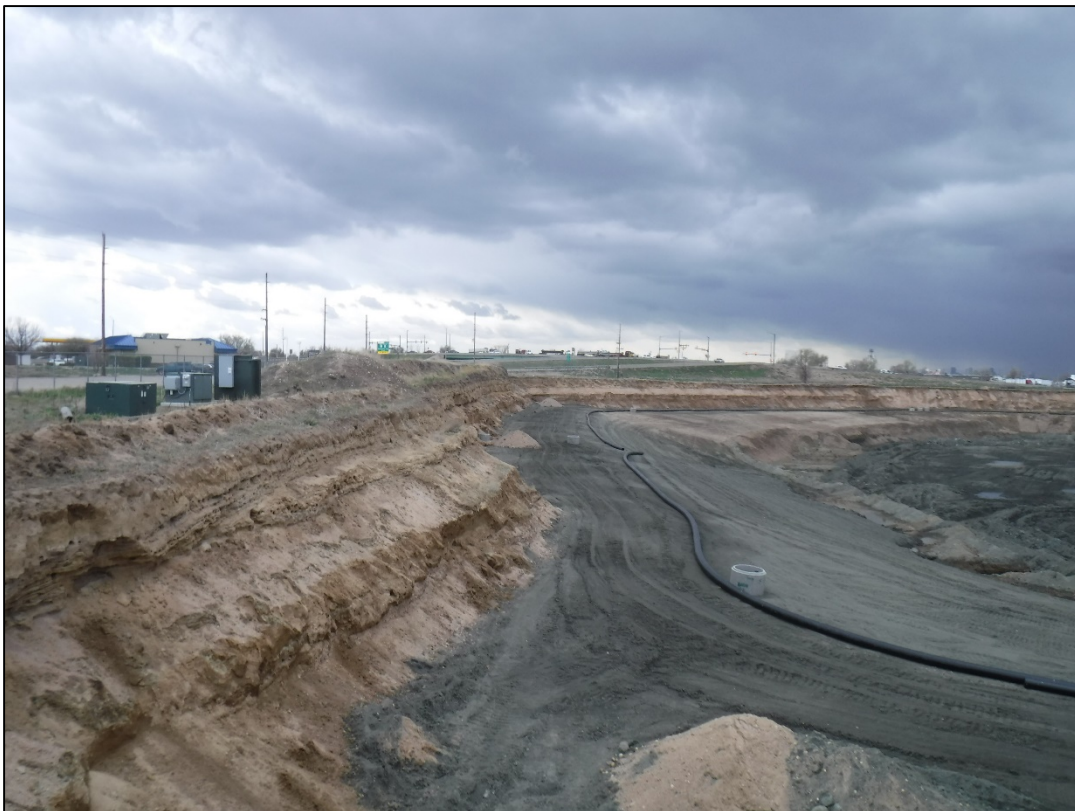
**Photo 12:** Looking from MW-1 location south across the Phase 2 area

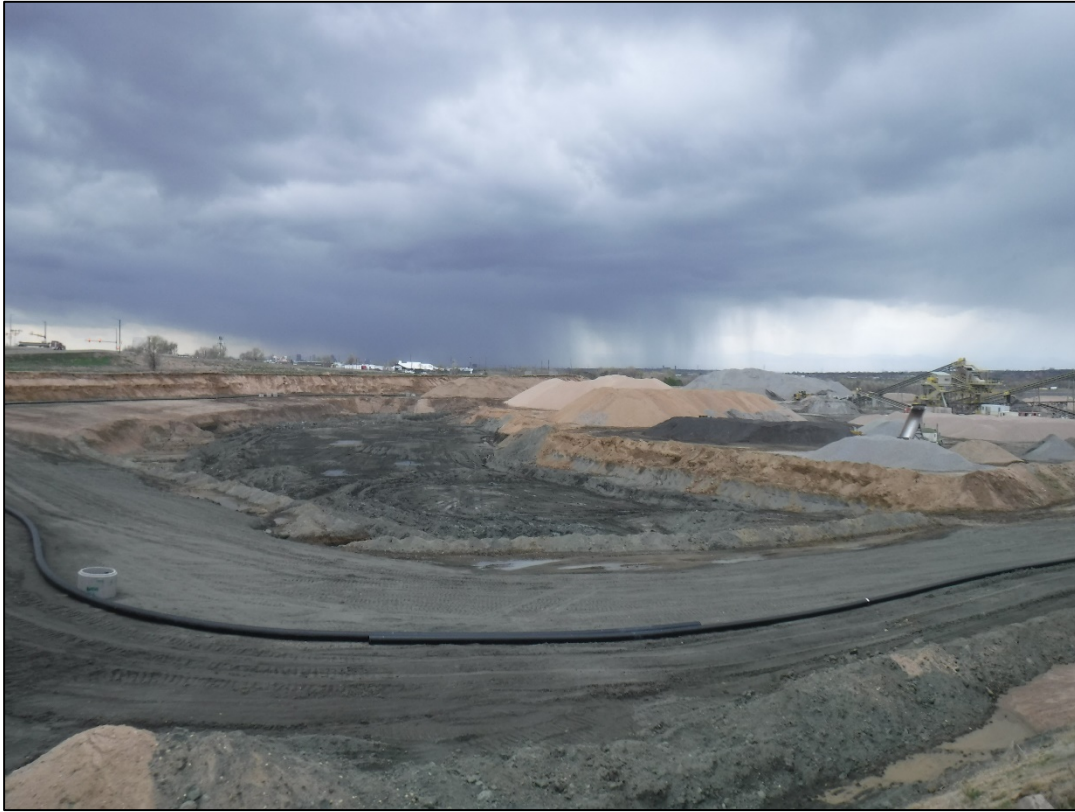
**Photo 13:** Looking from MW-1 location southwest across the Phase 2 area

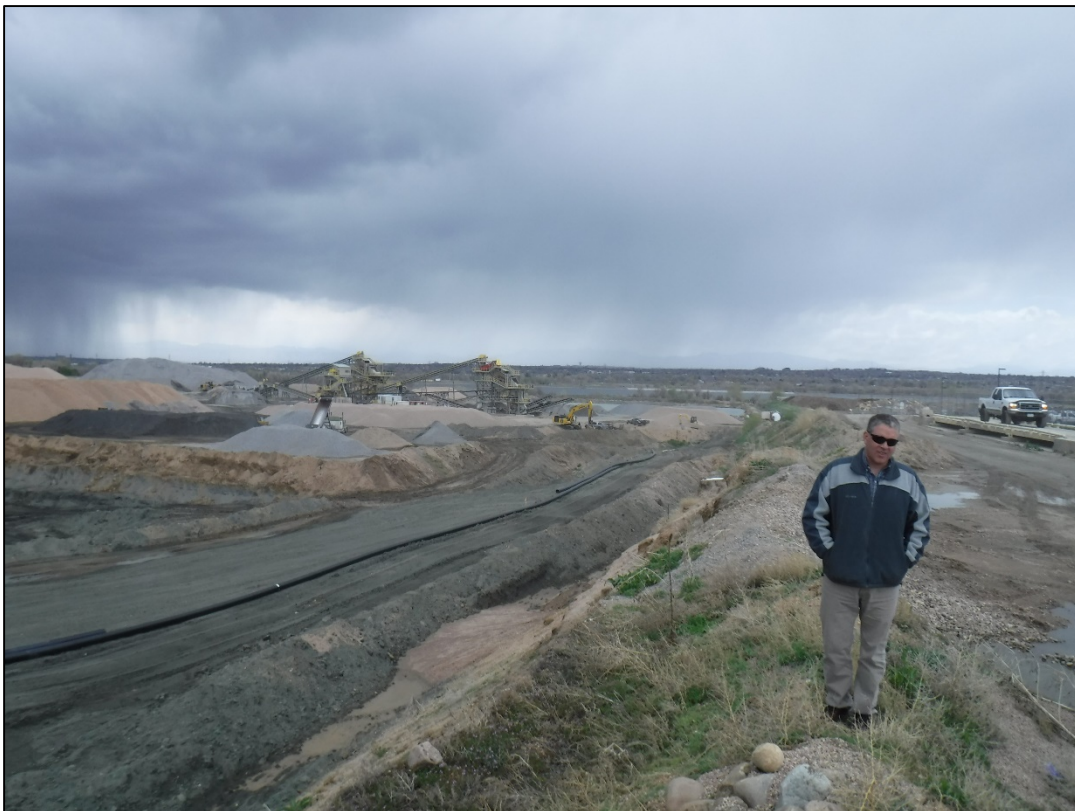
**Photo 14:** Looking from MW-1 location west across the Phase 2 area

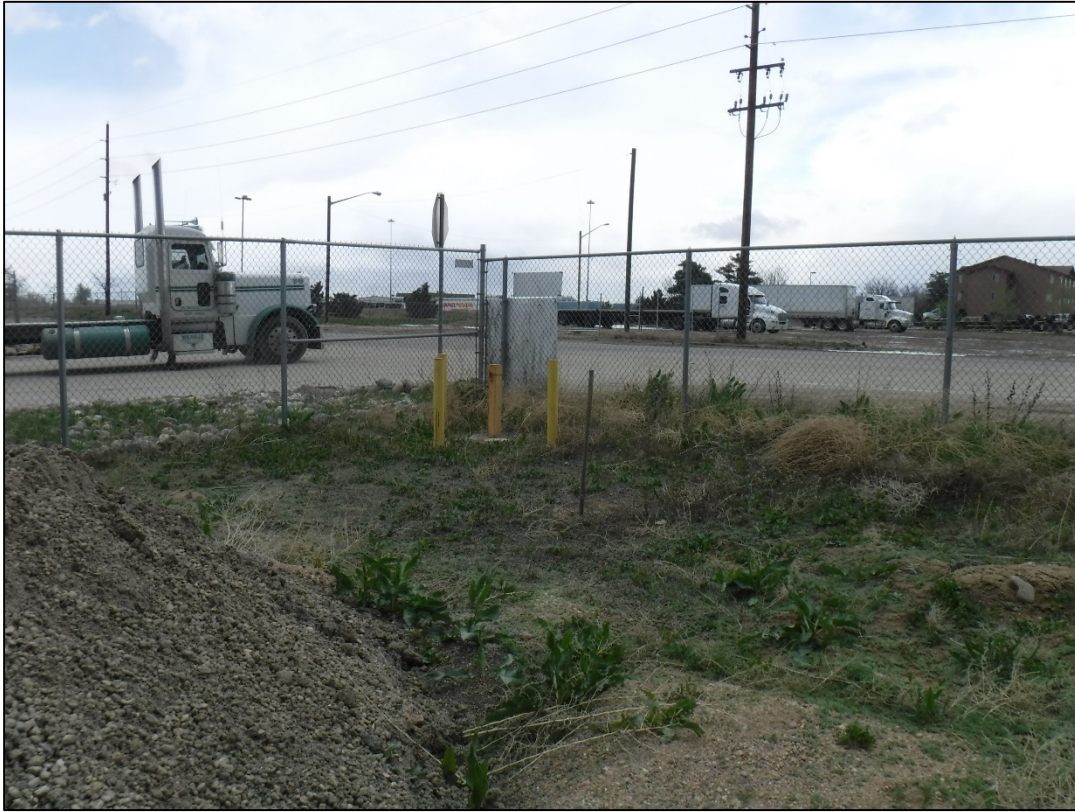
During the file review prior to the inspection it was noted in the Annual Groundwater Monitoring Data Report that MW-1 exceeded the low level limit in October 2020. The operator measures groundwater on a monthly basis at the site and only is required to inform the Division if groundwater elevations exceed a trigger level for 3 consecutive months. The Division did not have current groundwater data and was going to site problem for exceeding the trigger level. A discussion onsite and the operator's quick follow-up with additional groundwater information proves that the trigger was only exceeded at MW-1 for one month and has subsequently rebounded. It was also determined the depressed level was probably due in part to de-watering in the area near the well at the time of measurement. Attachment 3 provides graphs of groundwater levels to date across the site, including an offsite well, the Broda well. The graphs indicate there are no current impacts to the surrounding hydrology.

**Photo 15:** Monitoring well MW-1

Good news. MW-1 only dropped below the low trigger for one month and the monitoring plan states that an investigation if we exceed a trigger level for 3 consecutive months. The drop was associated with dewatering done specifically to install the compacted liner. Now that the liner is installed and dewatering stopped, water levels have returned to normal.

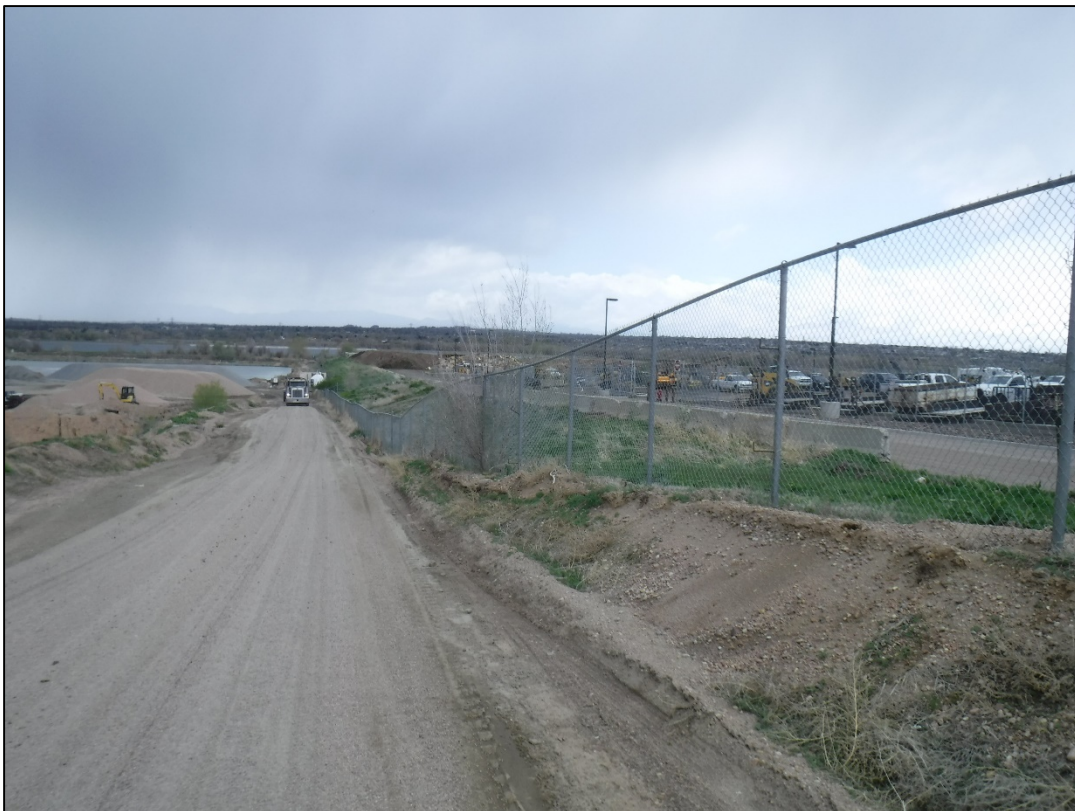
**Photo 16:** the approximate location of the Broda well in near the center right of the picture
