**MINERALS PROGRAM INSPECTION REPORT**  
**PHONE: (303) 866-3567**

| <b>MINE NAME:</b><br>Cresson Project | <b>MINE/PROSPECTING ID#:</b><br>M-1980-244 | <b>MINERAL:</b><br>Gold | <b>COUNTY:</b><br>Teller |
| <b>INSPECTION TYPE:</b><br>Monitoring | <b>INSPECTOR(S):</b><br>Brock Bowles | <b>INSP. DATE:</b><br>March 29, 2021 | <b>INSP. TIME:</b><br>09:00 |

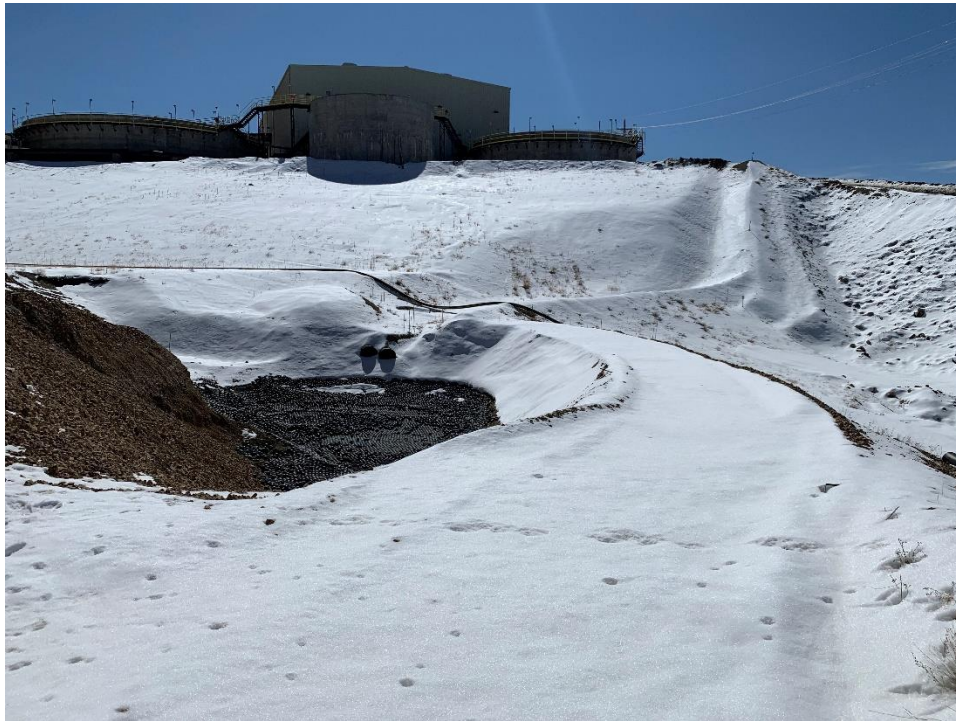
The PSES pond was the subject of a possible problem noted in the June 30, 2020 inspection. CC&V abated the problem in January 2021 by increasing the depth and surface area of the pond to accommodate larger flows, and increased the embankment width to 10 feet. This was a follow up inspection to see the repairs. The pond appeared to be bigger than when last observed, although, the pond dimensions were not recorded before or after the completed work to verify the increase in size. The larger pond capacity will increase the infiltration rate of solution. The embankment width was increased from 2 feet wide to 10 feet wide across the top (photo 1). The top of embankment measurement was verified. The larger embankment width greatly enhances the stability of the embankment. The embankment stability is important because of the pond's proximity to the edge of liner. No water/solution was in the pond and the bird balls were in place.

Photo 1 – PSES pond larger embankment

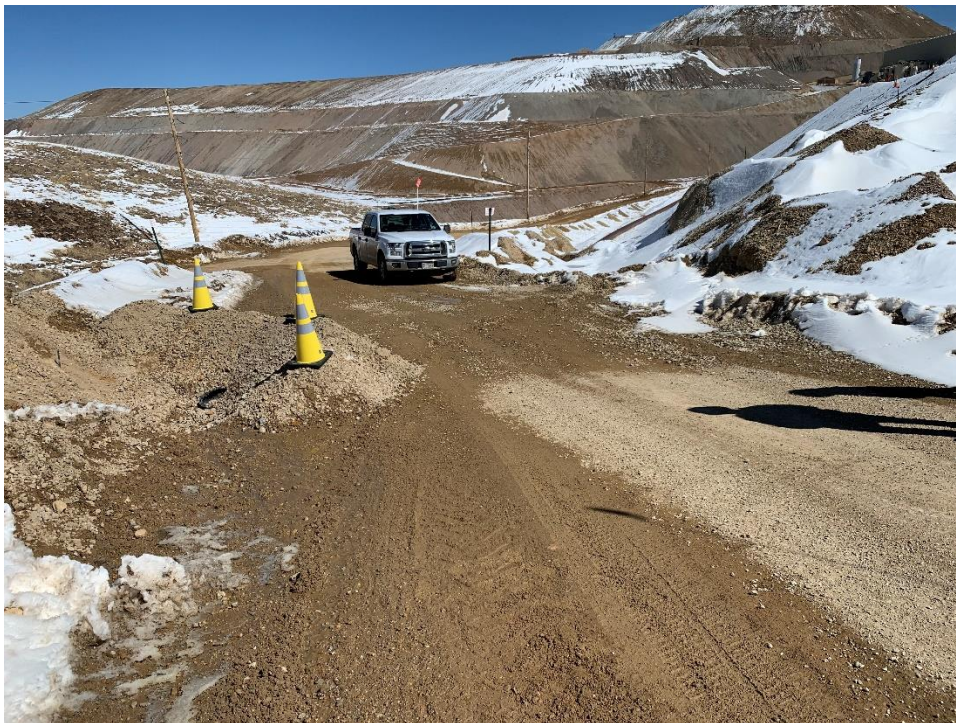
A section of the ADR2 Access Road, located SE of the ADR2 facility, crosses the VLF1 edge of liner. The grade of the road in this area is steep and due to the nature of the terrain, solution and impacted storm water has the potential to follow the road off-liner. A sump and water bar were installed across the road to direct solution off the road and back over liner (photo 2). The sump and water bar were in good condition and were directing solution away from the road and back towards lined areas. The Operator should monitor this area throughout the spring and summer to ensure the sump and water bar remain effective.

Photo 2 – Water bar and sump across the access road

The Operator may consider regrading the road above the sump/water bar as an additional low maintenance tool to keeping solution on-liner. The road through the area is sloped outward, or downhill. This forces solution to the outside of the road and into the sump and 6" culvert under the road. Sumps and culverts need constant maintenance, especially in winter. If the road above the sump/culvert was graded inward toward the hill, it forces solution to the inside of the road, into a roadside ditch and downhill to the big perimeter ditch keeping solution on-liner. Also, if 100-200 feet of road above the sump is sloped inward, it creates a gentle change in the roadbed that snow plows will have little effect on (versus a water bar which is easily taken out by a snow plow).

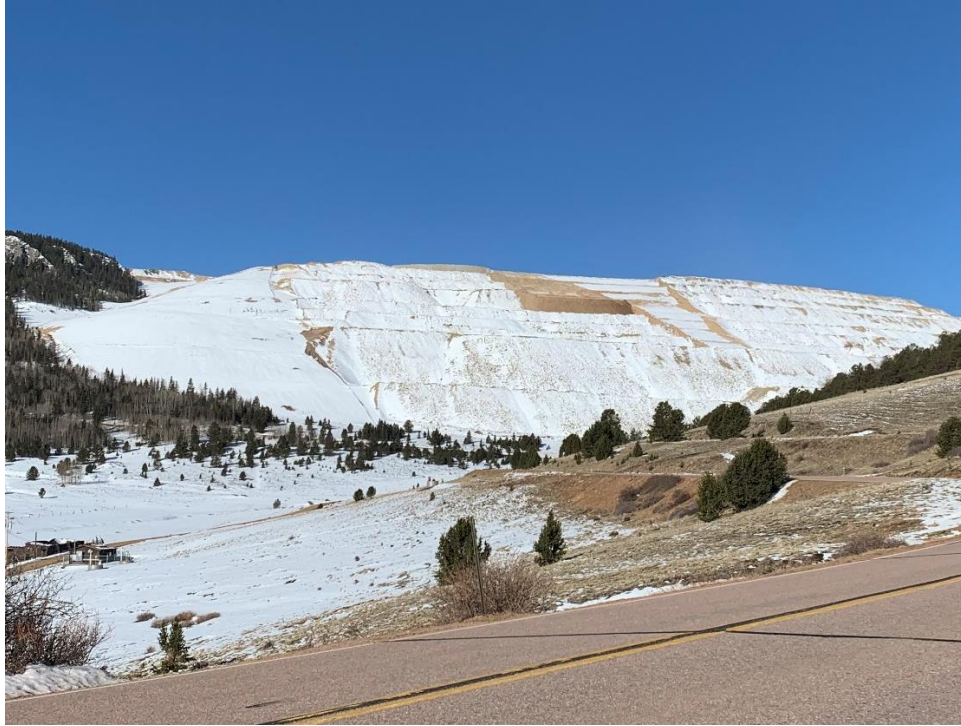
A section of the ECOSA was being graded to final grade. The work was being done on the southern end of the pile, north of last year's reclamation work (photo 3). A single bulldozer was pushing material downhill from the top of the pile. The top and bottom of the work area was inspected. The top of the work area had been graded, slightly sloped to the north (photo 4).

Photo 3 – Grading work on ECOSA

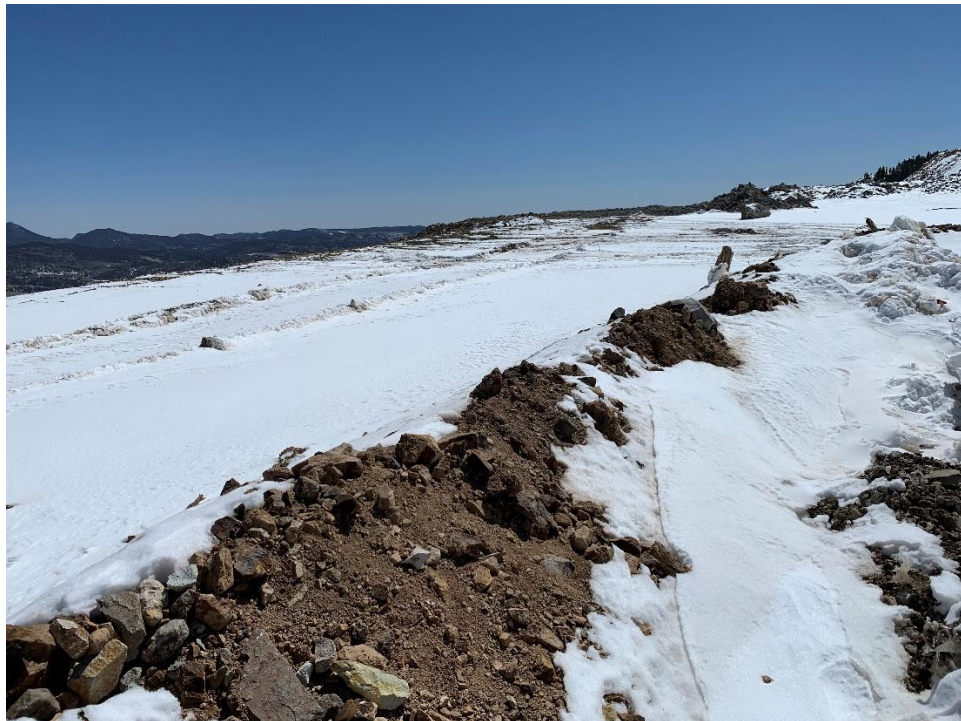
Photo 4 – ECOSA graded at the top, facing south

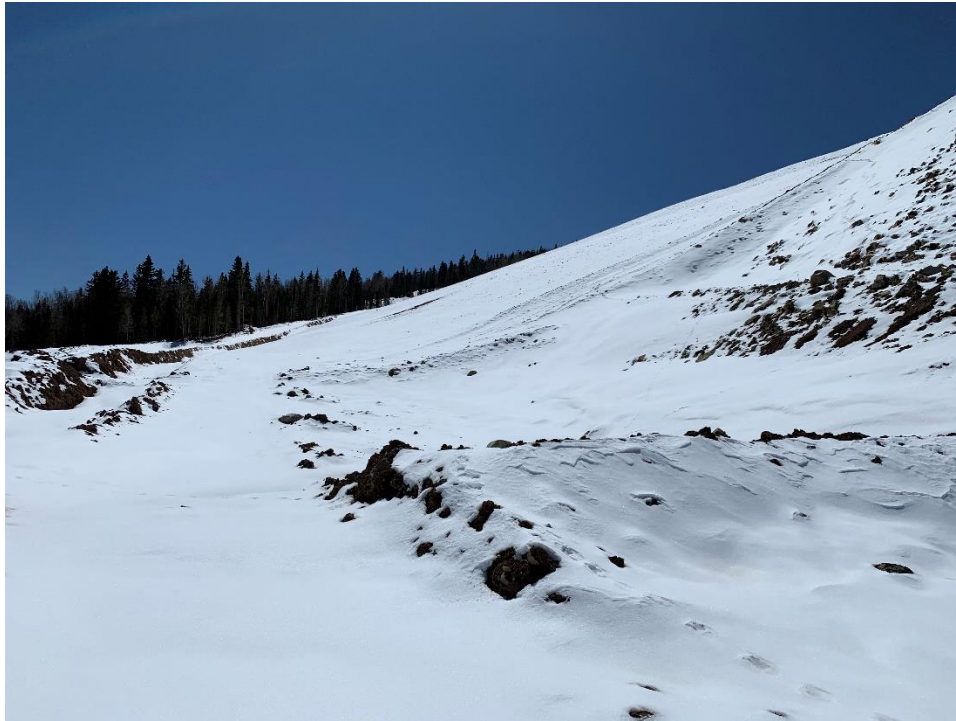
The bulldozer operator was contacted via radio and he gave permission to inspect the area below grading operations. The grading work did not reach the bottom of the ECOSA yet and the current grading work could not be seen due to the terrain. The area was snow covered and the access road was very muddy and slippery making driving conditions difficult. No slides, boulders, or evidence of falling loose material was seen below the grading operations (photo 5).

Photo 5 – ECOSA below grading operations

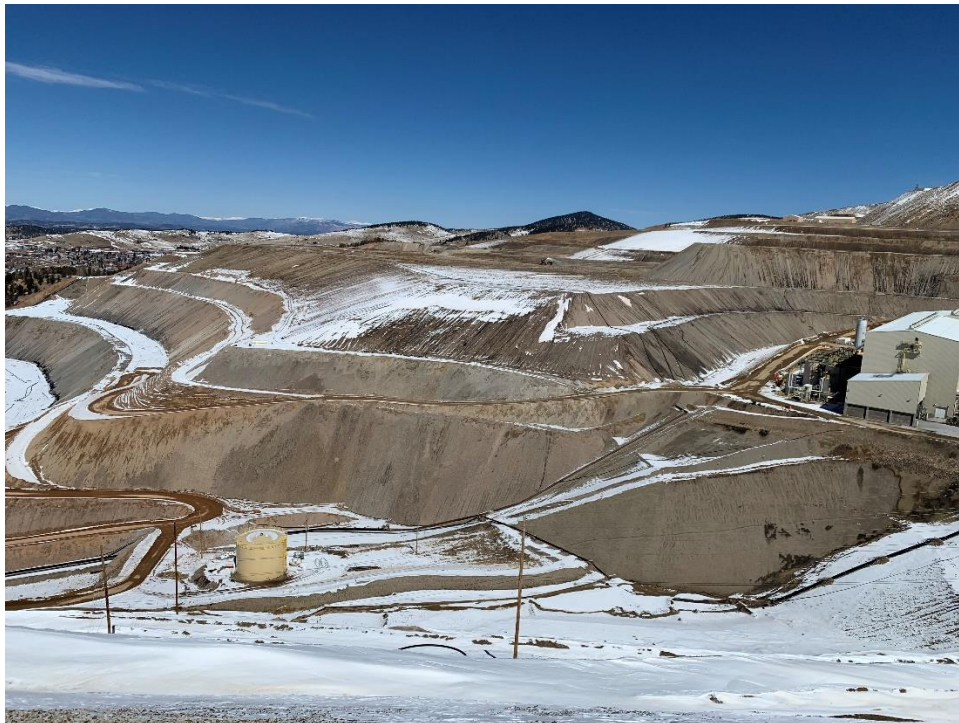
Photo 6 – VLF2 overlook
