Bowie #1 inspection report

PERMIT INFORMATION

Permit Number: C-1981-038	County: Delta	
Mine Name: Bowie No. 1 Mine	Operation Type: Underground	
Operator: Bowie Resources, LLC	Permit Status: Active	
Operator Address:	Ownership: Private	
Mr. Basil R Bear	-	
P.O. Box 1488	Operator Representative Present:	
Paonia, CO 81428	_	
	Basil Bear	
Operator Representative Signature: (Field Issuance Only)

Inspection Start Date: May 6, 20 Inspection Start Time: 07:45 Inspection End Date: May 6, 202 Inspection End Time: 14:45			Inspection Type: Coal Partial Inspection Inspection Reason: Surety Release Requested Weather: Clear
Joint Inspection Agency: Joint		Inspection Contacts:	
OSM			
Post Inspection Agency: Po		Post	Inspection Contacts:
None			
Inspector(s):	Inspector's Signature: Signature Date:		
Robert Zuber, P.E.	Phet		
Michael Cunningham			5/11/2021

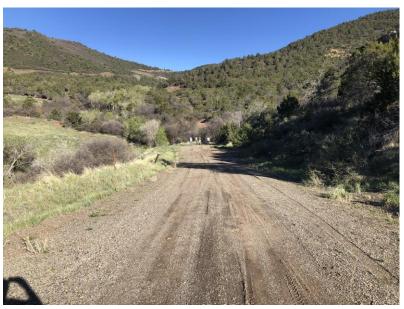
It appeared that no additional reclamation tasks are required at the ROM area, with one exception: the entrance road has not been reclaimed, and the Permit Application Package (PAP) for the mine does not indicate that this road has been designated as permanent. The Morgans (landowners) said during the inspection that they are completely satisfied with the reclamation of the ROM area (including the reclaimed pond), and they also said that they want the entrance road to remain. **Therefore, the road should be removed from the application by a request from BRL.**

Entrance road

The approximate area of the road is 0.25 acre (per a Division check using Google Earth), but this value shall be confirmed or adjusted by a BRL representative.

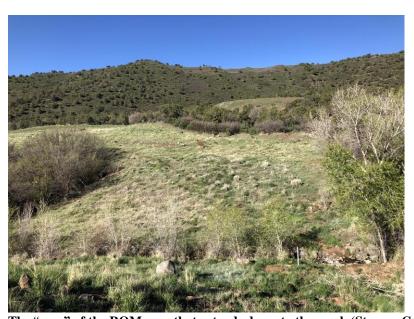
The "arm" of the ROM area that extends down to the creek (Stevens Gulch)

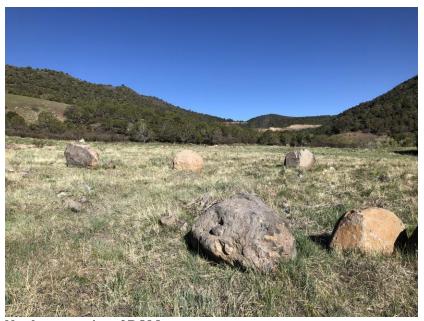
Northwest portion of ROM area

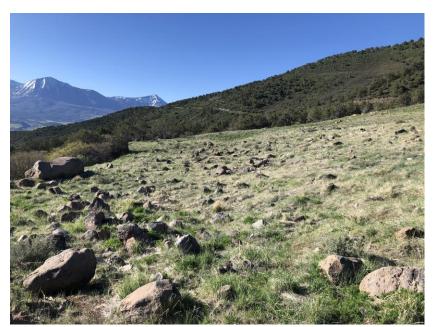
Southeast portion of ROM area

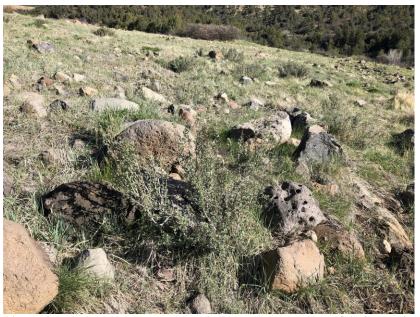
In the main part of the ROM area, the vegetation is excellent. There is significant cover, and there is a good diversity of species. The predominant species listed in the vegetation report of the bond release application includes:

Bitterbrush, grasses, and other species near southern end of main portion of ROM area (not pond area)

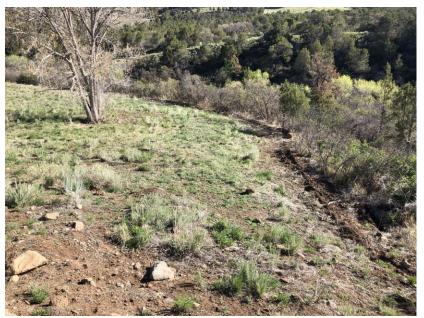
In the reclaimed pond area, the cover was not as thick as the main area, but it appears to be progressing well. The same species listed above were seen, and other desirable species were identified, including sage and rabbitbrush.

Phase II bond release applications are required to show that topsoil in the area of interest is sufficient (Rule 3.03.1(5)). Two holes were dug in the reclaimed pond area, and the topsoil was greater than six inches in both holes. This is in compliance with the general requirements of the PAP; there is no particular requirement for the ROM.

Reclaimed pond area
