**MINERALS PROGRAM INSPECTION REPORT**  
**PHONE: (303) 866-3567**

<b>MINE NAME:</b> Perkins Sandstone	<b>MINE/PROSPECTING ID#:</b> M-2006-016	<b>MINERAL:</b> Sandstone (silica, st quartzite)	<b>COUNTY:</b> Dolores
<b>INSPECTION TYPE:</b> Monitoring	<b>INSPECTOR(S):</b> Dustin Czapla	<b>INSP. DATE:</b> April 27, 2021	<b>INSP. TIME:</b> 13:30
<b>OPERATOR:</b> McStone Aggregates, LLC	<b>OPERATOR REPRESENTATIVE:</b>	<b>TYPE OF OPERATION:</b> 112c - Construction Regular Operation	
<b>REASON FOR INSPECTION:</b> Normal I&E Program	<b>BOND CALCULATION TYPE:</b> Complete Bond	<b>BOND AMOUNT:</b> \$15,696.00	
<b>DATE OF COMPLAINT:</b> NA	<b>POST INSP. CONTACTS:</b> None	<b>JOINT INSP. AGENCY:</b> None	
<b>WEATHER:</b> Snowing	<b>INSPECTOR'S SIGNATURE:</b>

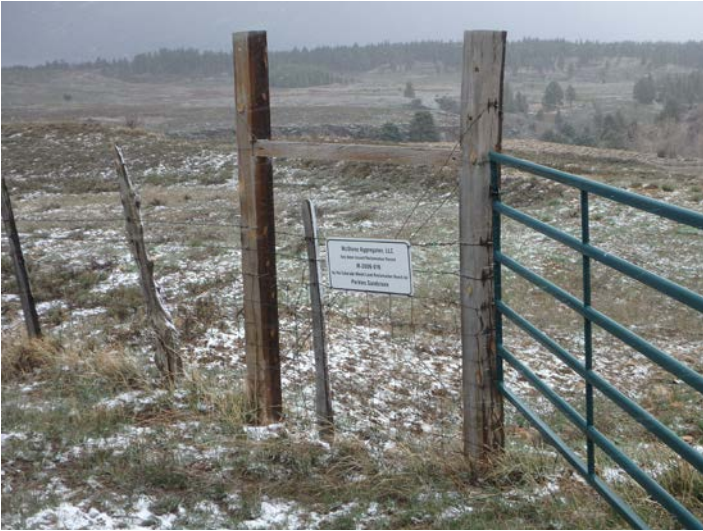
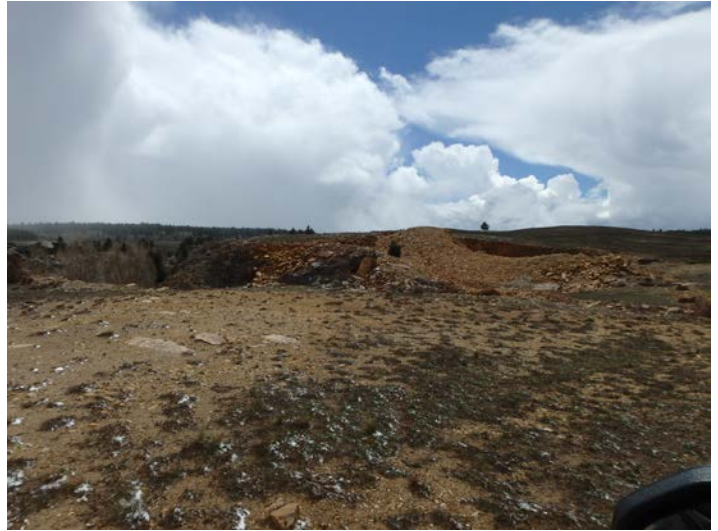
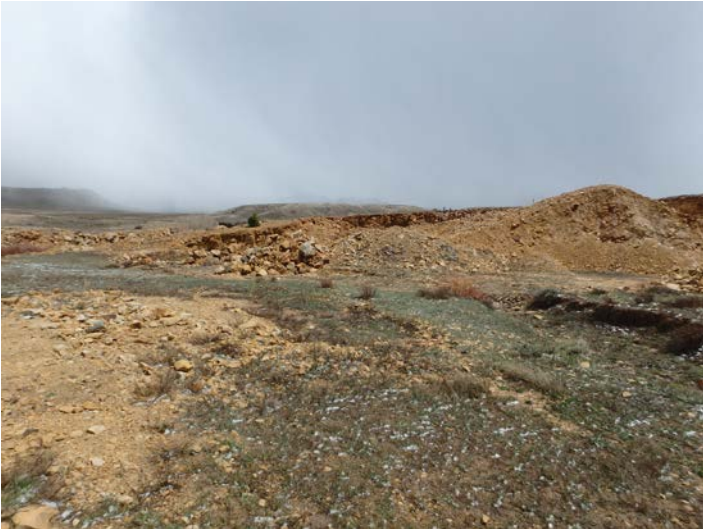
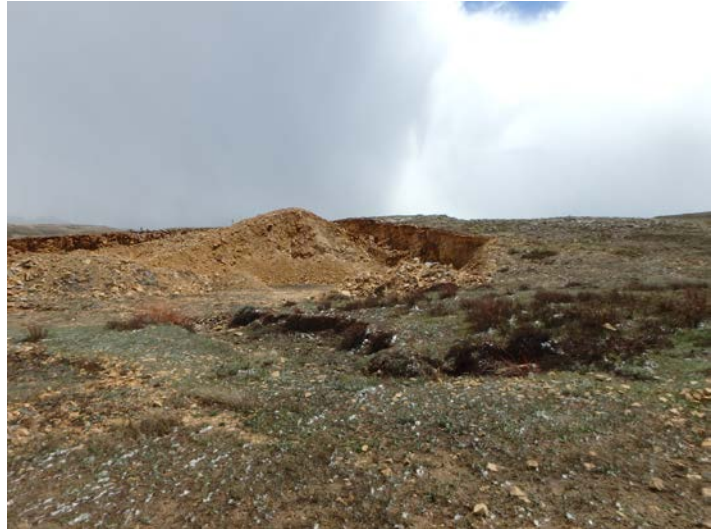
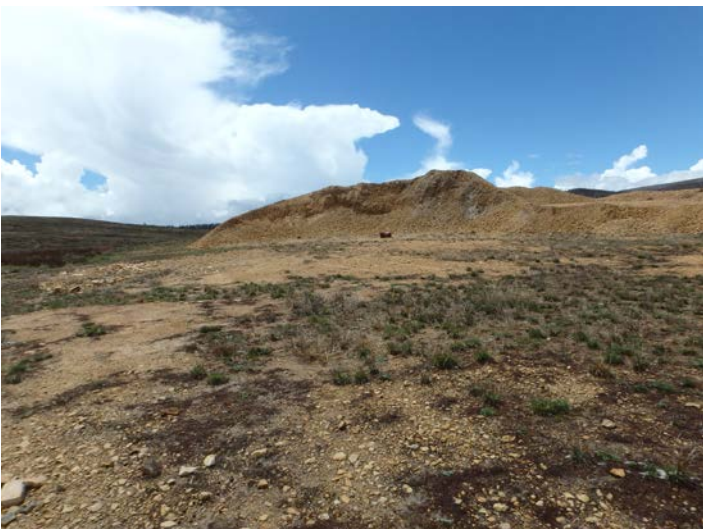
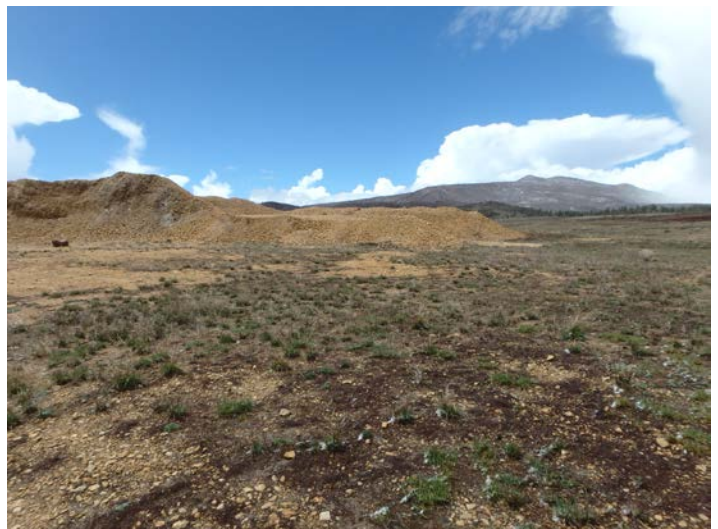
Adequate mine identification signage was noted at the entrance to the site.

Approximately three acres are currently disturbed by the operation. There was no equipment on site during this inspection. The active pit area is the southeast part of the permit area, where there is a section of vertical highwall, approximately 40 feet high by 80 feet in length. Unprocessed material is stockpiled at the base of the highwall. Crushed material is stockpiled on the west side of the pit area.

No trash or debris was noted around the site. Overall, the site is orderly. No problems or violations were noted during this inspection.
