COLORADO
Division of Reclamation,
Mining and Safety
Department of Natural Resources

Permit Number: C-1981-038 Mine Name: Bowie No. 1 Mine Operator: Bowie Resources, LLC Operator Address: Mr. Basil R Bear P.O. Box 1488 Paonia, CO 81428	County: Delta Operation Type: Underground Permit Status: Active Ownership: Private
	Operator Representative Present: None
Operator Representative Signature: (Field Issuance Only)

Inspection Start Date: May 12, 2021 Inspection Start Time: 16:30 Inspection End Date: May 12, 2021 Inspection End Time: 16:32		Inspection Type: Aerial Inspection Inspection Reason: Normal I&E Program Weather: Clear	
Joint Inspection Agency: None		Joint Inspection Contacts:	
Post Inspection Agency: None		Post Inspection Contacts:	
Inspector(s): Robert Zuber, P.E. Brock Bowles	Inspector's Signature:

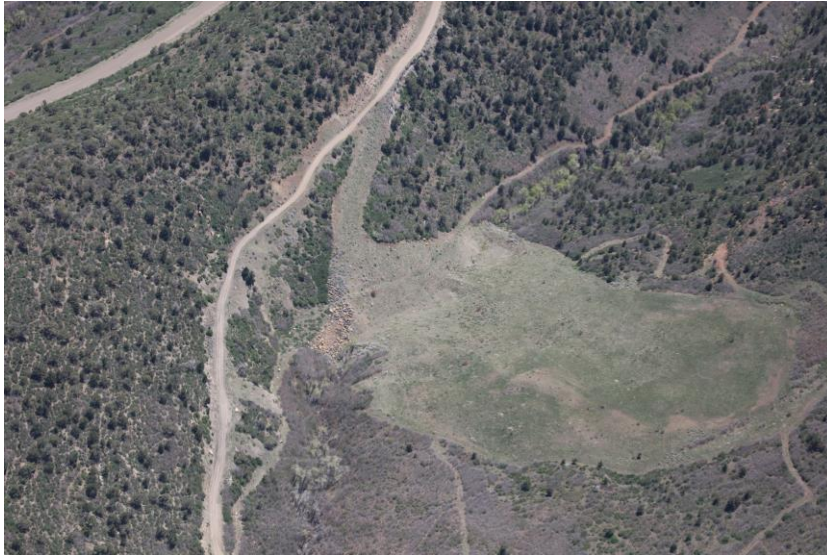
West Mine

The ponds at the West Mine, the pond at the former coal storage area by Black Bridge Road, and the pond at the loadout appeared to be completely dry. No problems were seen with the embankments or other portions of these ponds.

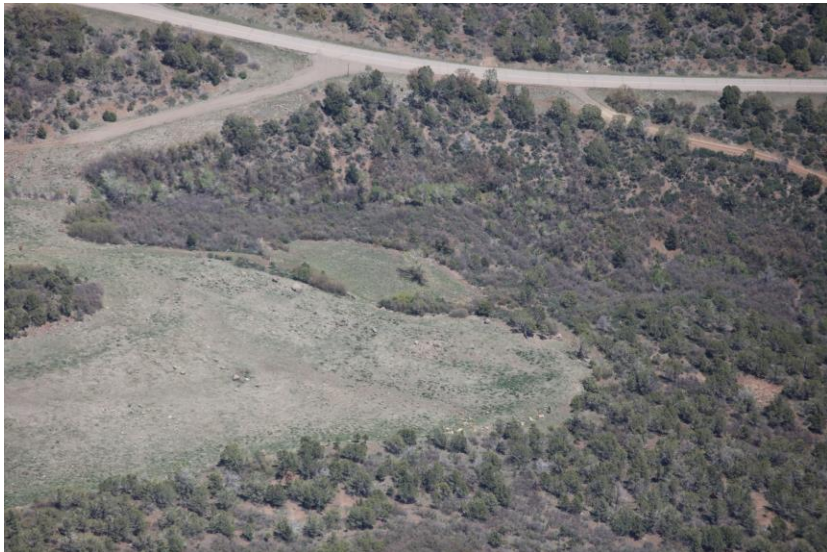
ROM Area

No erosion problems were identified. The vegetation was brown in some areas and green in others, as expected in May.

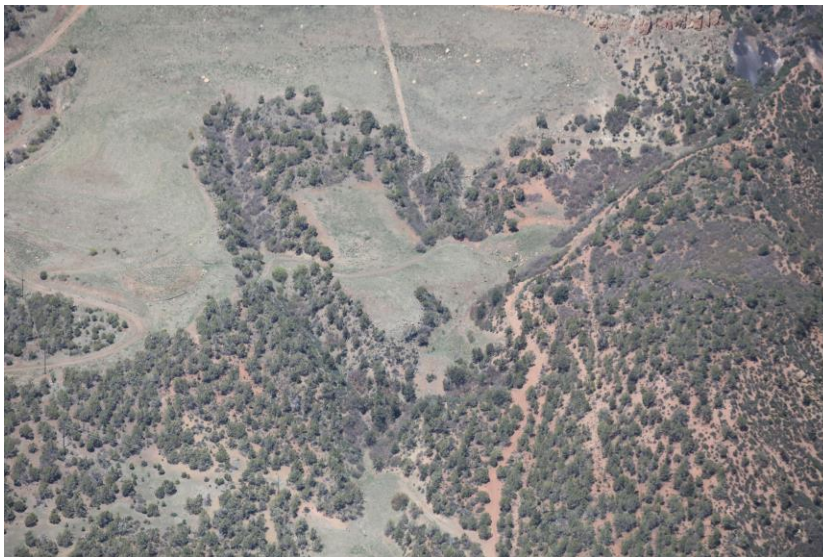
Lower end of the East Mine, including the RDA, the Old Waste Disposal Area, and Ponds 1 and 2

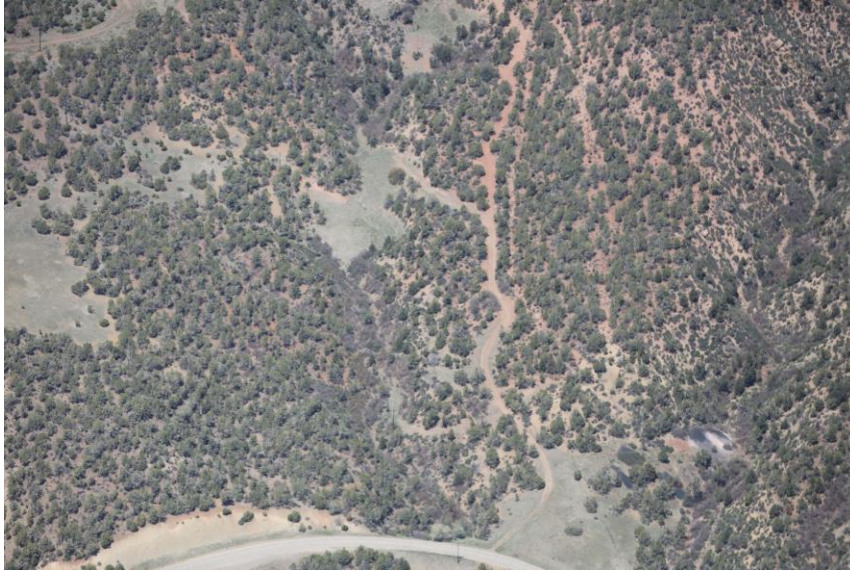
Ponds 3 and 4 at East Mine (center of photo)

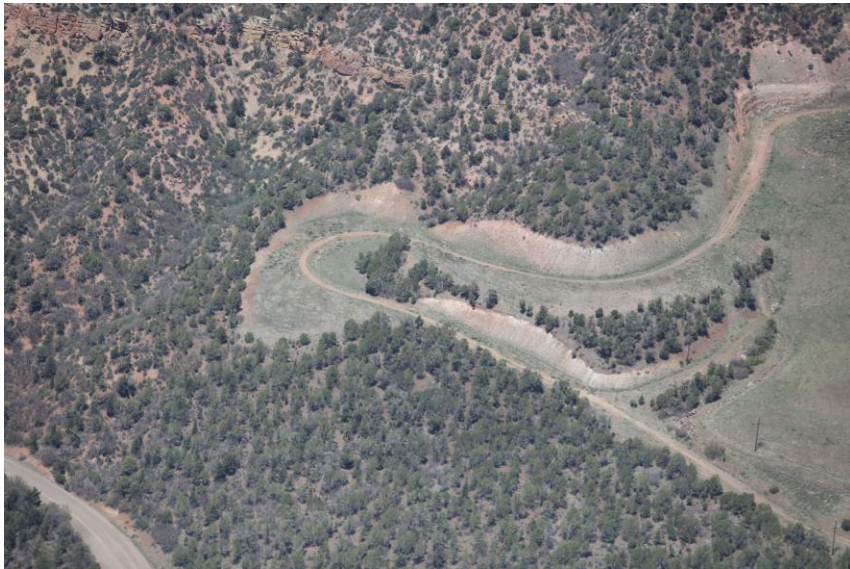
No erosion or other problems were identified with the road at the East Mine.

Road west of the RDA at the East Mine

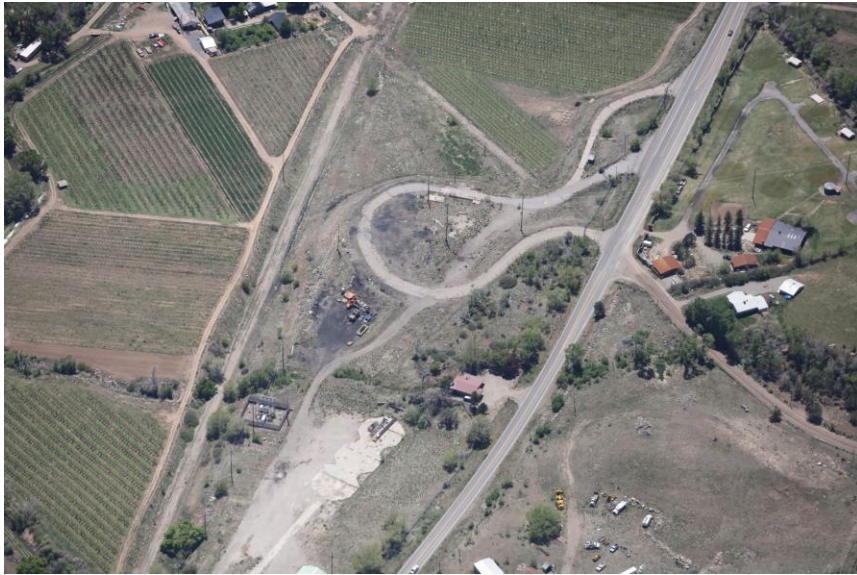
The loadout

No erosion or other problems were identified at the loadout. This includes the eastern portion, along the UPRR tracks and adjacent to Grange Road and Black Bridge Road.

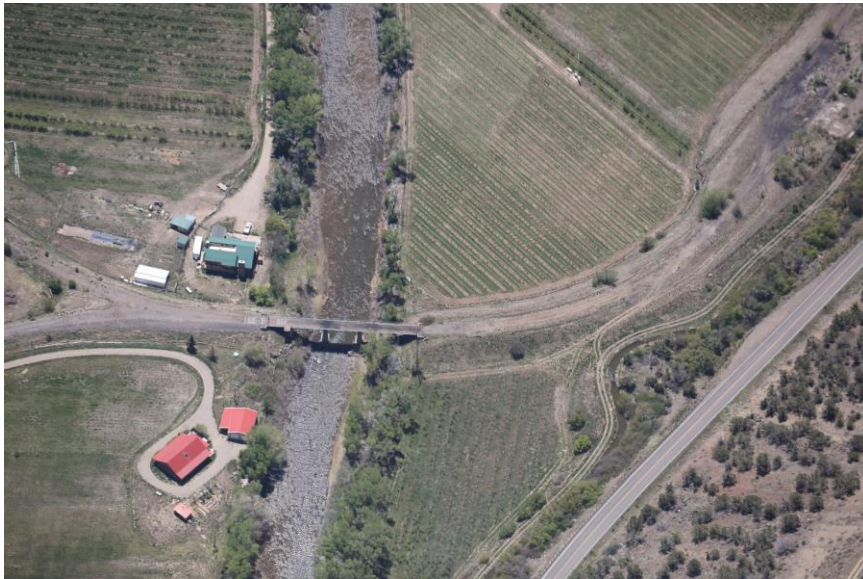
Trestle at the loadout

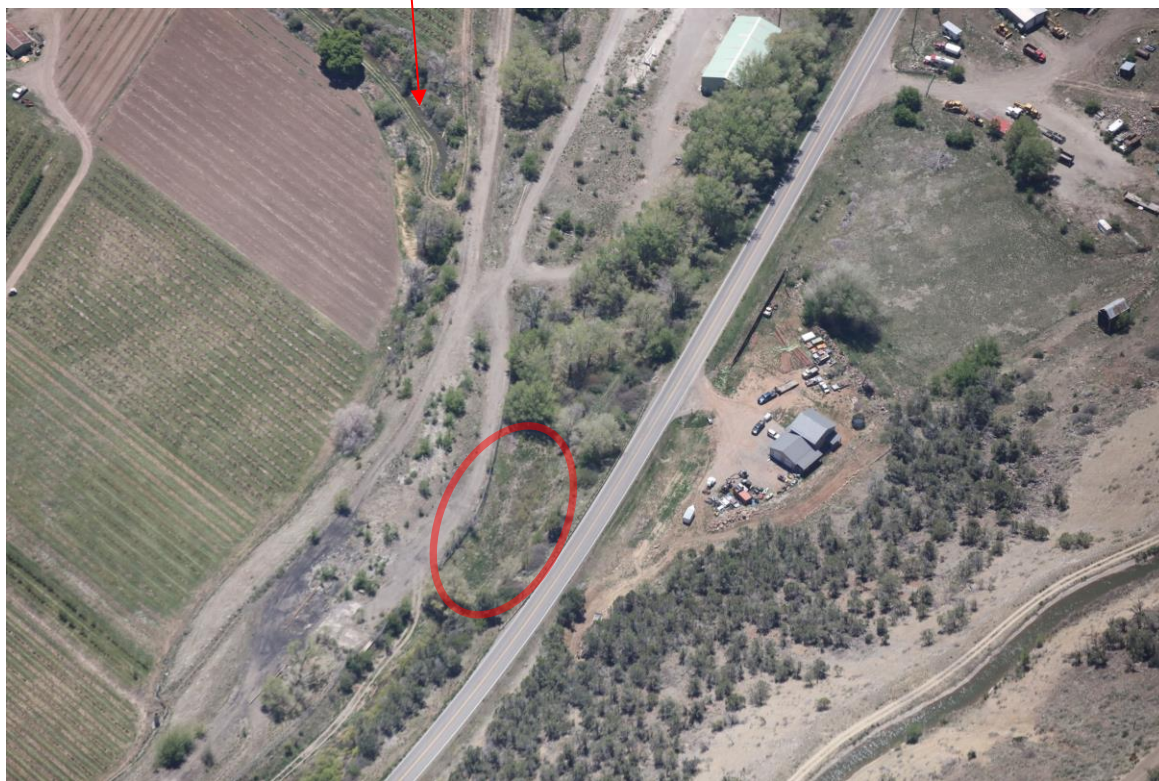
The pond at the loadout (circled)
