**COLORADO**Division of Reclamation,
Mining and Safety

Permit Number: C-1981-041 Mine Name: Roadside Portals Operator: Snowcap Coal Company, Inc. Operator Address: MS Tonya Hammond P.O. Box 1430 Palisade, CO 81526	County: Mesa Operation Type: Underground Permit Status: Active Ownership: Private
	Operator Representative Present: NA
Operator Representative Signature: (Field Issuance Only)

Inspection Start Date: May 12, 2021 Inspection Start Time: 12:00 Inspection End Date: May 12, 2021 Inspection End Time: 12:05		Inspection Type: Aerial Inspection Inspection Reason: Normal I&E Program Weather: Clear	
Joint Inspection Agency: None		Joint Inspection Contacts: None	
Post Inspection Agency: None		Post Inspection Contacts: None	
Inspector(s): Clayton Wein Brock Bowles	Inspector's Signature: <i>Clayton Wein</i>		Signature Date: 5/13/2021

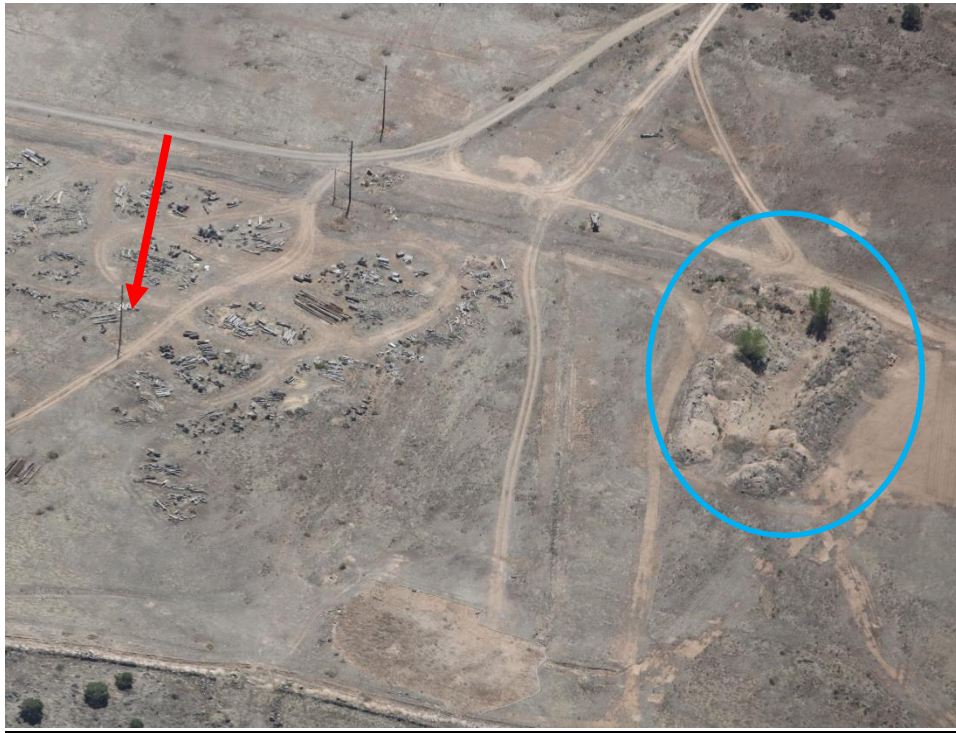
The Carey Pit (Photo 1), located on Tract 71, was observed to be dry. There were no indications of recent water application by the landowner to the pit. There was no indication of water application by the landowner to the field just east of the TR-69 repair area. The landowner's middle field (Photo 2), also to the east of the TR-69 repair area and east of the previously mentioned field, was also dry. There were no indications of recent water applications to the field. The trenches to the north on the Tract 70 mesa were dry during the inspection. There were no indications of recent water application to the area. A small section of the landowner's pipeline had been excavated and was exposed on top of the mesa (Photo 3). This excavated portion of the pipeline was not seen during the Division's March 2, 2021 Aerial Inspection.

Photo 1: The Carey Pit is outlined in the blue circle in the photo above.

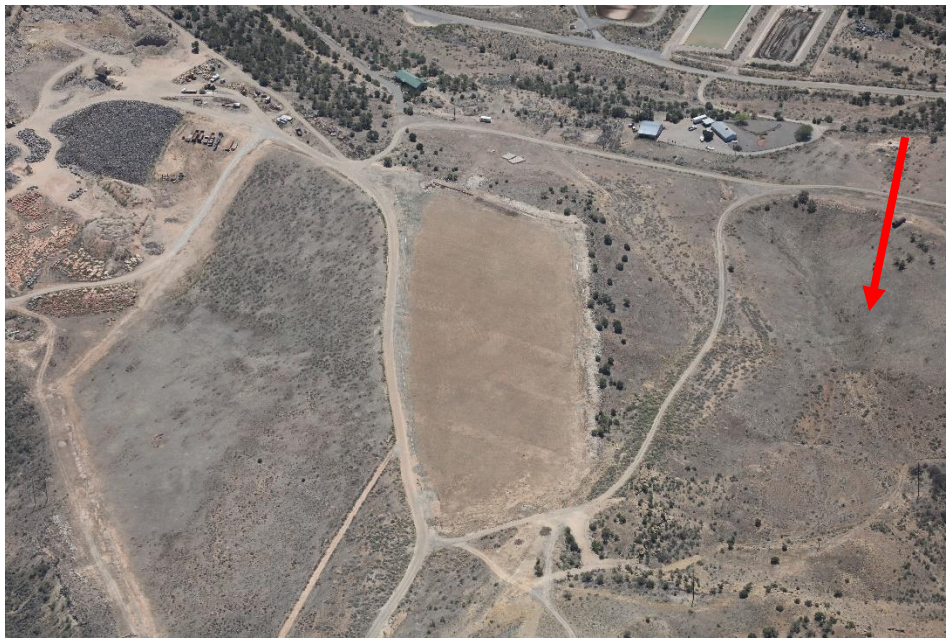
Photo 2: The Landowner's middle field.

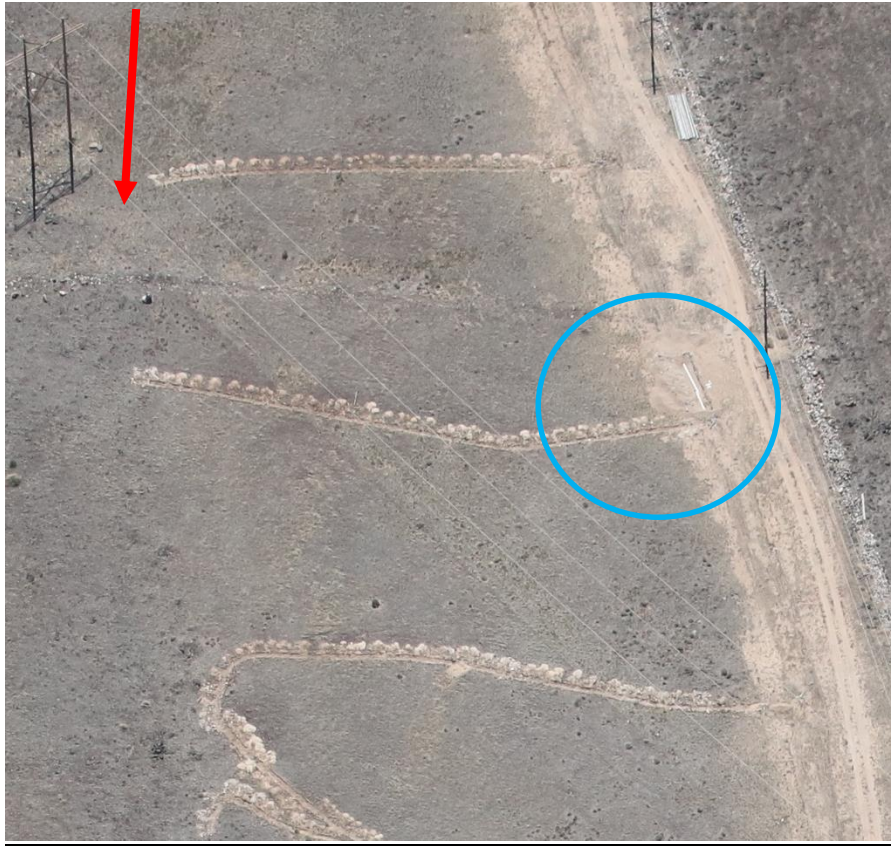
Photo 3: The landowner's exposed pipeline on Tract 70 is outlined in the blue circle in the photo above.

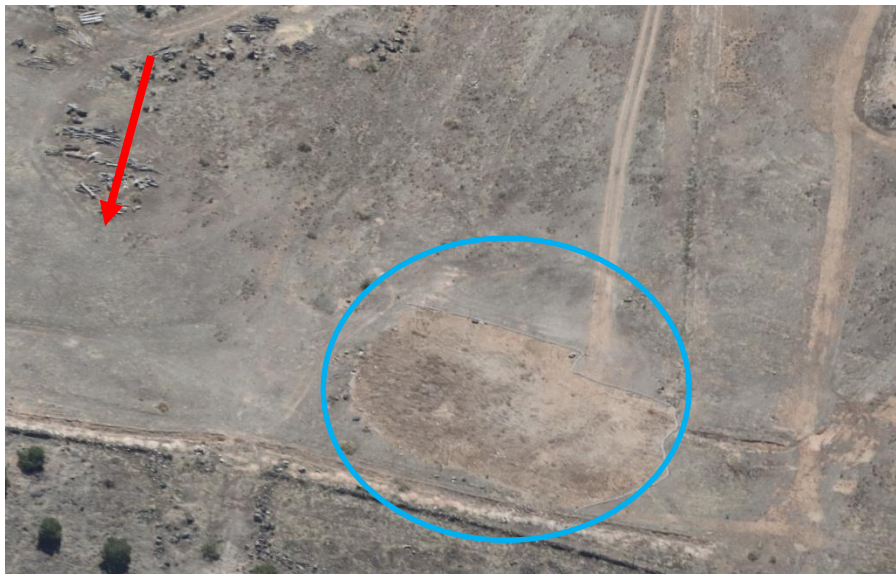
The remaining permitted disturbed area at the mine is 0.4 acres related to the repair work approved under TR-69. The repair work was completed in the fall of 2019. The area was returned to approximate original contour and seeded. The site was dry and stable during the inspection (Photo 4). The area was vegetated and there were no erosional features identified. The sediment logs at the site were in place and in good condition. There were no

Photo 4: The reclaimed TR-69 repair is outlined in the blue circle in the photo above.
