Permit Number: C-1996-083 Mine Name: Bowie No. 2 Mine Operator: Bowie Resources, LLC Operator Address: Mr. Basil Bear P.O. Box 1488 Paonia, CO 81428	County: Delta Operation Type: Underground Permit Status: Active Ownership: Private
	Operator Representative Present: None
Operator Representative Signature: (Field Issuance Only)

Inspection Start Date: May 12, 2021 Inspection Start Time: 16:33 Inspection End Date: May 12, 2021 Inspection End Time: 16:35	Inspection Type: Aerial Inspection Inspection Reason: Normal I&E Program Weather: Clear
Joint Inspection Agency: None	Joint Inspection Contacts:
Post Inspection Agency: None	Post Inspection Contacts:
Inspector(s): Robert Zuber, P.E. Brock Bowles	Inspector's Signature:

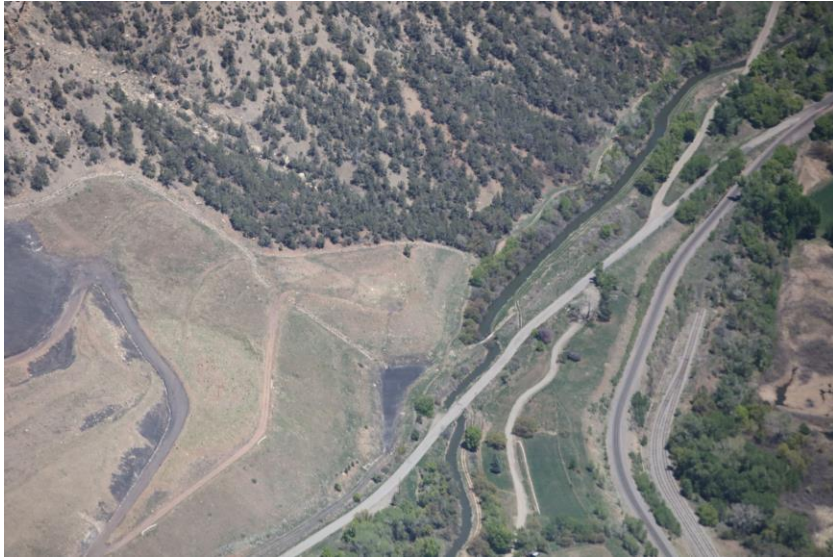
Gob Pile #2 and surrounding area

No problems were detected with any of the surface water control ditches. This includes the diversion ditches above Gob Pile #2 and Gob Pile #4 and the ditches between Gob Pile #3 and Pond J.

Minor erosion on Gob Pile #2 and Gob Pile #3 does not appear to be a problem, and there is no sign of significant coal waste in the ditch below the pile (Ditch J3).

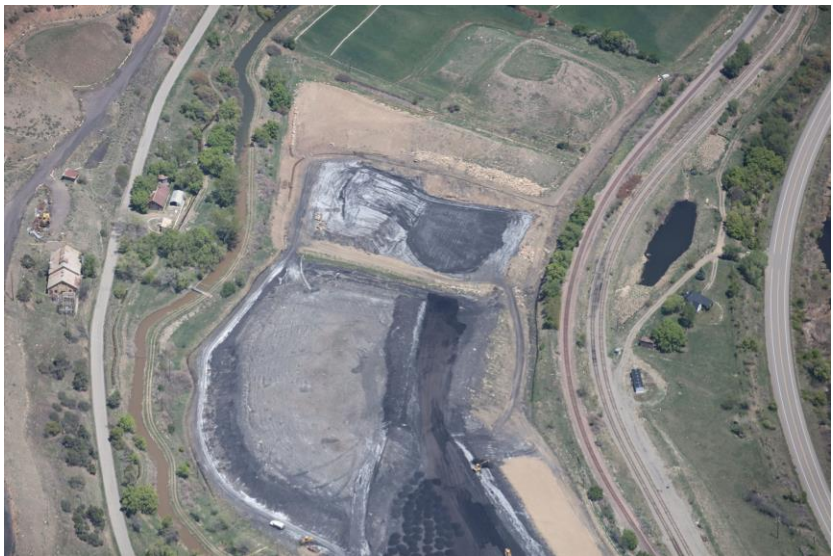
Gob Pile #3 and surrounding area

The following ponds were inspected: B, C, D, F, J, and K. Most of the ponds appeared to be dry or nearly dry. The exception was Pond J below Gob Pile #3. No problems were identified with embankments or other features of the ponds.

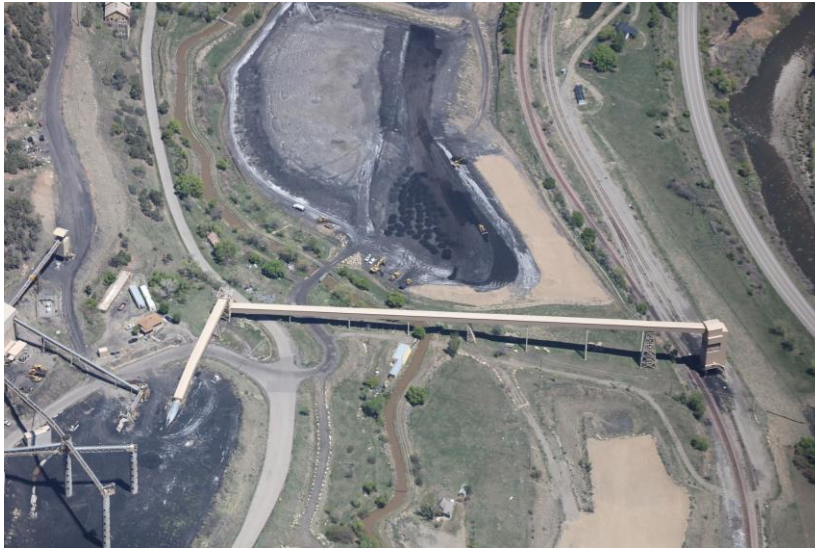
Gob Pile #3, lower conveyor, and Coal Stockpile Pad

No problems were identified with any facility areas, including the following: the Utility Bench, the D Portal Bench, the B Portal Bench, the Material Storage Area by Curve #4, the Conveyor Corridor, the Coal Stockpile Pad, the office, the Preparation Plant area, the storage area and buildings near Pond D, the Pump House and Filter Building, the train loadout area.

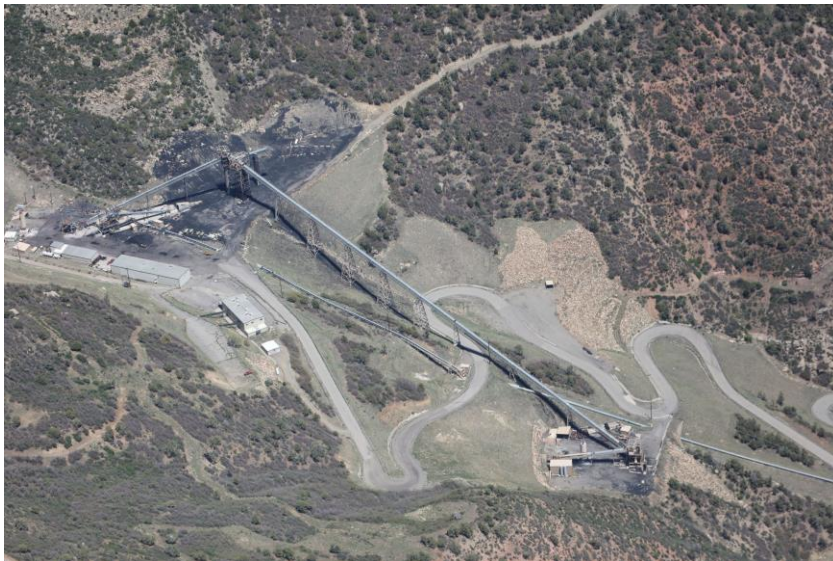
D Portal Bench, B Portal Bench and surrounding area

It appears that slumps have not moved significantly in the recent past. These include slumps by the B Portal and by Curve Number 11 along the Haul Road.

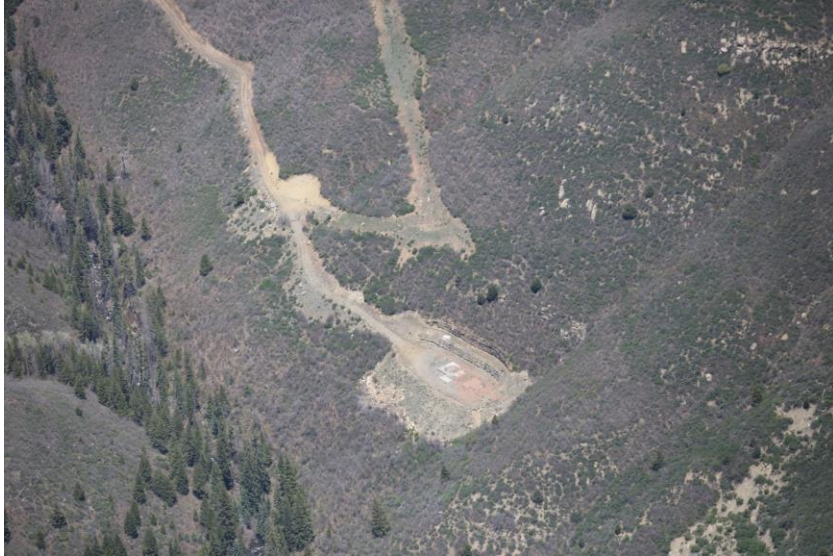
Pad for Terror Creek Vent Shaft

The pad for the Terror Creek Vent Shaft was inspected. No problems were identified. Also, no problems were seen at the pads for GVB-B17A, GVB-B17B, GVB-B17C, or GVB-B17D.
