MINERALS PROGRAM INSPECTION REPORT**PHONE: (303) 866-3567**

MINE NAME: Pioneer Farm	MINE/PROSPECTING ID#: M-2000-080	MINERAL: Sand	COUNTY: Arapahoe
INSPECTION TYPE: Monitoring	INSPECTOR(S): Jared L. Ebert	INSP. DATE: September 20, 2017	INSP. TIME: 10:30
OPERATOR: Pioneer Sand Company, Inc.	OPERATOR REPRESENTATIVE: Russ Bartz	TYPE OF OPERATION: 112c - Construction Regular Operation	
REASON FOR INSPECTION: Normal I&E Program	BOND CALCULATION TYPE: Complete Bond	BOND AMOUNT: \$47,215.00	
DATE OF COMPLAINT: NA	POST INSP. CONTACTS: None	JOINT INSP. AGENCY: None	
WEATHER: Clear	INSPECTOR'S SIGNATURE:

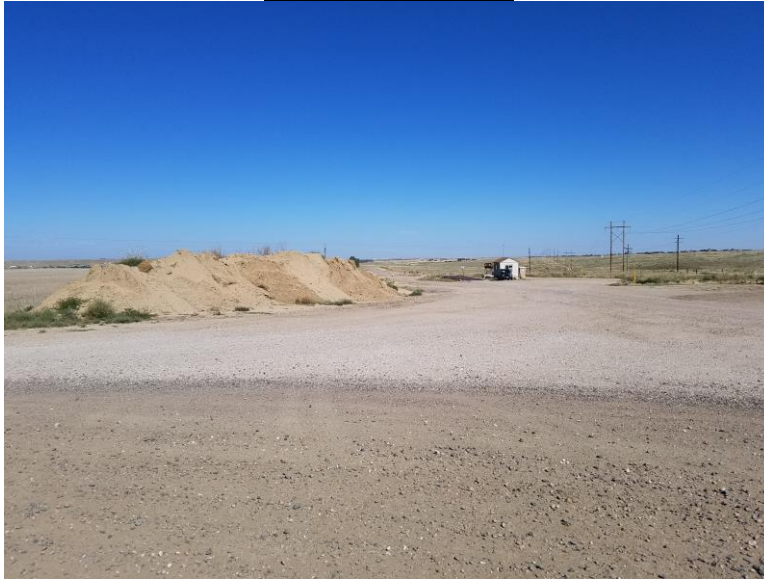
Pioneer appears to be conducting the operation in accordance with the approved plan and has conducted concurrent reclamation at the site. The active mine area is about 9.5 acres in size. A small 2 acre area is located near the entrance to the mine site where a scale and scale house has been constructed. Small stockpiles of material were also located near the scale house.

Figure 1. From the entrance to the permit area in the southeast corner of the site looking north. Scale house and scale.

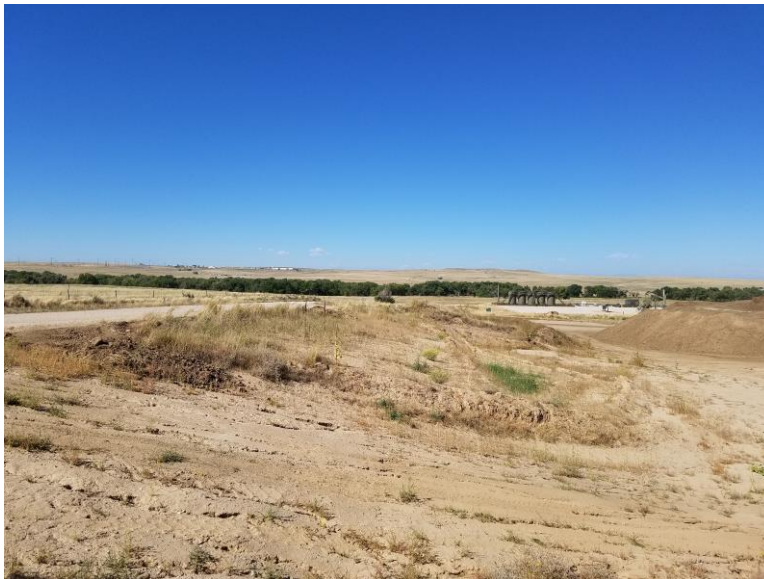
Figure 2. From the southeast corner of the active mine area looking west.

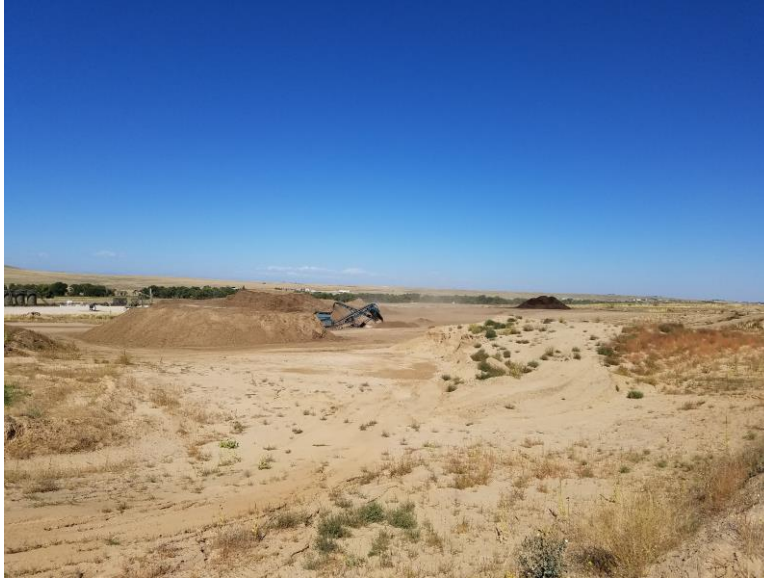
The active portion of site currently consists of two small excavated areas. The primary excavation area is directly east of the Conoco oil well located in the southwest corner of the site. The slopes of the excavation were set at a 3H:1V ratio or less. Piles of product are located within the excavation area and on the affected land above the excavation to the east. A smaller pit was located north of the main pit. This small excavation is shallow with steeper side slopes.

Figure 3. From the southeast corner of the main mine area looking northwest.

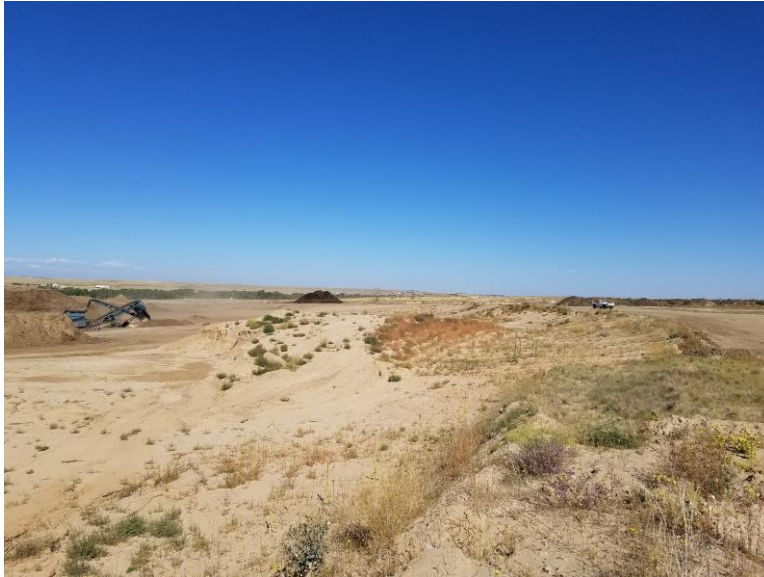
Figure 4. From the southeast corner of the main mine area looking north.

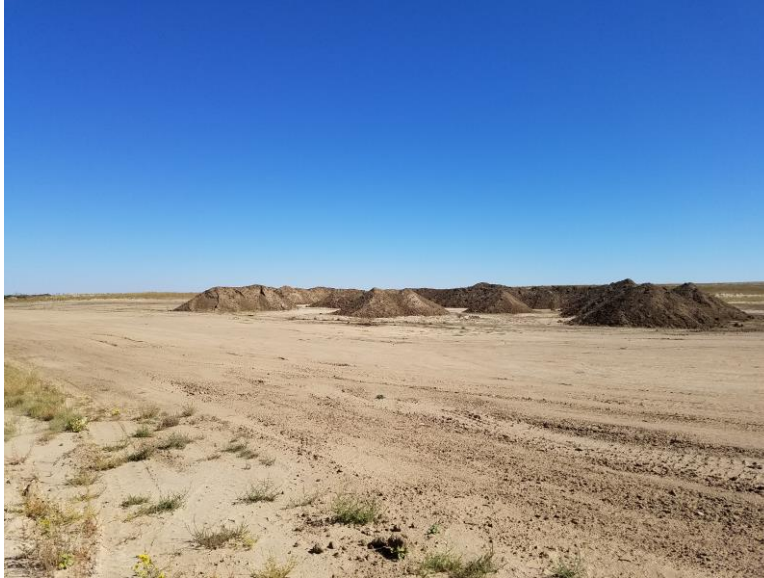
Figure 5. Stockpile area located east of the main mine area.

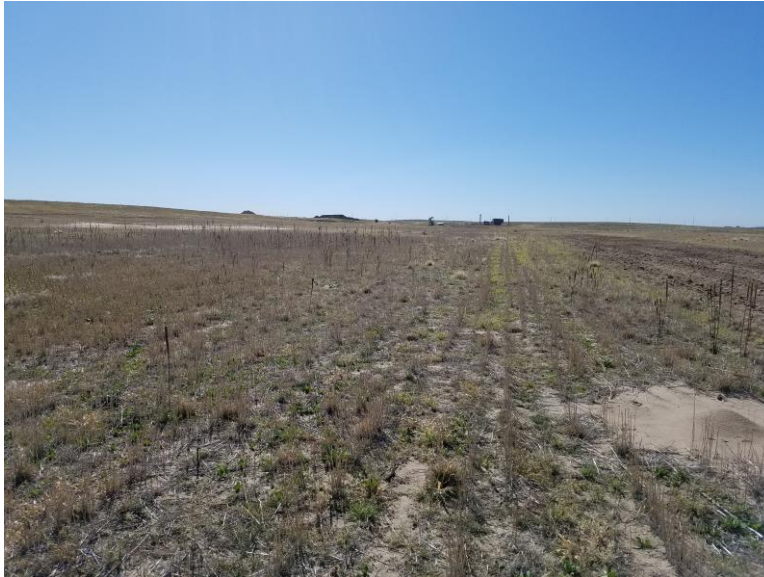
Based on the Division's estimate, Pioneer has reclaimed about 68.5 acres of land. The reclaimed land is located to the north and west of the active mine area. The reclaimed land slopes gently to the west and the topography blends in well with the surrounding farmland. The reclaimed area appears stable.

Based on a recent aerial photograph of the site it appears about 80 acre has been affected by the mining operation. Of this area about 68.5 acres has been graded, topsoiled and revegetated. The post mine land use approved for the site is cropland. The reclaimed area was observed. The landowner has planted the area with a grass crop. The area appears to have been recently harvested so it was difficult to determine the species of grass that has been planted. Annual vegetation and some weeds such as Common Mullen was observed within the reclaimed area.

Figure 6. From the northwest corner of the permit area looking south at the reclaimed land.
