**MINERALS PROGRAM INSPECTION REPORT**  
**PHONE: (303) 866-3567**

<b>MINE NAME:</b> Penrose Pit	<b>MINE/PROSPECTING ID#:</b> M-1987-131	<b>MINERAL:</b> Sand and gravel	<b>COUNTY:</b> Fremont
<b>INSPECTION TYPE:</b> Preoperation Inspection	<b>INSPECTOR(S):</b> Timothy Cazier, P.E.	<b>INSP. DATE:</b> March 30, 2021	<b>INSP. TIME:</b> 10:45
<b>OPERATOR:</b> Fremont Paving & Redi-Mix, Inc.	<b>OPERATOR REPRESENTATIVE:</b> Jodi Schreiber	<b>TYPE OF OPERATION:</b> 112c - Construction Regular Operation

<b>REASON FOR INSPECTION:</b> Preoperation Inspection	<b>BOND CALCULATION TYPE:</b> Complete Bond	<b>BOND AMOUNT:</b> \$320,000.00
<b>DATE OF COMPLAINT:</b> NA	<b>POST INSP. CONTACTS:</b> None	<b>JOINT INSP. AGENCY:</b> None
<b>WEATHER:</b> Snowing	<b>INSPECTOR'S SIGNATURE:</b>

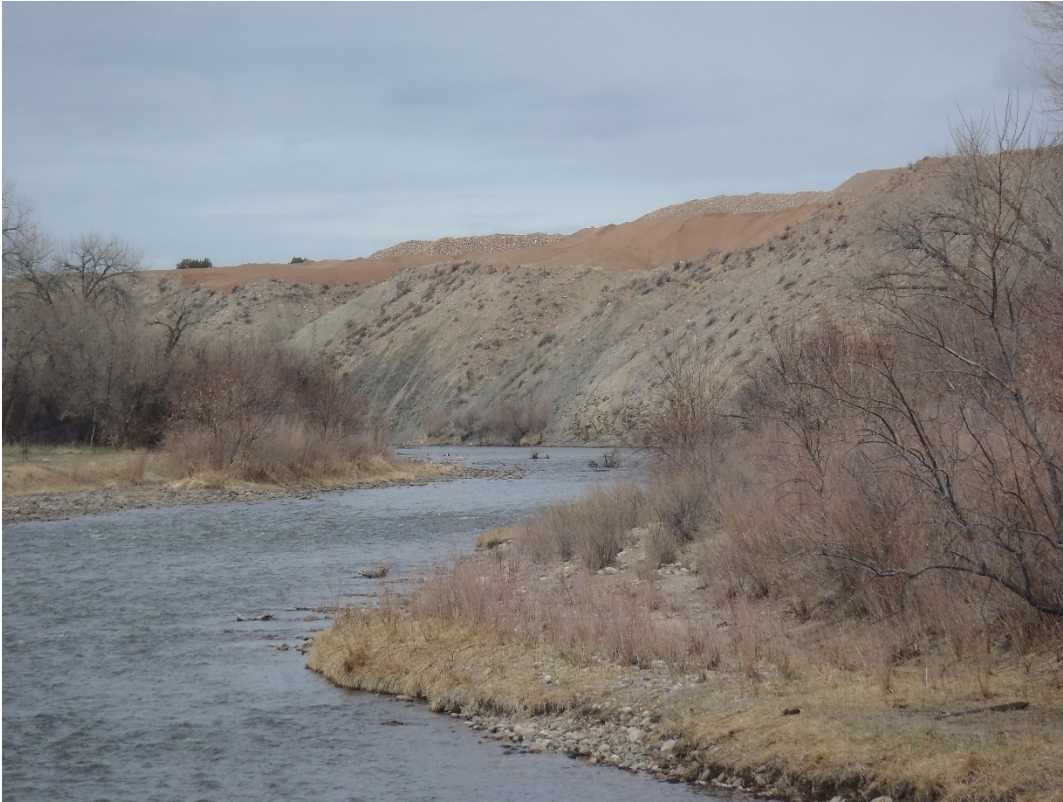
**PROBLEM/POSSIBLE VIOLATION:** Problem: The visual berms facing the Arkansas River do not have established vegetation on them and are therefore susceptible to erosion. This is a problem at this time for failure to protect the affected land and potentially adjacent land from erosion pursuant to C.R.S. 34-32.5-116 (4) (j).

Backfilling and Grading: A comment was received during the public comment period for this amendment related to unvegetated berms (see **Photos 1** and **2**) possibly contributing sediment to the Arkansas River on the south side of the operation. Ms. Schreiber explained the County permit requires Fremont Paving to construct visual berms for the operation and this is what is visible from the south side of the Arkansas River. Active mining was taking place in this area during the inspection causing access to the area to be unsafe. However, Fremont Paving provided an aerial photo (see **Photo 3**) taken from a drone shortly after the inspection.

Photo 1. Visual berms and product stockpile above Arkansas River (looking WNW from Florence River Park).

**CORRECTIVE ACTIONS:** The operator shall provide photo documentation to the Division verifying best management practices (BMPs) have been installed at or near the toe of the outward facing berms by the corrective action date.

Sediment Control: No erosion problems were observed. However, based on observations from south of the Arkansas River and the aforementioned concern received during the AM-03 public comment period, we discussed installing BMPs (or best management practices) along the toe of the outside slope of the berm for the purpose of controlling erosion. Ms. Schreiber agreed this would be feasible. For the purpose of tracking this commitment, the **DRMS is citing the lack of erosion control on the outside slopes of the visual berms as a Problem on page 1 of this report.** If the visual berms are not to be removed prior to final reclamation, the operator shall seed them with the seed mix that was submitted as part of the approved Reclamation Plan. If the berms are removed, final site grading shall ensure stormwater runoff is directed away from the bluff above the river.

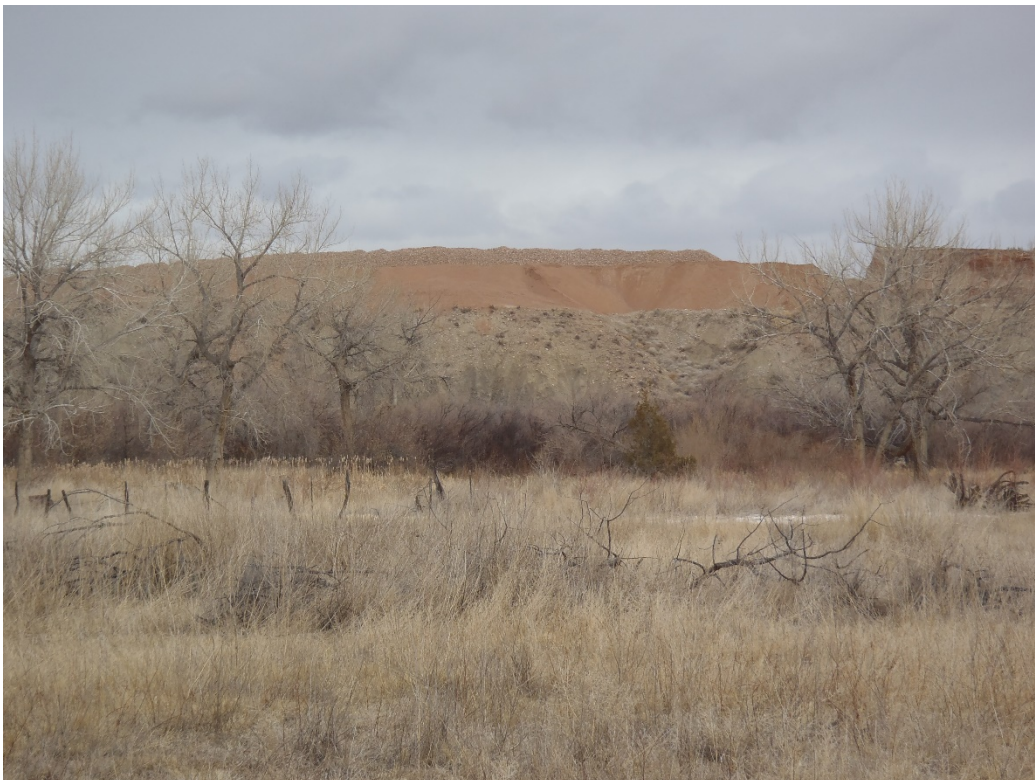
Photo 2. Visual berms and product stockpile above Arkansas River (looking north from E 8<sup>th</sup> St/Hwy 119).

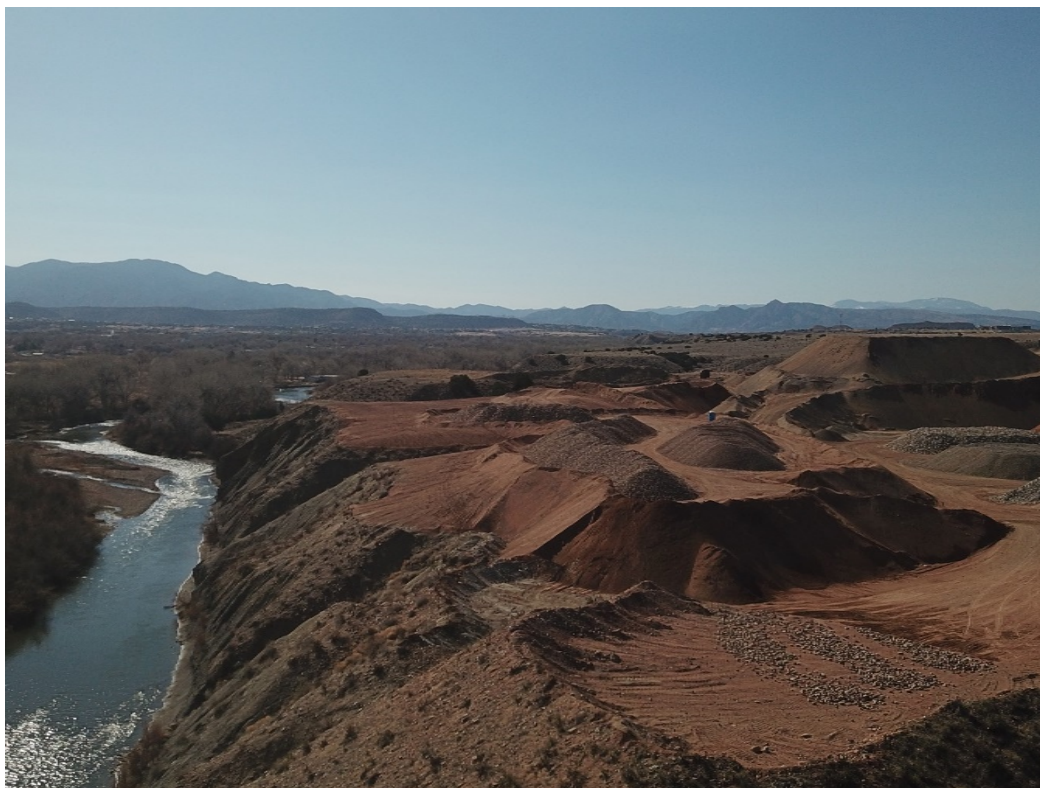
Photo 3. Visual berms and product stockpile above Arkansas River (looking west).  
*{post inspection Operator provided photo}*

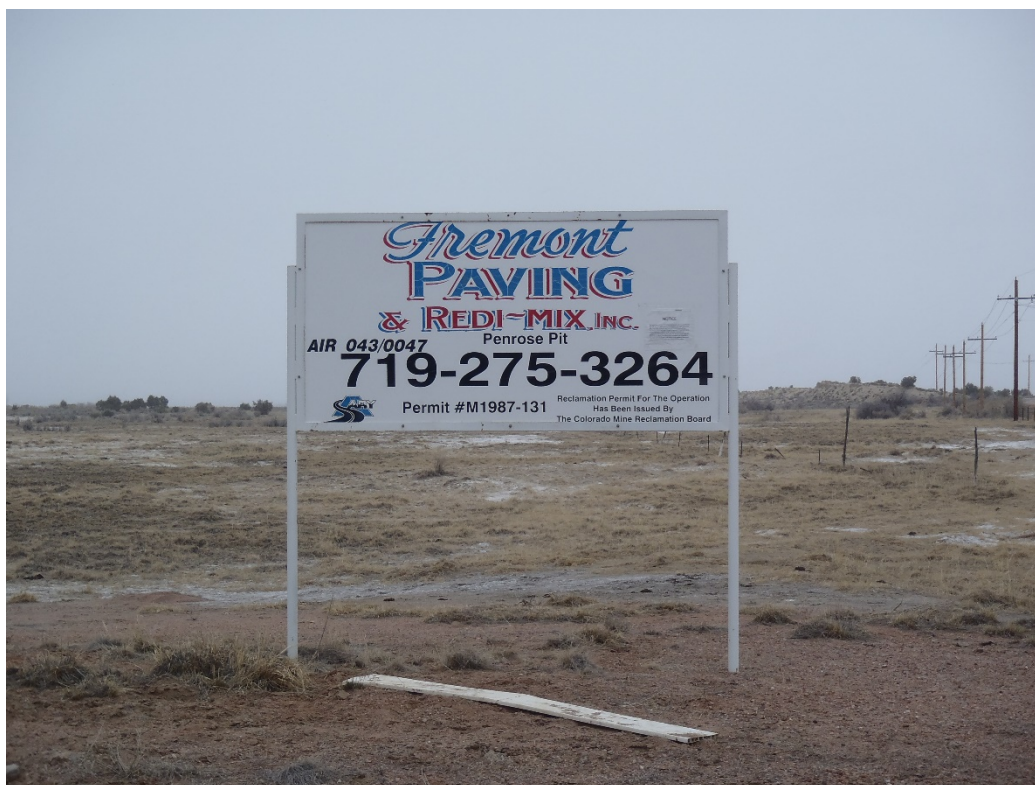
Signs and Markers: The permit sign was properly posted (see **Photo 4**) and some of the boundary markers were observed to delineate the permit boundary (see **Photo 5**) in areas that are not expected to be mined for quite some time. The topic of **Permit Area vs Affected Area** was discussed during the inspection. As a reminder, there is no real importance to the Permit Boundary. The DRMS is concerned with the affected area boundary as this is what dictates the reclamation financial warranty. Rule 3.1.12(2) requires the boundaries of the **affected area** be marked by monuments or other markers that are clearly visible and adequate to delineate such boundaries. The permit boundary does not need to be marked under DRMS requirements. The AM-03 application revised the affected area approved in AM-02. In some areas this was expanded, in others it was reduced. **DRMS requirements dictate a revision to the permit is necessary to release any approved affected area from the permit, even if that affected area has not yet been disturbed.** The DRMS is aware Fremont Paving is reviewing and comparing the affected area boundaries approved as AM-02 with those currently proposed for AM-03. Please be aware any areas that were previously approved as affected area will require an acreage reduction request be filed to remove those areas from the affected area boundary (e.g., AM-02 Phase 11). This removal process can be accomplished in parallel with the amendment (AM-03) process, but as a separate revision.

Photo 4. Permit sign (near Hwy 115 entrance).

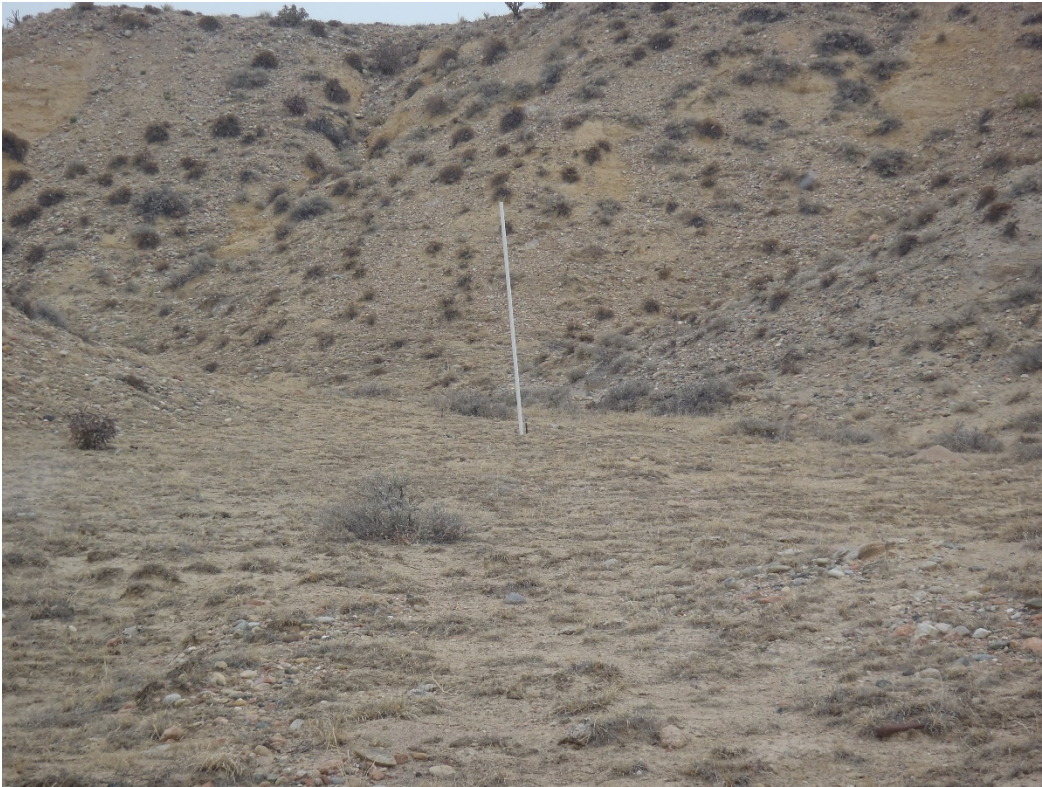
Photo 5. Typical marker (SE corner, near BLM/Grisenti diversion structure).

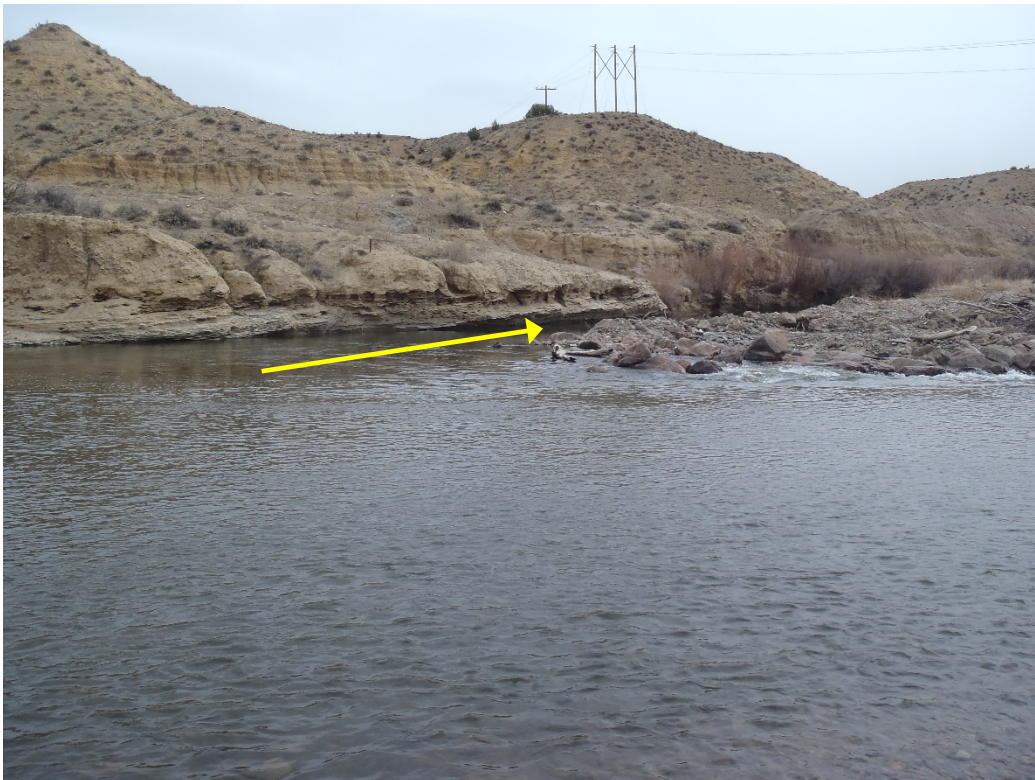
Structures: Several structures have been identified as being within 200 feet of the proposed affected area boundary based on the AM-03 application, Google Earth images review and site observations. These structures include active and inactive ditches, irrigation diversion structures, powerlines, State Hwy 115, fences and outbuildings on the east side of Hwy 115. All relevant structures with the exception of the inactive ditches are shown on **Figure 1** and will require damage compensation agreements be filed with the DRMS. The inactive ditches were remote with no existing roads present to access them. Structures observed prior to and during the inspection are: the BLM/Grisenti diversion structure and powerline (see **Photo 6**); Fremont Sanitation District fence, concrete pad and building (see **Photo 7**). There are also remains of a scale house near the site entrance off Hwy 115 (see **Photo 8**). It appears to have been left by a previous Operator, but will need to be removed as part of final reclamation, if not sooner.

Photo 6. BLM/Grisenti Diversion structure and powerline (looking NE from Florence River Park).

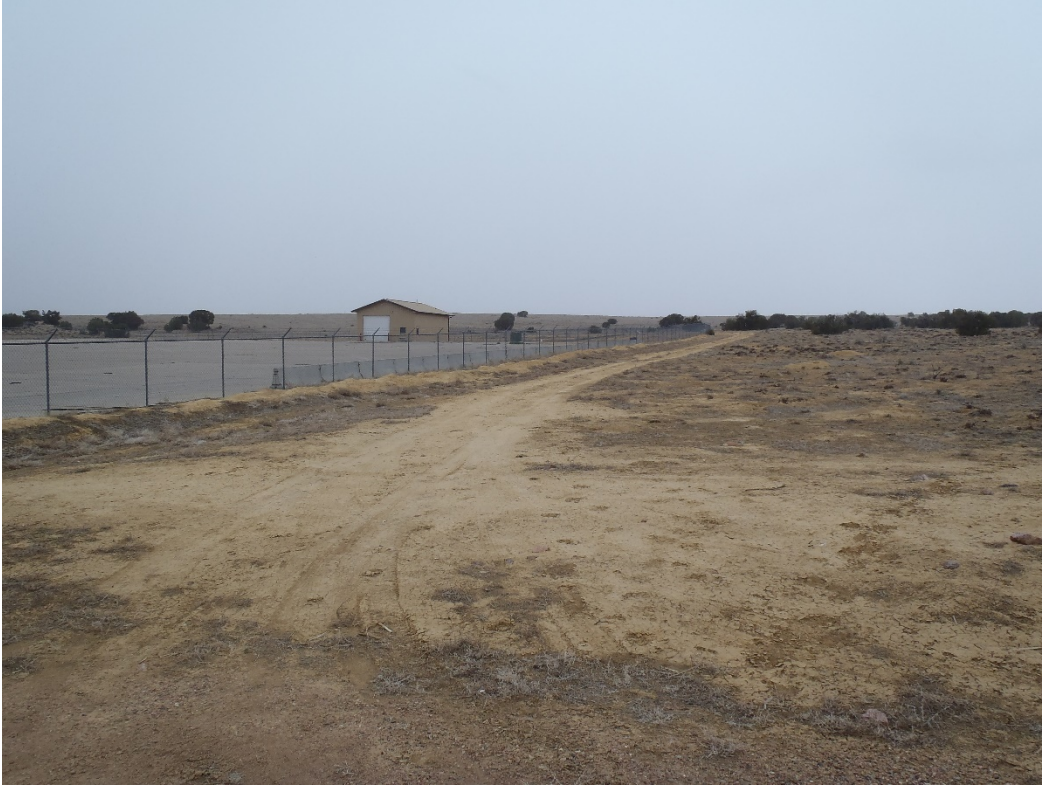
Photo 7. Fremont Sanitation District building, concrete pad and fence (north side, looking WSW).

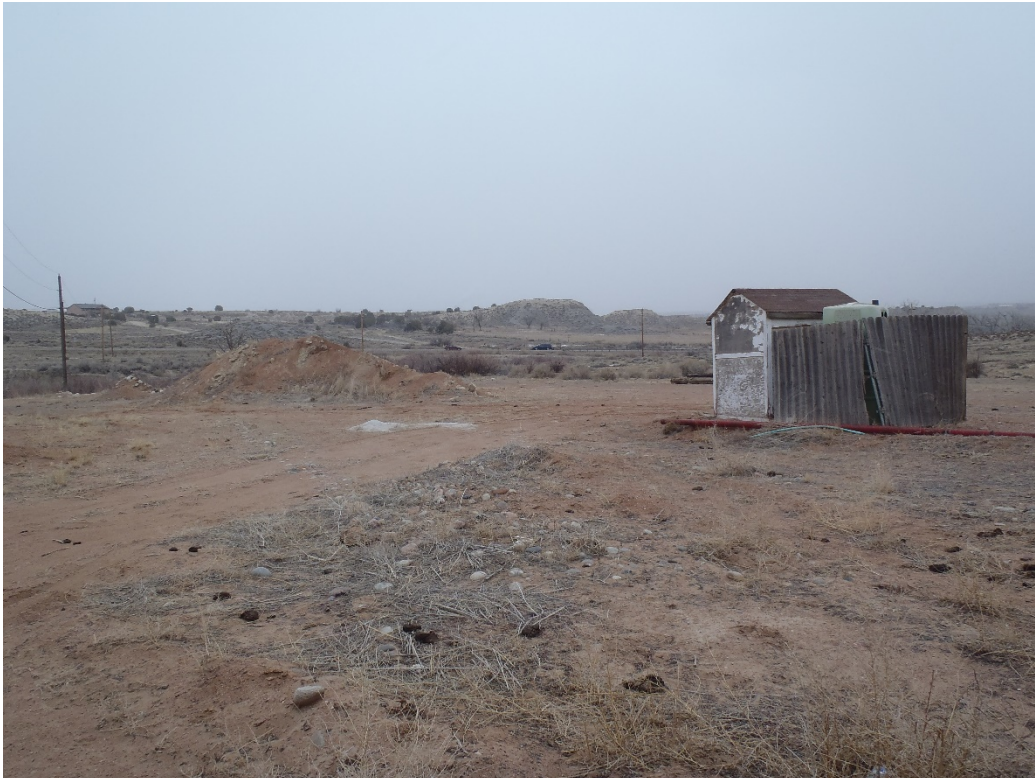
Photo 8. Scale house remnants near Hwy 115 entrance (looking SE).
