**MINERALS PROGRAM INSPECTION REPORT**  
**PHONE: (303) 866-3567**

<b>MINE NAME:</b> 6th Avenue Pkwy Borrow Pit	<b>MINE/PROSPECTING ID#:</b> M-2018-035	<b>MINERAL:</b> Borrow material for	<b>COUNTY:</b> Arapahoe
<b>INSPECTION TYPE:</b> Monitoring	<b>INSPECTOR(S):</b> Patrick Lennberg	<b>INSP. DATE:</b> May 13, 2021	<b>INSP. TIME:</b> 09:30
<b>OPERATOR:</b> SEMA Construction, Inc.	<b>OPERATOR REPRESENTATIVE:</b> Jason Kidston	<b>TYPE OF OPERATION:</b> 111 - Construction by Government Agency	
<b>REASON FOR INSPECTION:</b> Normal I&E Program	<b>BOND CALCULATION TYPE:</b> Partial Bond	<b>BOND AMOUNT:</b> \$45,500.00	
<b>DATE OF COMPLAINT:</b> NA	<b>POST INSP. CONTACTS:</b> None	<b>JOINT INSP. AGENCY:</b> None	
<b>WEATHER:</b> Clear	<b>INSPECTOR'S SIGNATURE:</b>

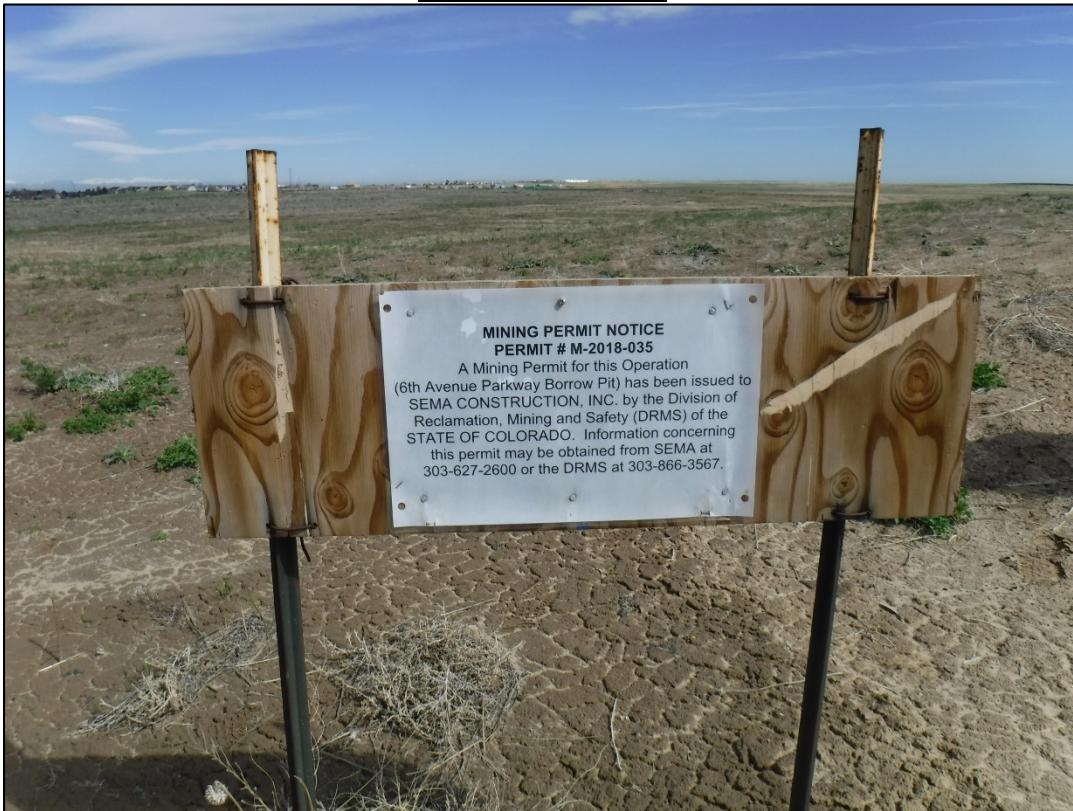
The 6th Avenue Pkwy Borrow Pit is located approximately 250 feet west of the intersection of East 6<sup>th</sup> Parkway and Valdai Street in Aurora CO. The pit is a 111c operation permitted for 29.16 acres for the removal of sand and gravel for construction purposes. The site is surrounded by rangeland and the post-mining land use is rangeland. A mine sign was observed as required by Rule 3.1.12.

**Photo 1:** Mine Sign

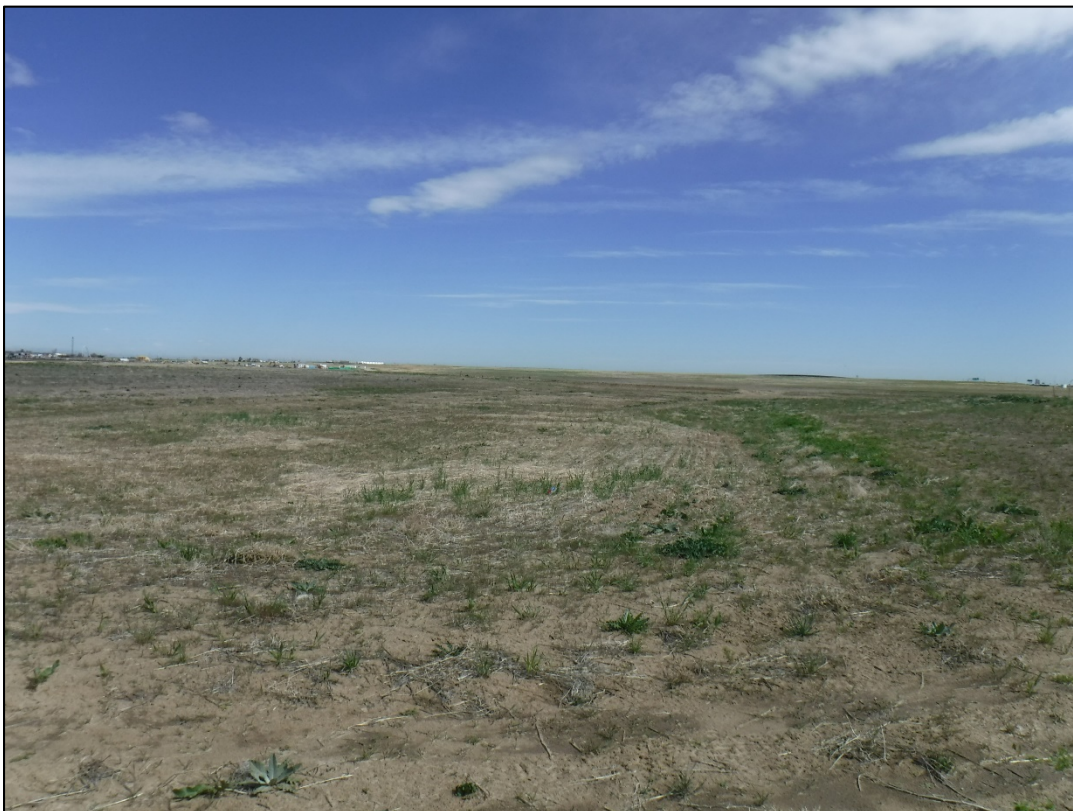
**Photo 2:** Looking north across the site along the eastern boundary

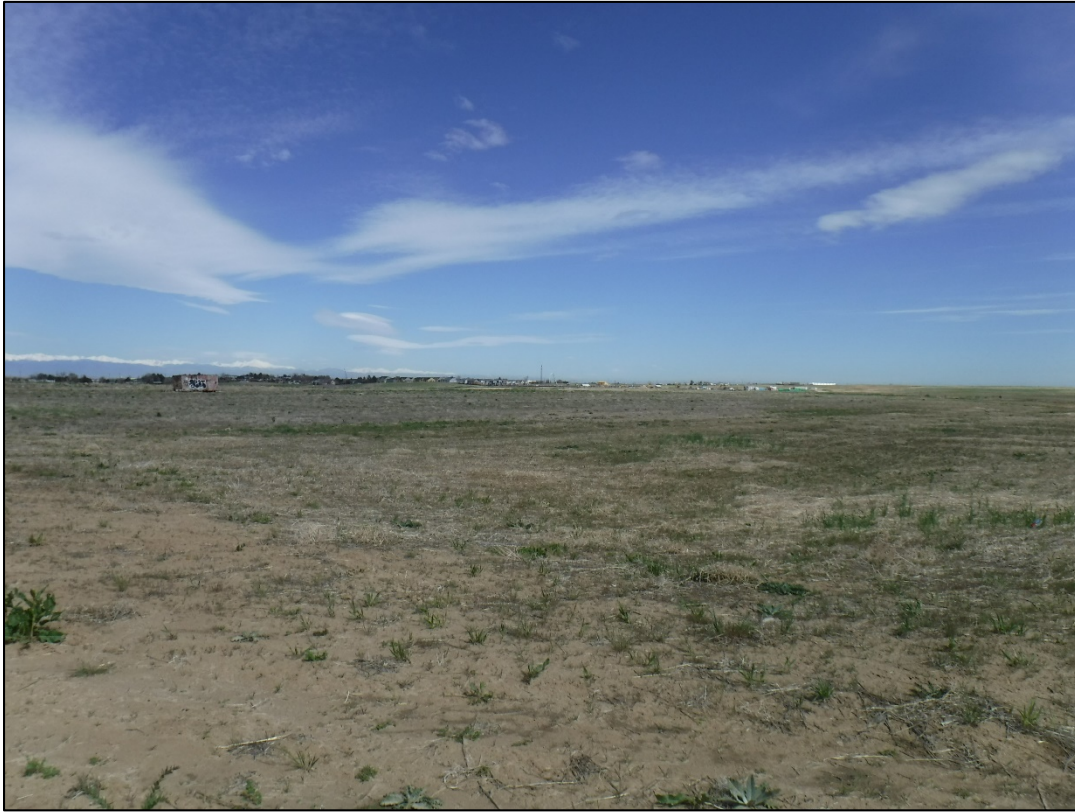
**Photo 3:** Looking northwest across the site from the southeastern corner of permit

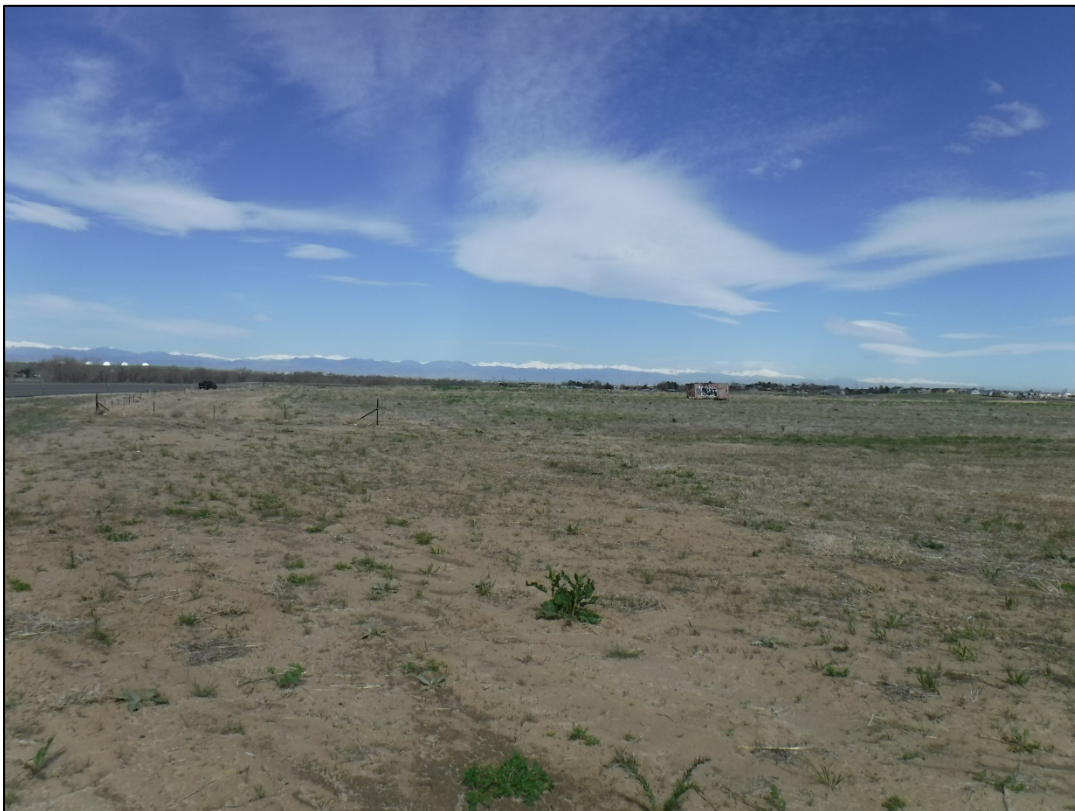
**Photo 4:** Looking west across the site from the southeastern corner of permit

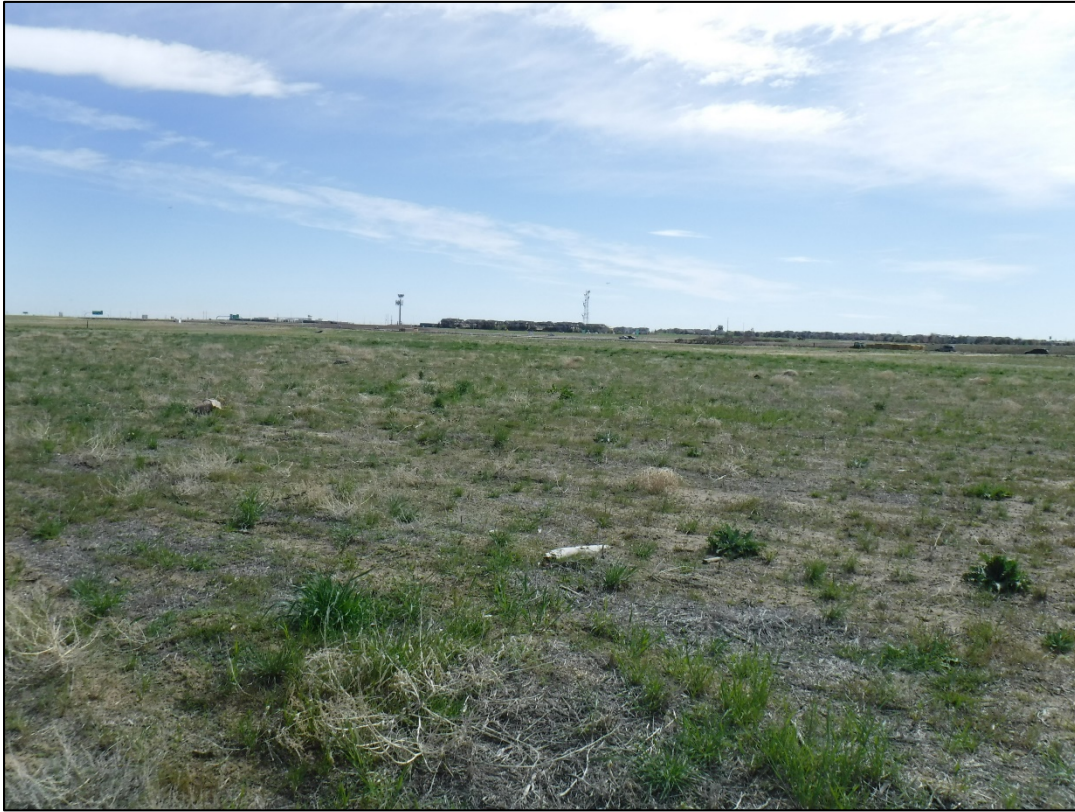
**Photo 5:** Looking east across the site from the southwestern area of permit

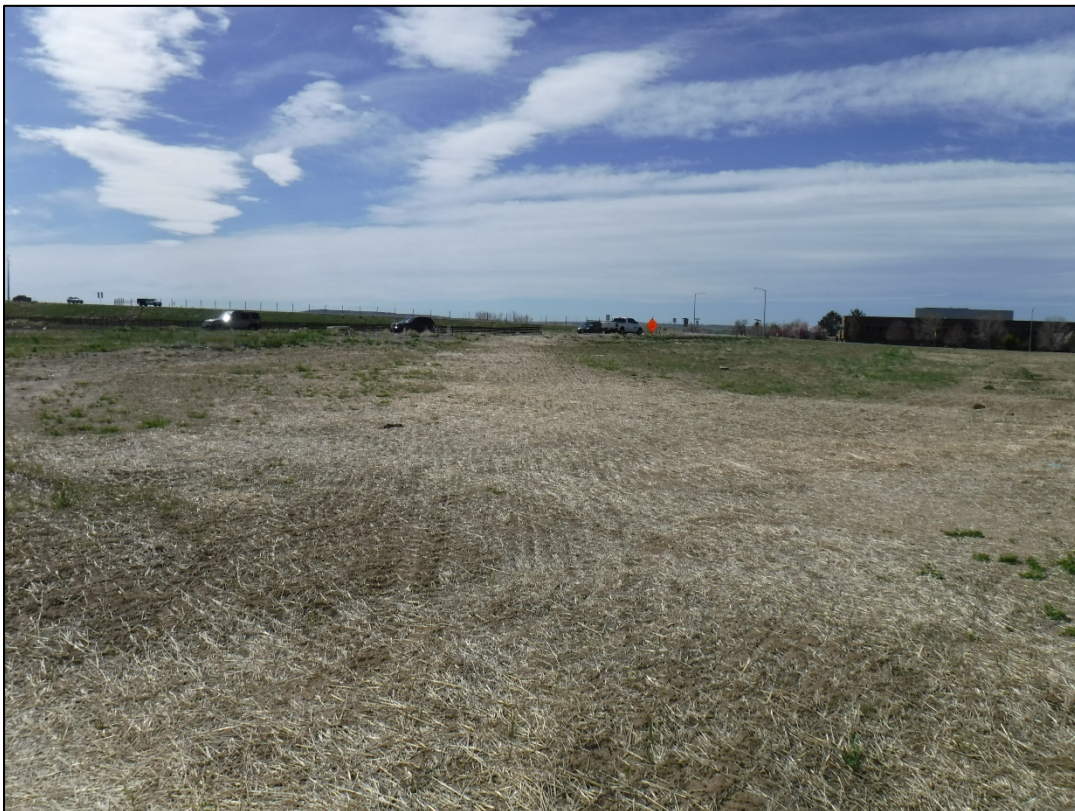
The site was not active during the inspection. The site has been reseeded and has vegetation establishing in most areas. However, there is an area in the northern portion of the site adjacent to the frontage road that was reseeded approximately last fall. The area had a swale installed to prevent ponding at the request of the city. The swale has been mulched, crimped, and seeded. Native vegetation and annual weeds are growing at the site. It is recommended that the operator continue to spray to control weeds, especially thistles, as they have done in previous years. The area has been graded to 3H:1V slopes or shallower where mining has occurred.

**Photo 6:** Area disturbed by the swale construction, northeastern part of permit

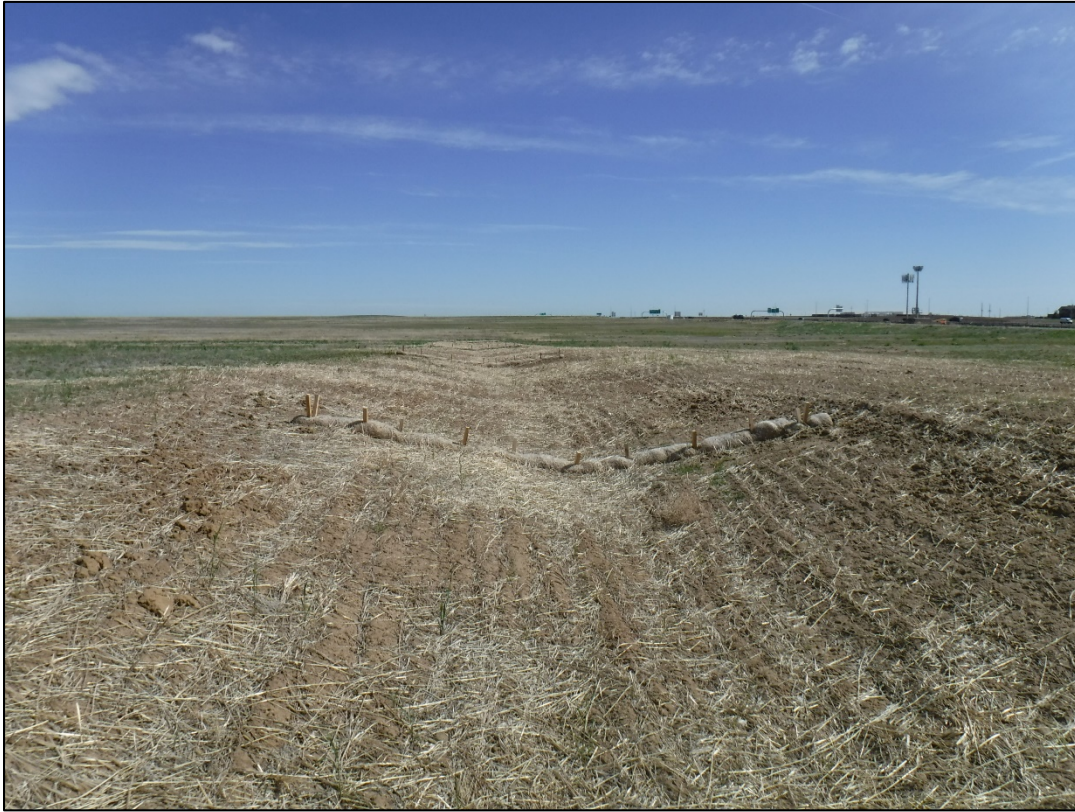
**Photo 7:** Swale leading to the north

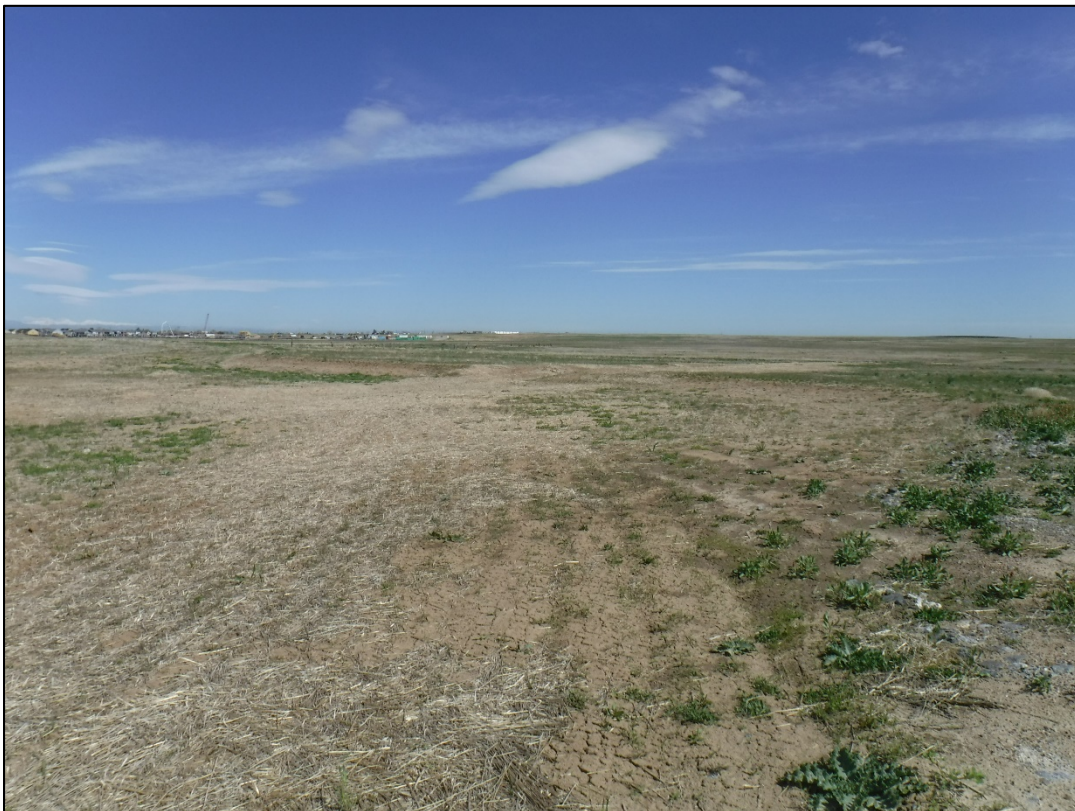
**Photo 8:** Swale area looking northwest
