**COLORADO**  
Division of Reclamation,  
Mining and Safety  
Department of Natural Resources

<b>Permit Number:</b> C-1981-018 <b>Mine Name:</b> Deserado Mine <b>Operator:</b> Blue Mountain Energy, Inc. <b>Operator Address:</b> Mr. Kurtis Blunt 3607 County Road 65 Rangely, CO, 81648	<b>County:</b> Moffat, Rio Blanco <b>Operation Type:</b> Underground <b>Permit Status:</b> Active <b>Ownership:</b> Private
	<b>Operator Representative Present:</b>  NA
<b>Operator Representative Signature:</b> (Field Issuance Only)

<b>Inspection Start Date:</b> May 12, 2021 <b>Inspection Start Time:</b> 10:00 <b>Inspection End Date:</b> May 12, 2021 <b>Inspection End Time:</b> 11:05	<b>Inspection Type:</b> Aerial Inspection <b>Inspection Reason:</b> Normal I&E Program <b>Weather:</b> Clear
<b>Joint Inspection Agency:</b>  None	<b>Joint Inspection Contacts:</b>  None
<b>Post Inspection Agency:</b>  None	<b>Post Inspection Contacts:</b>  None
<b>Inspector(s):</b>  Clayton Wein  Brock Bowles	<b>Inspector's Signature:</b>

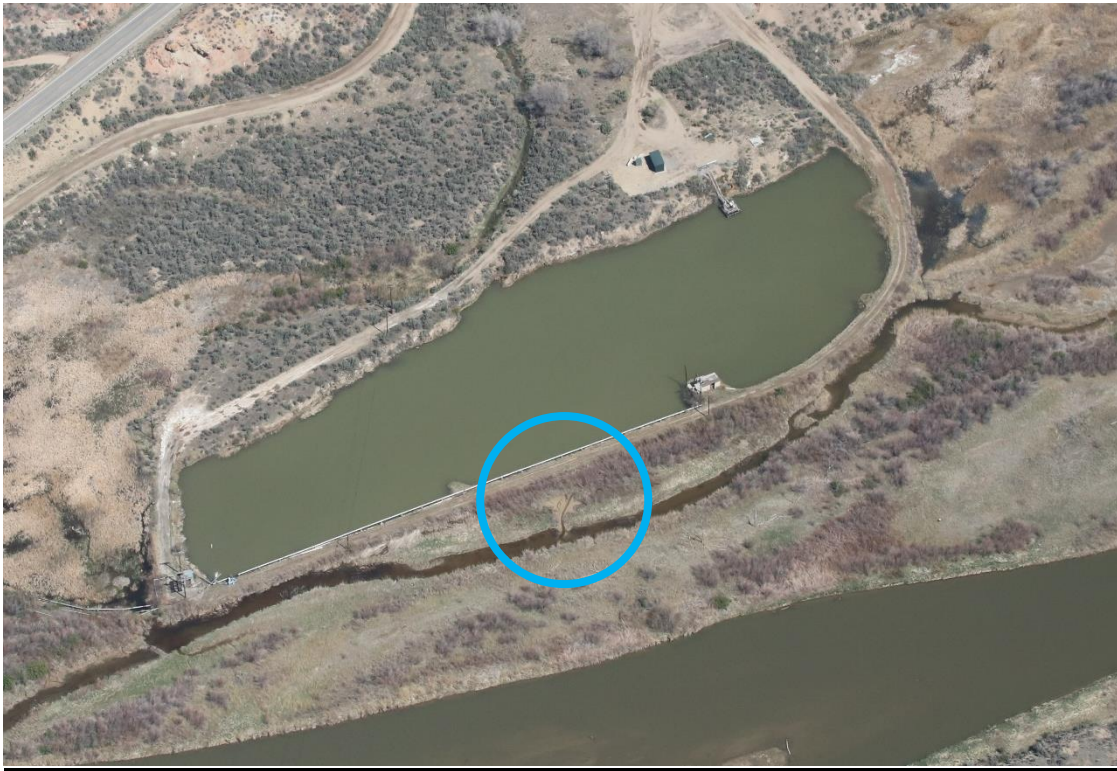
1. **Raw Water Lagoon** - There was a large rill or gully spotted next to the south-central portion of the embankment. The rill/gully had water in it at the time of the inspection. Please inspect the location identified in Photo 1 to ensure the rill is not affecting the embankment of the pond.

**Photo 1:** The Raw Water Lagoon. The erosional feature is outlined in the blue circle.

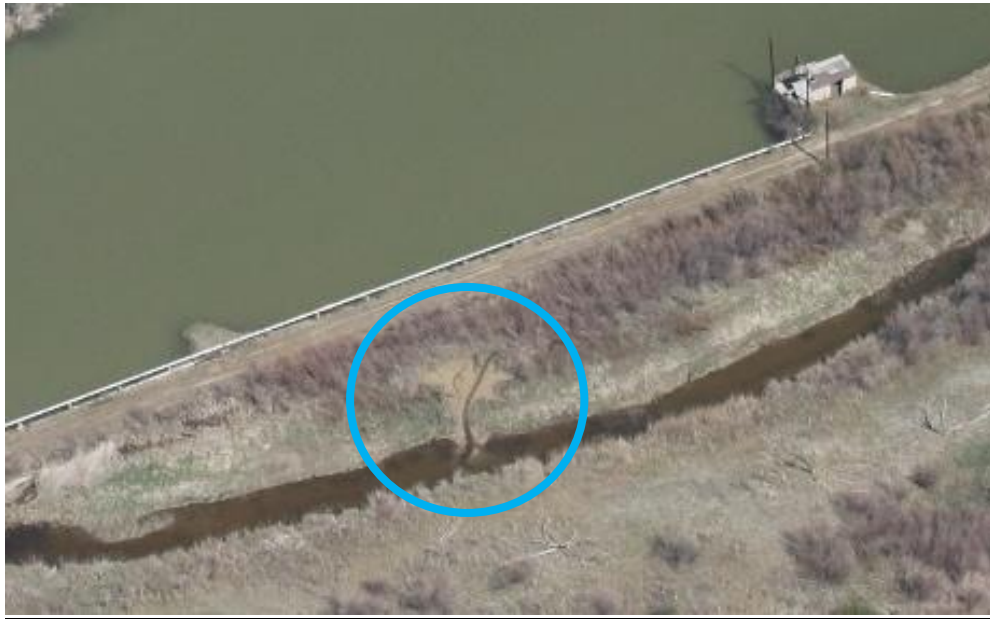
The Raw Water Lagoon is located at the southern end of the permit area next to the White River. The pond was full of water during the inspection. The embankment was stable with vegetative cover. There were no erosional features identified on the embankment. **There was a large rill or gully spotted next to the south-central portion of the embankment (Photo 1). The rill/gully had water in it at the time of the inspection. Please inspect the location identified in Photo 1a to ensure the rill is not affecting the embankment of the pond.**

**Photo 1a:** A zoomed in view of the erosional feature next to the Raw Water Lagoon's south embankment.

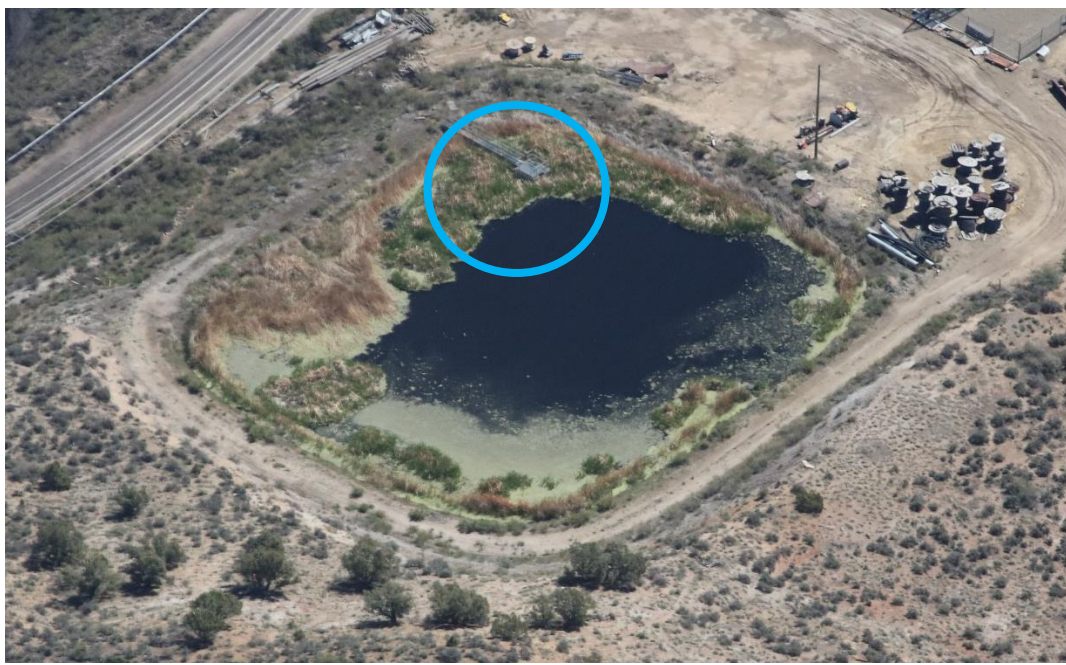
2. **PP-2 Pond** - Cattails have grown around the outlet structure. Please ensure the outlet is able to function as designed and clear cattails from the area if needed.

**Photo 2:** The PP-2 Pond. The outlet is outlined in the blue circle.

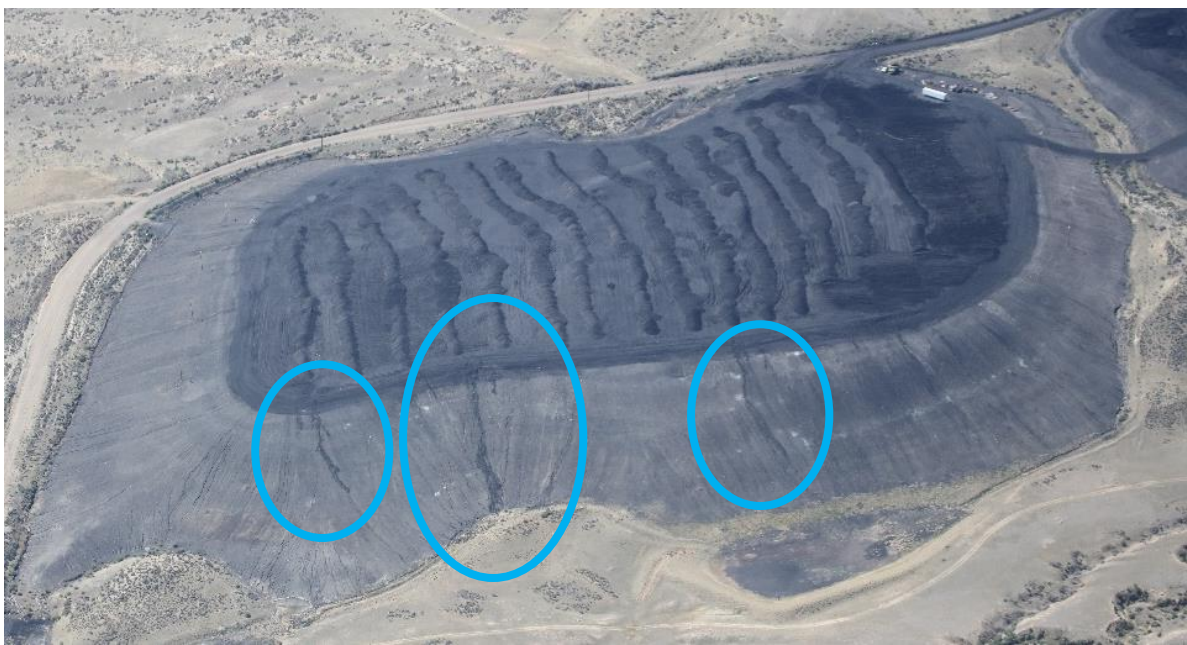
Refuse material on top of the RP-2/3/4 Refuse Pile was placed in windrows. The pile was stable. Erosion on the slopes of the pile has been noted in previous Division inspection reports. **It was observed during this inspection that some of the rills have significantly enlarged into gullies (Photo 3). There are portions on the north-facing slope that were observed to have deep and wide gullies. Please repair the slopes of the RP-2/3/4**

3. **Refuse Pile RP-2/3/4** - It was observed during this inspection that some of the rills have significantly enlarged into gullies. There are portions on the north-facing slope that were observed to have deep and wide gullies. Please repair the slopes of the RP-2/3/4 Refuse Pile as soon as possible to ensure that the stability of the pile does not become affected.

**Photo 3:** The RP-2/3/4 Refuse Pile. The largest gullies are outlined in blue ovals.

**Refuse Pile as soon as possible to ensure that the stability of the pile does not become affected.** No off-site impacts were observed.

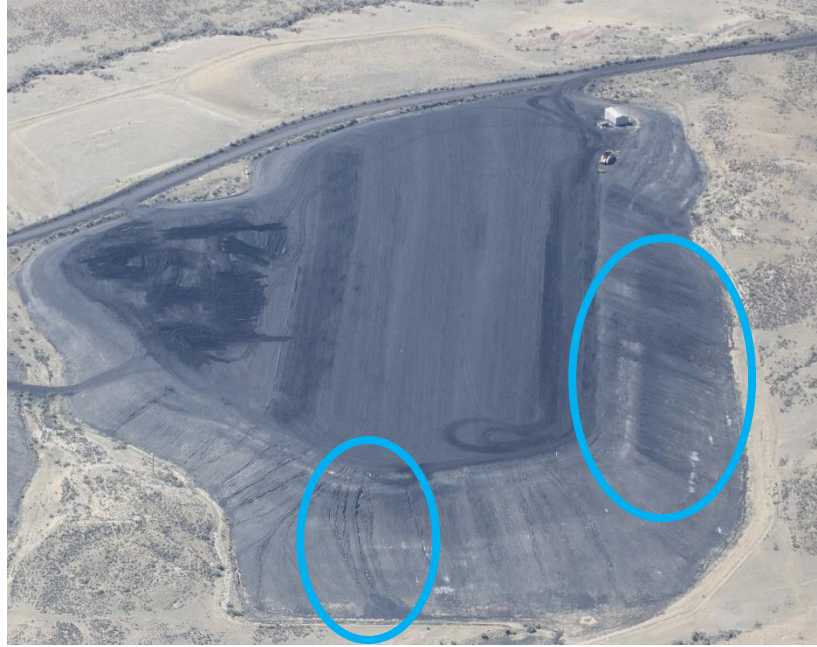
Refuse on top of the RP-5a pile has been spread and compacted. The pile was stable during the inspection. Erosion on the slopes of the pile has been noted in previous Division inspection reports. **Similar to RP-2/3/4, the Division observed during this inspection that some of the rill have significantly enlarged into gullies. There are portions on the north-facing slope that were observed to have deep and wide gullies (Photo 4). Please repair the slopes of the RP-5a Refuse Pile as soon as possible to ensure that the stability of the pile does not become affected.** No off-site impacts were identified.

4. **RP-5a** - Similar to RP-2/3/4, the Division observed during this inspection that some of the rill have significantly enlarged into gullies. There are portions on the north-facing slope that were observed to have deep and wide gullies. Please repair the slopes of the RP-5a Refuse Pile as soon as possible to ensure that the stability of the pile does not become affected.

**Photo 4:** The RP-5a Refuse Pile. The large Gullies are outlined in the blue ovals.

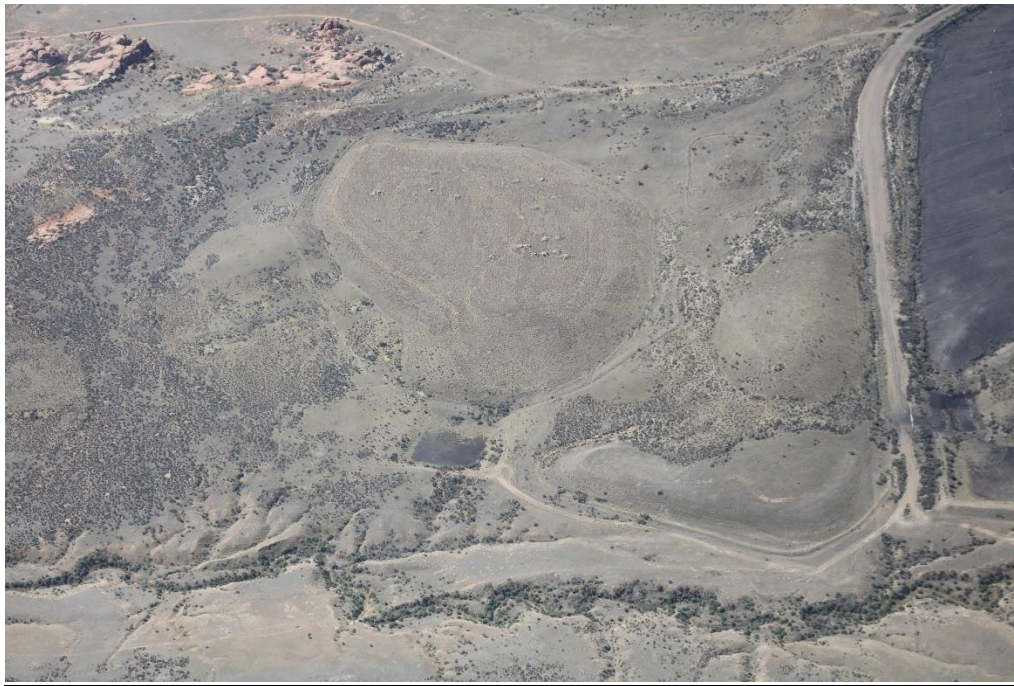
The RP-1 Refuse Pile is the only reclaimed refuse pile at the mine site. The pile was stable with vegetative cover (Photo 5). There were no erosional features noted. The perimeter ditches were dry and stable. There were no off-site impacts observed.

**Photo 5:** The RP-1 Refuse Pile.

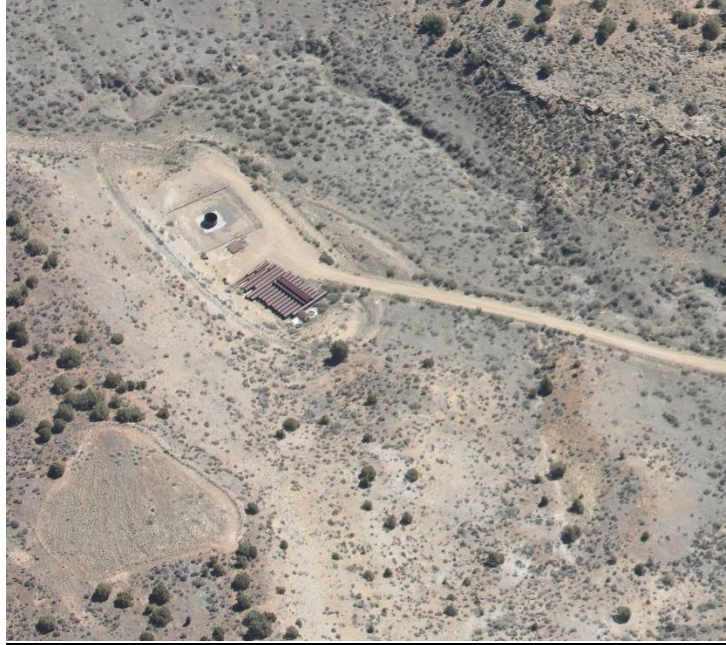
**Photo 6:** The B Seam Vent Shaft No.1.

Pads for the support facilities were observed to be stable with no erosional features. The pads were covered with gravel to prevent erosional features from developing. Berms were vegetated and stable. The Division did not observe any off-site impacts.
