# **PERMIT INFORMATION**

Permit Number: C-1992-081	County: Routt			
Mine Name: Hayden Gulch Loadout	Operation Type: Loadout			
Operator: Hayden Gulch Terminal, LLC	Permit Status: Active			
Operator Address:	Ownership: Private			
Ms Miranda Kawcak				
	Operator Representative Present:			
P.O. Box 670				
Hayden, CO 81639	Kevin Copeland			
Operator Representative Signature: (Field Issuance Only)

## **INSPECTION INFORMATION**

This was an aerial inspection of the Hayden Gulch Loadout; DRMS Permit No. C-1992-081, operated by Hayden Gulch Terminal, LLC. Photos were taken by Brock Bowles on 5/12 and photos were observed by Tabetha Lynch with the Colorado Division of Reclamation, Mining, and Safety (Division) on 5/17.

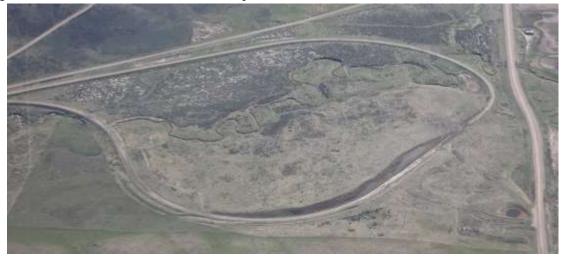
Train loop pond is not holding water, the truck pond is holding water. Dry Creek was flowing. No issues were notes on the ponds or drainage structure during this inspection.

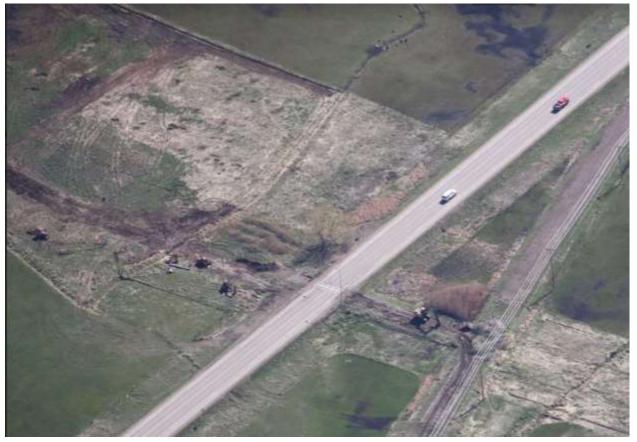
It appears reclamation work is being done in removing the remaining track on both sides of Hwy 40.

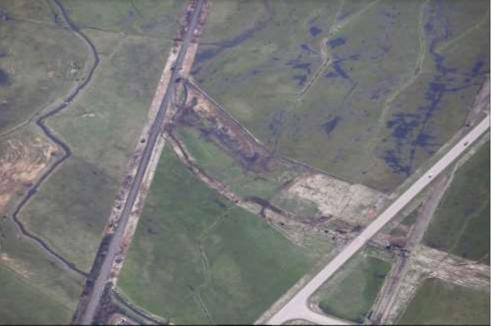
Photo above shown reclamation area, irrigation channels and surrounding flood irrigated fields. Walker ditch is on the left, tracks middle left, Hyw 40 Middle/middle right.
