**PERMIT INFORMATION**

<b>Permit Number:</b> C-1982-056 <b>Mine Name:</b> Foidel Creek Mine <b>Operator:</b> Twentymile Coal, LLC <b>Operator Address:</b> Ms Miranda Kawcak 29515 Routt County Road No. 27 Oak Creek, CO 80467	<b>County:</b> Routt <b>Operation Type:</b> Underground <b>Permit Status:</b> Active <b>Ownership:</b> Private
<b>Operator Representative Present:</b>	
<b>Operator Representative Signature:</b> (Field Issuance Only)

**INSPECTION INFORMATION**

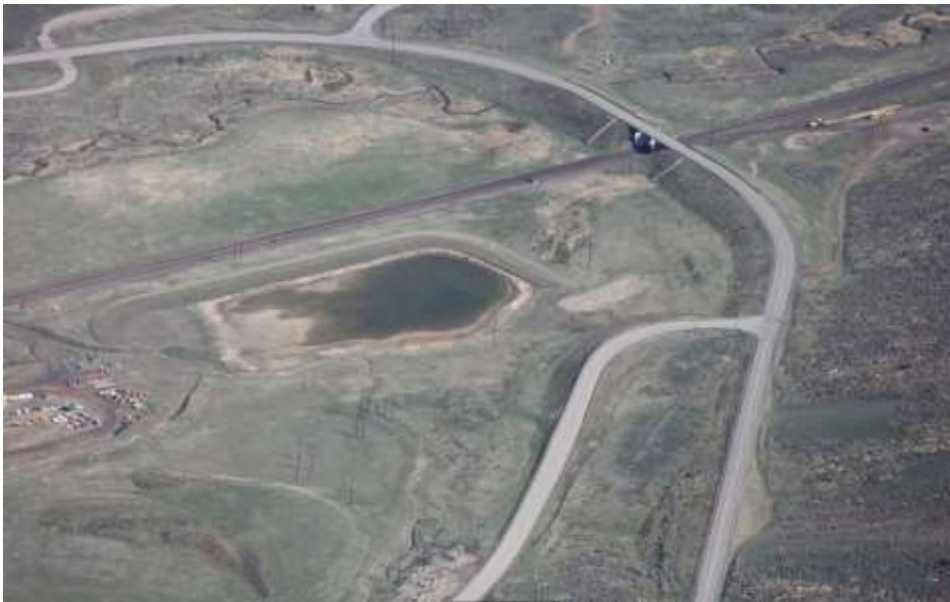
Ponds are holding water, but appear lower than average for the time of year. Pond G shown below, with Foidel Creek at the top and topsoil pile at the bottom of the photo.

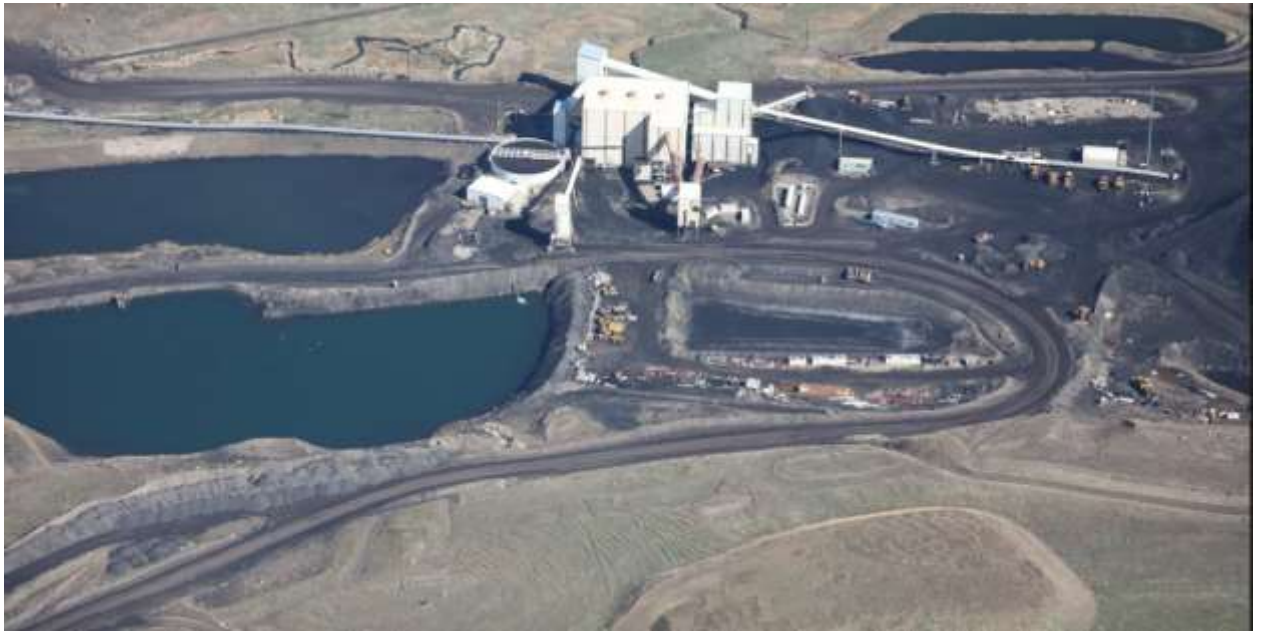
Photo below shows Pond E at the top right, pit pond middle left and pond D just above. The wash plant and thickener tank are mid photo. Topsoil pile is at the bottom of the photo. Part of the waste refuse pile is lower right. No issues are noted from this photo.

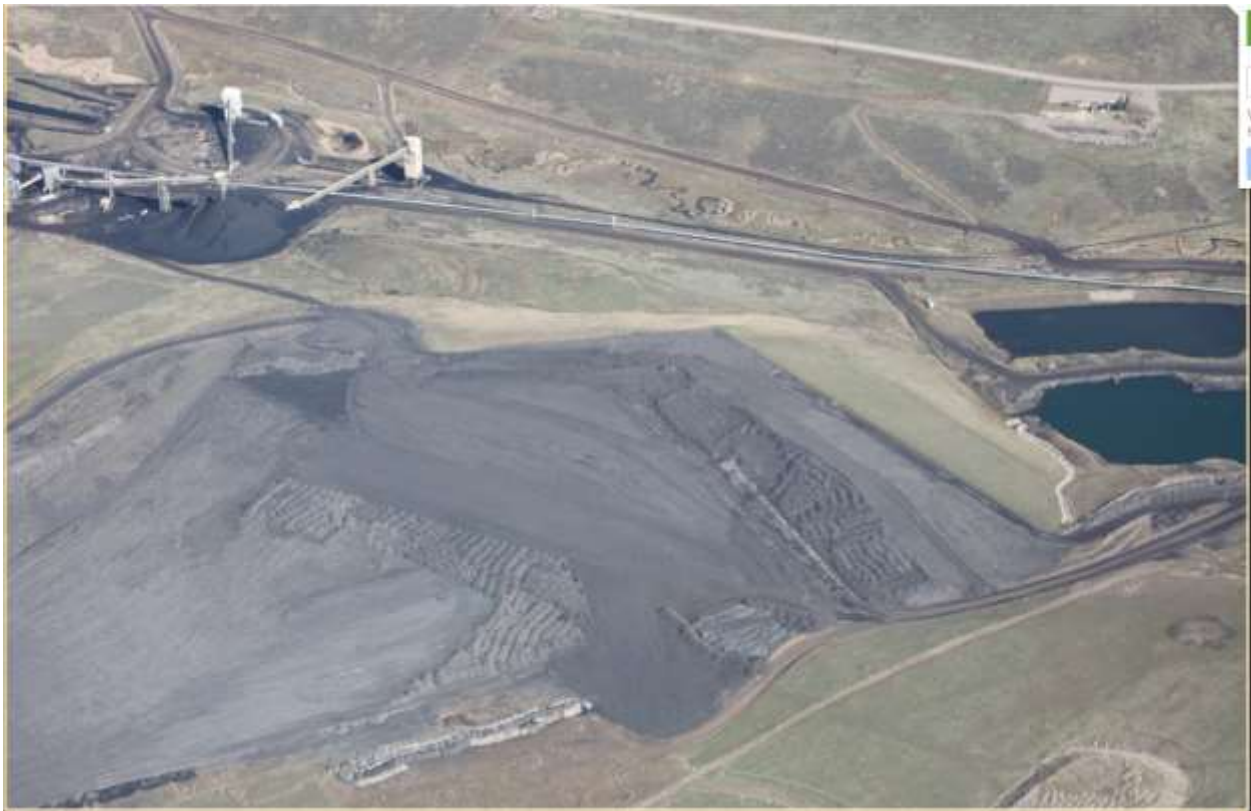
Waste pile is pictured above with the truck and train loadout in top right. No issues are noted from this photo. Cattle are on site. Below is shown the passive treatment ponds at 6MN. Stock pond is shown bottom right.
