**MINERALS PROGRAM INSPECTION REPORT**  
**PHONE: (303) 866-3567**

<b>MINE NAME:</b> Bennett Crossing Filing 2 (Parcel 1 & 2)	<b>MINE/PROSPECTING ID#:</b> M-2019-029/M-2019-030	<b>MINERAL:</b> Borrow material	<b>COUNTY:</b> Adams
<b>INSPECTION TYPE:</b> Monitoring	<b>INSPECTOR(S):</b> Patrick Lennberg	<b>INSP. DATE:</b> May 13, 2021	<b>INSP. TIME:</b> 12:00
<b>OPERATOR:</b> LGI Homes - Colorado, LLC	<b>OPERATOR REPRESENTATIVE:</b> Kacy Flemons	<b>TYPE OF OPERATION:</b> 111(1)(b) - Special One-Time Incidental	
<b>REASON FOR INSPECTION:</b> Normal I&E Program	<b>BOND CALCULATION TYPE:</b> None	<b>BOND AMOUNT:</b> \$75,000.00/\$75,000.00	
<b>DATE OF COMPLAINT:</b> NA	<b>POST INSP. CONTACTS:</b> None	<b>JOINT INSP. AGENCY:</b> None	
<b>WEATHER:</b> Clear	<b>INSPECTOR'S SIGNATURE:</b>

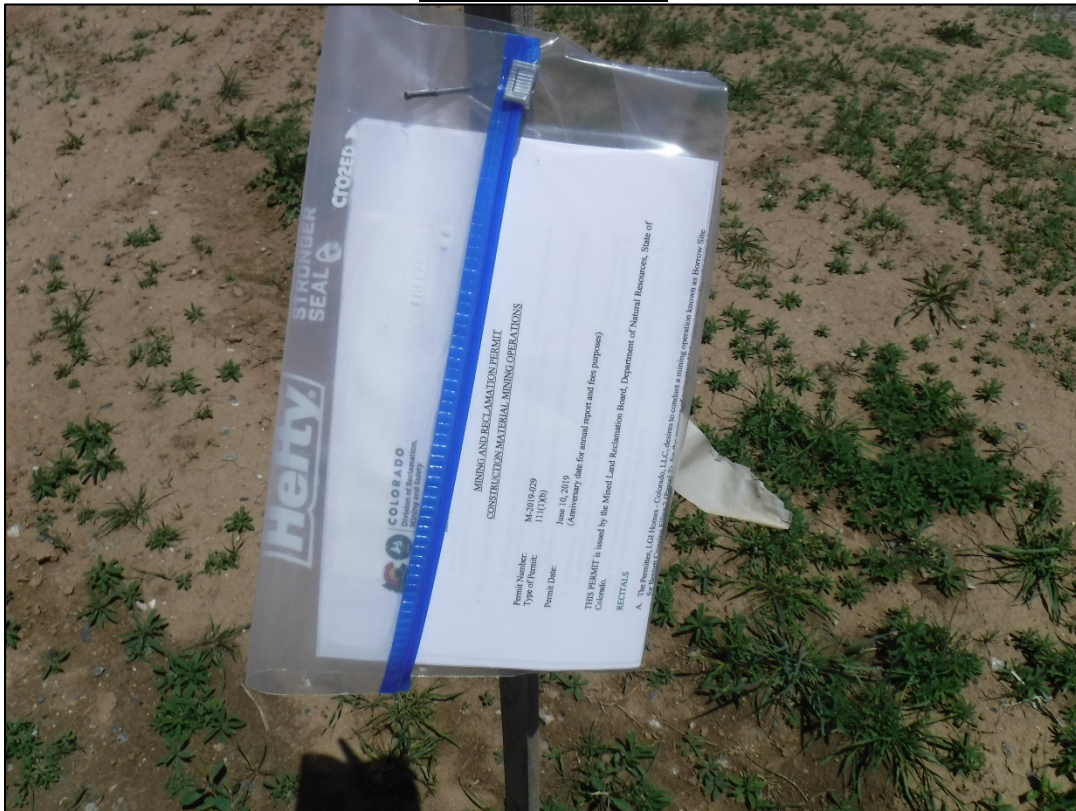
The entrance to Parcel 1 and 2 is located at the east end of Edward Ave off of 1<sup>st</sup> Street in Bennett, Colorado. Each parcel is a 111(1)(b) operation permitted for 25.9 and 30 acres for the removal of borrow material to assist in home construction purposes in the immediate area. The site is surrounded by residential and rangeland with the post-mining land use of industrial/commercial. A mine sign was observed as required by Rule 3.1.12.

**Photo 1:** Mine Sign

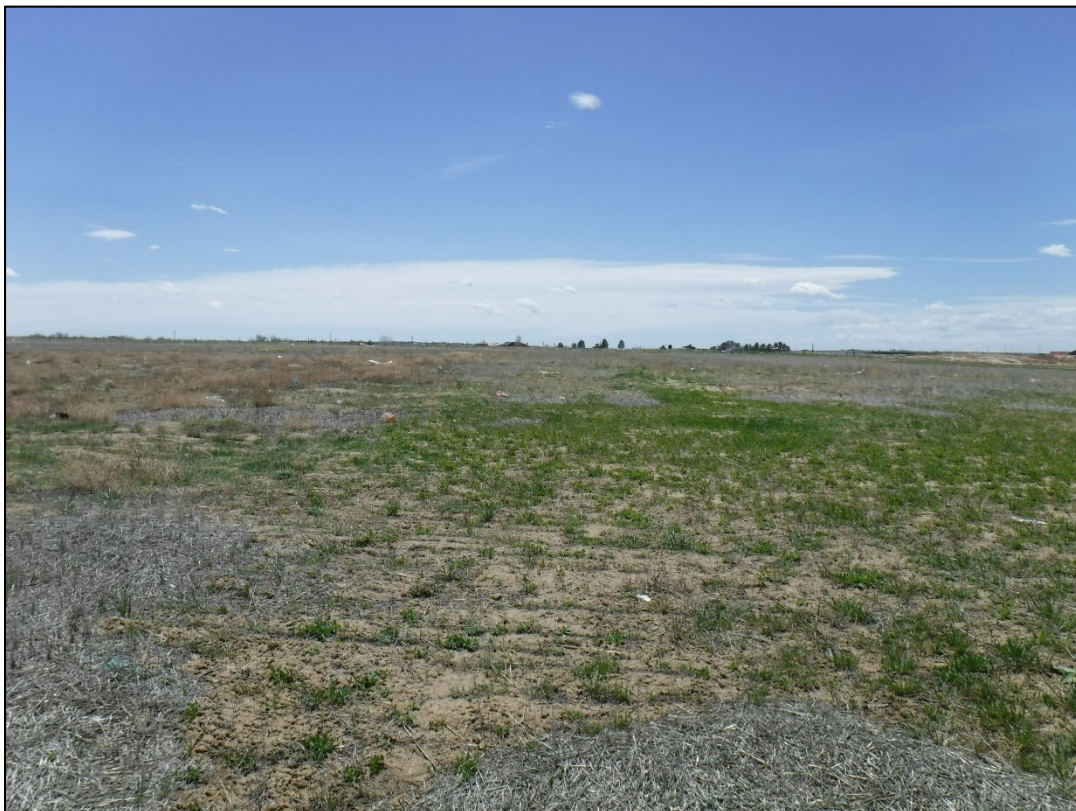
**Photo 2:** Typical new season growth on the southern parcel looking east, M2019-030

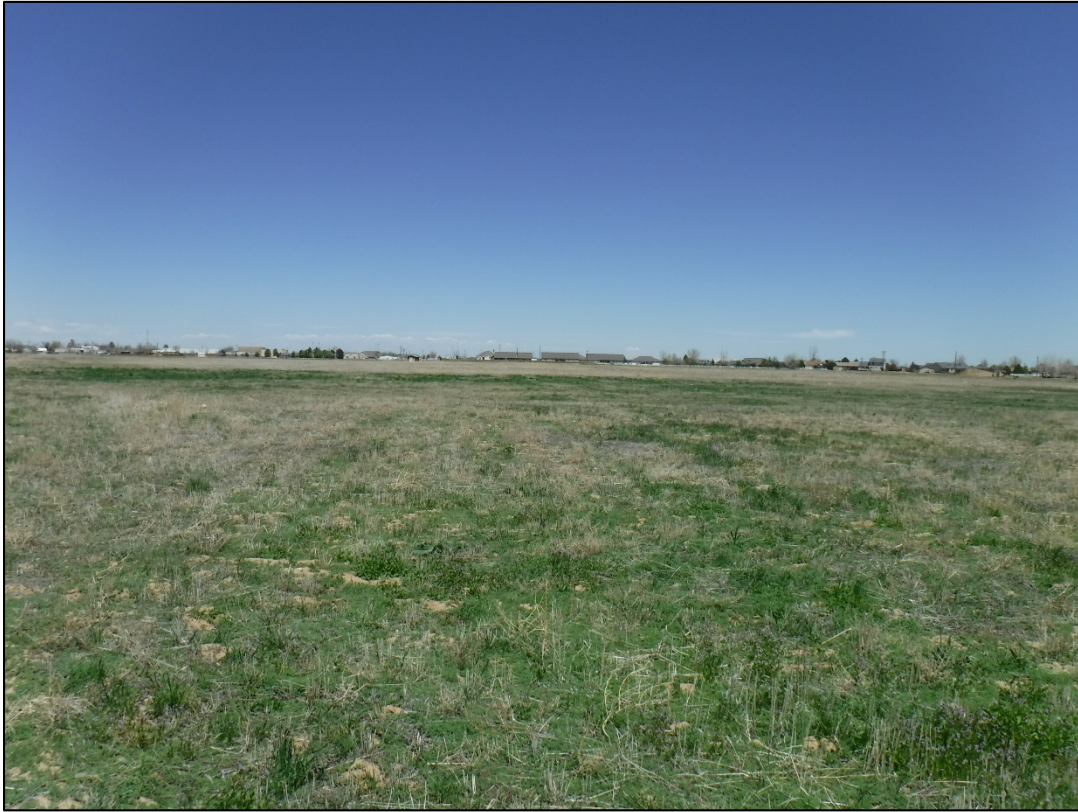
**Photo 3:** Typical new season growth from the middle of the southern parcel looking west, M2019-030

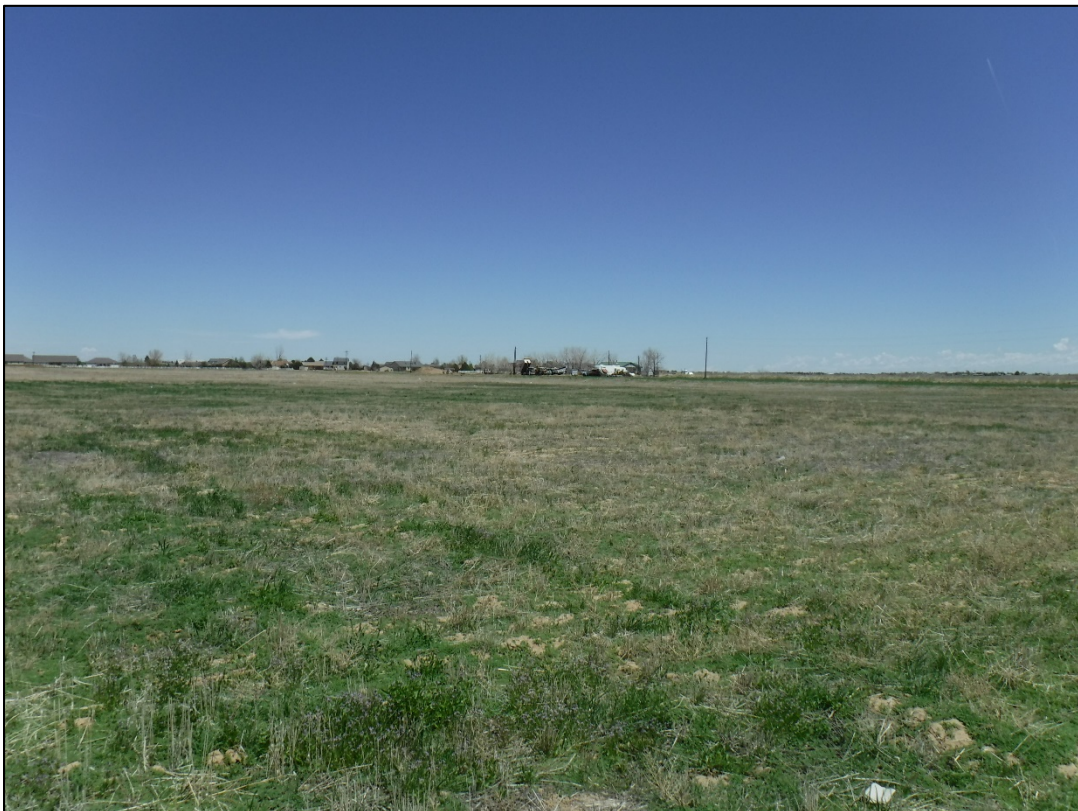
**Photo 4:** Typical new season growth from the middle of the southern parcel looking northeast, M2019-030

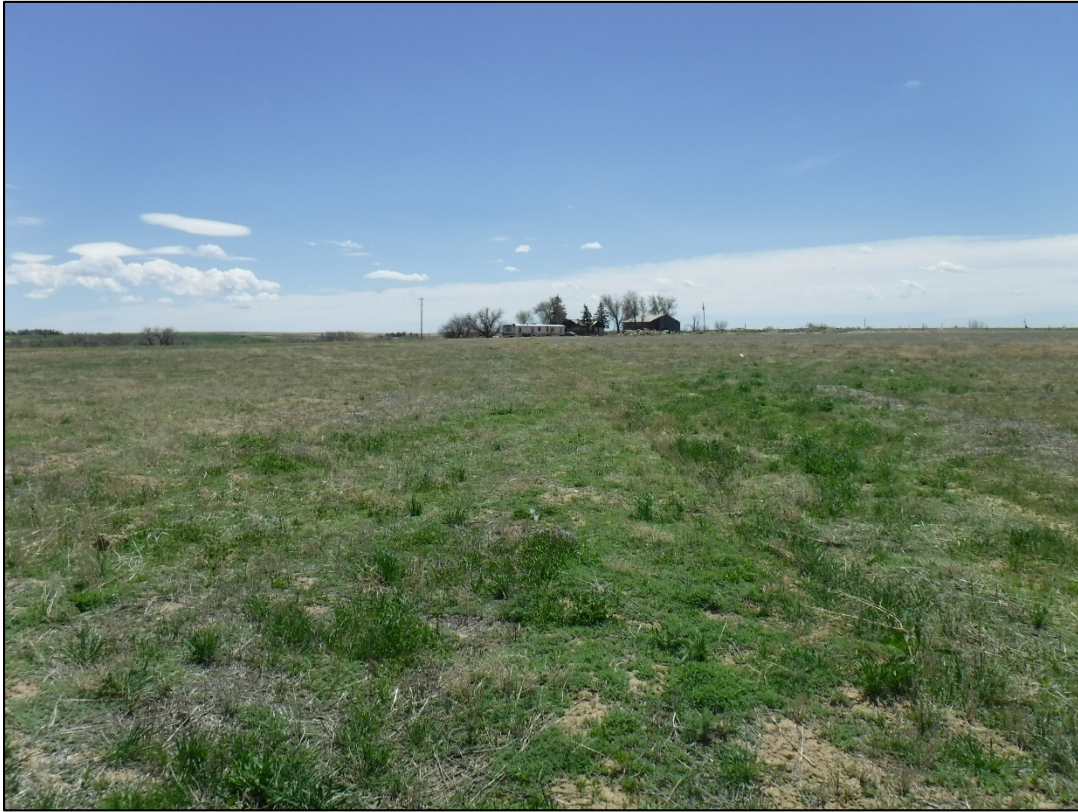
**Photo 5:** Typical new season growth from the middle of the southern parcel looking south, M2019-030

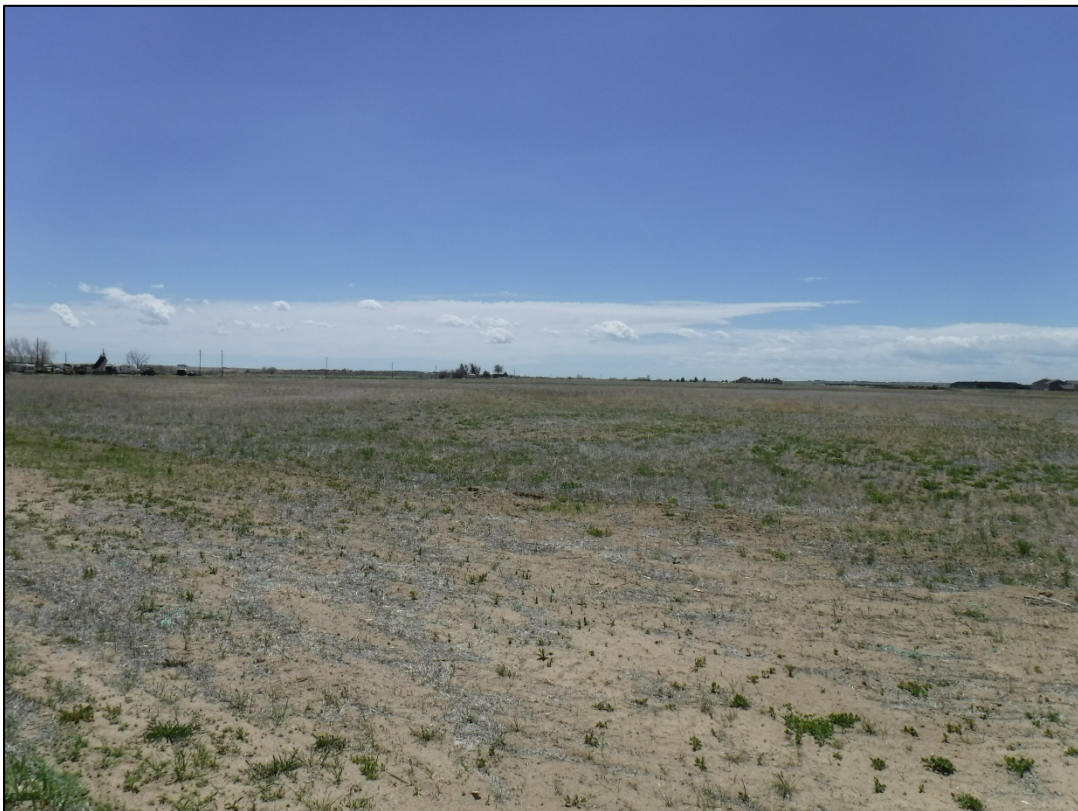
The site was not active at the time of inspection and all mining at the sites has been complete. The sites were mulched and seeded in Fall 2019. Vegetation appears to be growing as expected for the area. There were some weeds volunteering into the sites but they are not acting a source to the surrounding properties. The northern parcel Parcel 1 (M2019-029) has couple areas towards the north end of the permit where vegetation is not growing as well as similar locations and the Division recommends inter-seeding of these areas. Although the post-mining land use industrial/commercial the approved reclamation plan states that the parcels will be reseeded and vegetation will be established to meet the criteria as defined in Rule 3.1.10(1). The rule states land shall be revegetated in such a way as to establish a diverse, effective, and long-lasting vegetative cover that is capable of self-regeneration without continued dependence on irrigation, soil amendments or fertilizer, and is at least equal in extent of cover to the natural vegetation of the surrounding area. The Division, also, recommends the operator perform weed management so the parcels don't become a source to surrounding properties.

**Photo 6:** Typical growth on the north parcel, M2019-029, note gaps in vegetation

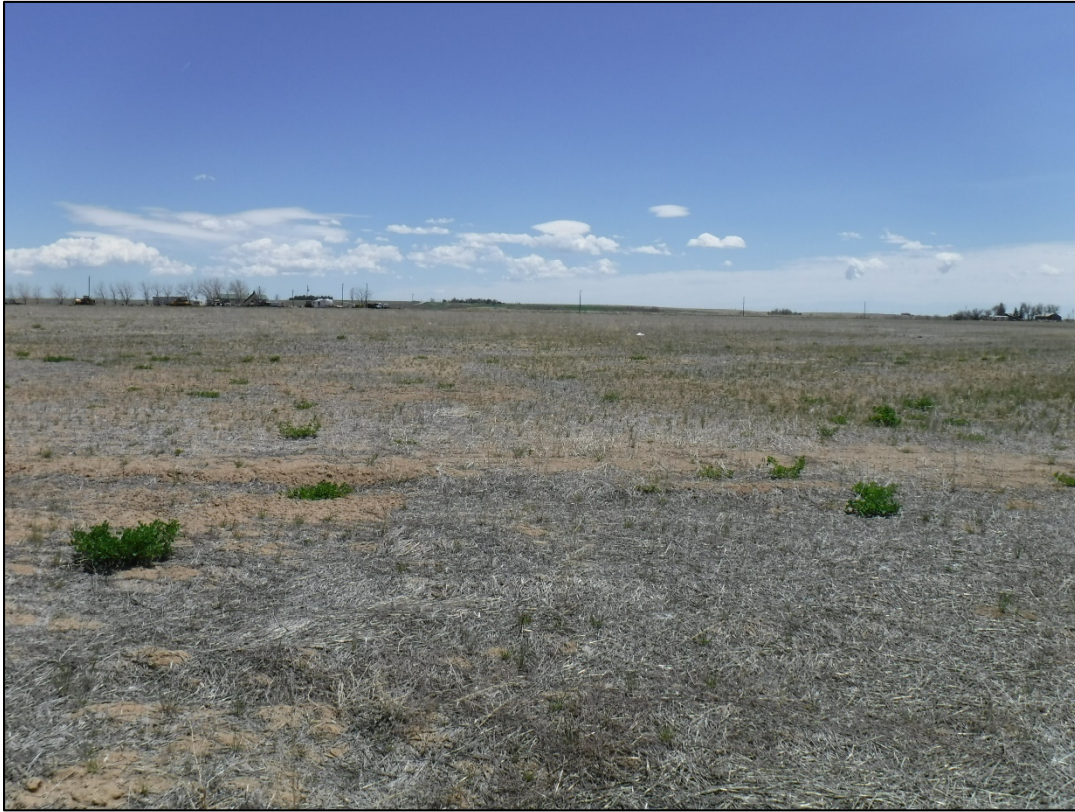
**Photo 7:** Typical growth on the north parcel, M2019-029, looking southeast, note gaps in vegetation

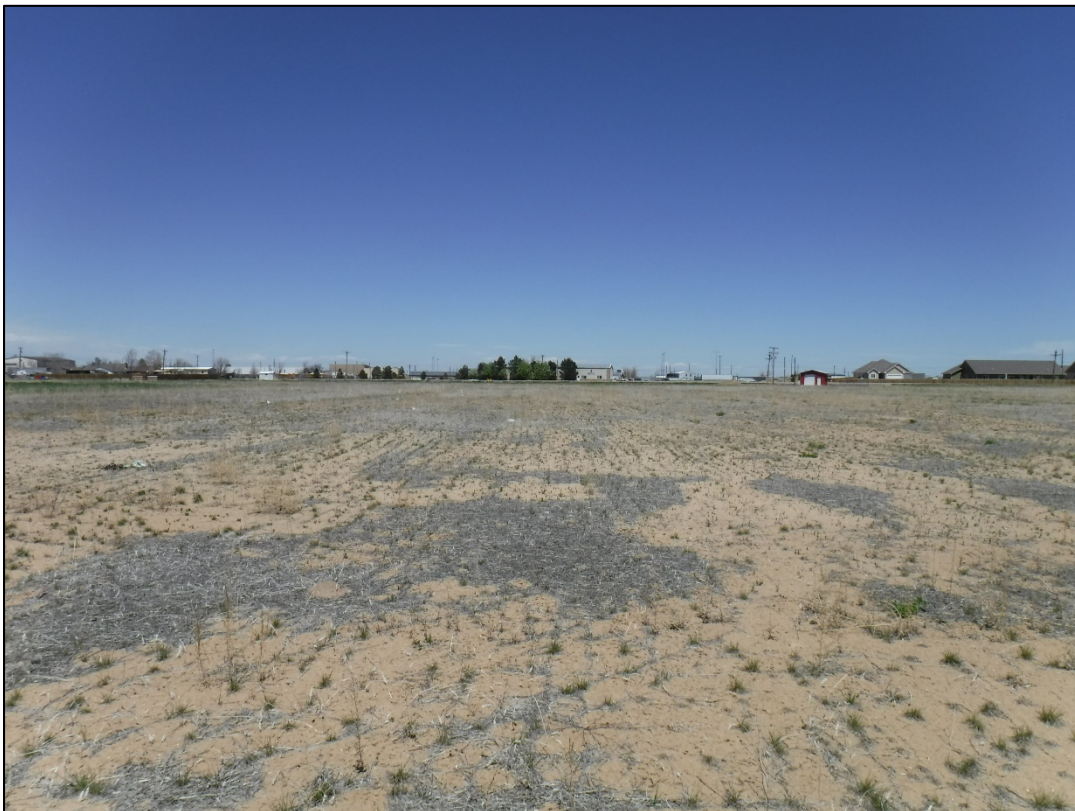
**Photo 8:** Looking north from M2019-029.
