COLORADO
Division of Reclamation,
Mining and Safety
Department of Natural Resources

Permit Number: C-1992-081 Mine Name: Hayden Gulch Loadout Operator: Hayden Gulch Terminal, LLC Operator Address: Ms Miranda Kawcak P.O. Box 670 Hayden, CO 81639	County: Routt Operation Type: Loadout Permit Status: Active Ownership: Private Operator Representative Present: Kevin Copeland
Operator Representative Signature: (Field Issuance Only)

Inspection Start Date: May 13, 2021 Inspection Start Time: 13:30 Inspection End Date: Inspection End Time:		Inspection Type: Coal Partial Inspection Inspection Reason: Normal I&E Program Weather: Clear	
Joint Inspection Agency: None		Joint Inspection Contacts: 	
Post Inspection Agency: None		Post Inspection Contacts: 	
Inspector(s): Tabetha Lynch	Inspector's Signature:

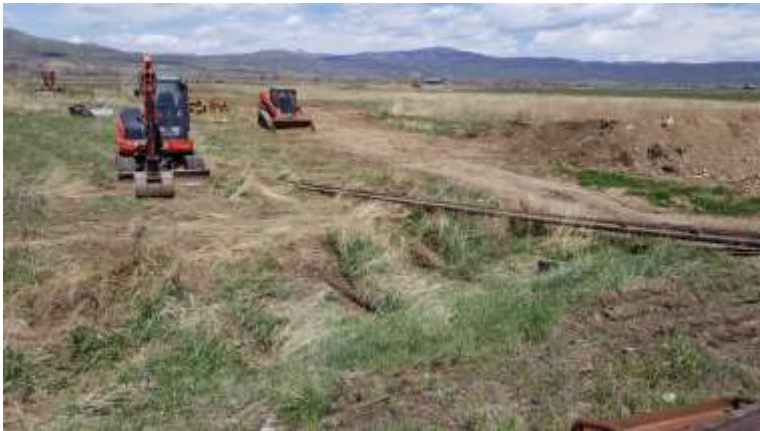
Additional track has been pulled from both sides of Hwy 40. The only track remaining during the inspection was that in Hwy 40.

Photo below is looking north from the north side of Hwy 40

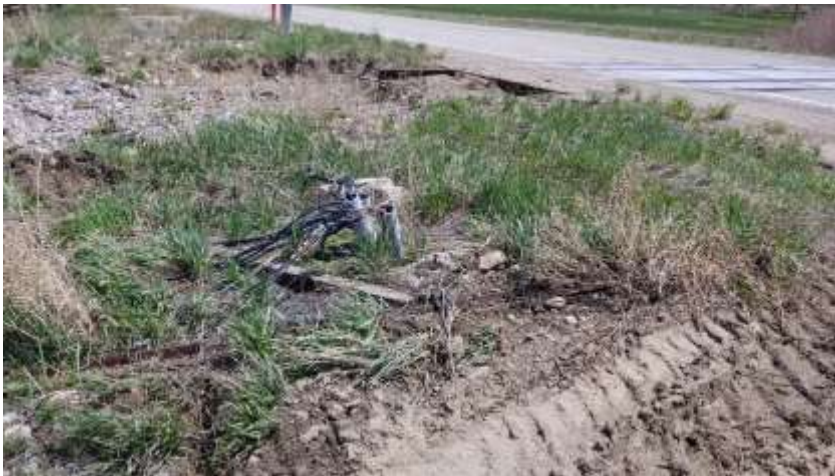
Photo below shows remaining track and wiring to be removed.

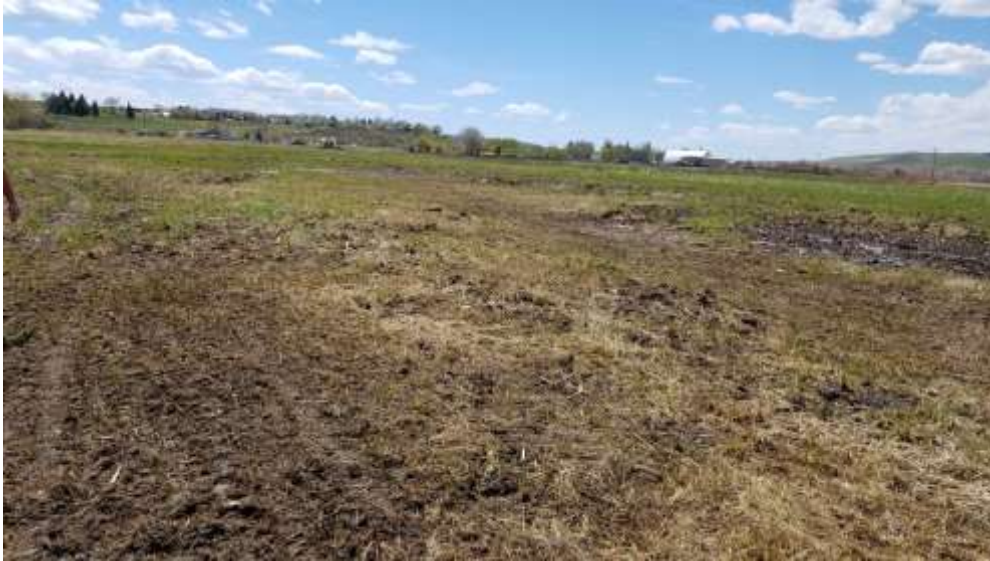
Photo below is looking southwest across remaining area to be reclaimed on the north side of Hwy 40
