SL-7 Bond Release Inspection

COMPANY: Bowie Resources, LLC

MINE: Bowie No. 1

PERMIT NO: C1981038

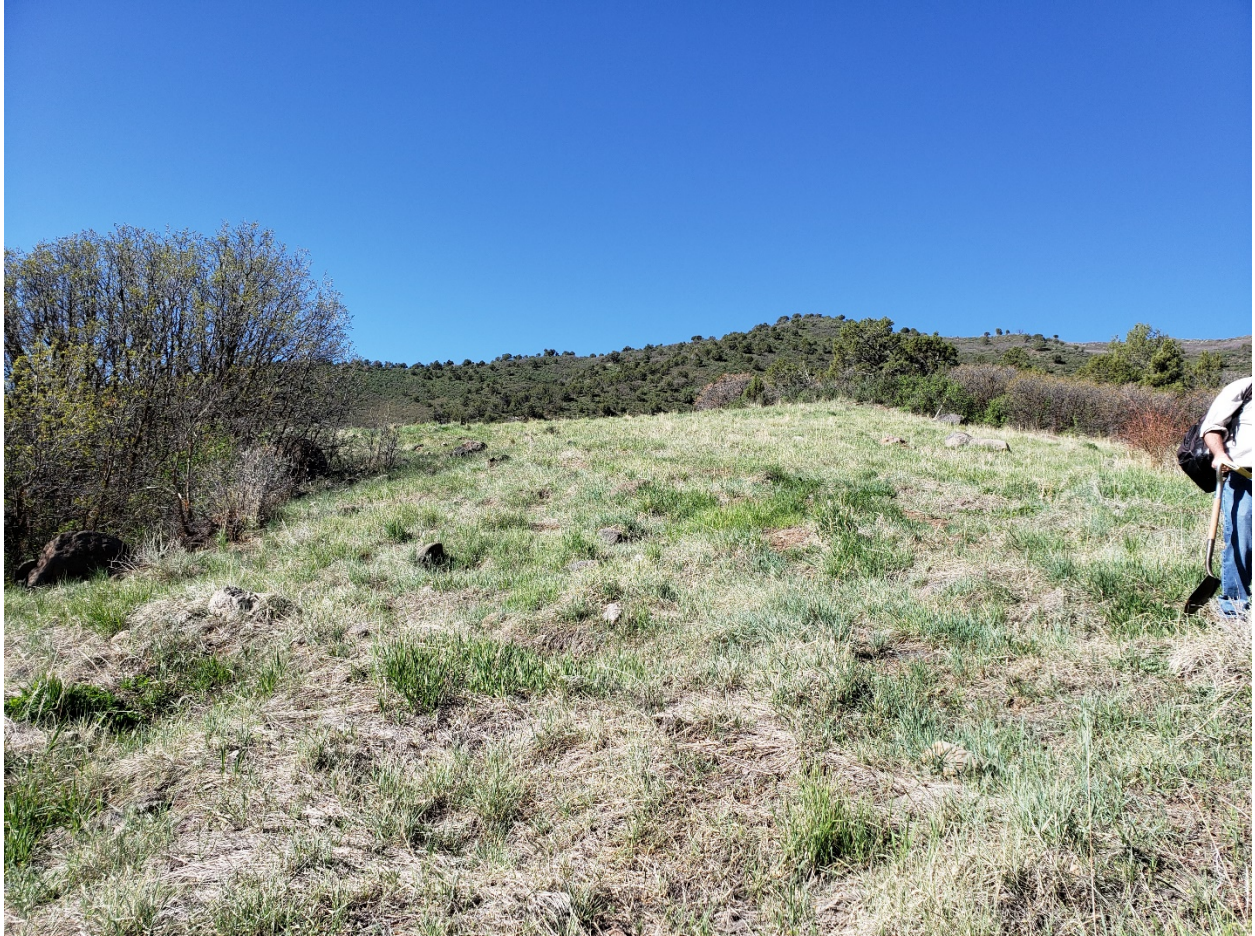
Figure 1 - An example of the reclamation (grassland) adjacent to undisturbed lands (shrubland and forest).

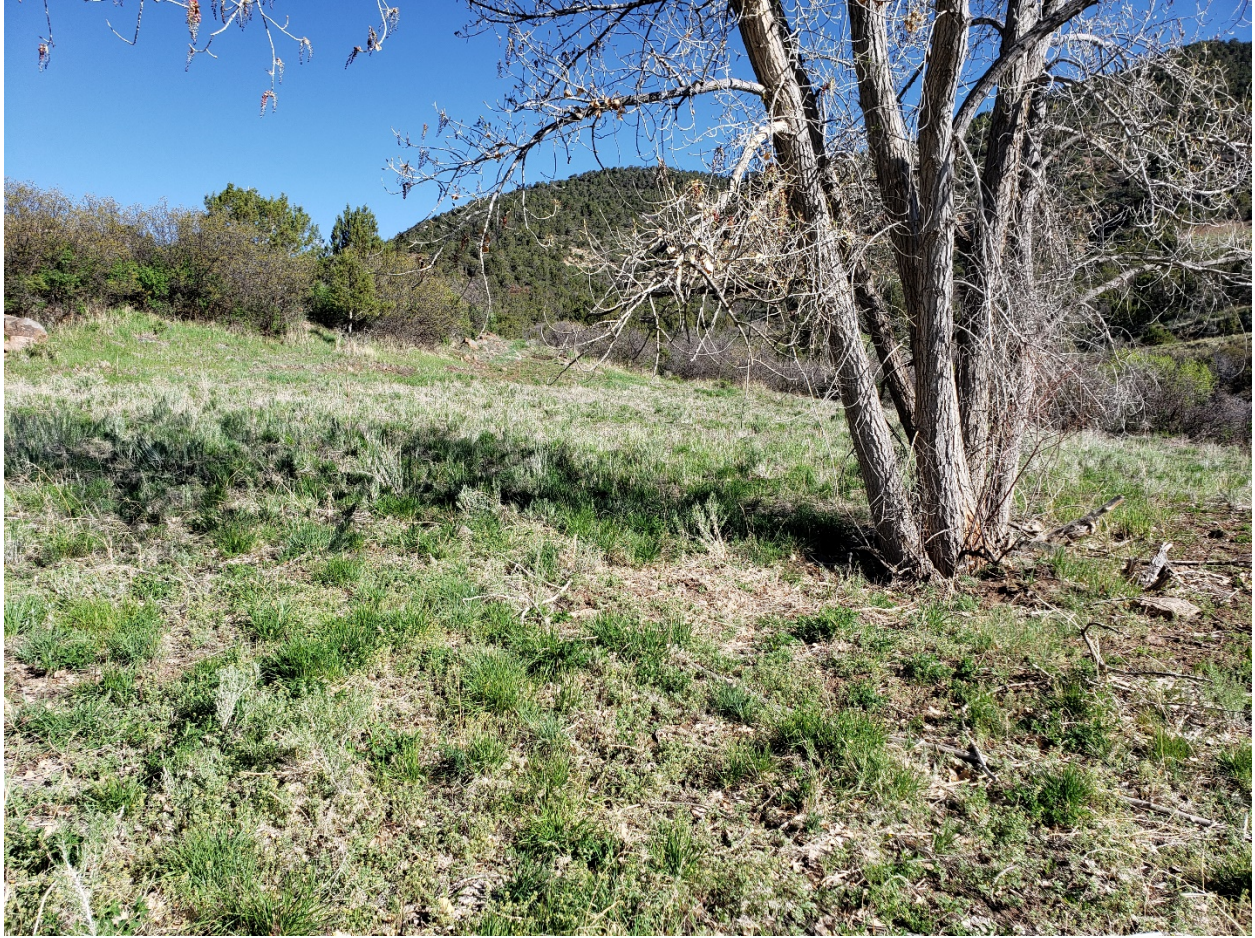
Figure 2 - The reclamation inspected from another vantage point.

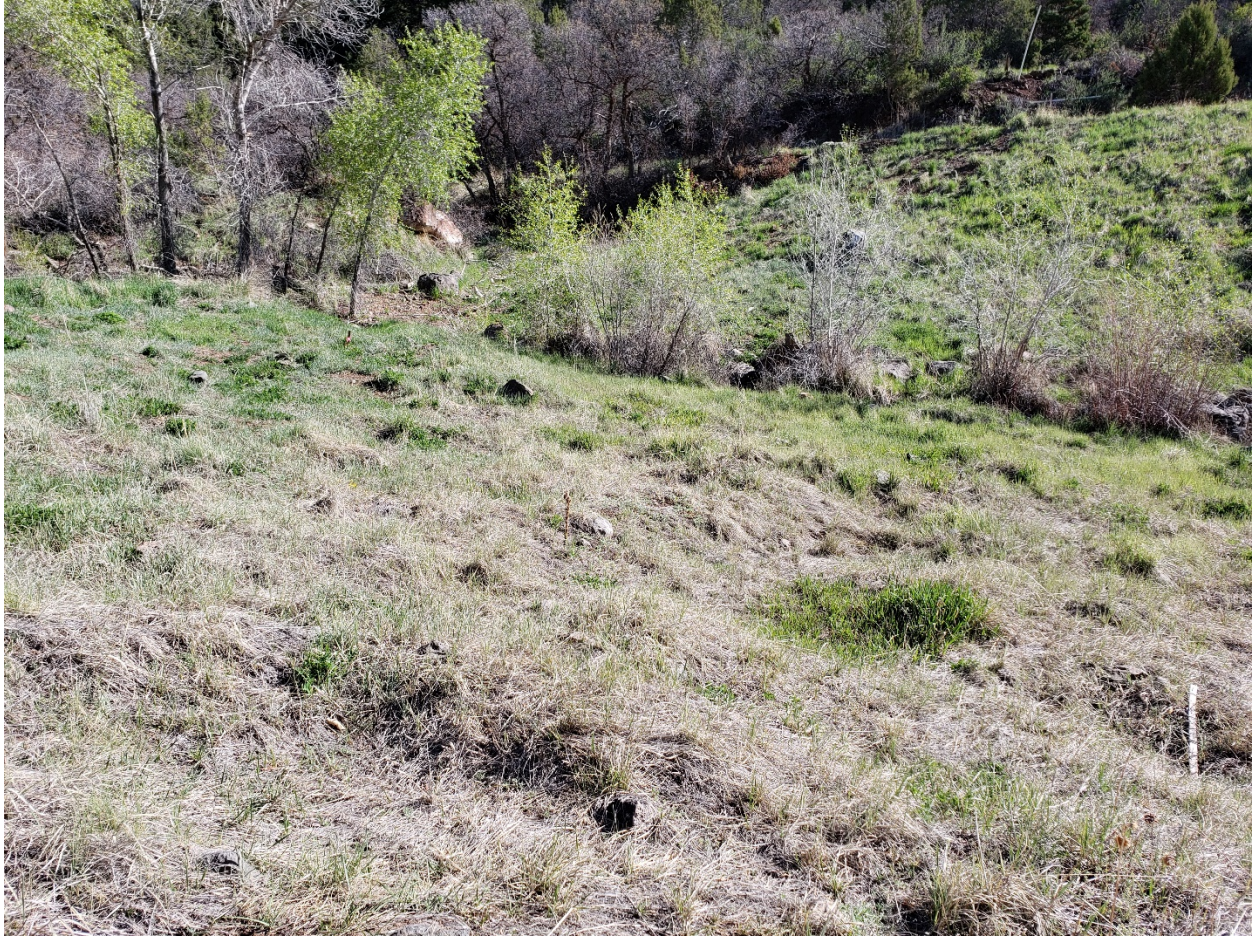
Figure 3 - Reclamation just upslope of a stream (not pictured). All lands were appropriately vegetated and stable.
