**MINERALS PROGRAM INSPECTION REPORT**  
**PHONE: (303) 866-3567**

| <b>MINE NAME:</b><br>Goddard Pit #1 | <b>MINE/PROSPECTING ID#:</b><br>M-2018-050 | <b>MINERAL:</b><br>Sand and gravel and (general) | <b>COUNTY:</b><br>Sedgwick |
| <b>INSPECTION TYPE:</b><br>Surety Release Inspection | <b>INSPECTOR(S):</b><br>Brock Bowles | <b>INSP. DATE:</b><br>May 14, 2021 | <b>INSP. TIME:</b><br>10:00 |

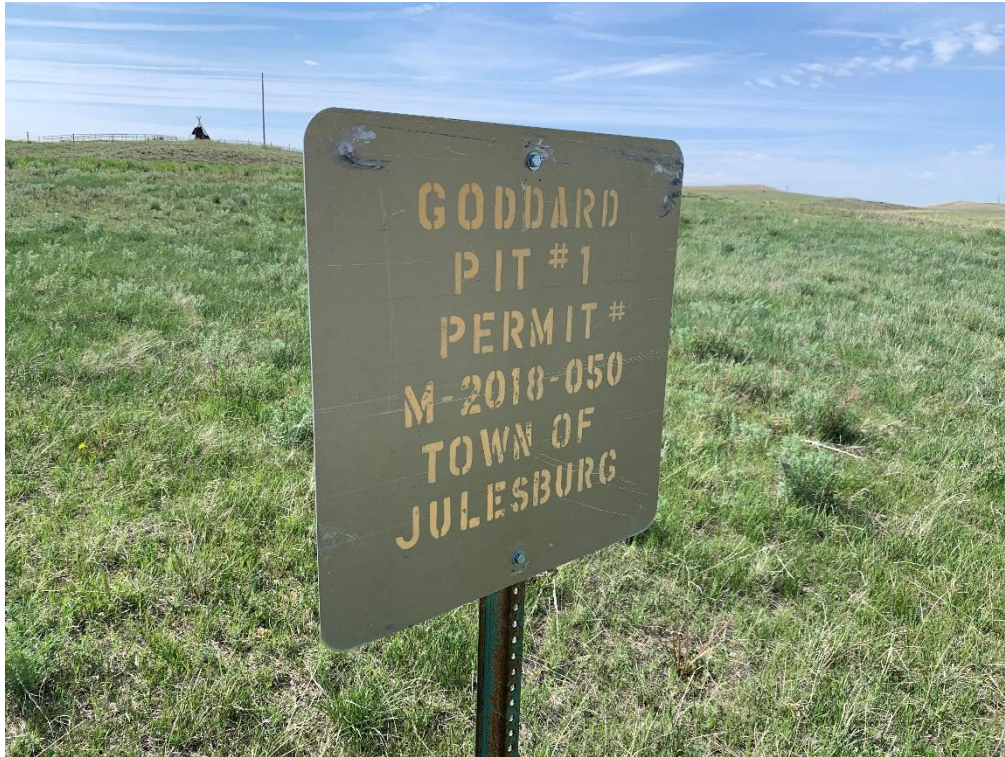
The mine entrance sign was in place facing CR 28 (photo 1). The permit area was fenced and no livestock was in the reclaimed area. Some old cow pies were seen indicating the area has been grazed, probably within the last year.

Photo 1 – Mine entrance sign facing CR 28

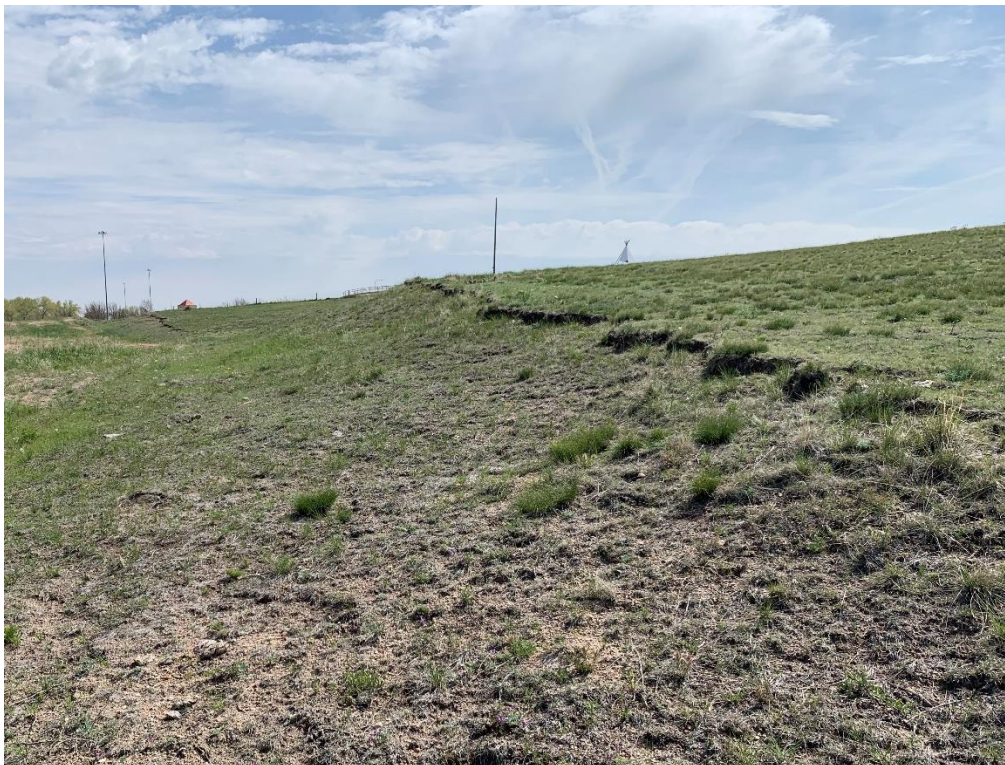
The pit slopes were graded to approximately 3h:1v or greater. A couple sections of the backfilled slopes on the east side of the permit area appeared to have settled a little resulting in a small bench on the top of the backfills (photo 2). These small benches were 6 inches or less in height. The vegetation above and below the bench was well established. There were no rills, gullies or other signs of erosion on the benches or backfilled areas. The benches appeared to be stable.

Photo 2 – Small benches from backfill settling

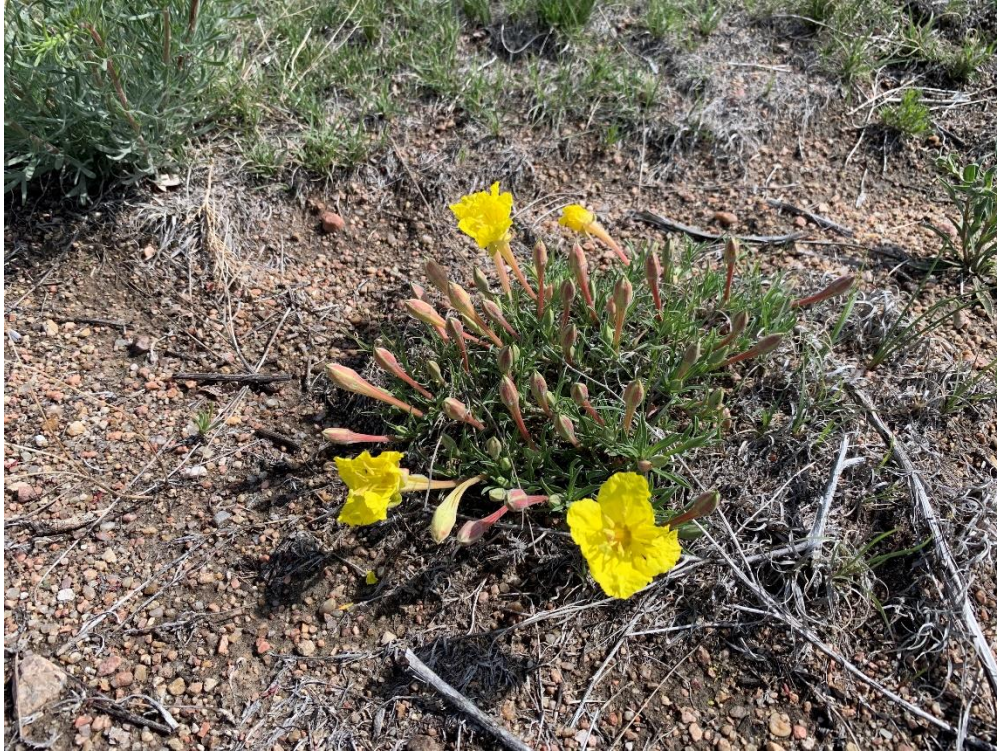
The vegetation was well established and the cover was similar to that of the surrounding areas (Rule 3.1.10(1)). Several different grass species were noted but species identification was not possible because the seed heads were not developed. Several forb species were seen including lavenderleaf sundrops (photo 3), plains stoneseed (photo 4), sand lily, blazing star, alfalfa, wavyleaf dandelion, milkvetch, four-nerve daisy, fringed sage and rubber rabbitbrush. The vegetation was dense in most places especially the low areas (photo 5). There were a few areas where the vegetation was not as well established (photo 6). These areas accounted for a small percentage of the overall permitted area.

Photo 3 – Lavenderleaf sundrops

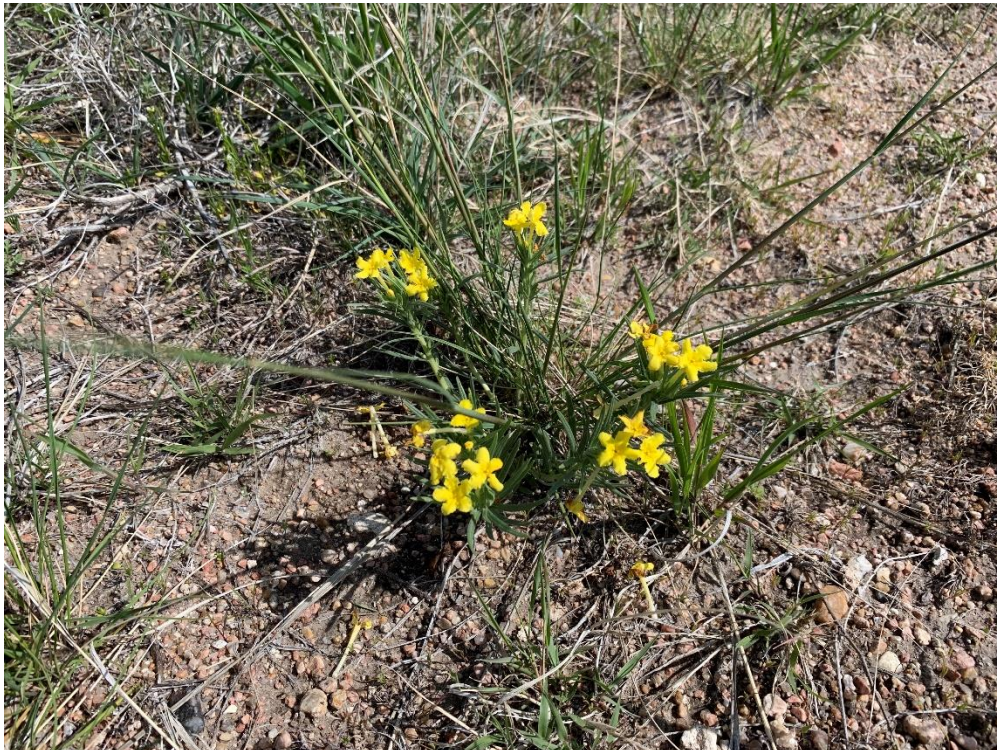
Photo 4 – Plains stoneseed

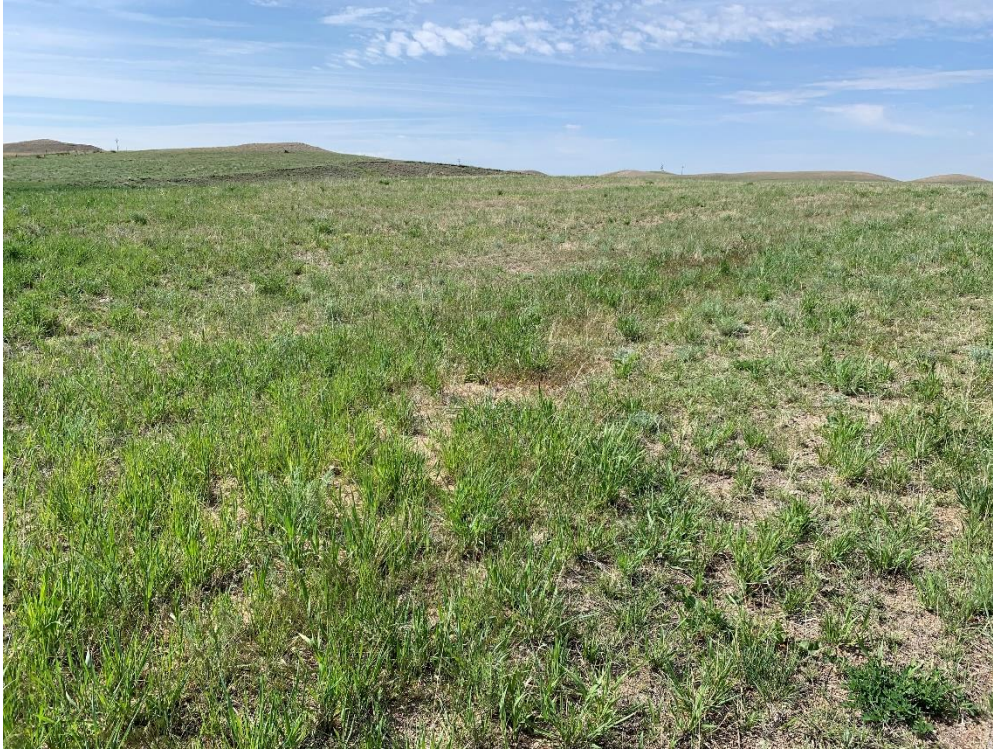
Photo 5 – Grasses well established

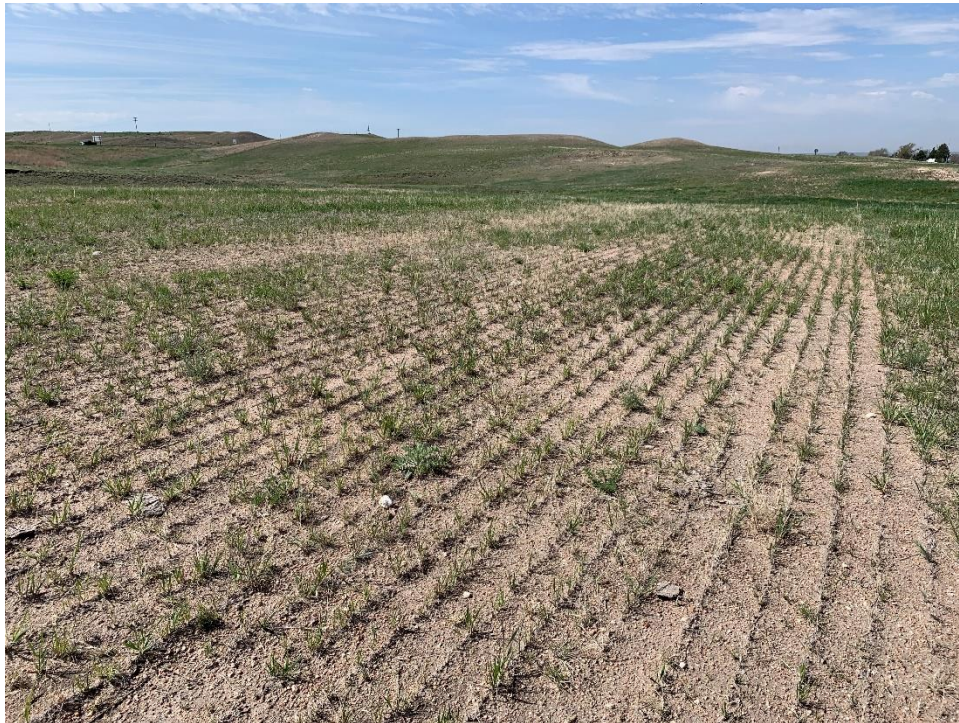
Photo 6 – Vegetation thin spot in southwest corner

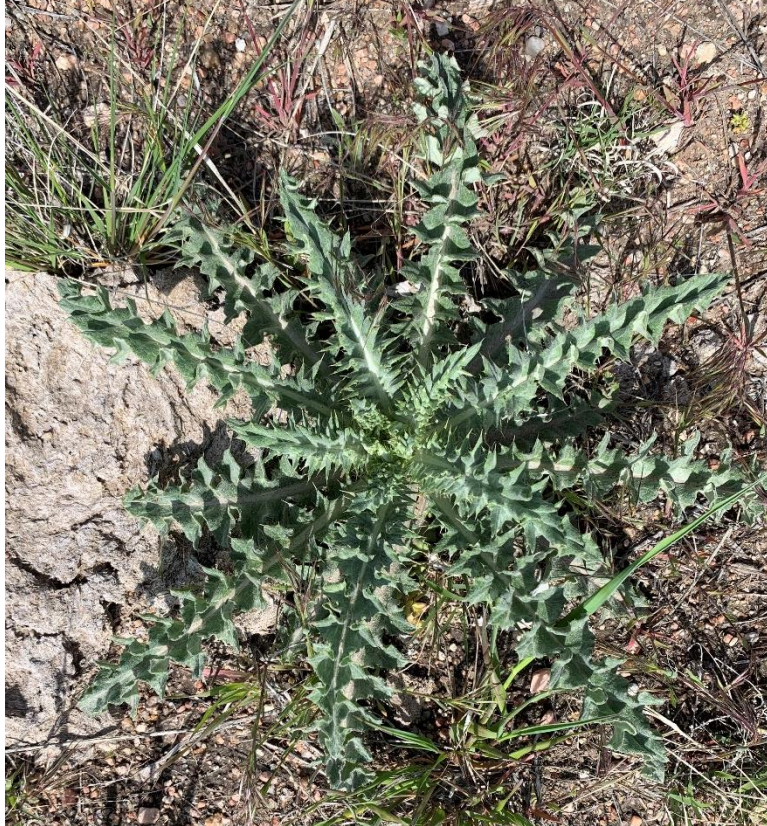
There were a couple of small patches of cheatgrass, but the amount of cheatgrass was significantly less than the areas outside the reclamation. A few thistle rosettes were noted in the reclamation (photo 7). It appears these thistles may be wavyleaf thistles, which are native and common to the Julesburg area. The thistles should be monitored later in the spring once the flowers bloom to verify they are not a noxious species.

Photo 7 – Wavyleaf thistle, needs to be verified when the plant flowers.
