MINERALS PROGRAM INSPECTION REPORT
PHONE: (303) 866-3567

MINE NAME: Dist No 2 Gravel Pit	MINE/PROSPECTING ID#: M-1979-216	MINERAL: Sand and gravel	COUNTY: Fremont
INSPECTION TYPE: Monitoring	INSPECTOR(S): Timothy Cazier, P.E.	INSP. DATE: March 30, 2021	INSP. TIME: 11:05
OPERATOR: Fremont County	OPERATOR REPRESENTATIVE: Sterling Rife	TYPE OF OPERATION: 110c - Construction Limited Impact	
REASON FOR INSPECTION: Normal I&E Program	BOND CALCULATION TYPE: None	BOND AMOUNT: No Bond Held	
DATE OF COMPLAINT: NA	POST INSP. CONTACTS: None	JOINT INSP. AGENCY: None	
WEATHER: Cloudy	INSPECTOR'S SIGNATURE:

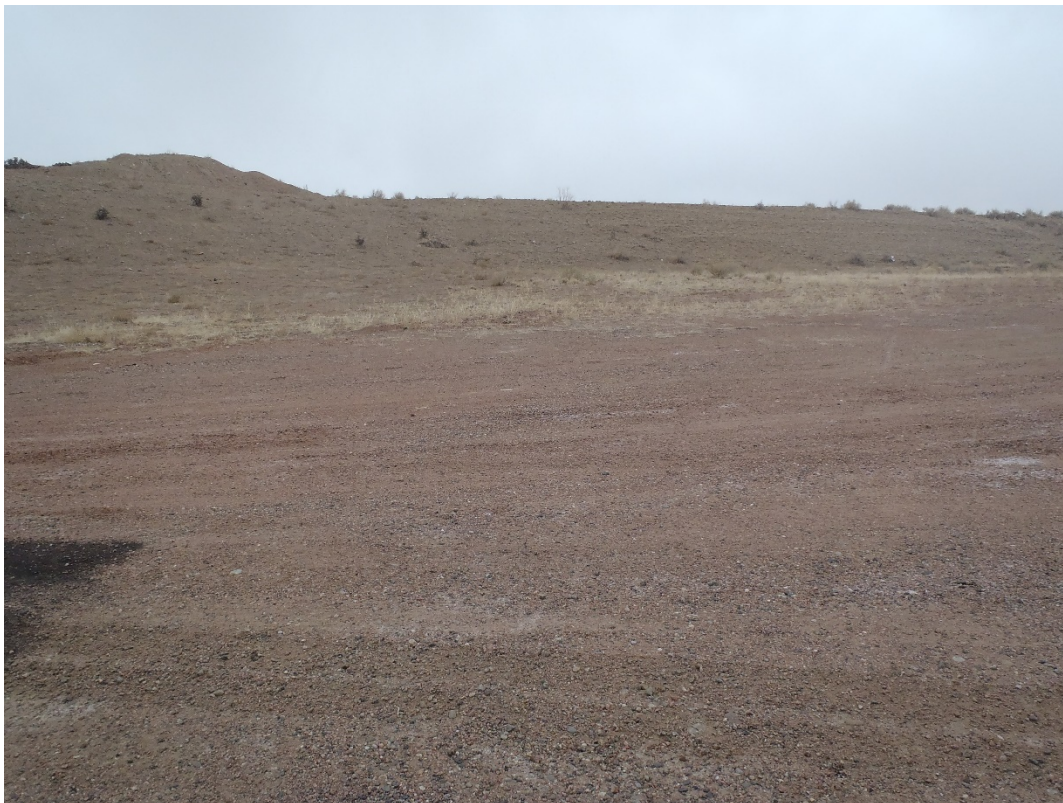
Gen. Compliance with Mine Plan: The operation appeared to be in compliance with the approved mine plan. The maximum allowed disturbed area is 9.9 acres. Google Earth was used to measure the disturbed area, which was estimated to be approximately 7.7 acres, based on 2019 imagery. Highwalls were highest on the north side (see **Photo 1**), estimated to be 20 feet in height and lower (~15 feet in height) in the southeast corner (see **Photo 2**). Highwalls appeared stable.

Photo 1. North (south facing) reclaimed highwalls (looking NE from pit floor).

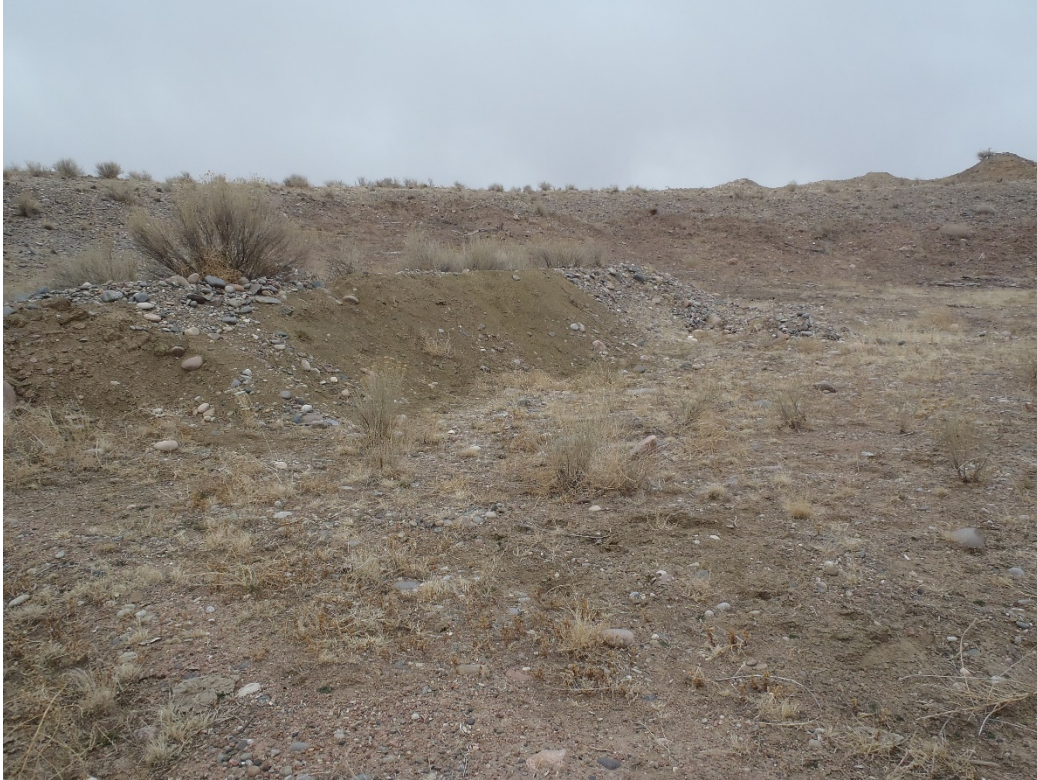
Photo 2. South / southeast partially reclaimed highwalls (looking south from east pit floor).

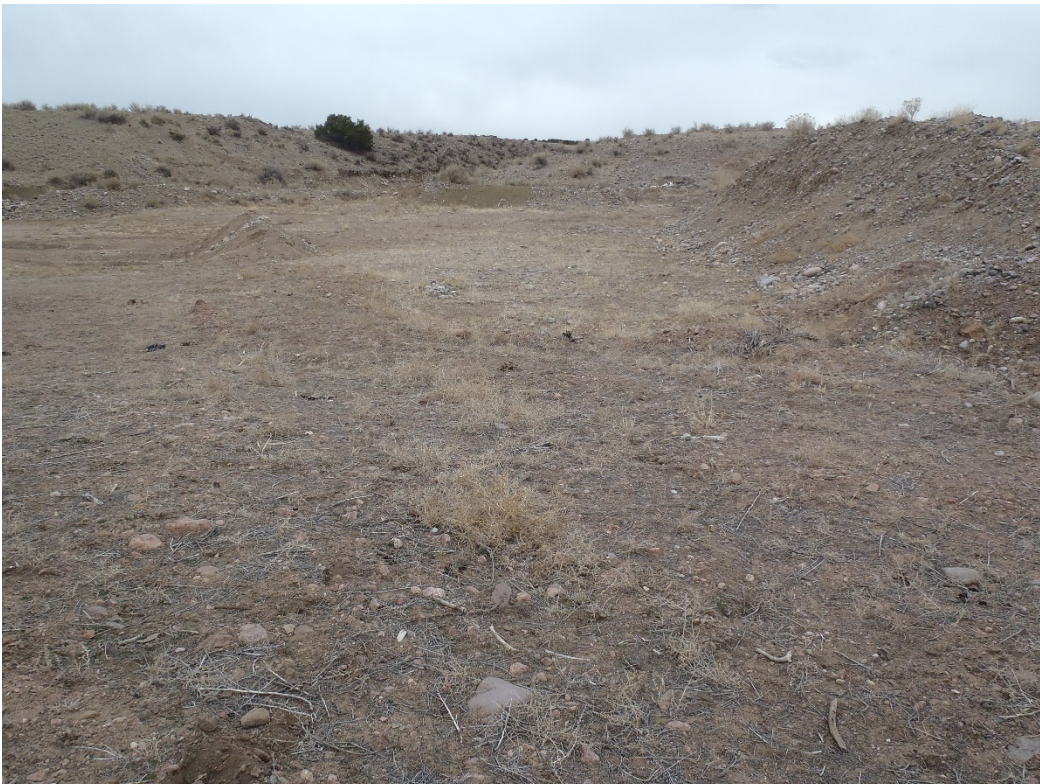
Processing Waste: A stockpile of material had been pushed up on the east end of the pit to expose the shale layer underneath. (see **Photo 3**).

Reclamation Success: Mr. Rife indicated this site is all but mined out. The County has completed the grading (to ~3H:1V), placed topsoil and seeded the highwalls on the north and south portions (see **Photo 4**) of the pit. The pushed up material in **Photo 3** remains to be graded out and the pit floor will need to be topsoiled and seeded.

Photo 3. Pushed up stockpiled material left from exposing shale layer on pit floor (south side, looking east).

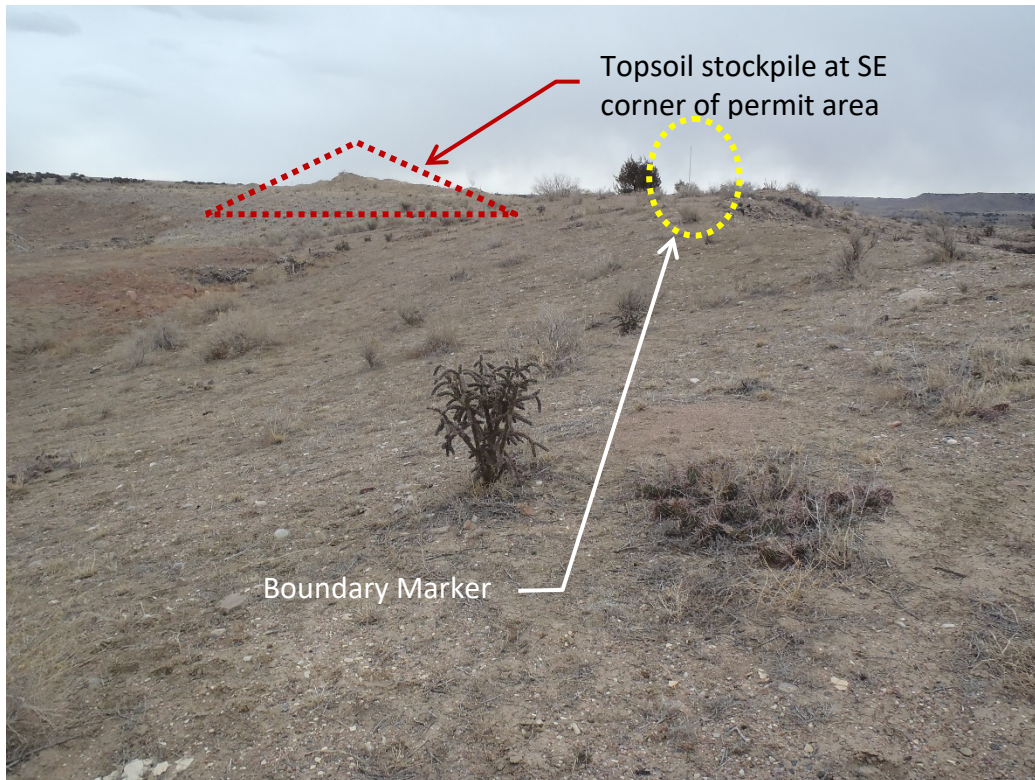
Signs and Markers: The permit sign was properly posted (see **Photo 5**) and boundary markers were observed to delineate the permit boundary (see **Photo 4**).

Topsoil: Topsoil was salvaged on the order of 40 years ago and was of poor quality as is the topsoil in most of this region. Mr. Rife presumed the stockpiles located on the northwest (see **Photo 7**) and southeast crests (see **Photo 4**) are what remains of the salvaged topsoil. [This material should be spread on the pit floor prior to final seeding to help assure vegetation is re-established.](#)

Photo 4. Crest of south self-vegetated highwall (looking east).

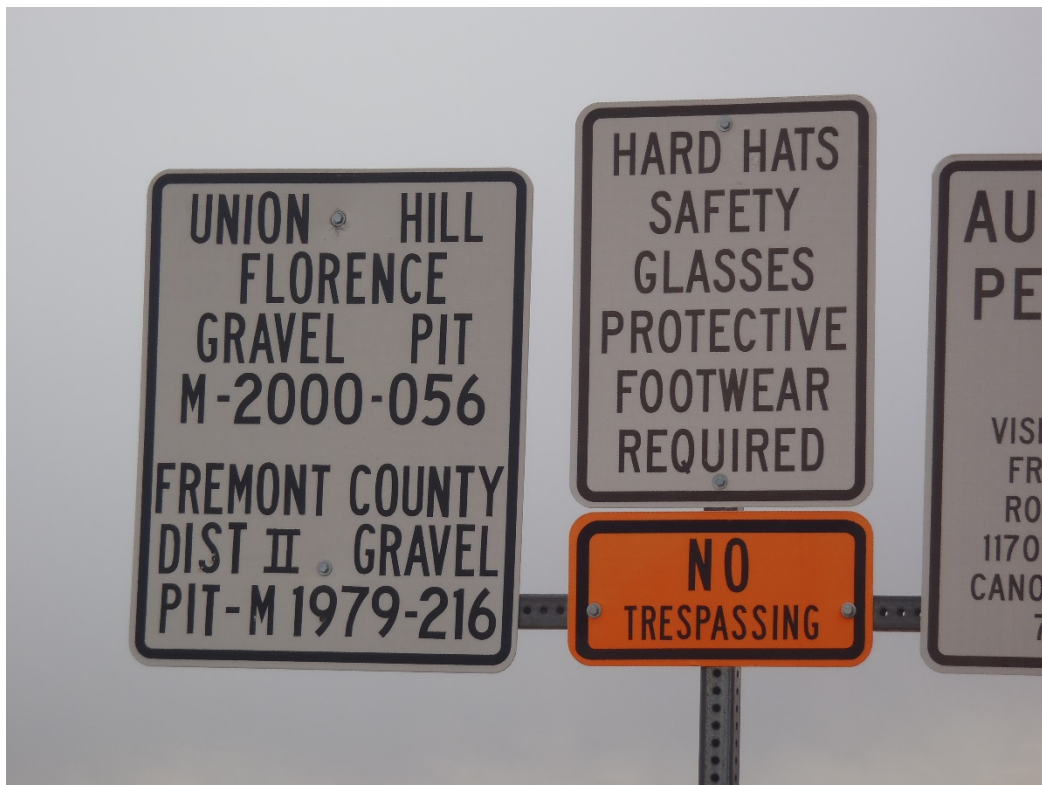
Photo 5. Permit sign at entrance (includes newer Union Hill permit accessed from the same entrance).

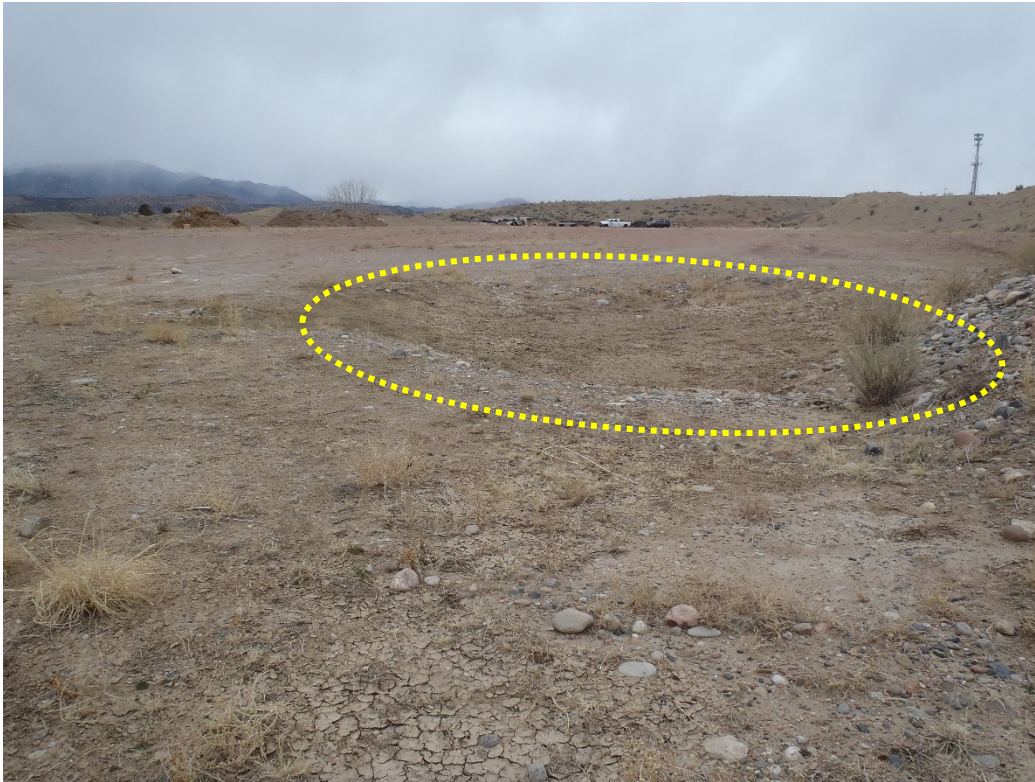
Storm Water MGT Plan: No oil or fuel spills observed. Stormwater drains to the pit floor (see **Photo 6**) and infiltrates.

Photo 6. Low point in pit where stormwater infiltrates (east end looking west).
